# LAKE ASSESSMENT REPORT FOR STRAWBERRY LAKE IN HILLSBOROUGH COUNTY, FLORIDA

Date Assessed: July 15, 2008

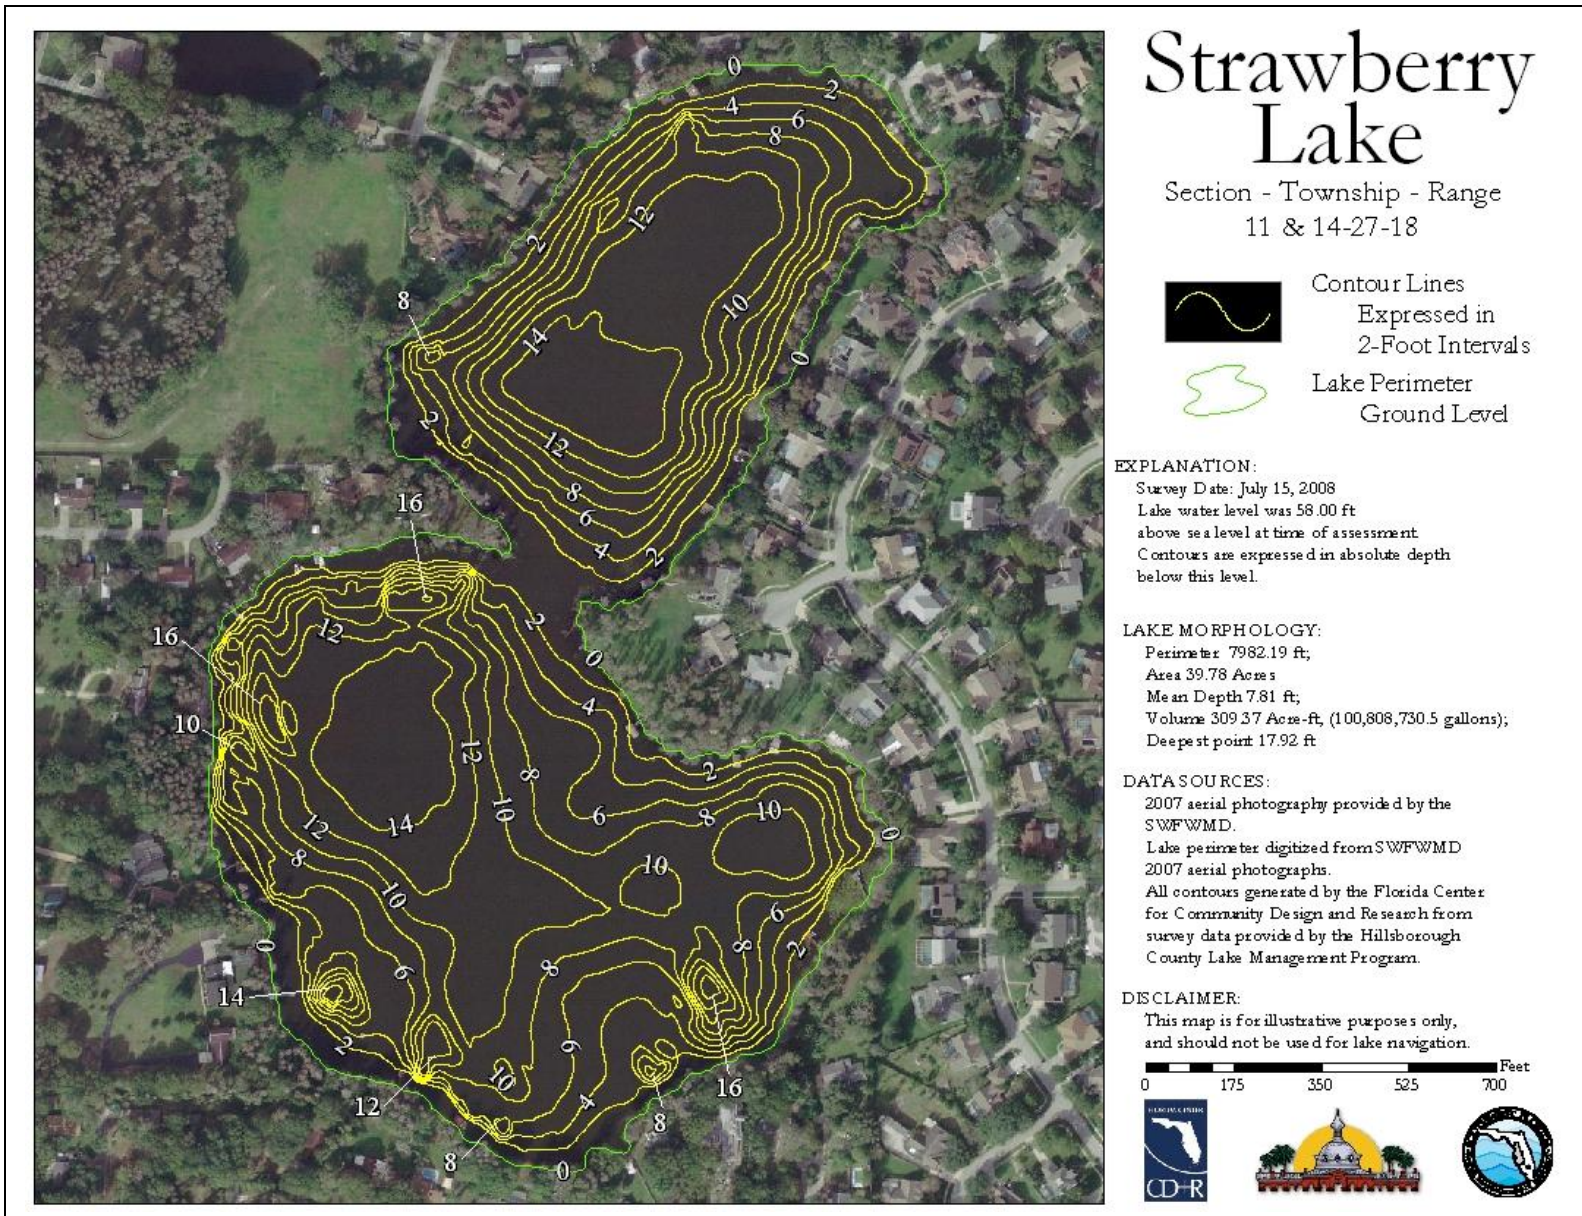
**Figure 1.** Contour map for Strawberry Lake. The mapping technique used in 2008 employs a standard DGPS for horizontal position and a fathometer for depth.

**Bathymetric Map<sup>ii</sup>**. Table 1 provides the lake's morphologic parameters in various units. The bottom of the lake was mapped using a Lowrance LCX 28C HD Wide Area Augmentation System (WAAS)<sup>iii</sup> enabled Global Positioning System (GPS) with fathometer (bottom sounder) to determine the boat's position, and bottom depth in a single measurement. The result is an estimate of the lake's area, mean and maximum depths, and volume and the creation of a bottom contour map (Figure 2). Besides pointing out the deeper fishing holes in the lake, the morphologic data derived from this part of the assessment can be valuable to overall management of the lake vegetation as well as providing flood storage data for flood models.

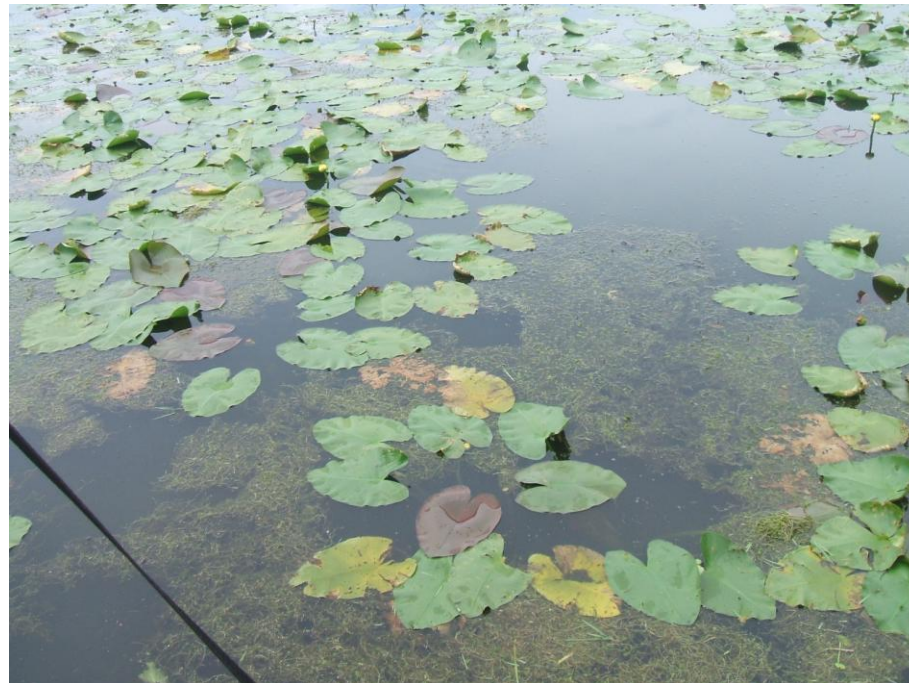
**Figure 4.** Photograph of Spatterdock, *Nuphar lutea* var. *advena*, on Strawberry Lake.

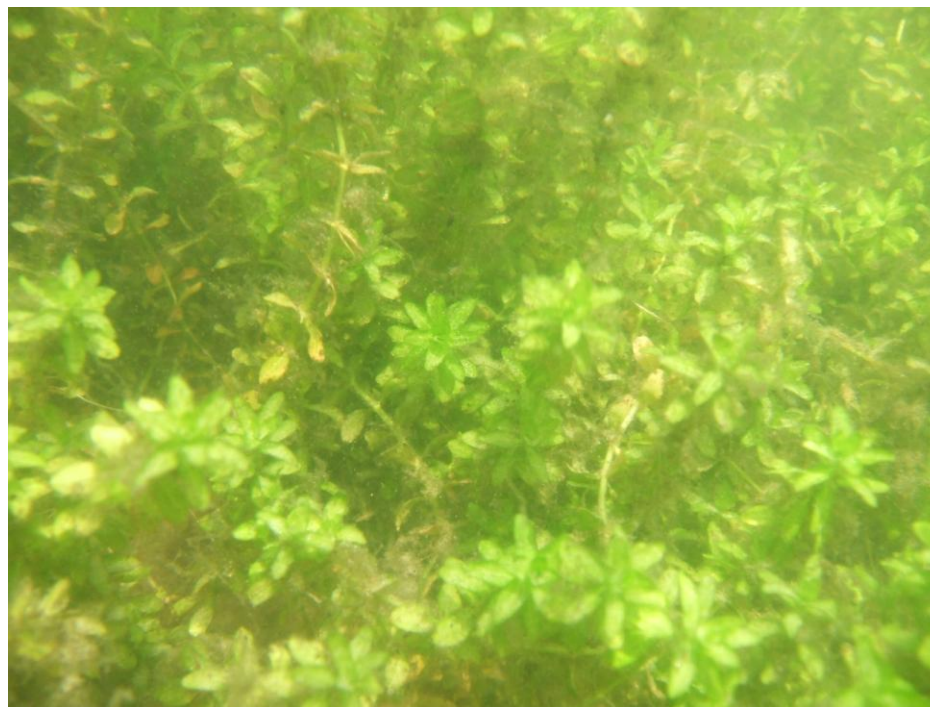
**Figure 5.** Photograph of Manatee Mudflower, *Micranthemum glomeratum*, on Strawberry Lake.

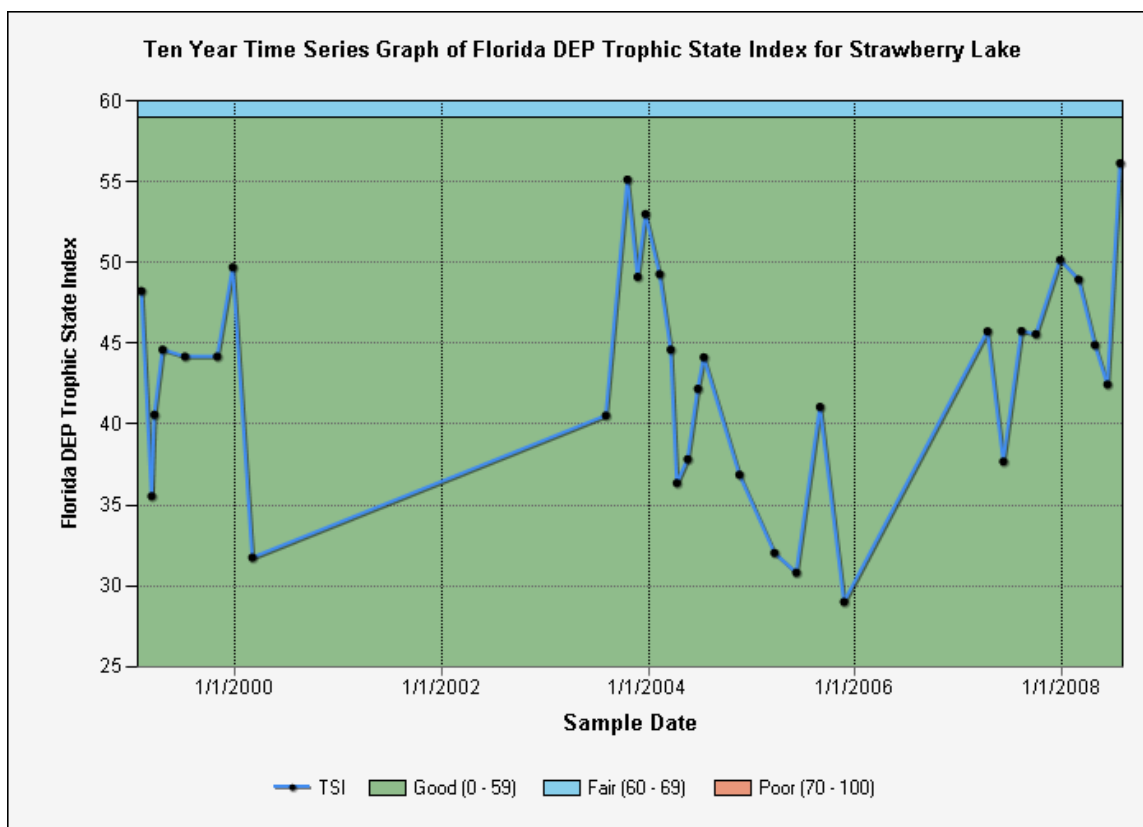
**Figure 6.** Recent Trophic State Index (TSI) graph from Hillsborough Watershed Atlas. For the latest data go to: <http://www.hillsborough.wateratlas.usf.edu/lake/waterquality.asp?wbodyid=5069&wbodyatlas=lake>

Note: The graph above includes benchmarks for using verbal descriptors of "good", "fair" and "poor". The verbal descriptors for these benchmarks are based on an early determination by stakeholders of the generally acceptable and understood terms for describing the state of lakes. The same benchmarks are used for nutrient graphs (Nitrogen and Phosphorus), chlorophyll graphs and trophic state index (TSI) graphs. The TSI is a calculated index of lake condition based on nutrient and chlorophyll (a) concentrations (please see "Learn more about Trophic State Index"). The benchmarks are established based on the TSI range that relates to a specific descriptor. The source for the TSI concentration relationships is the Florida Water Quality Assessment, 1996, 305(b) (Table 2-8).
