LAKE ASSESSMENT REPORT FOR LAKE CEDAR IN HILLSBOROUGH COUNTY FLORIDA

Date Assessed: May 15, 2007

INTRODUCTION

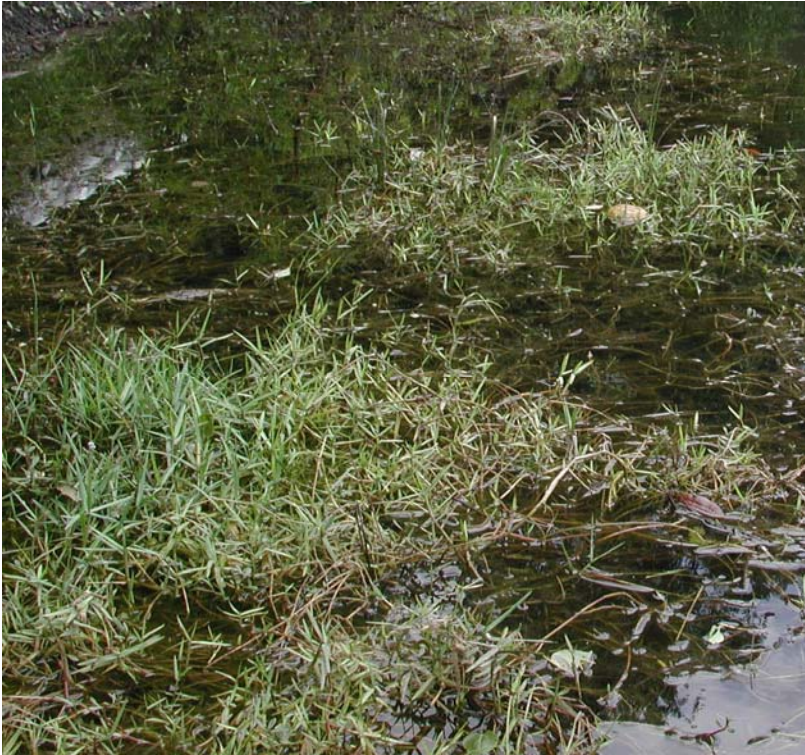
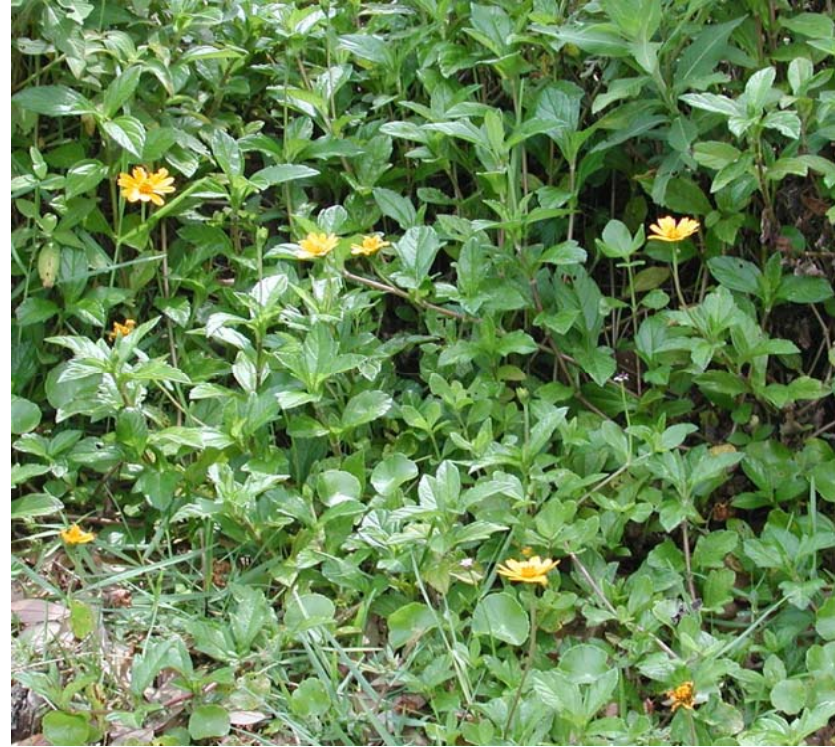
Figure 4a and 4b. Torpedo Grass, *Panicum repens*, **a**, is a non-native, invasive species which was present at all vegetation sites on Lake Cedar. This species displaces native grasses when shoreline vegetation is disturbed. *Sphagneticola (Wedelia) trilobata*, Creeping Oxeye, **b**, is also a non-native, invasive species which is commonly sold as a ground cover plant, unfortunately this plant can also dominate local plant communities along lake shorelines. Both species were found at a high percentage of vegetation assessment sites and are considered pest plants on Lake Cedar.

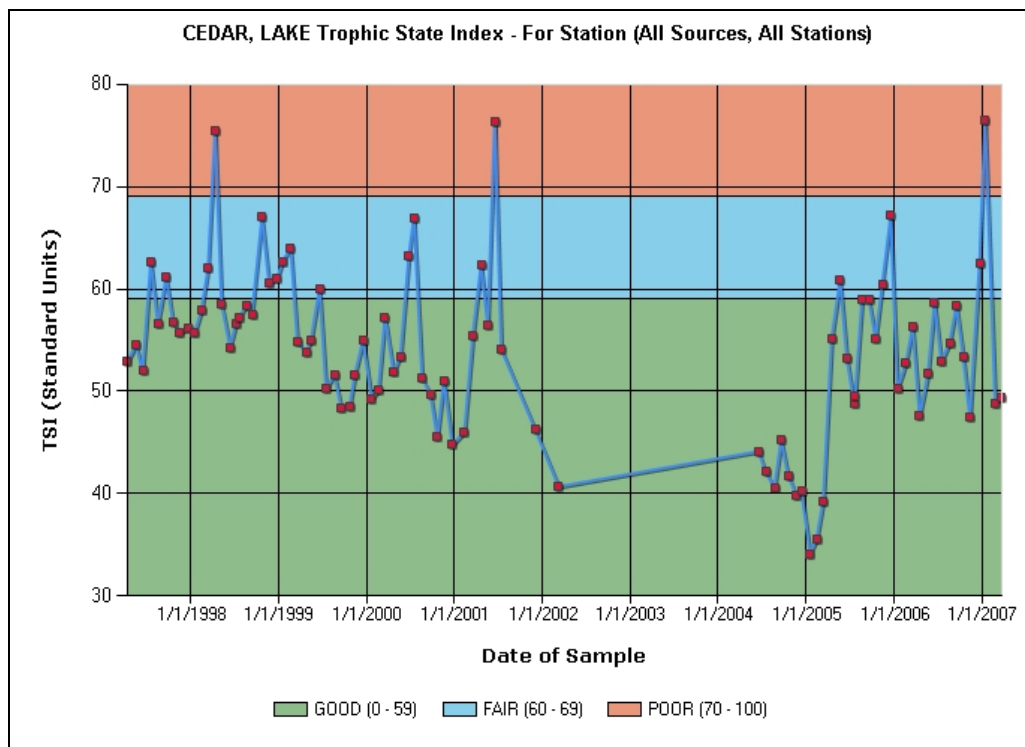
A critical element in any lake assessment is the long-term water chemistry data set. The primary source of water quality trend data for Florida Lakes, is the Florida LAKEWATCH volunteer and the Florida LAKEWATCH water chemistry data. Hillsborough County is fortunate to have a large cadre of volunteers who have collected lake water samples for significant time period. These data are displayed and analyzed on the Water Atlas as shown in Figure 5 for Lake Cedar. Additional data, when available, is also included on the Water Atlas; however, the LAKEWATCH data remains the primary source. By the trend data shown in the figure, the lake may be considered in fair health in terms of the trophic state index. This lake is a clear water lake and as such it must maintain a TSI of at or below 40 to not be considered impaired by the State of Florida guidelines^v. The lake's long term water quality data indicates enough violations of these criteria to be classified by Florida DEP as impaired. The more recent trends indicate that no change in this trend has occurred.
