# LAKE ASSESSMENT REPORT FOR LAKE ELLEN IN HILLSBOROUGH COUNTY, FLORIDA

Date Assessed: June 24, 2008

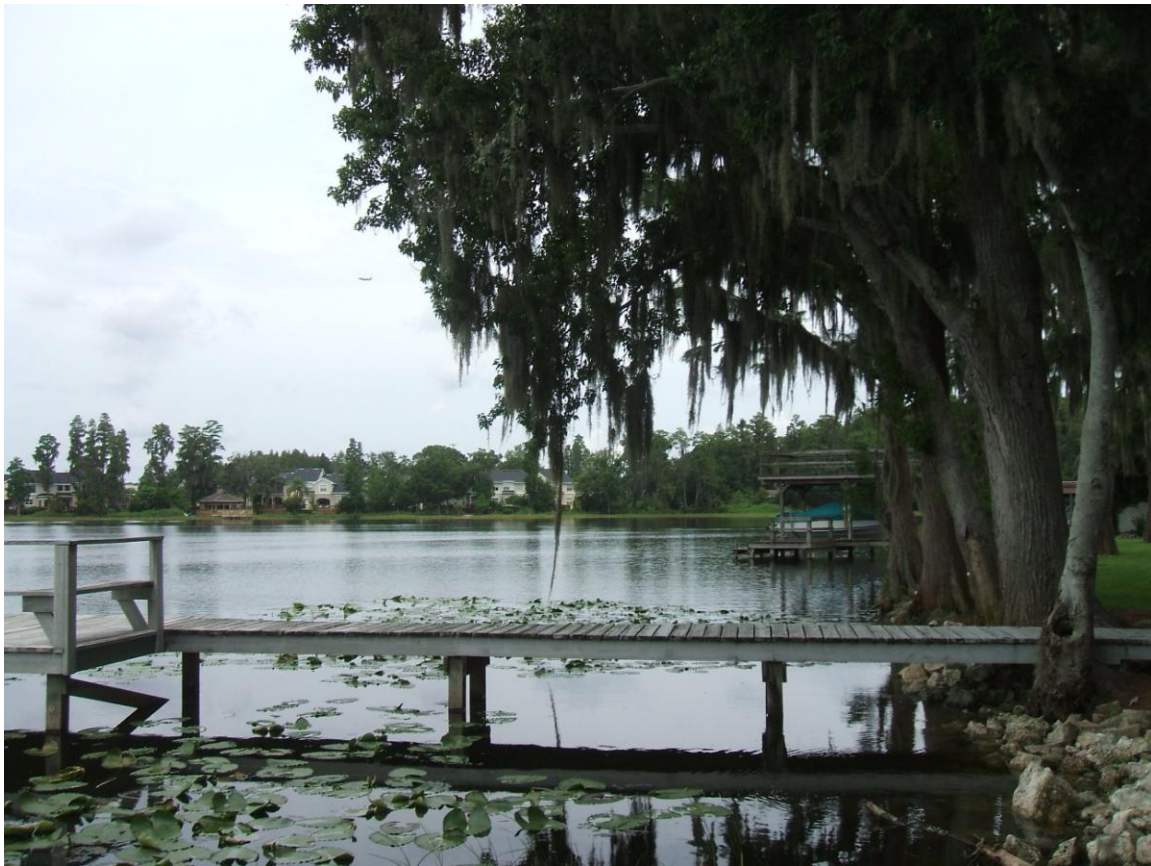
**Figure 1.** Photograph of Lake Ellen, taken June 24, 2008.

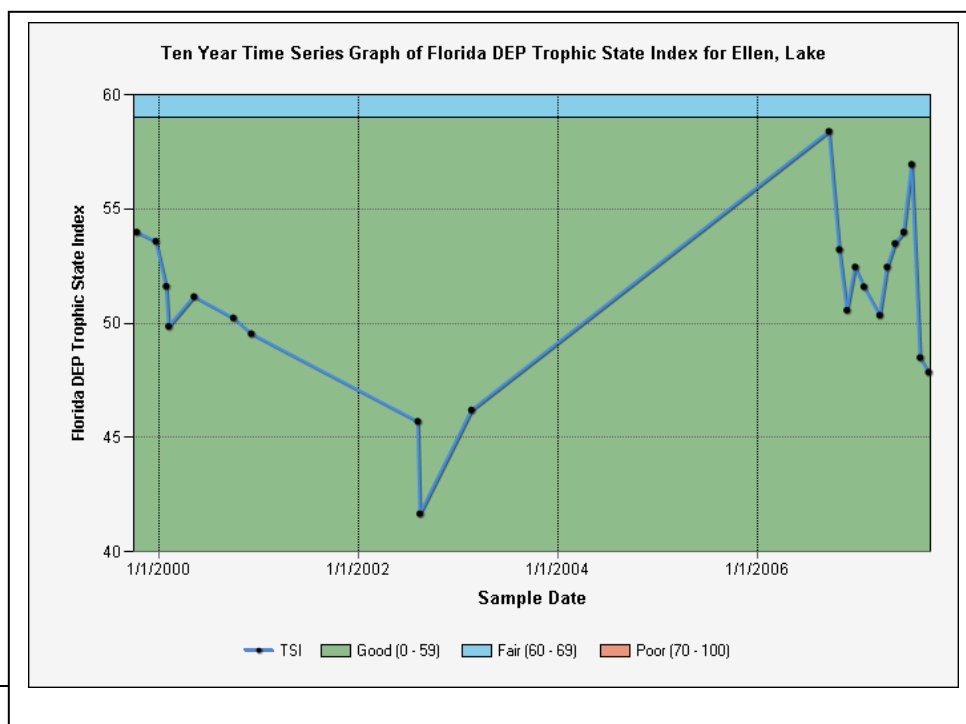
**Figure 6.** Recent Trophic State Index (TSI) graph from Hillsborough Watershed Atlas. For the latest data go to: (<http://www.hillsborough.wateratlas.usf.edu/lake/waterquality.asp?wbodyid=5182&wbodyatlas=lake>)

Note: The graph above includes benchmarks for using verbal descriptors of "good", "fair" and "poor". The verbal descriptors for these benchmarks are based on an early determination by stakeholders of the generally acceptable and understood terms for describing the state of lakes. The same benchmarks are used for nutrient graphs (Nitrogen and Phosphorus), chlorophyll graphs and trophic state index (TSI) graphs. The TSI is a calculated index of lake condition based on nutrient and chlorophyll (a) concentrations (please see "Learn more about Trophic State Index"). The benchmarks are established based on the TSI range that relates to a specific descriptor. The source for the TSI concentration relationships is the Florida Water Quality Assessment, 1996, 305(b) (Table 2-8).

As part of the lake assessment the physical water quality and chemical water chemistry of a lake are measured. These data only indicate a snap shot of the lakes water quality; however they are useful when compared to the trend data available from LAKEWATCH or other sources. Table 6 contains the summary water quality data and index values and adjusted values calculated from these data. The total phosphorus (TP), total nitrogen (TN) and chlorophyll (a) water chemistry sample data are the results of chemical analysis of samples taken during the assessment and analyzed by the Hillsborough County Environmental Protection Commission laboratory. These data compare reasonably well with the mean data from the LAKEWATCH data set for the lake. The trophic state index (TSI) calculated from the sample data 46.05 is within the values shown in the figure above.
