LAKE ASSESSMENT REPORT FOR LAKE JOSEPHINE IN HILLSBOROUGH COUNTY FLORIDA

Date Assessed: May 31, 2006

INTRODUCTION

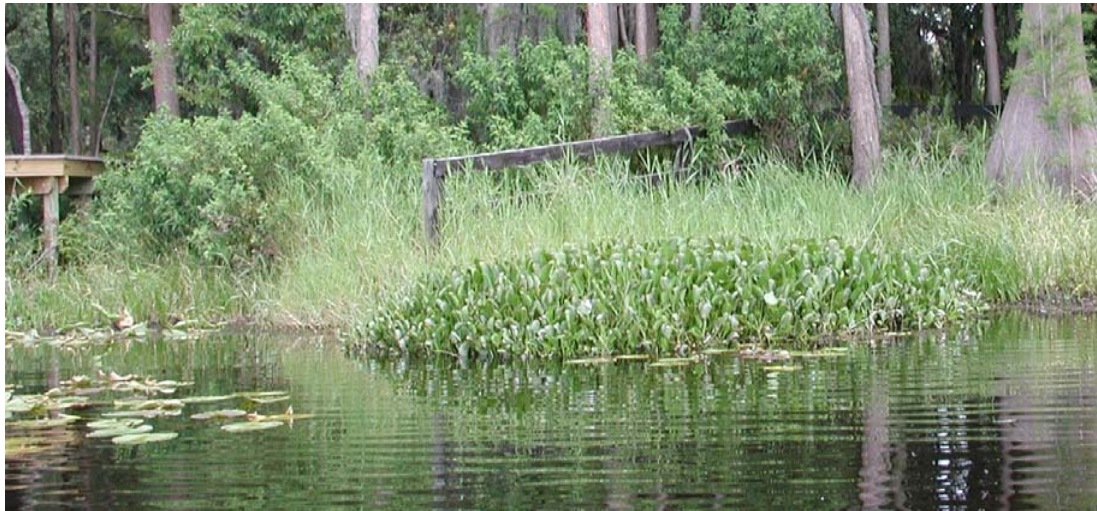
Figure 4. Water Hyacinth (*Eichornia crassipes*), a non-native invasive species along the shoreline of Lake Josephine.

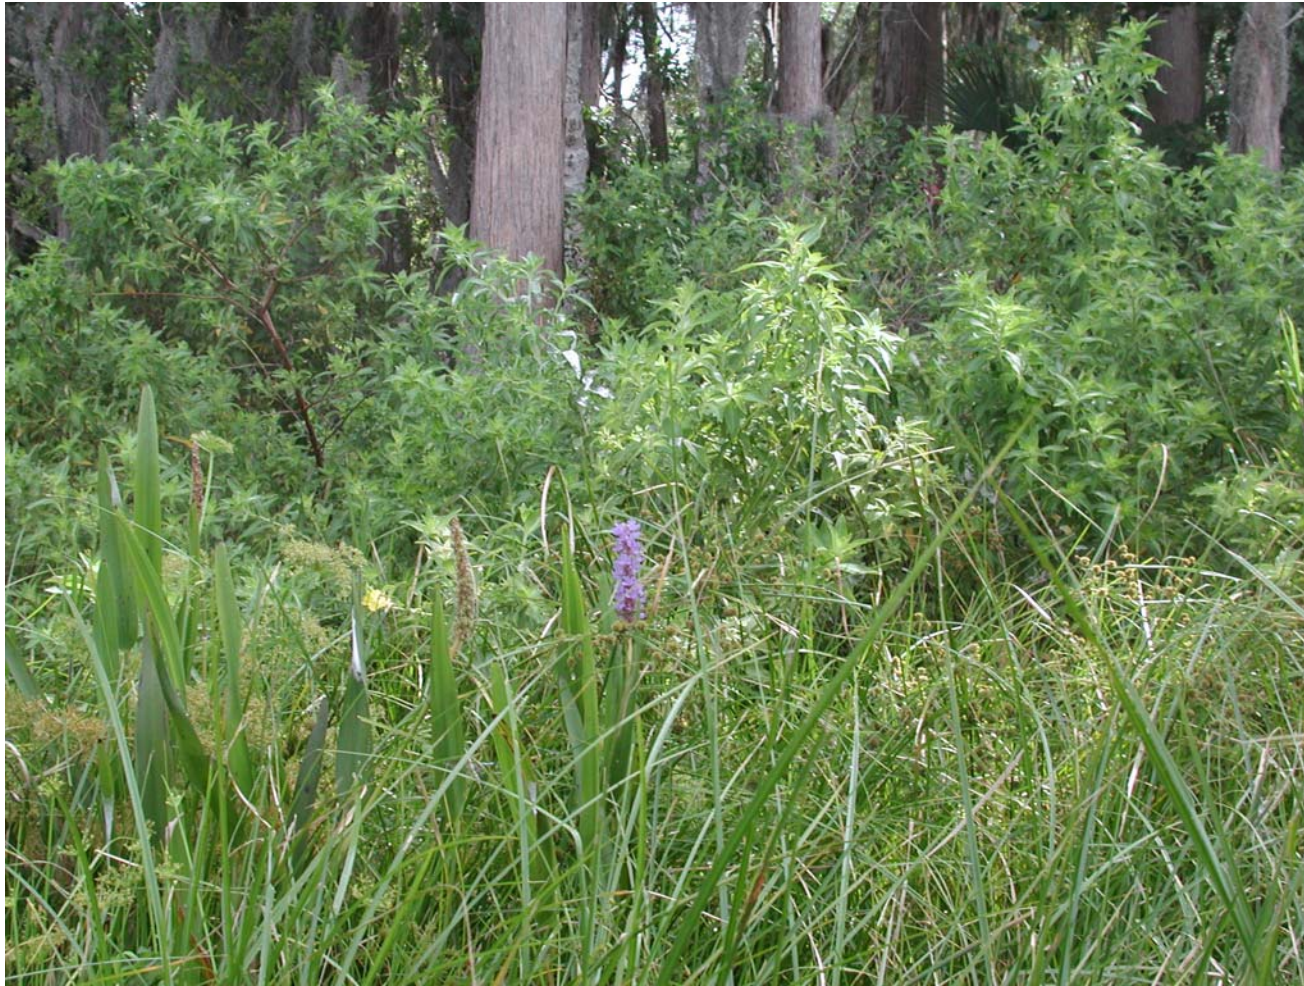
Figure 5. Pickerel Weed (*Pontederia cordata*), purple flower in foreground, and Primrosewillow (*Ludwigia spp.*), background shrub, on Lake Josephine.

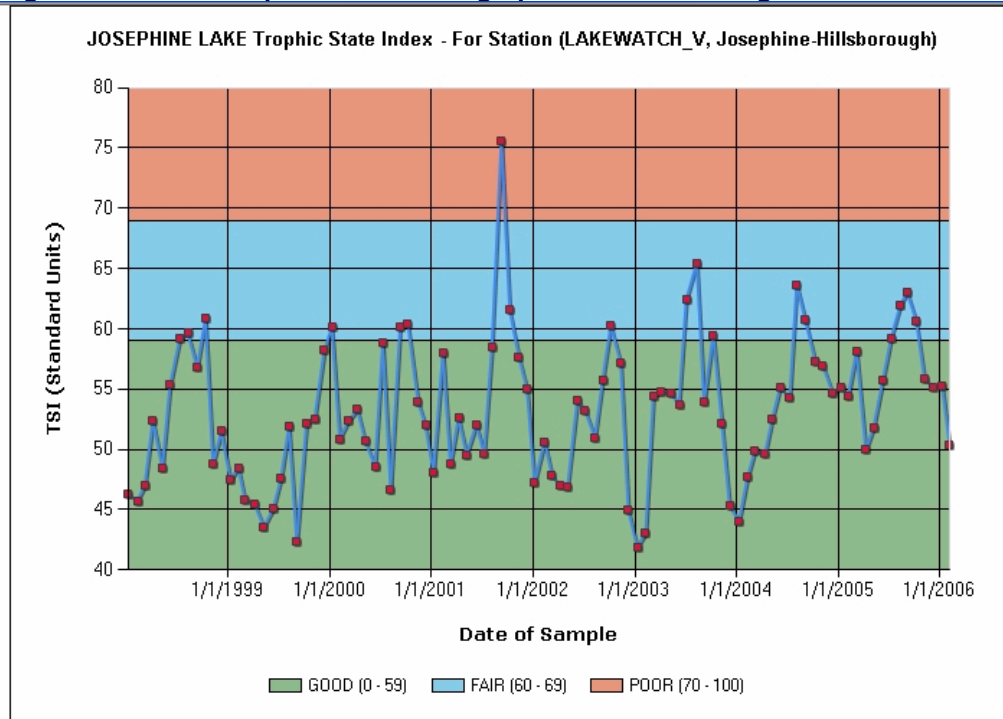
Figure 6. Recent Trophic State Index graph from Hillsborough Watershed Atlas.

Note: The graph above includes benchmarks for using verbal descriptors of "good", "fair" and "poor". The verbal descriptors for these benchmarks are based on an early determination by stakeholders of the generally acceptable and understood terms for describing the state of lakes. The same benchmarks are used for nutrient graphs (Nitrogen and Phosphorus), chlorophyll graphs and trophic state index (TSI) graphs. The TSI is a calculated index of lake condition based on nutrient and chlorophyll (a) concentrations (please see "Learn more about Trophic State Index"). The benchmarks are established based on the TSI range that relates to a specific descriptor. The source for the TSI concentration relationships is the [Florida Water Quality Assessment, 1996, 305\(b\)](#) (Table 2-8). For many lakes there is more than a single source of water quality data. You have the option with the "Select Data Source" drop down to select any available data source and create the graph using that source or you may select "All" to graph all available data. The graph header will also change to reflect the source used.

A critical element in any lake assessment is the long-term water chemistry data set. The primary source of water quality trend data for Florida Lakes is the Florida LAKEWATCH volunteer and the Florida LAKEWATCH water chemistry data. Hillsborough County is fortunate to have a large cadre of volunteers who have collected lake water samples for significant time period. These data are displayed and analyzed on the Water Atlas as shown in Figure 6 for Lake Josephine. Additional data, when available, is also included on the Water Atlas; however, the LAKEWATCH data remains the primary source. By the trend data shown in Figure 6, the lake may be considered in good to fair health in terms of the trophic state index. Lake Josephine is a dark water lake and as such it must maintain a TSI of below 60 to not be considered impaired by the State of Florida guidelines^{iv}. Lake Josephine's long term water quality data indicates some violations of these criteria; however, it is not classified by Florida DEP as impaired. The more recent trends indicate an improving trend and if this continues the lake should not be classified as impaired. The general trend seen in Figure 6 and an analysis of the trend data indicate that the highest TSI values occur between July and October of each year. This is the peak of the rainy season and suggests a relationship between stormwater runoff including Rocky Creek flow and Lake Josephine TSI.

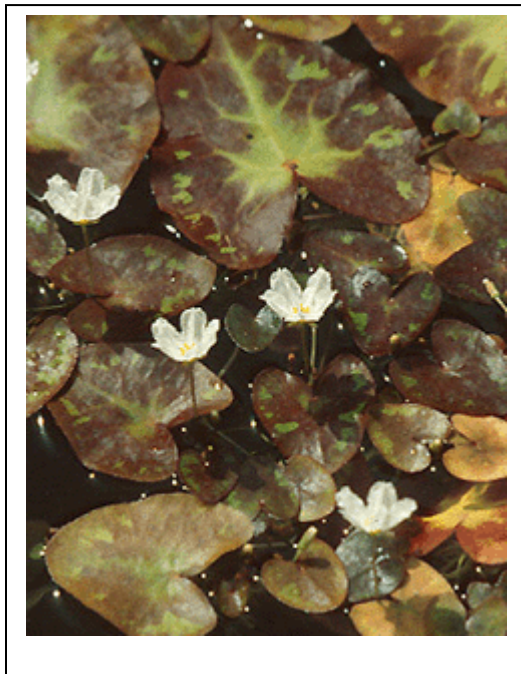
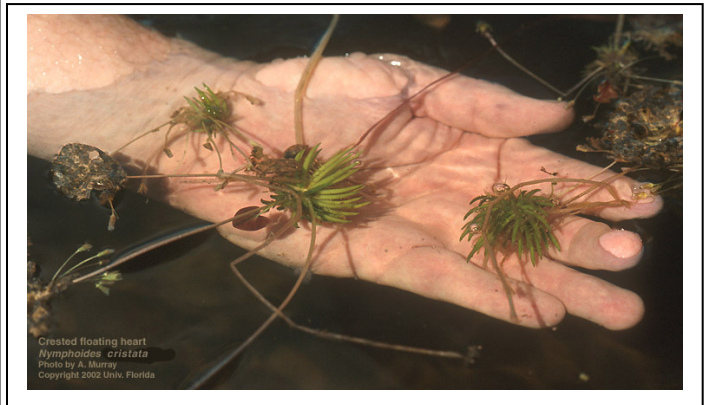
Figure 8. The exotic crested floating hear (*Nymphoides cristata*) has begun to spread in southern Florida. It looks similar to the native banana lily, *Nymphoides aquatica*. For additional information see: <http://aquat1.ifas.ufl.edu/nymcri.html>
