# Lake Assessment Report for Strawberry Lake in Hillsborough County, Florida

Date Assessed: July 7, 2010  
Assessed by: David Eilers  
Reviewed by: Jim Griffin

## ***INTRODUCTION***

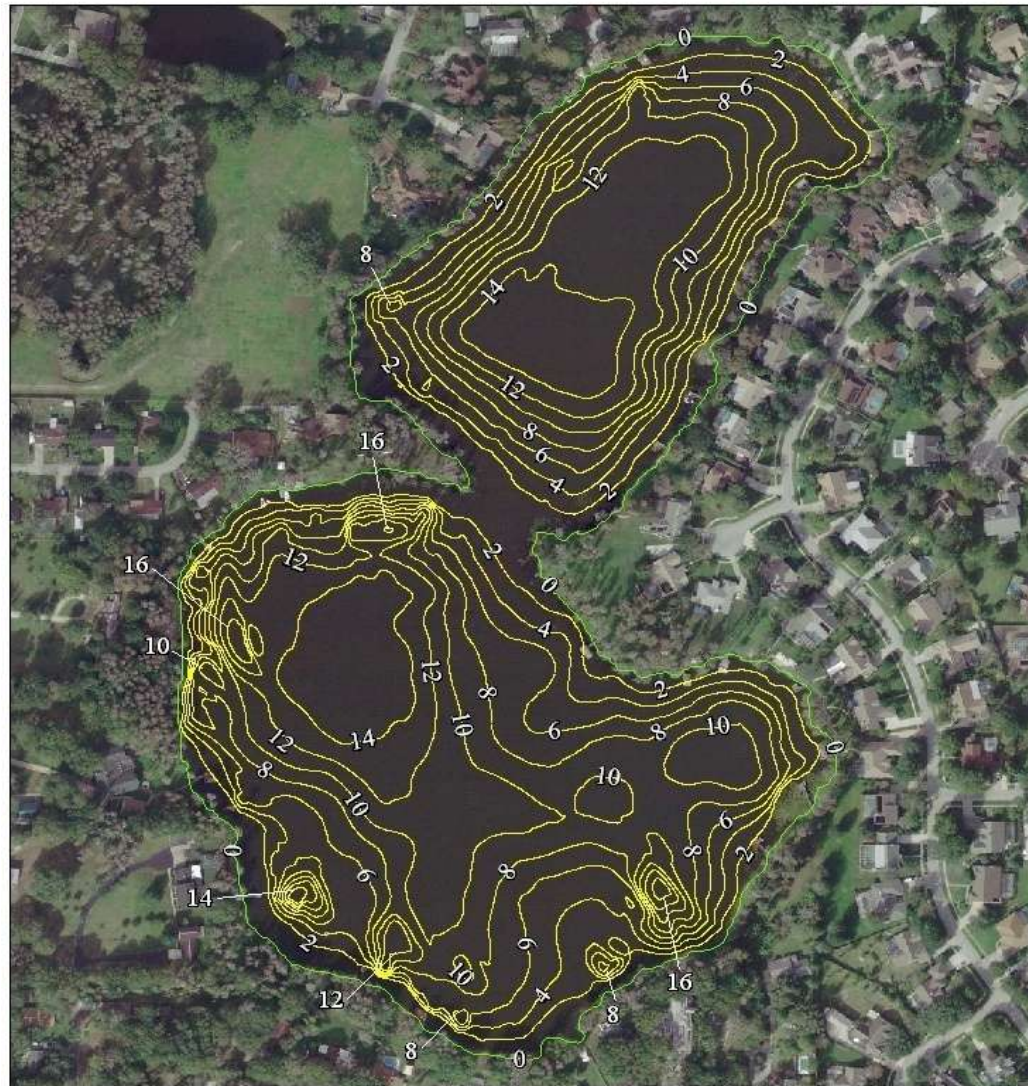
Figure 2. Strawberry Lake Bathymetric Contour Map

Survey Date: July 15, 2008  
 Lake water level was 58.00 ft  
 above sea level at time of assessment  
 Contours are expressed in absolute depth  
 below this level.

Perimeter 7982.19 ft,  
 Area 39.78 Acres  
 Mean Depth 7.81 ft,  
 Volume 309.37 Acre-ft, (100,808,730.5 gallons);  
 Deepest point 17.92 ft

**Bathymetric Map<sup>ii</sup>**. Table 1 provides the lake's morphologic parameters in various units. The bottom of the lake was mapped using a Lowrance LCX 28C HD Wide Area Augmentation System (WAAS)<sup>iii</sup> enabled Global Positioning System (GPS) with fathometer (bottom sounder) to determine the boat's position, and bottom depth in a single measurement. The result is an estimate of the lake's area, mean and maximum depths, and volume and the creation of a bottom contour map (Figure 2). Besides pointing out the deeper fishing holes in the lake, the morphologic data derived from this part of the assessment can be valuable to overall management of the lake vegetation as well as providing flood storage data for flood models.

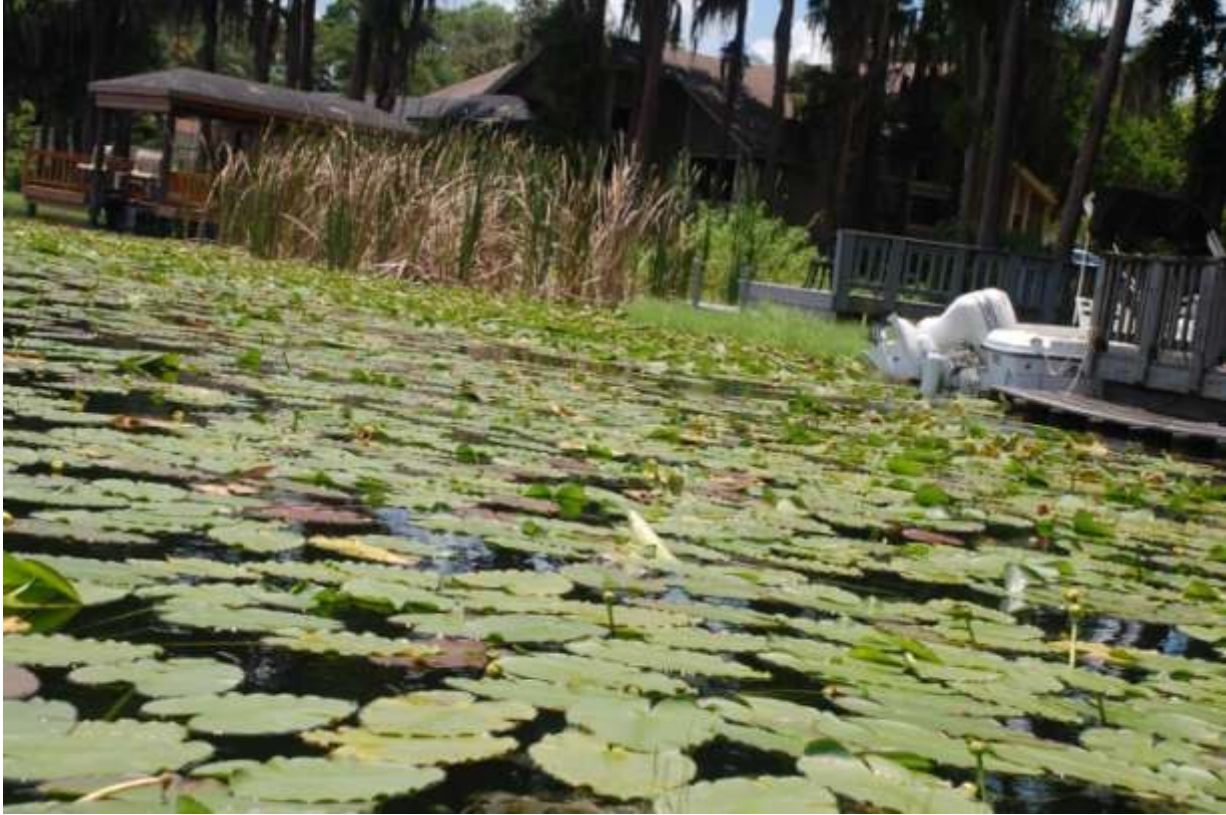
**Figure 4. Photo of *Nuphar advena*, a native floating leaved vegetation, on Strawberry Lake**

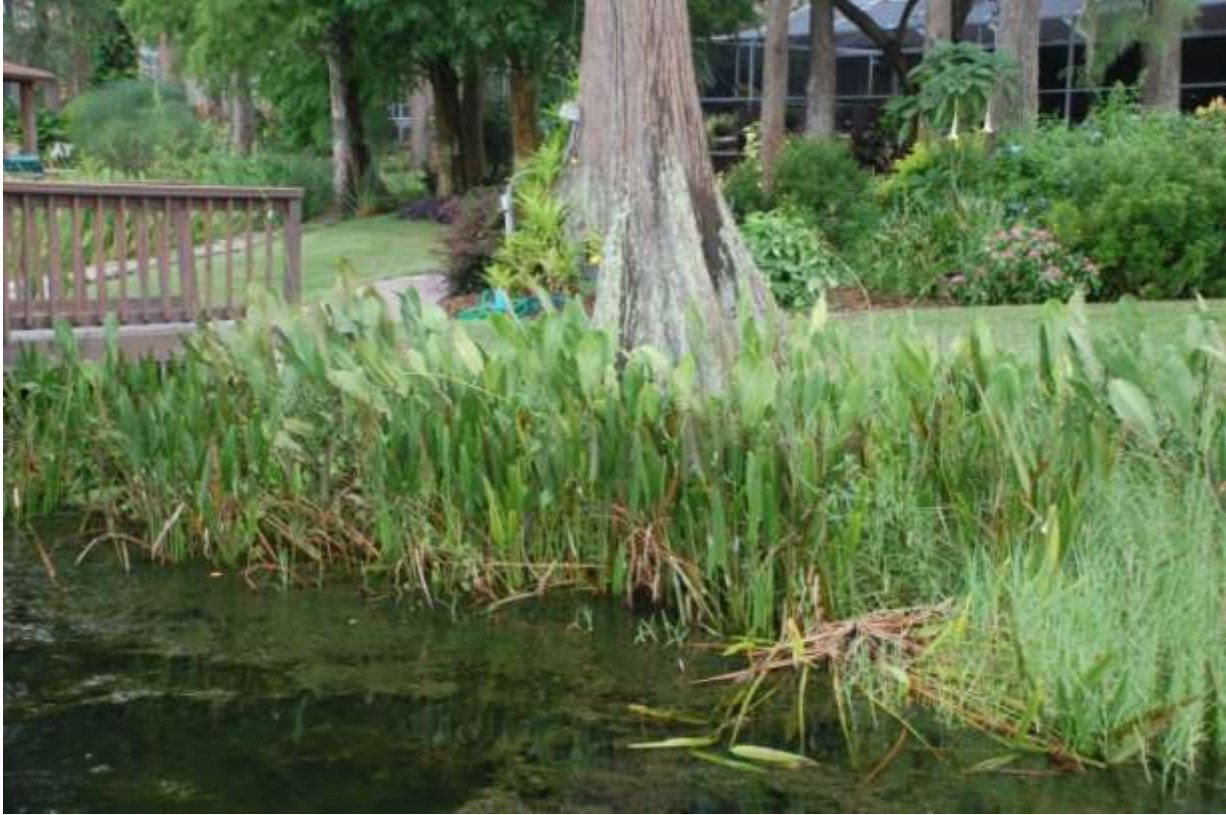
**Figure 5. Photo of emergent vegetation zone featuring *Sagittaria lancifolia* and *Pontederia cordata*, native species, on Strawberry Lake**

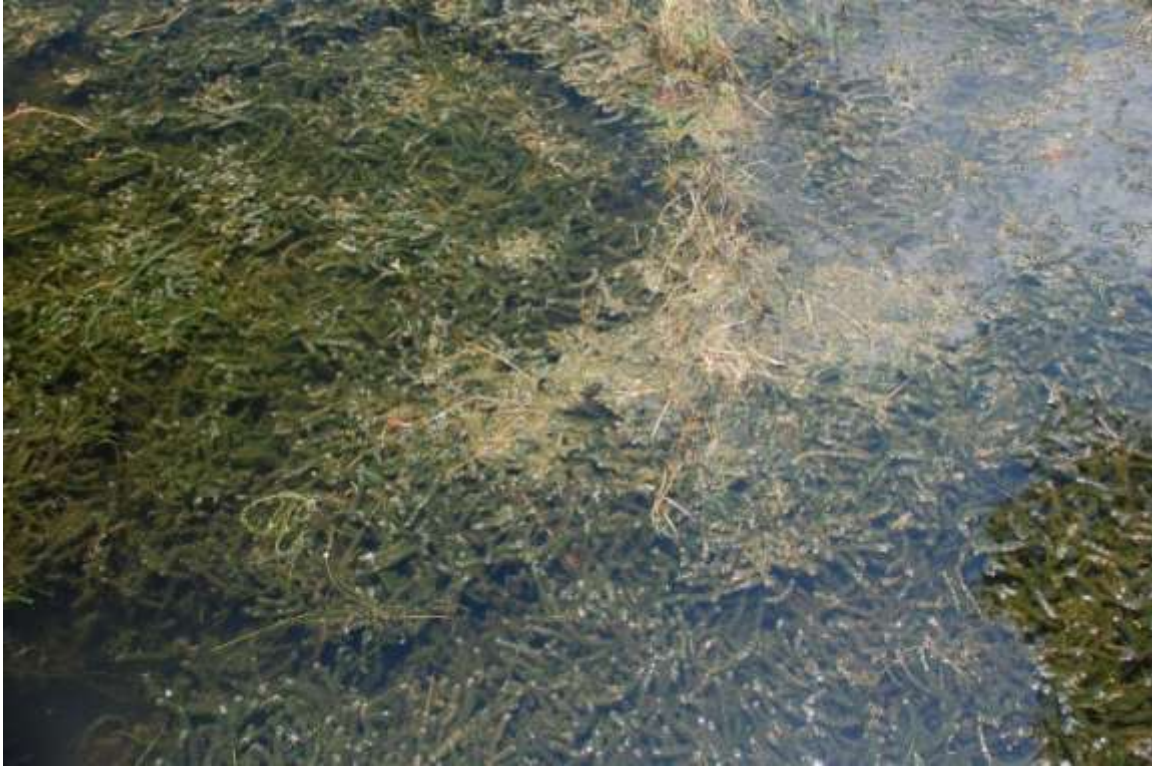
**Figure 6. Photo of *Hydrilla verticillata*, a non-native invasive species of submerged vegetation on Strawberry Lake**

Lake Strawberry has relatively high coverage of submerged vegetation (PAC = 58%) and vegetation represents 13 % of the volume of the lake. Vegetation, especially, submerged vegetation is a reservoir for nutrients and for Lake Strawberry this reservoir represents a potential available nutrient concentration of 23 µg/L total phosphorus, 309 µg/L total nitrogen with the potential chlorophyll (produced from released nutrients) concentration of 8.7 µg/L. These data indicate that the removal of submerged vegetation in Lake Strawberry would result in a TSI increase from 50 to 59 and would cause a larger level of impairment for the lake. Hydrilla was found in Lake Strawberry at one of the 10 stations surveyed. Hydrilla is a fast spreading invasive non-native submerged vegetation species and lake property owners should be aware of its being present in the lake and should consider steps to control it and prevent its spreading.

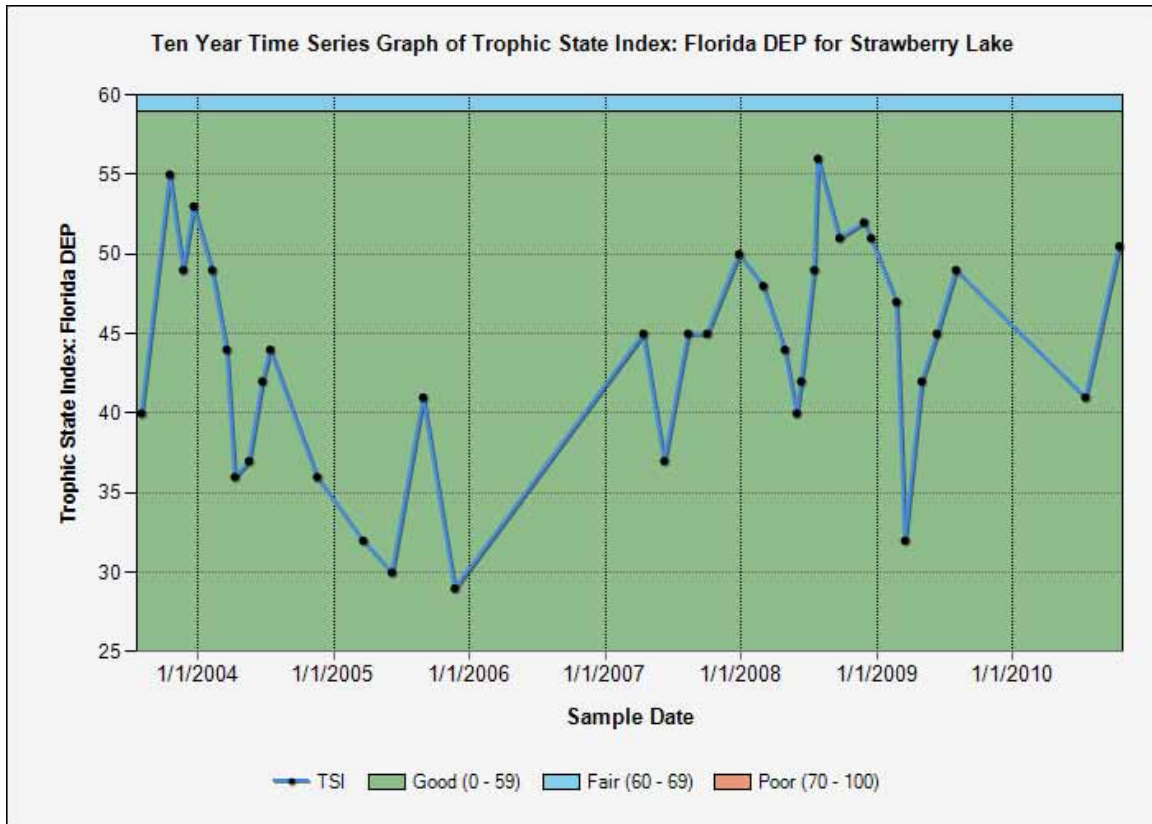
Figure 7. Recent Trophic State Index (TSI) graph for Strawberry Lake<sup>vi</sup>

These data are displayed and analyzed on the Water Atlas as shown in Figure 7, Figure 8, and Figure 9 for Strawberry Lake. The figures are graphs of: (1) the overall trophic state index (TSI)<sup>1</sup>, which is a method commonly used to characterize the productivity of a lake, and may be thought of as a lake's ability to support plant growth and a healthy food source for aquatic life; (2) the chlorophyll *a* concentration, which indicates the lake's algal concentration, and (3) the lake's Secchi Disk depth which is a measure of water visibility and depth of light penetration. These data are used to evaluate a lake's ecological health and to provide a method of ranking lakes and are indicators used by the US Environmental Protection Agency (USEPA) and the Florida Department of Environmental Protection (FDEP) to determine a lake's level of impairment. The chlorophyll *a* and Secchi Disk depth graphs include benchmarks which indicate the median values for the various parameters for a large number of Lakes in Florida expressed as percentiles.

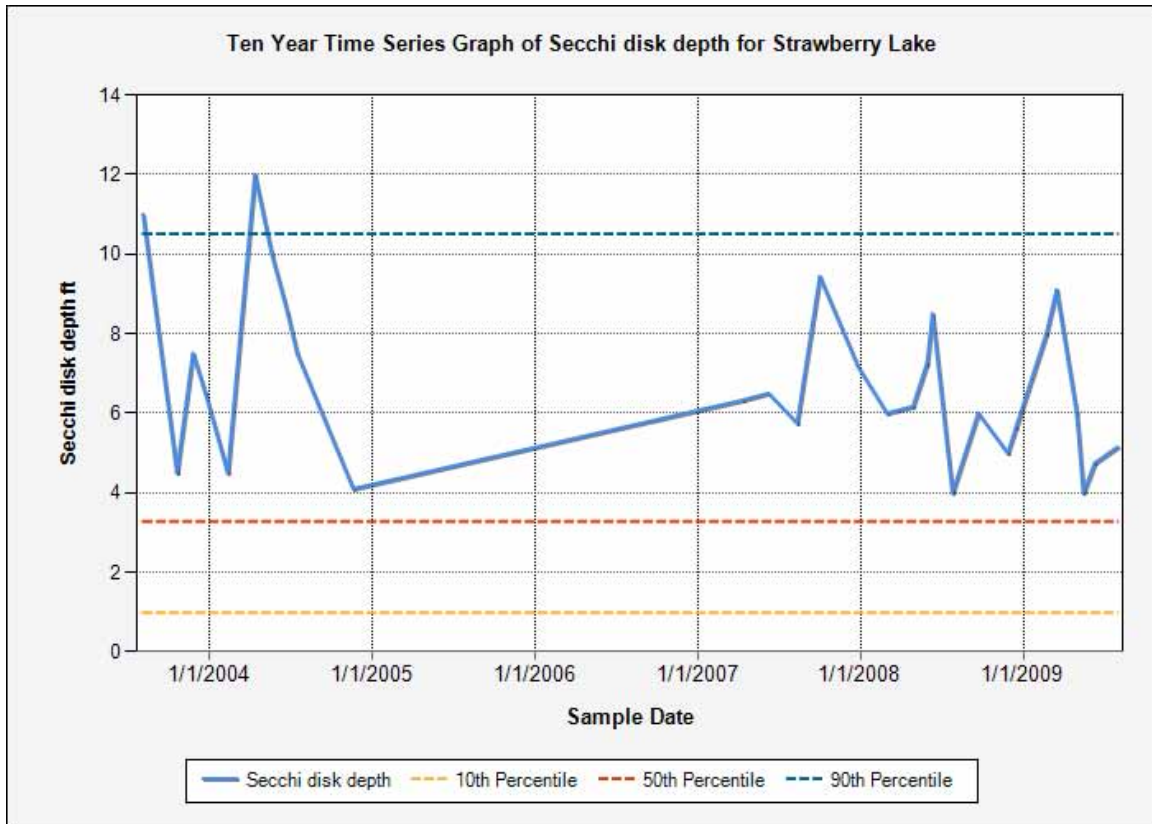
**Figure 9. Recent Secchi Disk graph for Strawberry Lake<sup>viii</sup>**
