LAKE ASSESSMENT REPORT FOR LAKE VIRGINIA IN HILLSBOROUGH COUNTY, FLORIDA

Date Assessed: July 8, 2008

Assessed by: Monetta Wilson and David Eilers

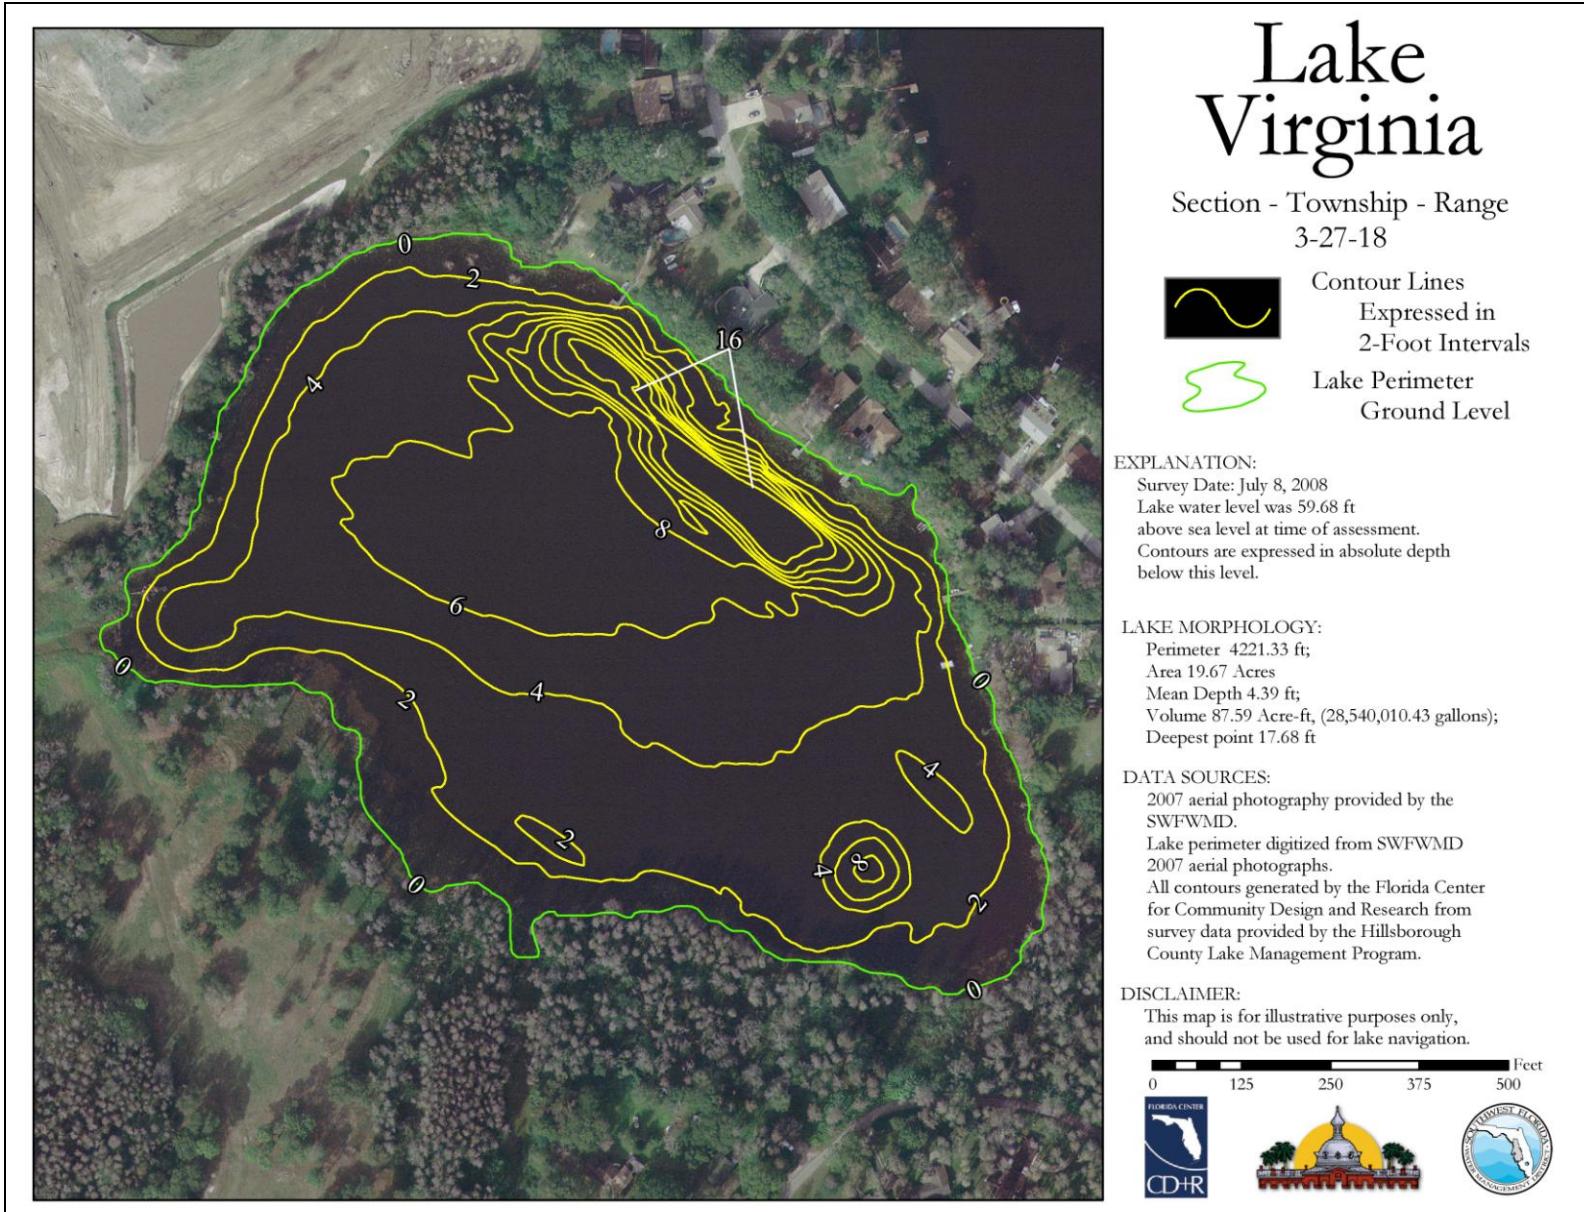
Figure 1. Contour map for Lake Virginia. The mapping technique used in 2008 employs a standard DGPS for horizontal position and a fathometer for depth.

Bathymetric Mapⁱⁱ. Table 1 provides the lake's morphologic parameters in various units. The bottom of the lake was mapped using a Lowrance LCX 28C HD Wide Area Augmentation System (WAAS)ⁱⁱⁱ enabled Global Positioning System (GPS) with fathometer (bottom sounder) to determine the boat's position, and bottom depth in a single measurement. The result is an estimate of the lake's area, mean and maximum depths, and volume and the creation of a bottom contour map (Figure 2). Besides pointing out the deeper fishing holes in the lake, the morphologic data derived from this part of the assessment can be valuable to overall management of the lake vegetation as well as providing flood storage data for flood models.

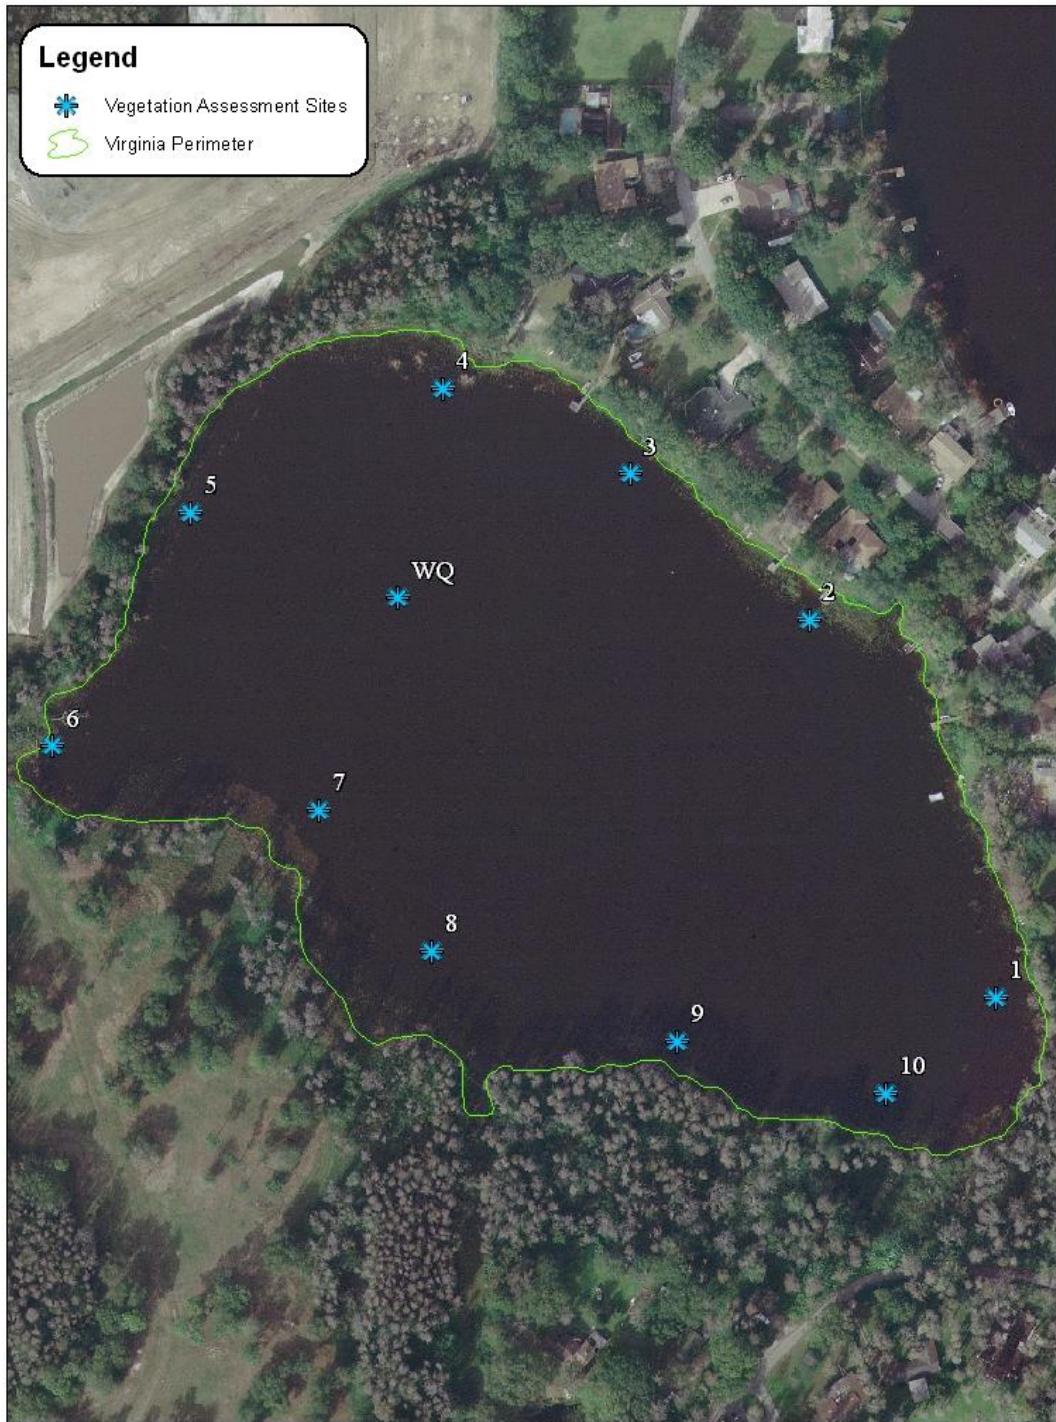
Figure 3. 2007 six-inch resolution aerial photograph showing location of vegetation assessment sites on Lake Virginia. Major emergent and floating vegetation zones as well as structures are also observable in this aerial.

The lake's apparent vegetative cover and shoreline detail are evaluated using the latest lake aerial photograph as shown in Figure 3 and by use of WAAS enabled GPS. Submerged vegetation is determined from the analysis of bottom returns from the Lowrance 28c HD combined GPS/fathometer described earlier. As depicted in Figure 3, ten vegetation assessment sites were chosen for intensive sampling based on the *Lake Assessment Protocol* (copy available on request) for a lake of this size. The site positions are set using GPS and then loaded into a GIS mapping program (ArcGIS) for display. Each site is sampled in the three primary vegetative zones (emergent, submerged and floating).^{iv} The latest high resolution aerial photos are used to provide shore details (docks, structures, vegetation zones) and to calculate the extent of surface vegetation coverage. The primary indices of submerged vegetation cover and biomass for the lake, percent area coverage (PAC) and percent volume infestation (PVI), are determined by transiting the lake by boat and employing a fathometer to collect "hard and soft return" data. These data are later analyzed for presence and absence of vegetation and to determine the height of vegetation if present. The PAC is determined from the presence and absence analysis of 100 sites in the lake and the PVI is determined by measuring the difference between hard returns (lake bottom) and soft returns (top of vegetation) for sites (within the 100 analyzed sites) where plants are determined present (Figure 6).

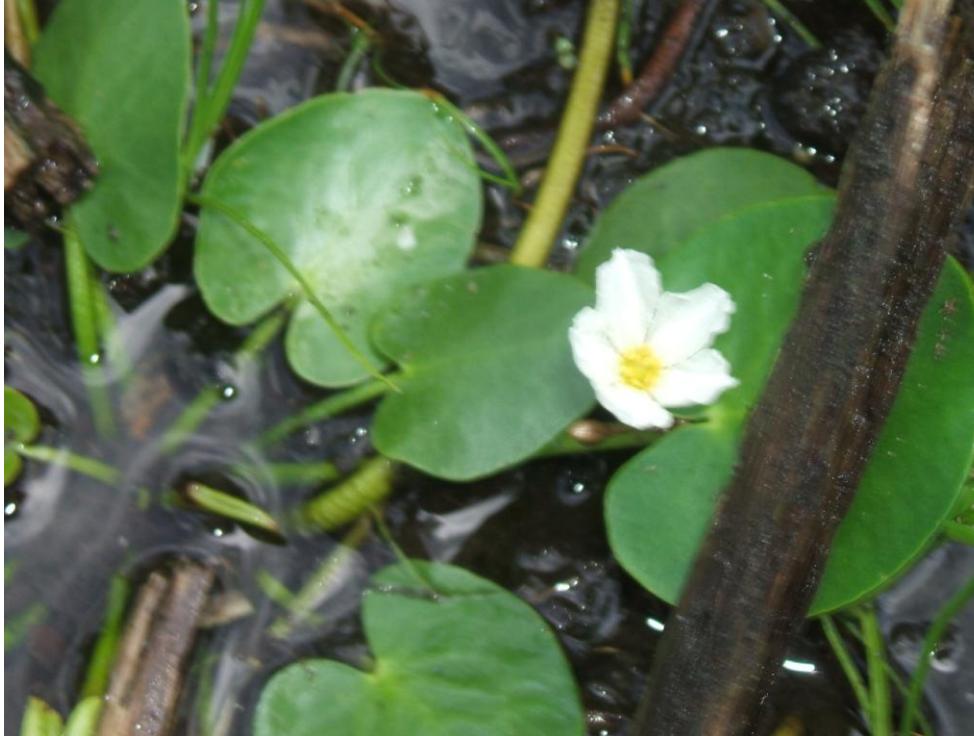
Figure 4. Photograph of Banana Lily, *Nymphoides aquatica*, on Lake Virginia.

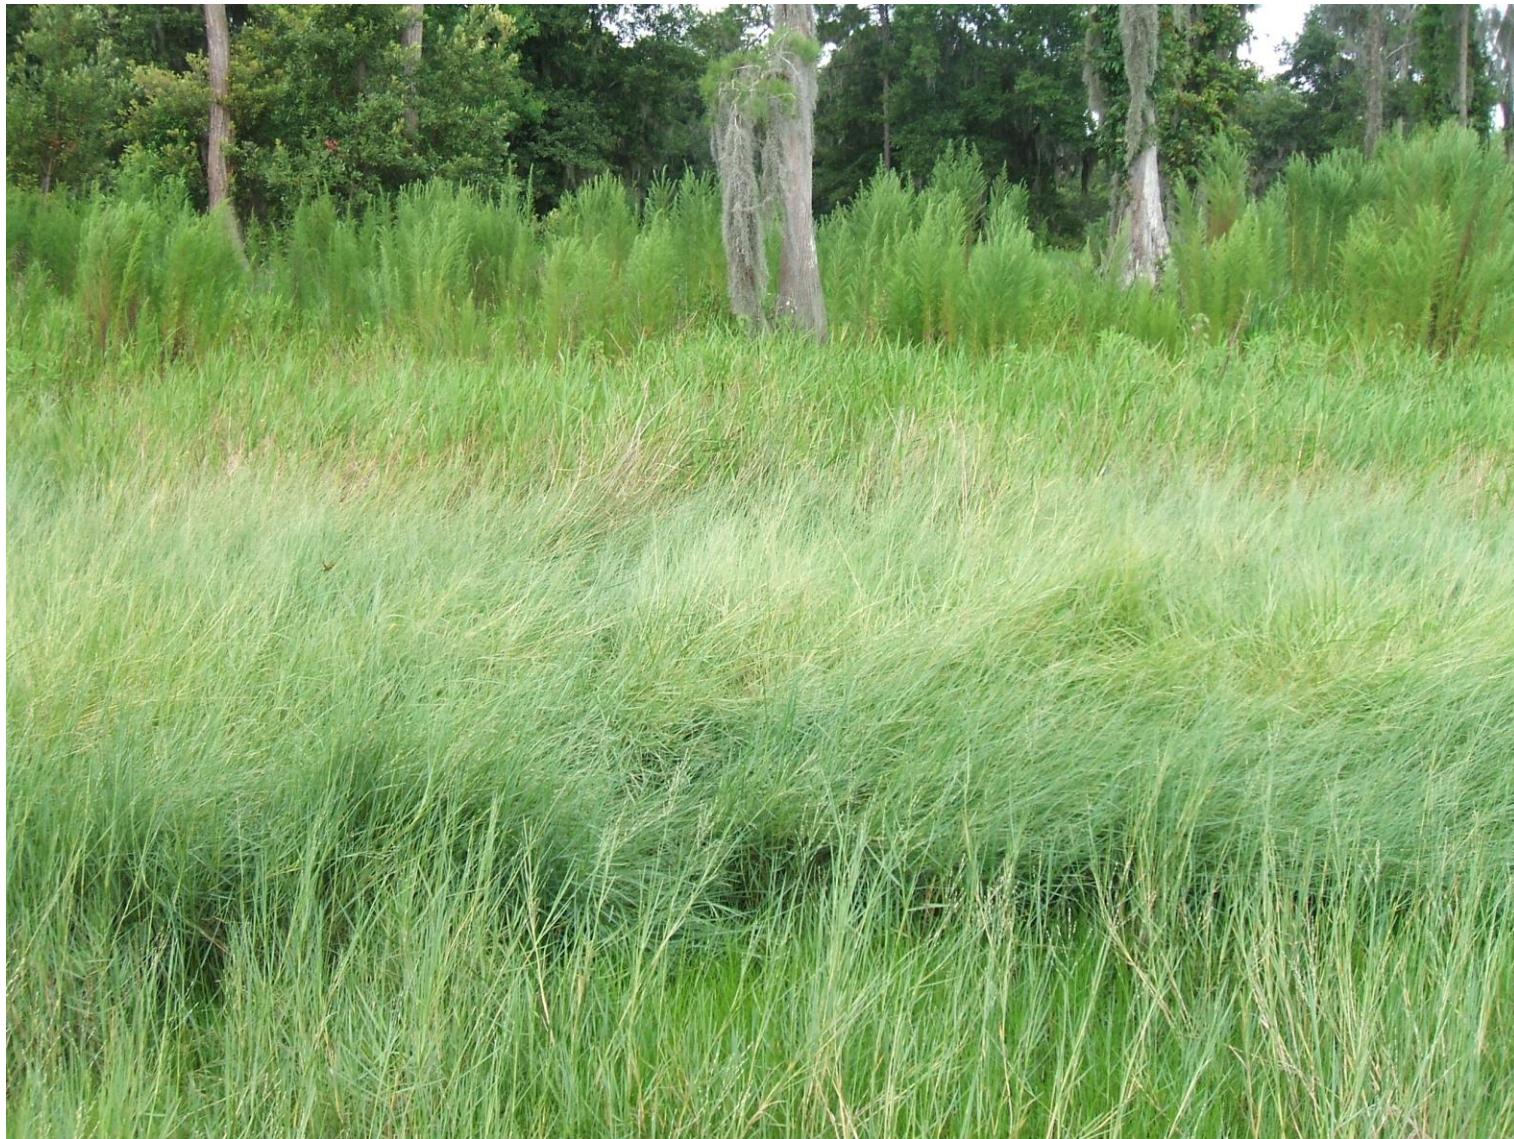
Figure 5. Photograph of Torpedo Grass, *Panicum repens*, on Lake Virginia. Torpedo Grass is a non-native invasive species that displaces native grass species along Florida lake shorelines.

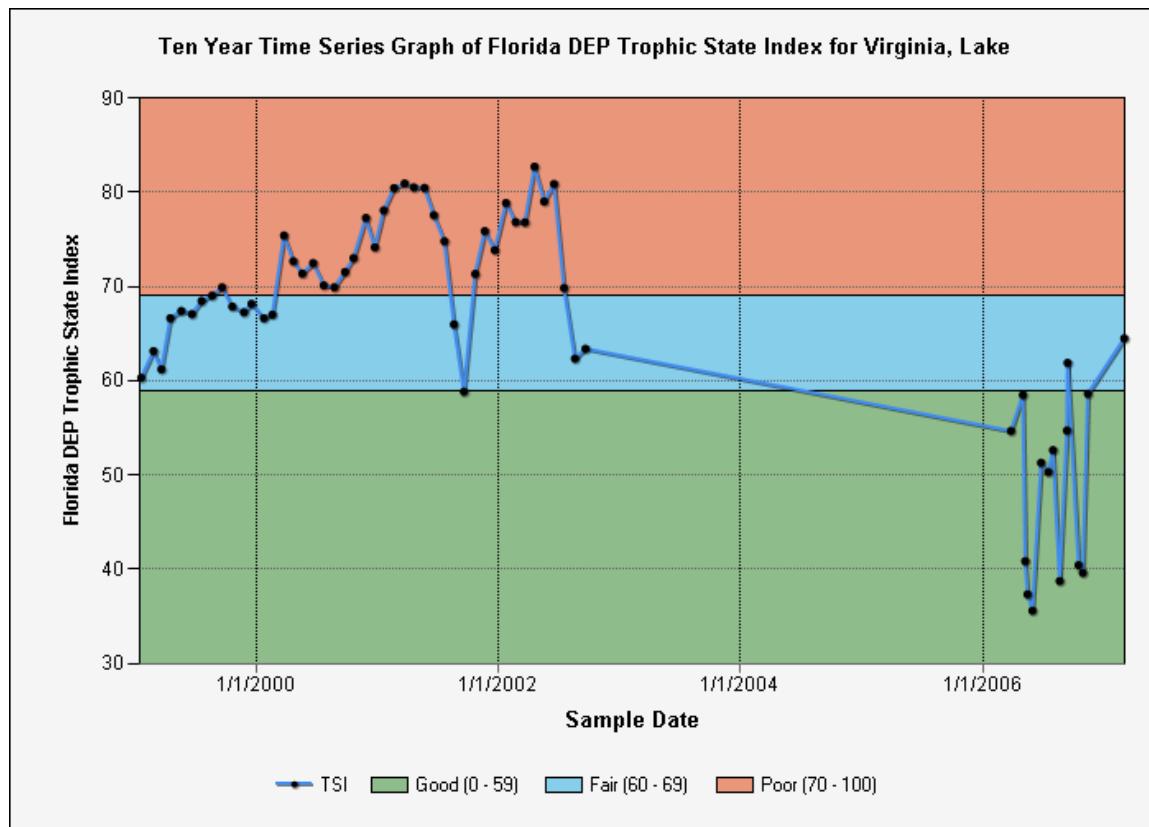
Figure 6. Recent Trophic State Index (TSI) graph from Hillsborough Watershed Atlas. For the latest data go to:

Note: The graph above includes benchmarks for using verbal descriptors of "good", "fair" and "poor". The verbal descriptors for these benchmarks are based on an early determination by stakeholders of the generally acceptable and understood terms for describing the state of lakes. The same benchmarks are used for nutrient graphs (Nitrogen and Phosphorus), chlorophyll graphs and trophic state index (TSI) graphs. The TSI is a calculated index of lake condition based on nutrient and chlorophyll (a) concentrations (please see "Learn more about Trophic State Index"). The benchmarks are established based on the TSI range that relates to a specific descriptor. The source for the TSI concentration relationships is the Florida Water Quality Assessment, 1996, 305(b) (Table 2-8).

As part of the lake assessment the physical water quality and chemical water chemistry of a lake are measured. These data only indicate a snap shot of the lakes water quality; however they are useful when compared to the trend data available from LAKEWATCH or other sources. Table 6 contains the summary water quality data and index values and adjusted values calculated from these data. The total phosphorus (TP), total nitrogen (TN) and chlorophyll (a) water chemistry sample data are the results of chemical analysis of samples taken during the assessment and analyzed by the Hillsborough County Environmental Protection Commission laboratory. These data compare reasonably well with the mean data from the LAKEWATCH data set for the lake. The trophic state index (TSI) calculated from the sample data 69.43 is within the values shown in the figure above and corresponds to the general trend from earlier measurements.

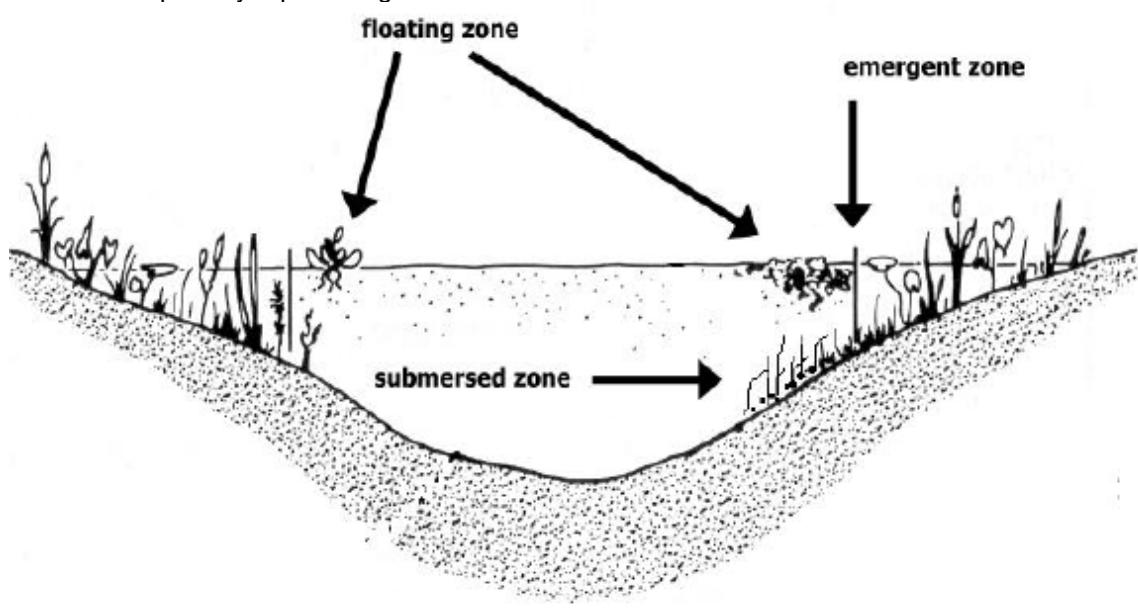
iv The three primary aquatic vegetation zones are shown below:
