LAKE ASSESSMENT REPORT FOR LAKE CARLTON IN HILLSBOROUGH COUNTY, FLORIDA

Date Assessed: August 26, 2008

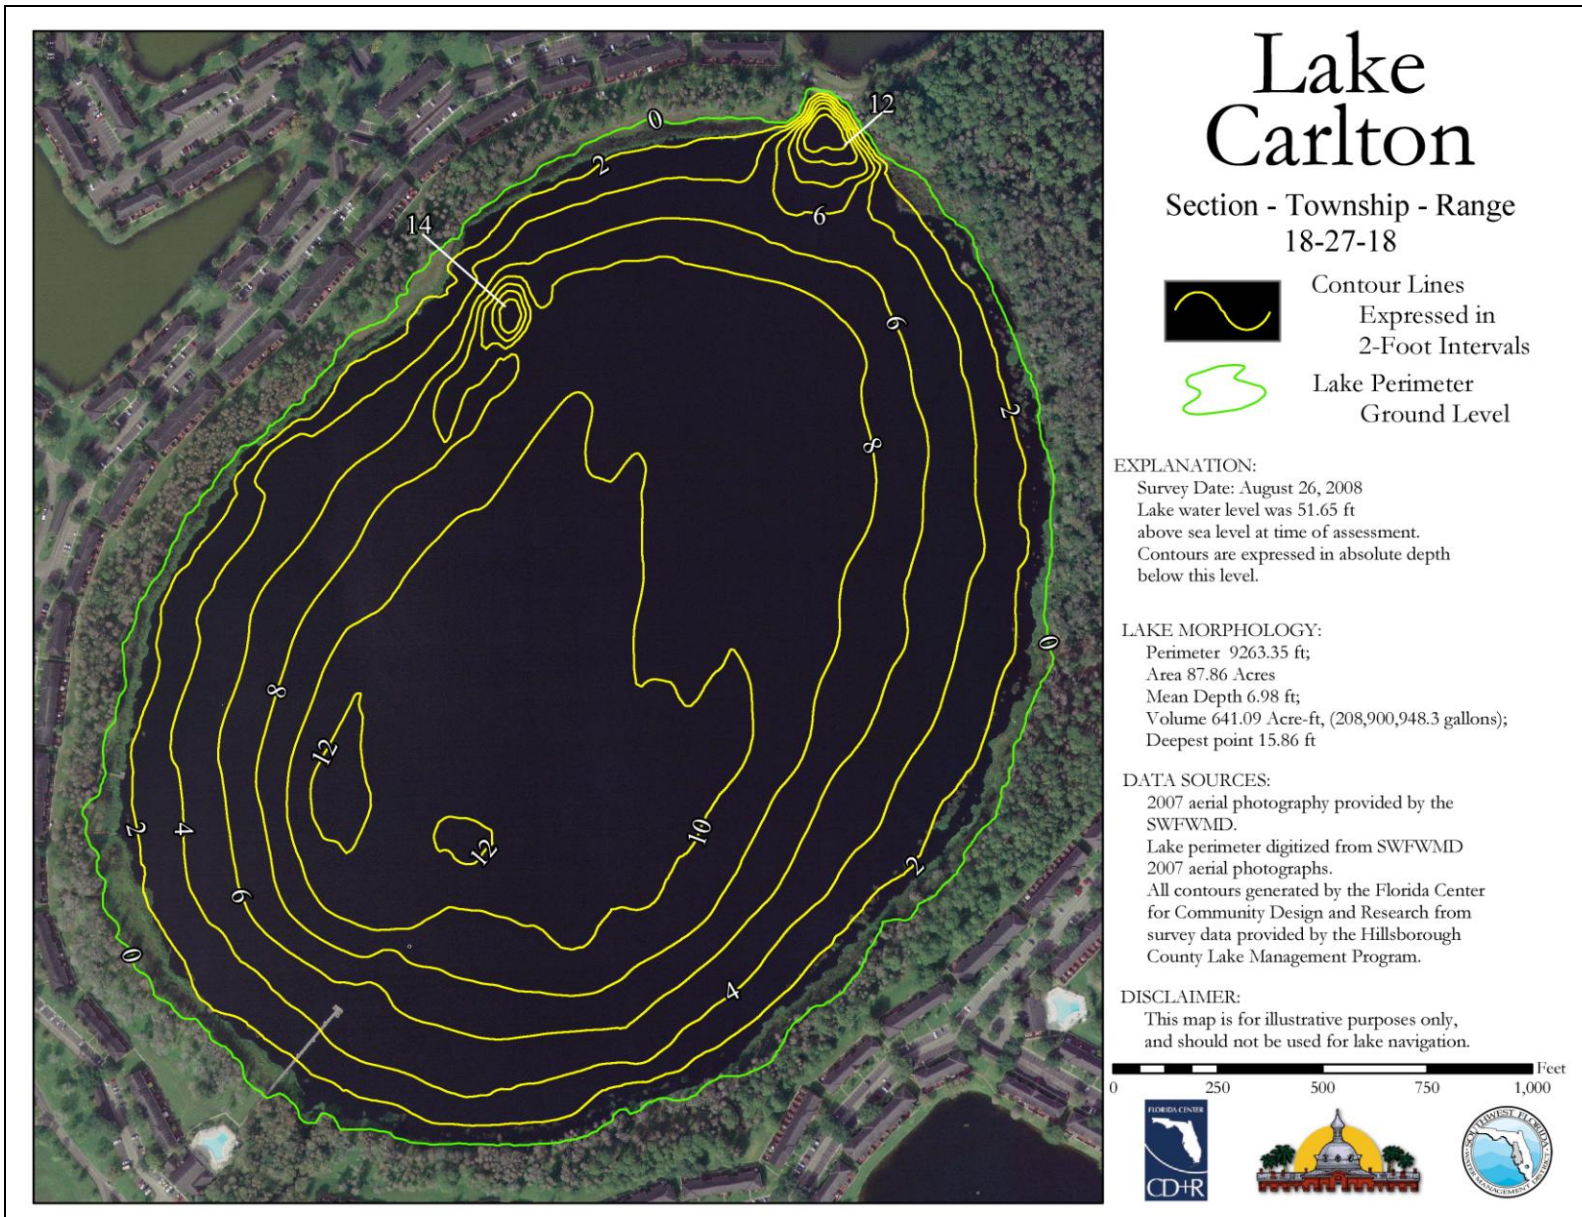
Figure 1. Contour map for Lake Carlton. The mapping technique used in 2008 employs a standard DGPS for horizontal position and a fathometer for depth.

Bathymetric Mapⁱⁱ. Table 1 provides the lake's morphologic parameters in various units. The bottom of the lake was mapped using a Lowrance LCX 28C HD Wide Area Augmentation System (WAAS)ⁱⁱⁱ enabled Global Positioning System (GPS) with fathometer (bottom sounder) to determine the boat's position, and bottom depth in a single measurement. The result is an estimate of the lake's area, mean and maximum depths, and volume and the creation of a bottom contour map (Figure 2). Besides pointing out the deeper fishing holes in the lake, the morphologic data derived from this part of the assessment can be valuable to overall management of the lake vegetation as well as providing flood storage data for flood models.

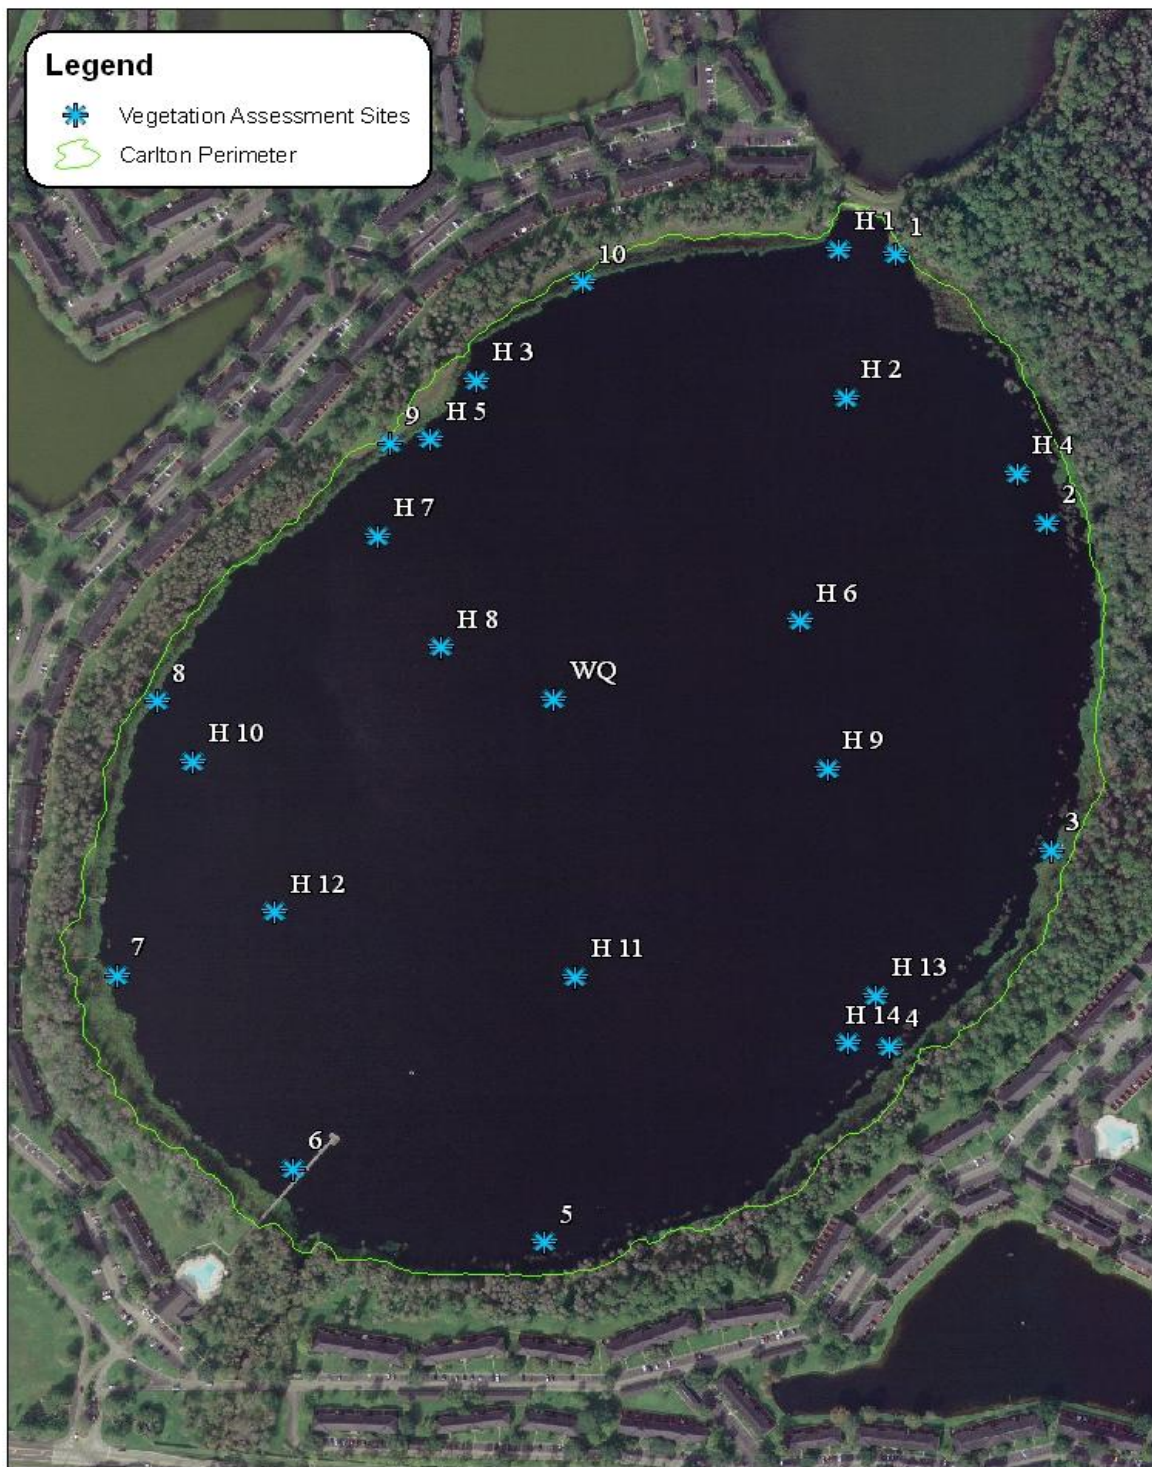
Figure 3. 2007 six-inch resolution aerial photograph showing location of vegetation assessment sites (sites 1-10) on Lake Carlton. Major emergent and floating vegetation zones as well as structures are also observable in this aerial. See Appendix A for an explanation of sites H1-H14.

The lake's apparent vegetative cover and shoreline detail are evaluated using the latest lake aerial photograph as shown in Figure 3 and by use of WAAS enabled GPS. Submerged vegetation is determined from the analysis of bottom returns from the Lowrance 28c HD combined GPS/fathometer described earlier. As depicted in Figure 3, ten vegetation assessment sites were chosen for intensive sampling based on the *Lake Assessment Protocol* (copy available on request) for a lake of this size. The site positions are set using GPS and then loaded into a GIS mapping program (ArcGIS) for display. Each site is sampled in the three primary vegetative zones (emergent, submerged and floating).^{iv} The latest high resolution aerial photos are used to provide shore details (docks, structures, vegetation zones) and to calculate the extent of surface vegetation coverage. The primary indices of submerged vegetation cover and biomass for the lake, percent area coverage (PAC) and percent volume infestation (PVI), are determined by transiting the lake by boat and employing a fathometer to collect "hard and soft return" data. These data are later analyzed for presence and absence of vegetation and to determine the height of vegetation if present. The PAC is determined from the presence and absence analysis of 100 sites in the lake and the PVI is determined by measuring the difference between hard returns (lake bottom) and soft returns (top of vegetation) for sites (within the 100 analyzed sites) where plants are determined present (Figure 6).

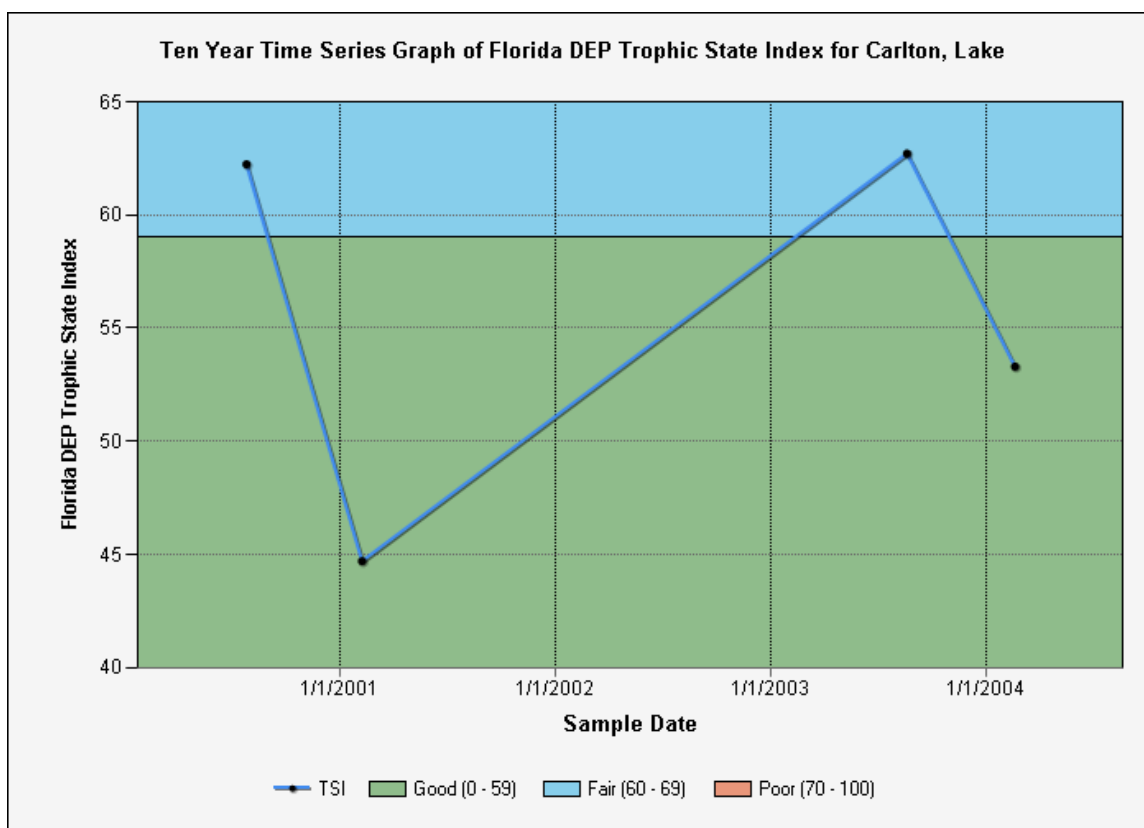
Figure 7. Recent Trophic State Index (TSI) graph from Hillsborough Watershed Atlas. For the latest data go to: <http://www.hillsborough.wateratlas.usf.edu/lake/waterquality.asp?wbodvid=5077&wbodvatlas=lake>

Note: The graph above includes benchmarks for using verbal descriptors of "good", "fair" and "poor". The verbal descriptors for these benchmarks are based on an early determination by stakeholders of the generally acceptable and understood terms for describing the state of lakes. The same benchmarks are used for nutrient graphs (Nitrogen and Phosphorus), chlorophyll graphs and trophic state index (TSI) graphs. The TSI is a calculated index of lake condition based on nutrient and chlorophyll (a) concentrations (please see "Learn more about Trophic State Index"). The benchmarks are established based on the TSI range that relates to a specific descriptor. The source for the TSI concentration relationships is the Florida Water Quality Assessment, 1996, 305(b) (Table 2-8).

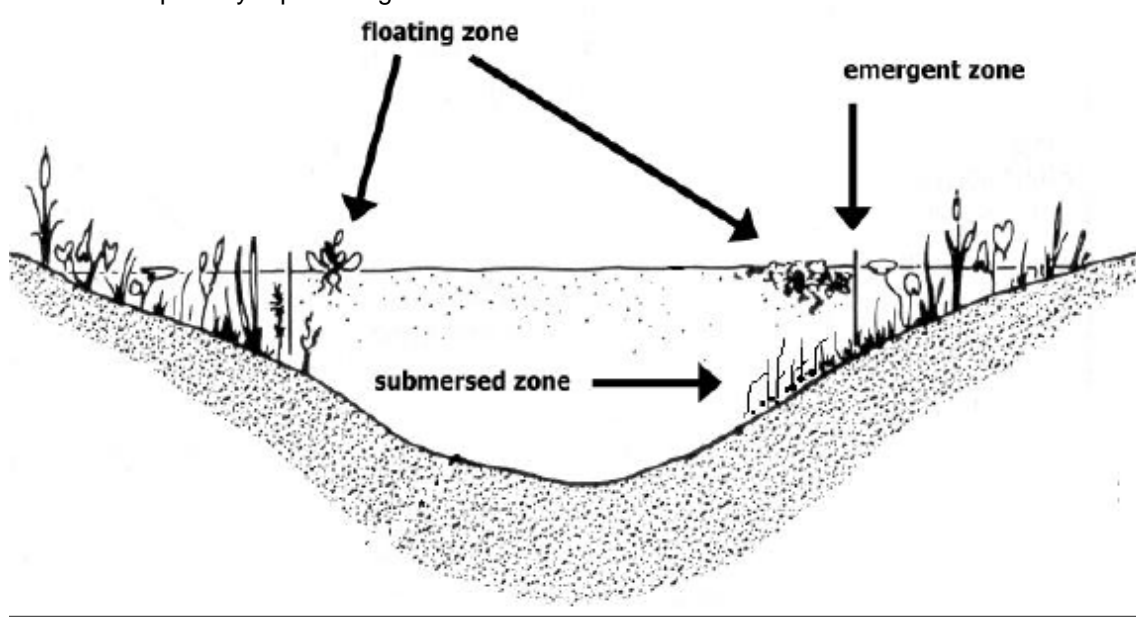
iv The three primary aquatic vegetation zones are shown below:

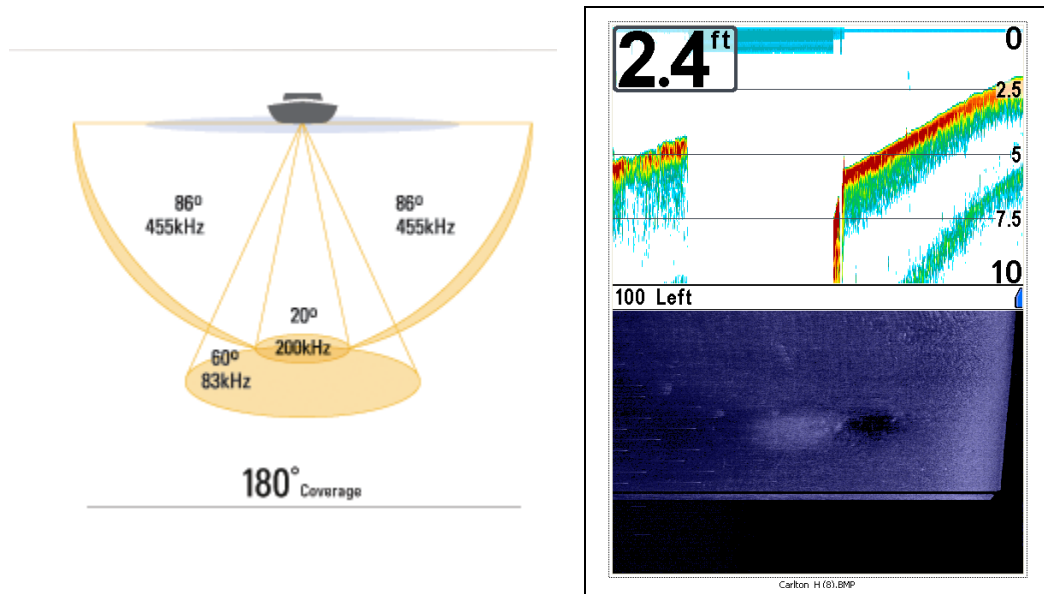
The display at the right was taken in Lake Carlton and shows a smooth bottom both in the vertical and side looking views (top/bottom). The lower image also indicates an object on the bottom by the brighter than background return and shadow. We use both views as well as a vegetation rake to verify presents and absence of vegetation. On the next page you will see the fourteen sites where vegetation verification was made and the associated Humminbird displays.

We use a Humminbird 797c GPS Chartplotter side scanning and bottom scanning sonar system to assist in the verification of vegetation present or absence. The "system uses a 200/83 kHz Dual Beam PLUS™ sonar system with a wide (60°) area of coverage. DualBeam PLUS™ sonar has a narrowly focused 20° center beam, surrounded by a second beam of 60°, expanding coverage to an area equal to lake depth. In 20 feet of water, the wider beam covers an area 20 feet wide. The 20° center beam is focused on the bottom, to show you structure, weeds and cover. The 60° wide beam is hunting for fish in the wide coverage area. DualBeam PLUS™ sonar returns can be blended together, viewed separately or compared side-by-side. DualBeam PLUS™ is ideal for a wide range of conditions - from shallow to very deep water in both fresh and salt water. Depth capability is affected by such factors as boat speed, wave action, bottom hardness, water conditions and transducer installation."¹

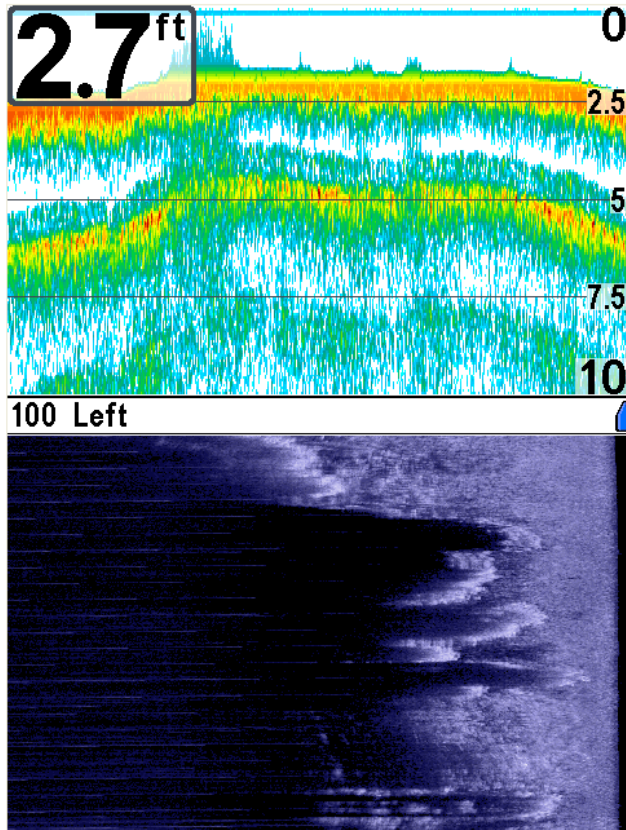
Site H 14 showed presents of vegetation. The upper trace indicates vegetation returns from the vertical transducer and which is supported by the side scan below. Notice the large shadow area and bright edge returns.

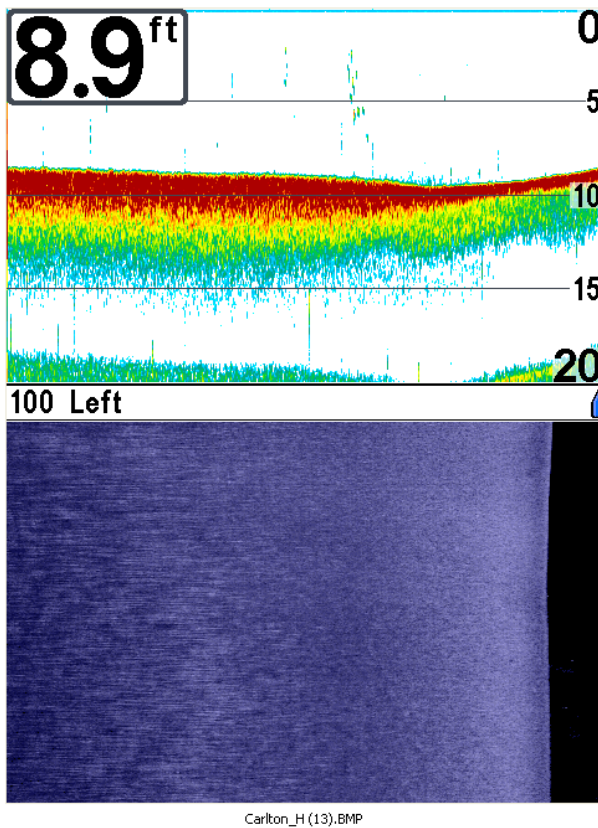
Site H 13 showed absence of vegetation. The upper trace indicates noise but no returns from the vertical transducer and this is supported by the side scan below. Notice smooth return without any noticeable shadowing or bright spots.
