LAKE ASSESSMENT REPORT FOR LAKE HEATHER IN HILLSBOROUGH COUNTY, FLORIDA

Date Assessed: July 22, 2008

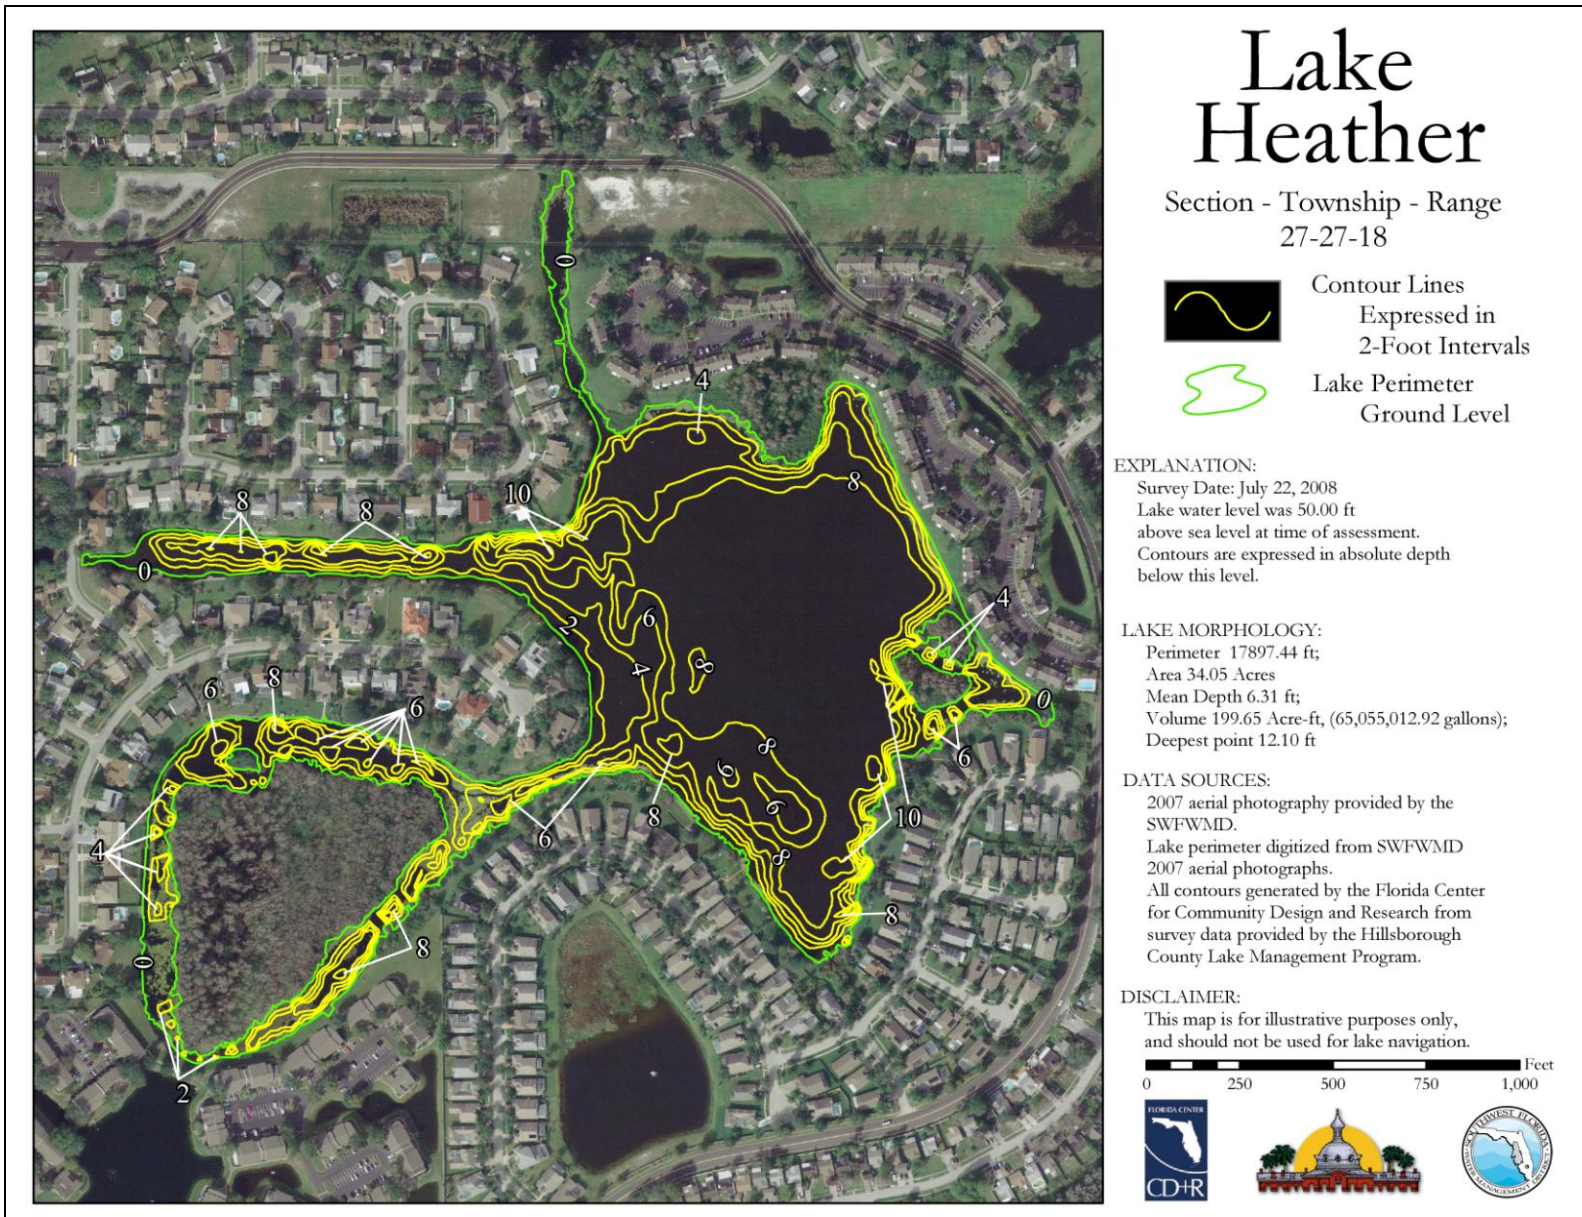
Figure 1. Contour map for Lake Heather. The mapping technique used in 2008 employs a standard DGPS for horizontal position and a fathometer for depth.

Bathymetric Mapⁱⁱ. Table 1 provides the lake's morphologic parameters in various units. The bottom of the lake was mapped using a Lowrance LCX 28C HD Wide Area Augmentation System (WAAS)ⁱⁱⁱ enabled Global Positioning System (GPS) with fathometer (bottom sounder) to determine the boat's position, and bottom depth in a single measurement. The result is an estimate of the lake's area, mean and maximum depths, and volume and the creation of a bottom contour map (Figure 2). Besides pointing out the deeper fishing holes in the lake, the morphologic data derived from this part of the assessment can be valuable to overall management of the lake vegetation as well as providing flood storage data for flood models.

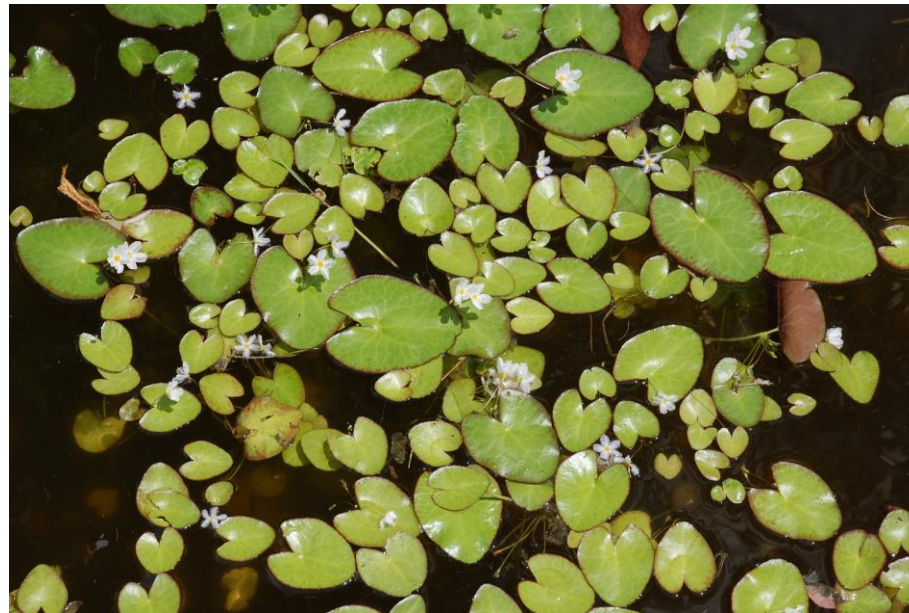
Figure 4. Photograph of Crested Banana Lily, *Nymphoides cristata*, on Lake Heather. The Crested Banana Lily is a non-native invasive species that can cover much of the waters surface.
