# LAKE ASSESSMENT REPORT FOR LAKE SUNSET IN HILLSBOROUGH COUNTY, FLORIDA

Date Assessed: June 18, 2008

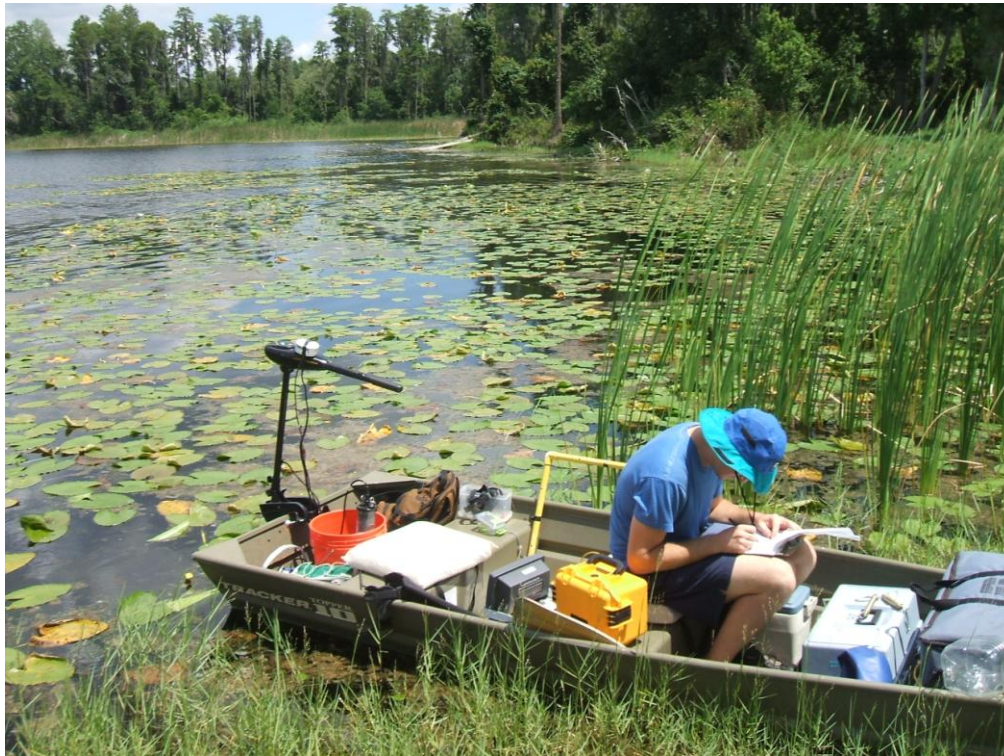
**Figure 4.** Photograph of Spatterdock, *Nuphar lutea var. advena* on Lake Sunset, Spatterdock is a native floating leaved plants which provide essential habitat for several species of fish and invertebrates. This species can grow into dense patches and become a pest species by inhibiting activities such as boating.

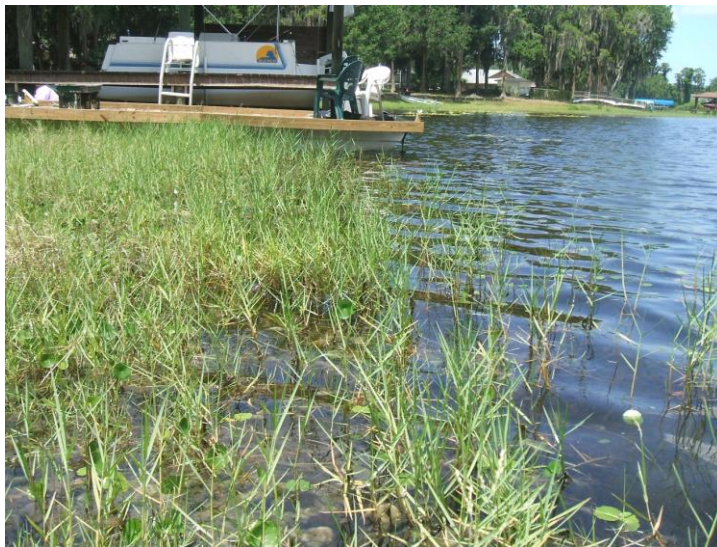
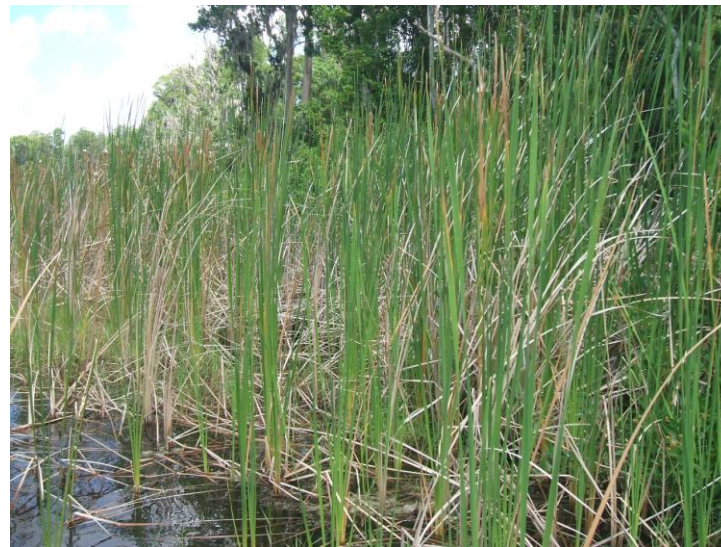
**Figure 5.** On the left Torpedo Grass, *Panicum repens*, is a common non-native, invasive grass in that grows along shorelines of Florida lakes. On the right are Cattails, *Typha spp.* Cattails are a commonly native species that grows along Florida lake shorelines where under certain conditions they can become a pest species, creating dense stands.

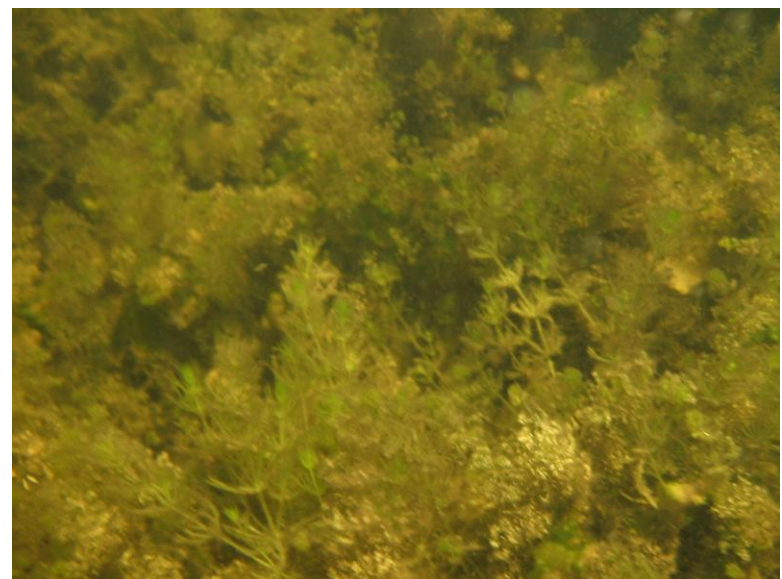
**Figure 5.** Photograph of Photograph of *Chara spp.* and *Nitella spp.*, on Lake Sunset.

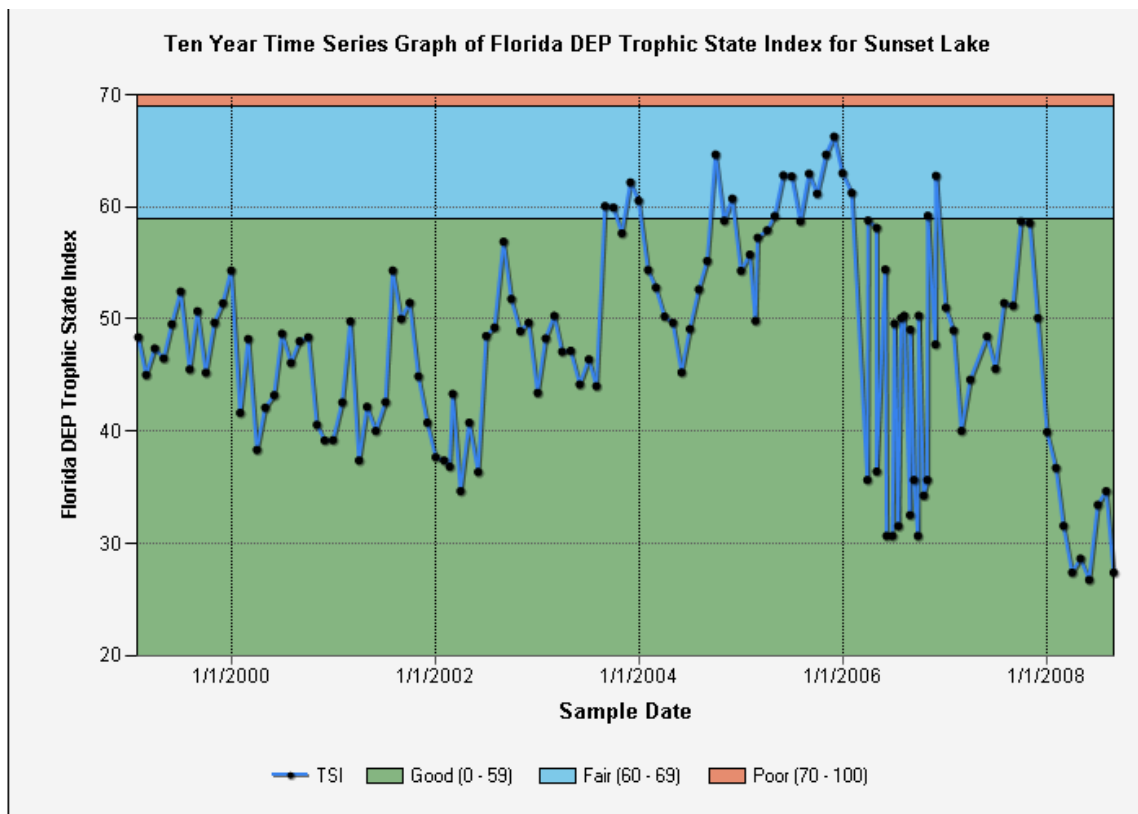
**Figure 6.** Recent Trophic State Index (TSI) graph from Hillsborough Watershed Atlas. For the latest data go to:

Note: The graph above includes benchmarks for using verbal descriptors of "good", "fair" and "poor". The verbal descriptors for these benchmarks are based on an early determination by stakeholders of the generally acceptable and understood terms for describing the state of lakes. The same benchmarks are used for nutrient graphs (Nitrogen and Phosphorus), chlorophyll graphs and trophic state index (TSI) graphs. The TSI is a calculated index of lake condition based on nutrient and chlorophyll (a) concentrations (please see "Learn more about Trophic State Index"). The benchmarks are established based on the TSI range that relates to a specific descriptor. The source for the TSI concentration relationships is the Florida Water Quality Assessment. 1996. 305(b) (Table 2-8).

As part of the lake assessment the physical water quality and chemical water chemistry of a lake are measured. These data only indicate a snap shot of the lakes water quality; however they are useful when compared to the trend data available from LAKEWATCH or other sources. Table 7 contains the summary water quality data and index values and adjusted values calculated from these data. The total phosphorus (TP), total nitrogen (TN) and chlorophyll (a) water chemistry sample data are the results of chemical analysis of samples taken during the assessment and analyzed by the Hillsborough County Environmental Protection Commission laboratory. These data compare reasonably well with the mean data from the LAKEWATCH data set for the lake. The trophic state index (TSI) calculated from the sample data 30.56 is within the most recent values shown in the figure above.
