LAKE ASSESSMENT REPORT FOR LAKE PINE IN HILLSBOROUGH COUNTY, FLORIDA

Date Assessed: May 28, 2007
Assessed by: Sarah Koenig and David Eilers
Reviewed by: Jim Griffin, Ph.D.

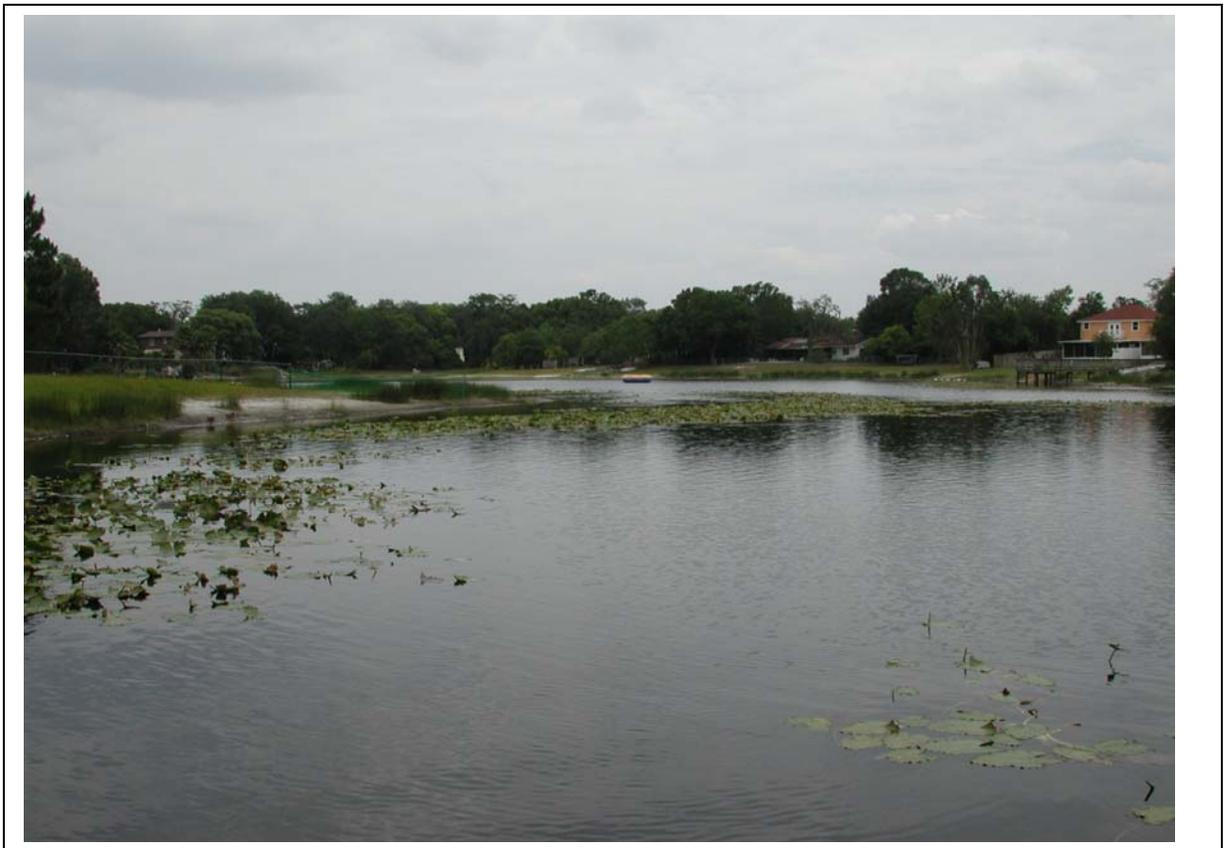
Figure 1. Photograph of Lake Pine May 2007.

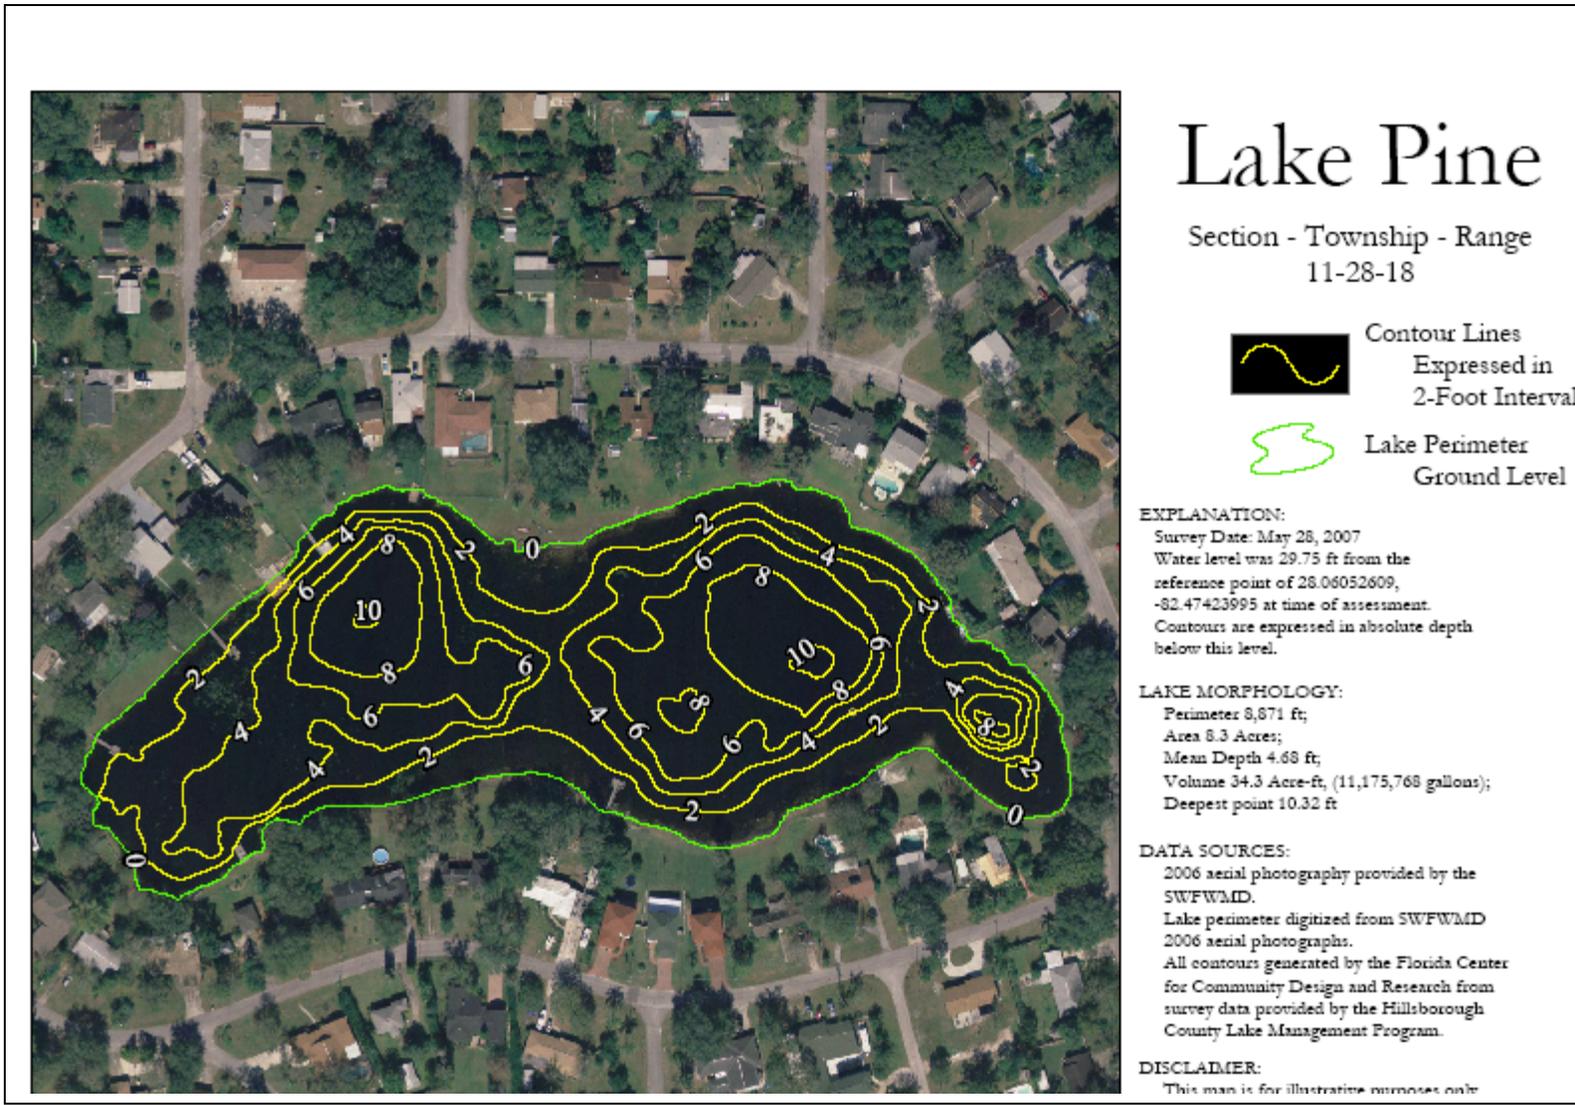
Figure 2. Lake Bathymetry for Lake Pine.

Bathymetric Mapⁱⁱ. Table 1 provides the lake's morphologic parameters in various units. The bottom of the lake was mapped using a Lowrance LCX 26C HD Wide Area Augmentation System (WAAS)ⁱⁱⁱ enabled Global Positioning System (GPS) with fathometer (bottom sounder) to determine the boat's position, and bottom depth in a single measurement. The result is an estimate of the lake's area, mean and maximum depths, and volume and the creation of a bottom contour map (Figure 2). Besides pointing out the deeper fishing holes in the lake, the morphologic data derived from this part of the assessment can be valuable to overall management of the lake vegetation as well as providing flood storage data for flood models.

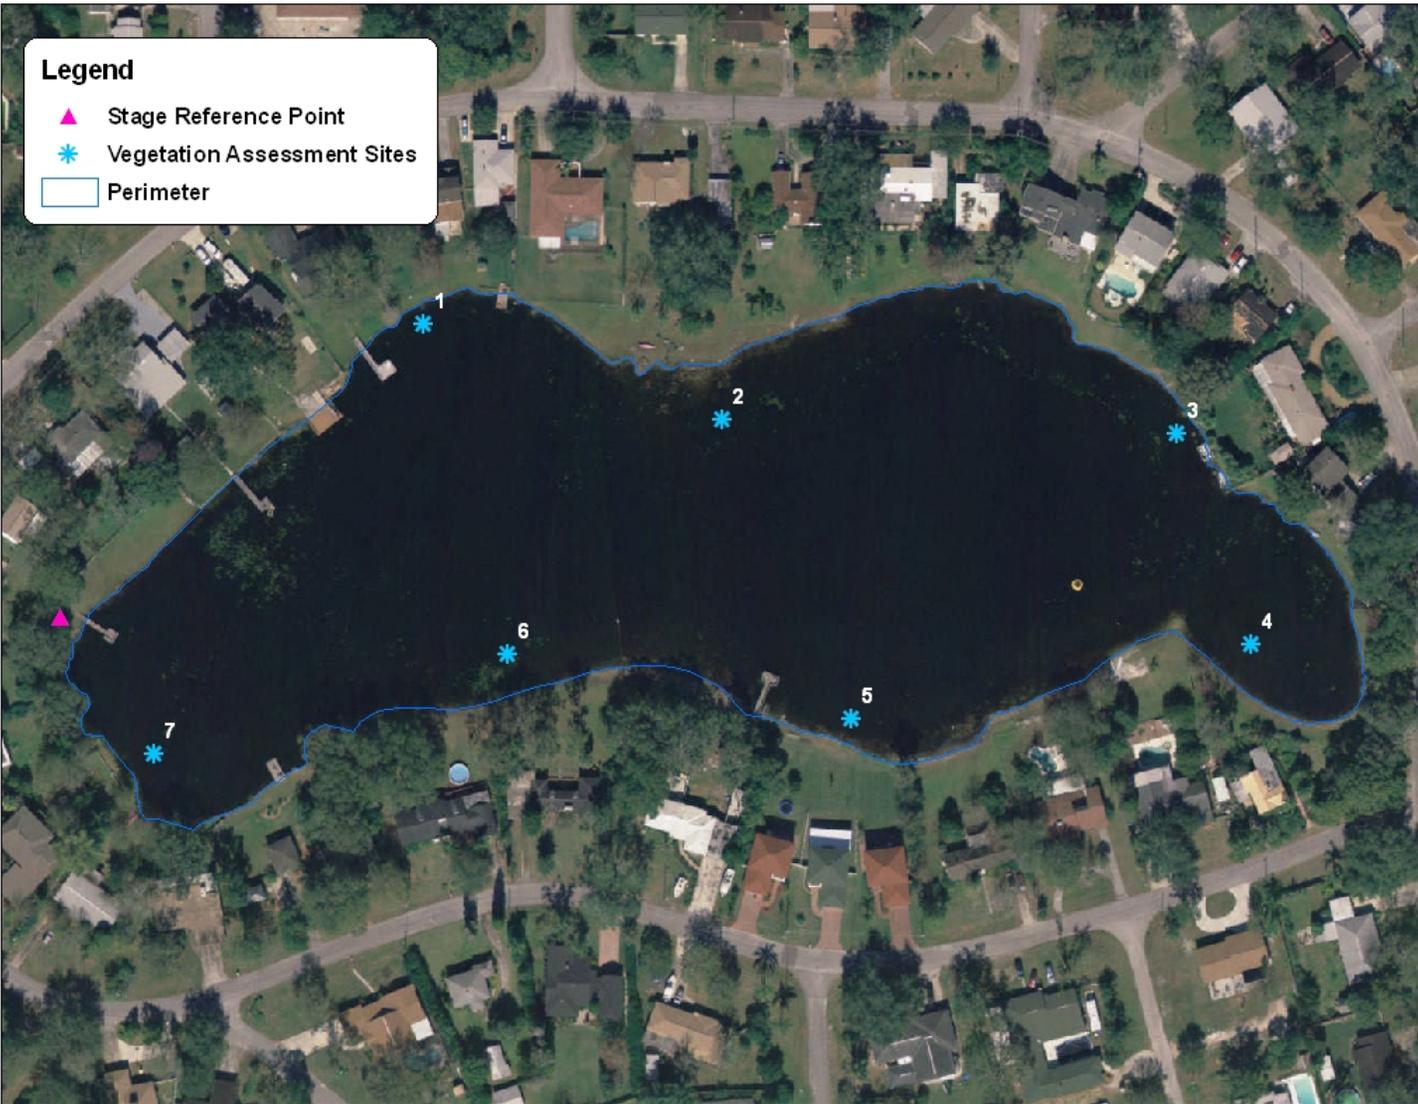
Figure 3. 2006 six-inch resolution aerial photograph showing location of vegetation assessment sites and stage reference point on Lake Pine. Major emergent and floating vegetation zones as well as structures such as docks are also observable in this aerial.

The lake's apparent vegetative cover and shoreline detail are evaluated using the latest lake aerial photograph as shown in Figure 3 and by use of WAAS enabled GPS. Submerged vegetation is determined from the analysis of bottom returns from the Lowrance 26c HD combined GPS/fathometer described earlier. As depicted in Figure 3, seven vegetation assessment sites were chosen for intensive sampling based on the *Lake Assessment Protocol* (copy available on request) for a lake of this size. The site positions are set using GPS and then loaded into a GIS mapping program (ArcGIS) for display. Each site is sampled in the three primary vegetative zones (emergent, submerged and floating)^{iv}. The latest high resolution aerial photos are used to provide shore details (docks, structures, vegetation zones) and to calculate the extent of surface vegetation coverage. The primary indices of submerged vegetation cover and biomass for the lake, percent area coverage (PAC) and percent volume infestation (PVI), are determined by transiting the lake by boat and employing a fathometer to collect "hard and soft return" data. These data are later analyzed for presence and absence of vegetation and to determine the height of vegetation if present. The PAC is determined from the presence and absence analysis of 100 sites in the lake and the PVI is determined by measuring the difference between hard returns (lake bottom) and soft returns (top of vegetation) for sites (within the 100 analyzed sites) where plants are determined present (Figure 6).

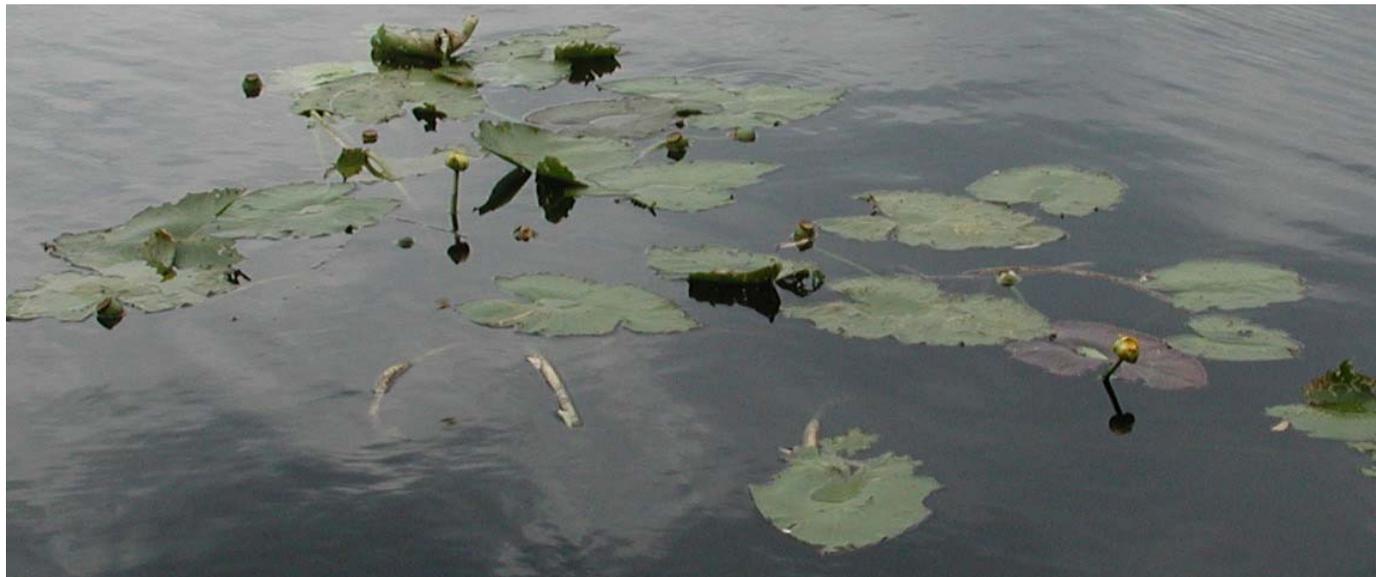
Figure 4. *Nuphar lutea var. advena*, Spatterdock, Yellow Pondlily, is a native floating leaved vegetation which serves as an important source of habitat for several species of fish and invertebrates at various life stages. Although native, this species is capable of dominating much of the surface of waterbodies, causing submerged vegetation to decline due to decreased light levels.

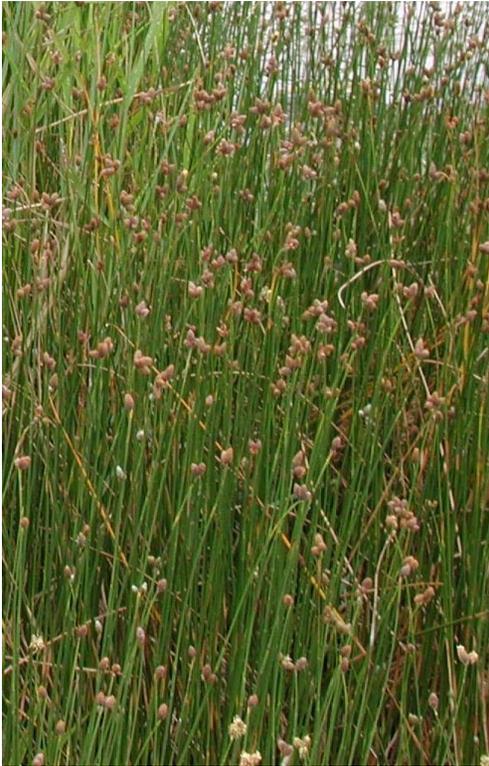
Figure 5. *Fuirena scirpoidea*, Southern Umbrellasedge, Rush Fuirena, is a native sedge that grows along lakeshores in Florida typically in shallow water.

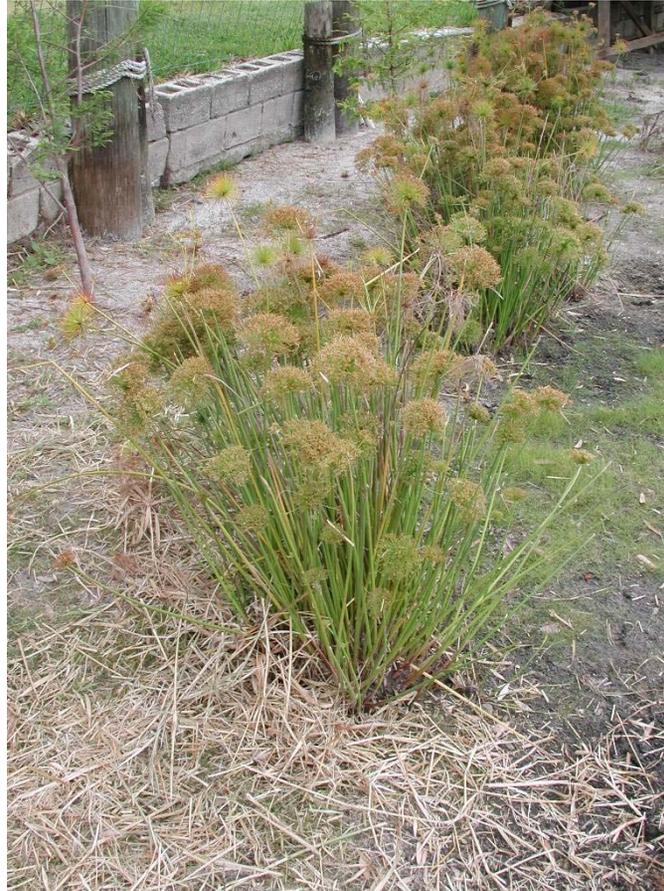
Figure 6. *Cyperus prolifer*, Dwarf Papyrus, is an invasive exotic plant that has increased in abundance but has not yet altered native plant communities. As such it is listed as a Category II Invasive by the Florida Exotic Pest Plant Council.

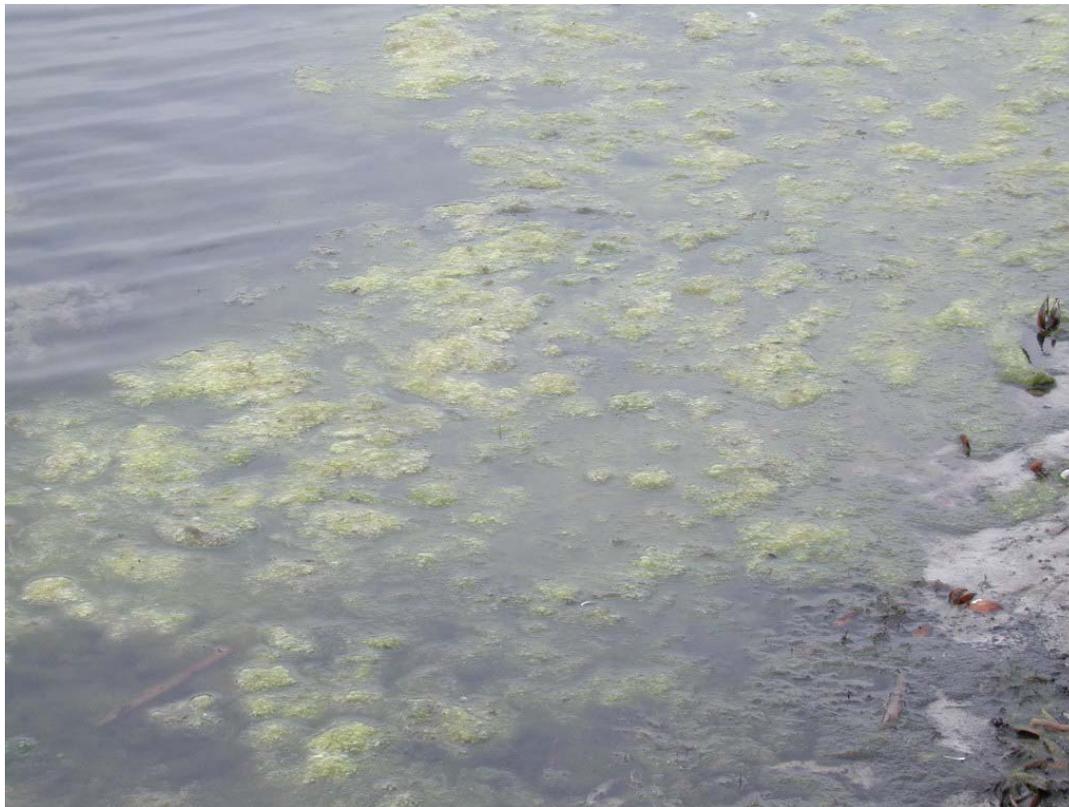
Figure 7. Algal mats such as this one can be a sign of increased nutrients in the water column. Typically the source of these nutrients is runoff from lawns along the lakeshore containing fertilizers, causing a bloom in the water.

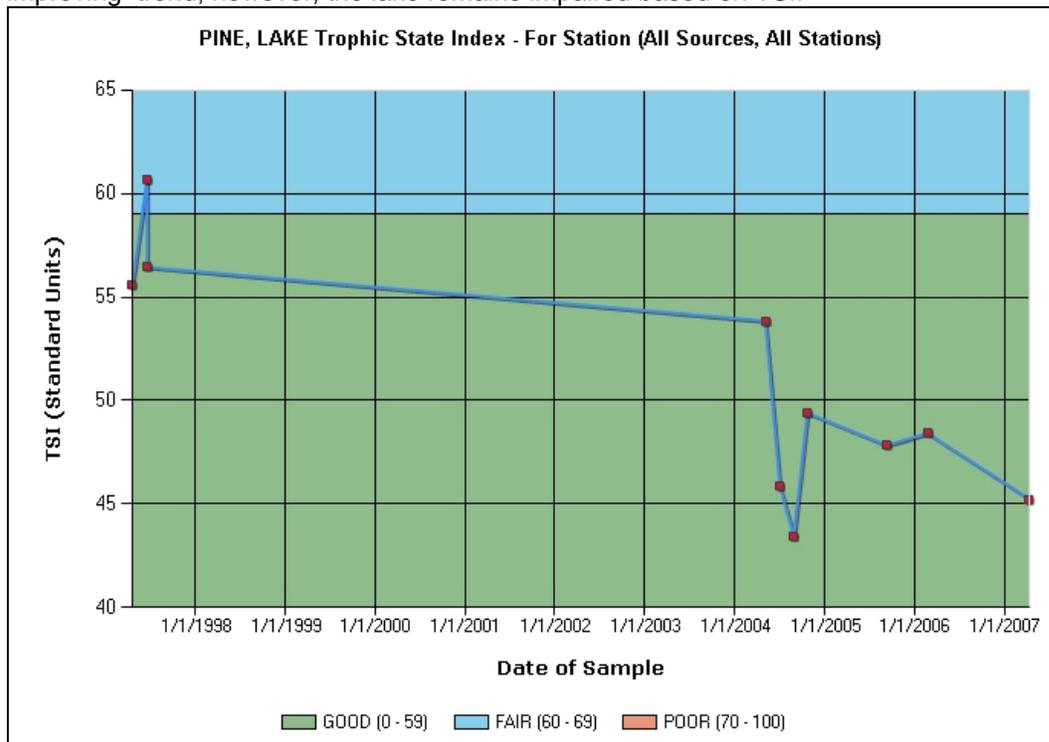
Figure 8. Recent Trophic State Index (TSI) graph from Hillsborough Watershed Atlas. For the latest date go to: (<http://www.hillsborough.wateratlas.usf.edu/lake/waterquality.asp?wbodyid=5390&wbodyatlas=lake>)

Note: The graph above includes benchmarks for using verbal descriptors of "good", "fair" and "poor". The verbal descriptors for these benchmarks are based on an early determination by stakeholders of the generally acceptable and understood terms for describing the state of lakes. The same benchmarks are used for nutrient graphs (Nitrogen and Phosphorus), chlorophyll graphs and trophic state index (TSI) graphs. The TSI is a calculated index of lake condition based on nutrient and chlorophyll (a) concentrations (please see "Learn more about Trophic State Index"). The benchmarks are established based on the TSI range that relates to a specific descriptor. The source for the TSI concentration relationships is the Florida Water Quality Assessment, 1996, 305(b) (Table 2-8).

A critical element in any lake assessment is the long-term water chemistry data set. The primary source of water quality trend data for Florida Lakes is the Florida LAKEWATCH volunteer and the Florida LAKEWATCH water chemistry data. Hillsborough County is fortunate to have a large cadre of volunteers who have collected lake water samples for significant time period. These data are displayed and analyzed on the Water Atlas as shown in Figure 8 for Lake Pine. Although Lake Pine does not have a consistent dataset, the data is adequate to make some trend statements. Additional data, when available, is also included on the Water Atlas; however, the LAKEWATCH data remains the primary source. By the trend data shown in the figure, the lake may be considered in good health in terms of the trophic state index. This lake is a clear water lake and as such it must maintain a TSI of below 40 to not be considered impaired by the State of Florida guidelines^v. The lake's long term water quality data indicates enough violations of these criteria to be classified by Florida DEP as impaired. The more recent trends indicate an improving trend; however, the lake remains impaired based on TSI.

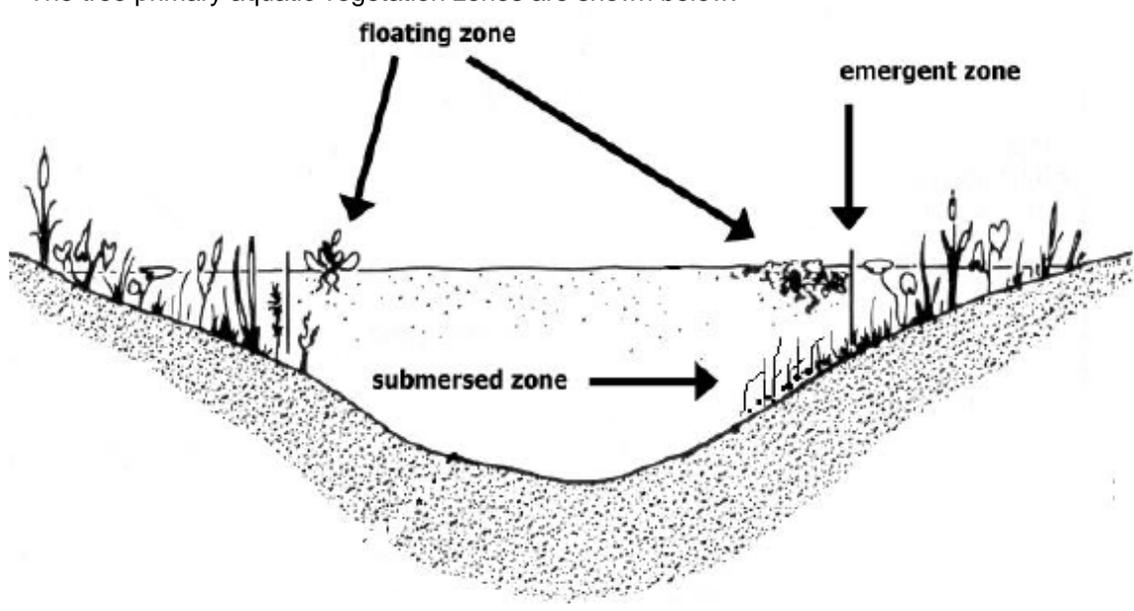
^{iv} The tree primary aquatic vegetation zones are shown below:
