# LAKE ASSESSMENT REPORT FOR HALF MOON LAKE IN HILLSBOROUGH COUNTY, FLORIDA

Date Assessed: July 23, 2008

Assessed by: Monetta Wilson and David Eilers

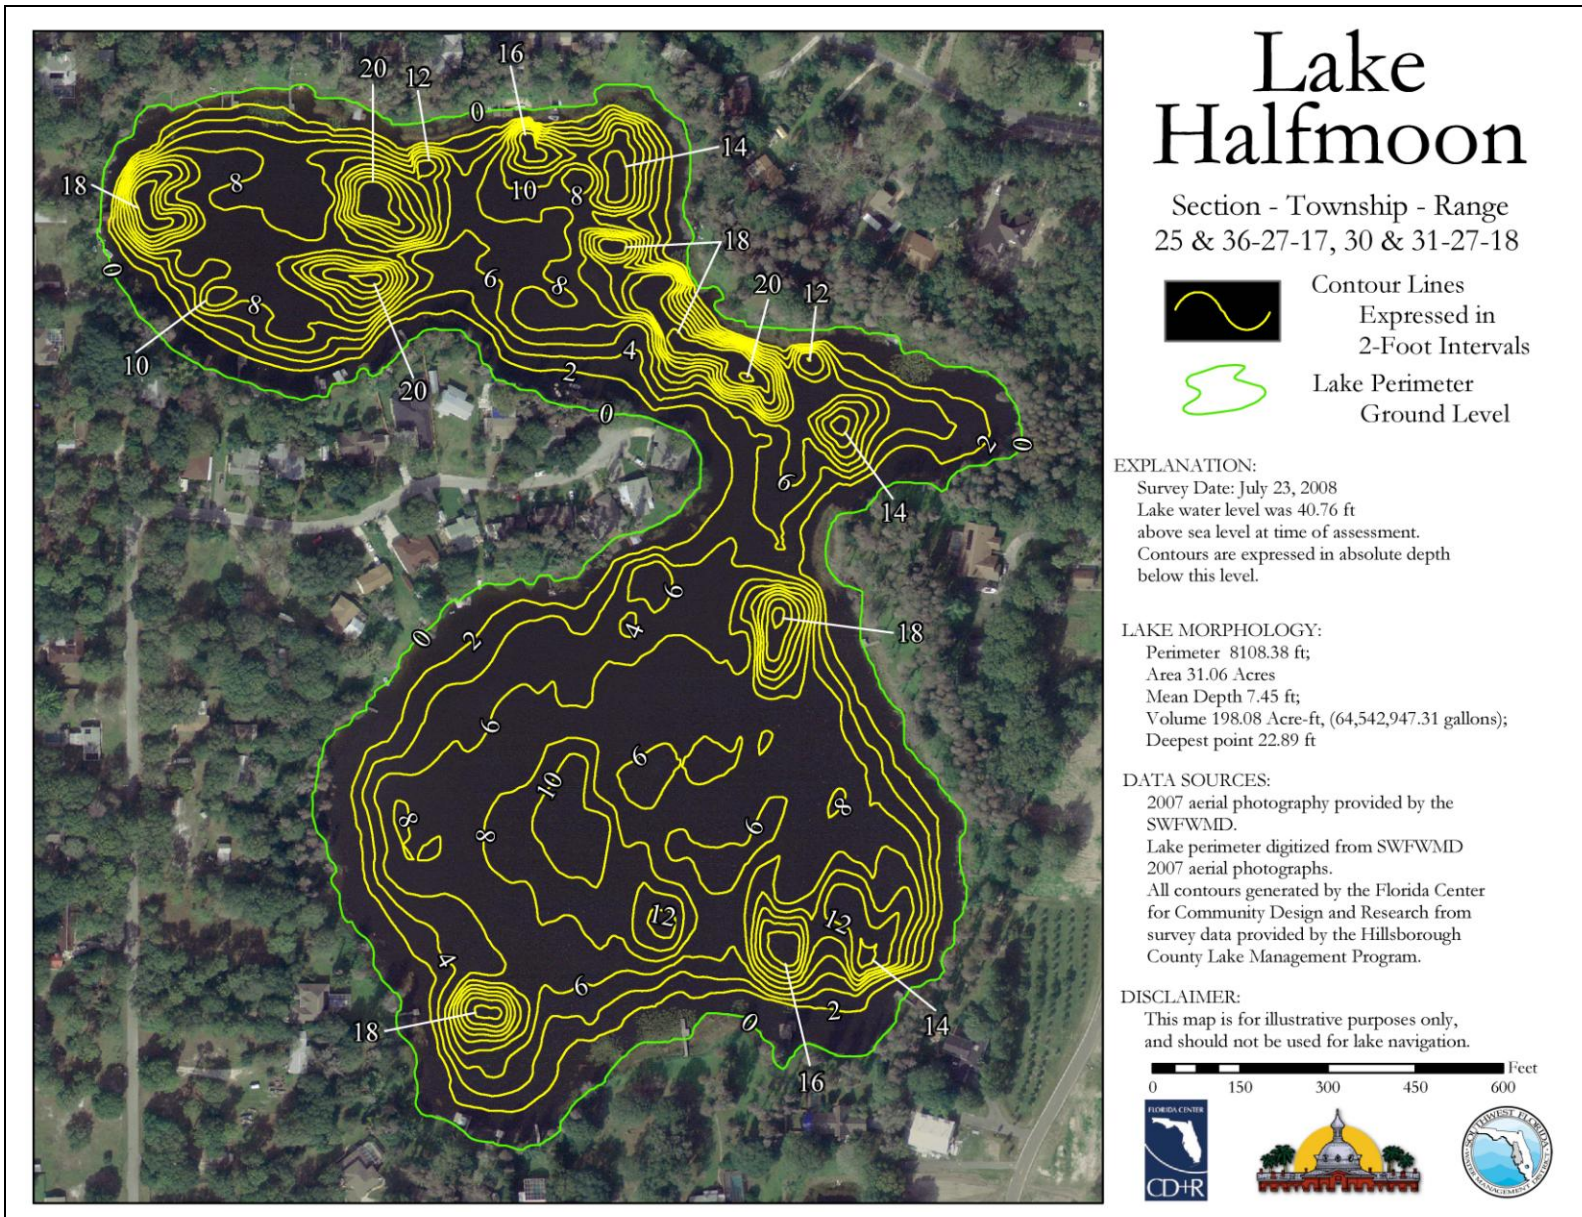
**Figure 1.** Contour map for Half Moon Lake. The mapping technique used in 2008 employs a standard DGPS for horizontal position and a fathometer for depth.

**Bathymetric Map<sup>ii</sup>**. Table 1 provides the lake's morphologic parameters in various units. The bottom of the lake was mapped using a Lowrance LCX 28C HD Wide Area Augmentation System (WAAS)<sup>iii</sup> enabled Global Positioning System (GPS) with fathometer (bottom sounder) to determine the boat's position, and bottom depth in a single measurement. The result is an estimate of the lake's area, mean and maximum depths, and volume and the creation of a bottom contour map (Figure 2). Besides pointing out the deeper fishing holes in the lake, the morphologic data derived from this part of the assessment can be valuable to overall management of the lake vegetation as well as providing flood storage data for flood models.
