# LAKE ASSESSMENT REPORT FOR ECHO LAKE IN HILLSBOROUGH COUNTY, FLORIDA

Date Assessed: June 17, 2008

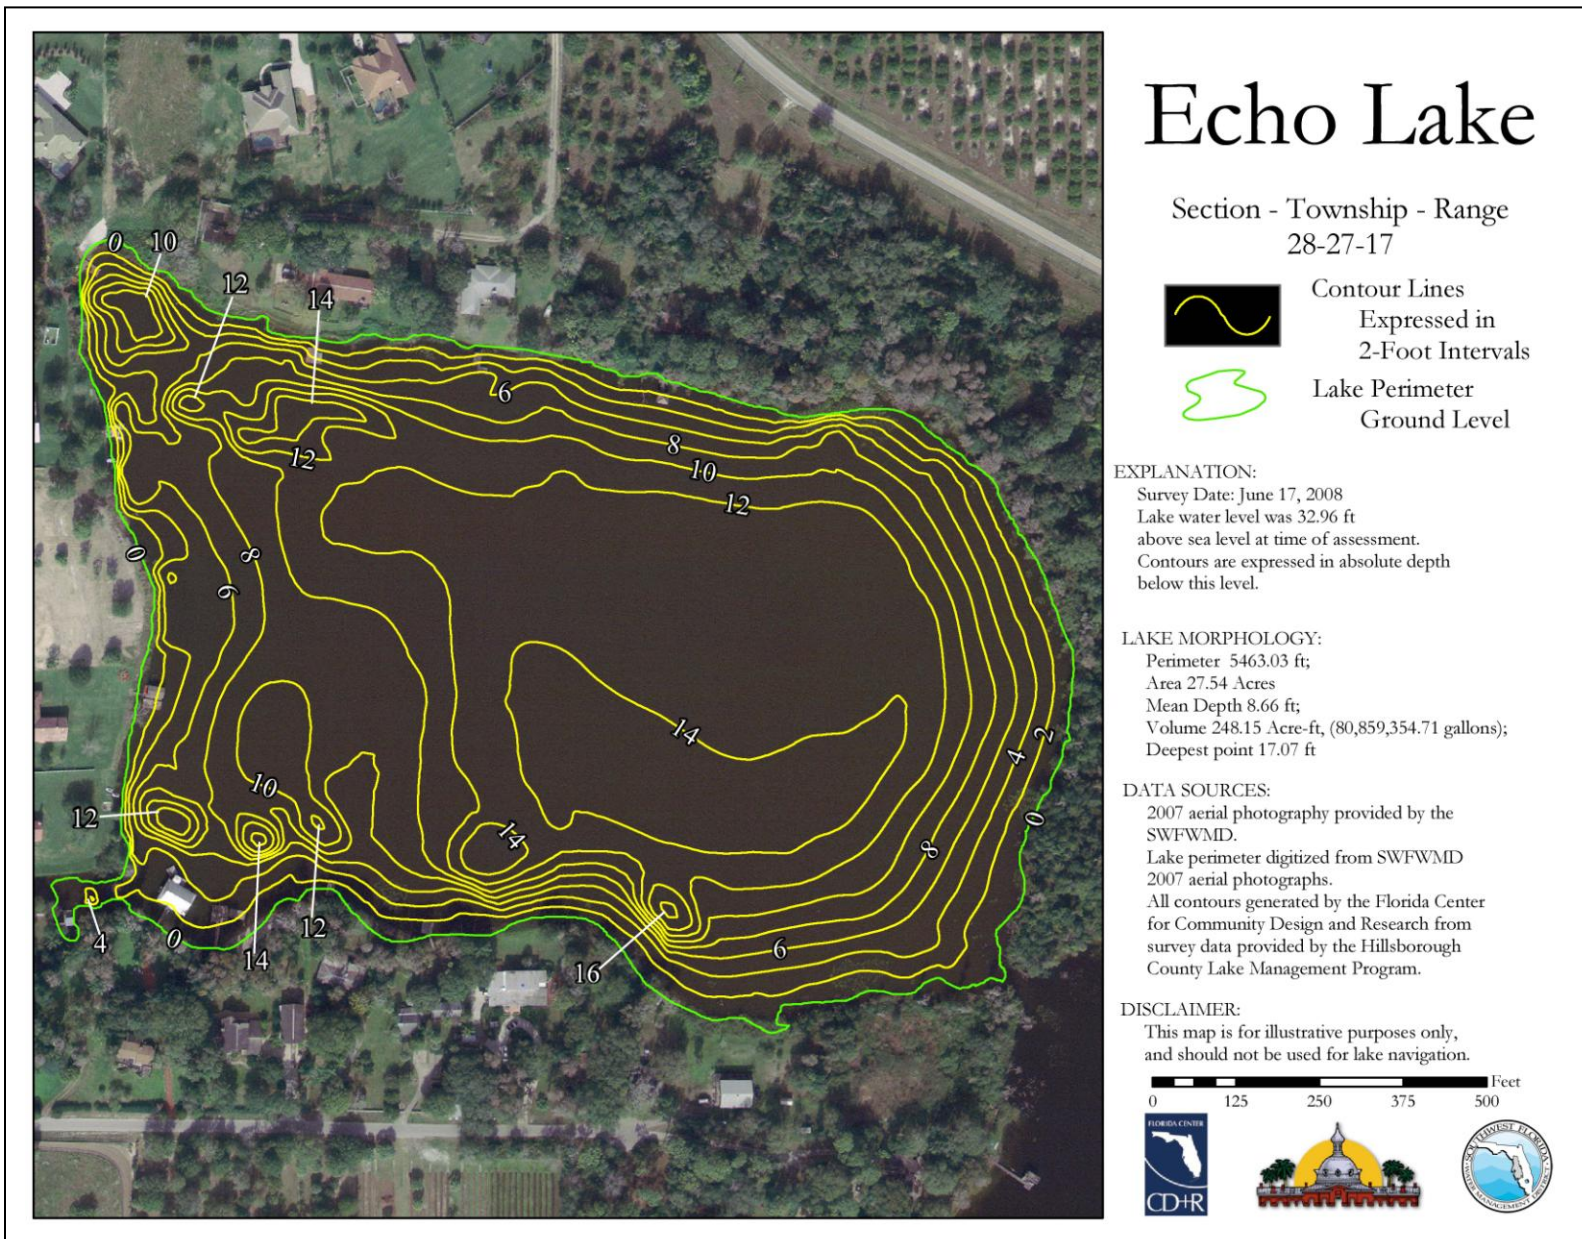
**Figure 1.** Contour map for Echo Lake. The mapping technique used in 2008 employs a standard DGPS for horizontal position and a fathometer for depth.

**Bathymetric Map<sup>ii</sup>**. Table 1 provides the lake's morphologic parameters in various units. The bottom of the lake was mapped using a Lowrance LCX 28C HD Wide Area Augmentation System (WAAS)<sup>iii</sup> enabled Global Positioning System (GPS) with fathometer (bottom sounder) to determine the boat's position, and bottom depth in a single measurement. The result is an estimate of the lake's area, mean and maximum depths, and volume and the creation of a bottom contour map (Figure 2). Besides pointing out the deeper fishing holes in the lake, the morphologic data derived from this part of the assessment can be valuable to overall management of the lake vegetation as well as providing flood storage data for flood models.

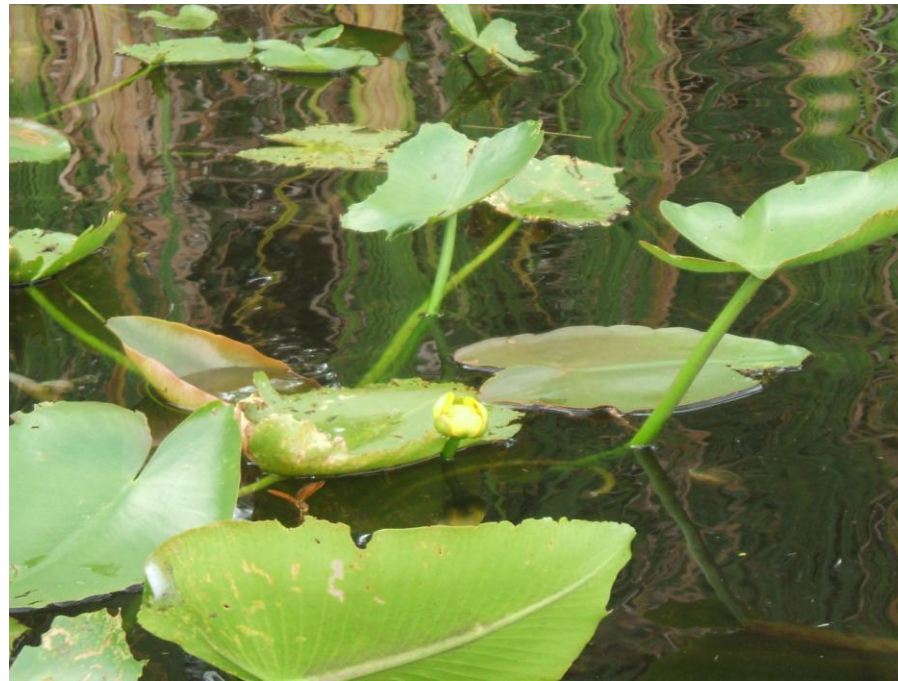
**Figure 4.** Photograph of Spatterdock, *Nuphar lutea var. advena*, on Echo Lake. This species of floating leaved vegetation is native to Florida lakes and its leaves and stems provide essential habitat for native species of fishes and invertebrates. In some situations this species can become a pest species and cover much of the waterbodies surface, limiting activities such as boating.

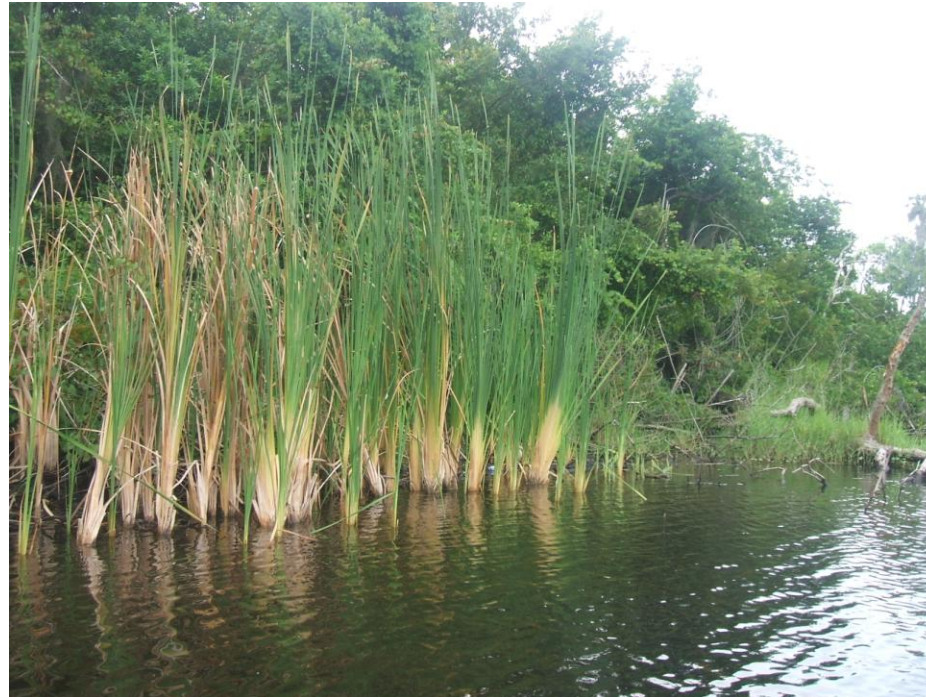
**Figure 5.** Photograph of Cattails, *Typha spp.* on Echo Lake. This is a native species that can become pest species, covering much of the waterbodies rim.

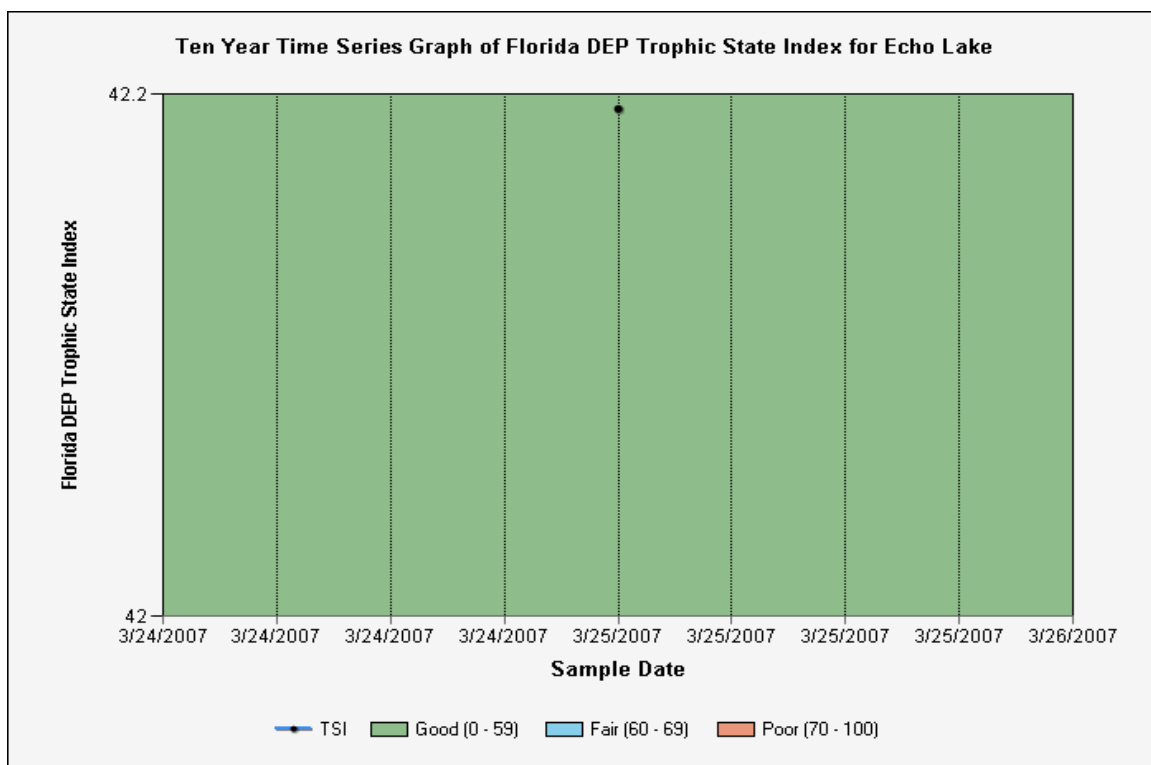
**Figure 7.** Recent Trophic State Index (TSI) graph from Hillsborough Watershed Atlas. For the latest data go to:

Note: The graph above includes benchmarks for using verbal descriptors of "good", "fair" and "poor". The verbal descriptors for these benchmarks are based on an early determination by stakeholders of the generally acceptable and understood terms for describing the state of lakes. The same benchmarks are used for nutrient graphs (Nitrogen and Phosphorus), chlorophyll graphs and trophic state index (TSI) graphs. The TSI is a calculated index of lake condition based on nutrient and chlorophyll (a) concentrations (please see "Learn more about Trophic State Index"). The benchmarks are established based on the TSI range that relates to a specific descriptor. The source for the TSI concentration relationships is the Florida Water Quality Assessment. 1996. 305(b) (Table 2-8).

A critical element in any lake assessment is the long-term water chemistry data set. The primary source of water quality trend data for Florida lakes is the Florida LAKEWATCH volunteer and the Florida LAKEWATCH water chemistry data. Hillsborough County is fortunate to have a large cadre of volunteers who have collected lake water samples for significant time period. These data are displayed and analyzed on the Water Atlas as shown in Figure 7 for Echo Lake. Additional data, when available, is also included on the Water Atlas; however, the LAKEWATCH data remains the primary source. Lake Echo does not have volunteer data and, as seen below, only one data point exists and therefore no trend can be determined. In early 2007 Echo would be classified as a “good” lake in terms of water chemistry. Lake Echo is a “clear” water lake (lake color less than 40 platinum-cobalt units PCU) and must maintain a TSI of less than 40 by the current Florida Department of Environmental Protection (FDEP) guidelines.
