# Lake Assessment Report for Keystone Lake in Hillsborough County, Florida

Date Assessed: June 22, 2010

Assessed by: David Eilers

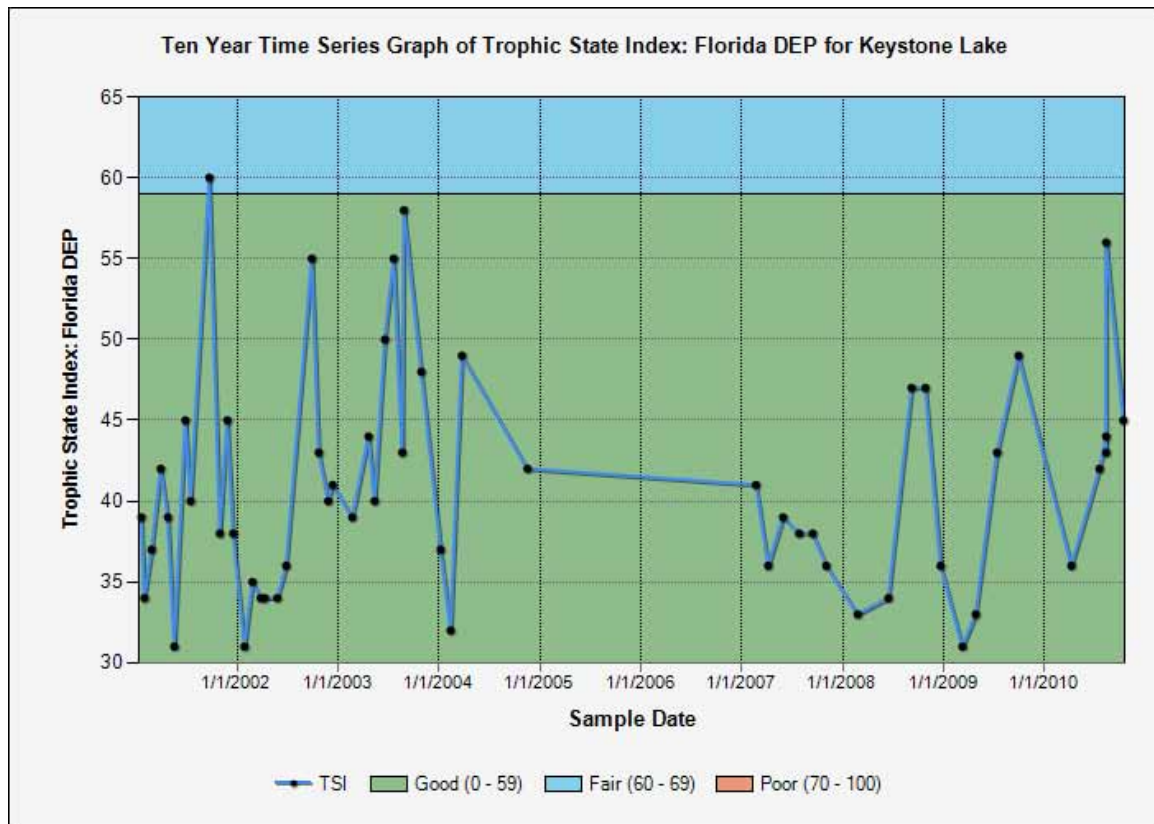
Figure 7. Recent Trophic State Index (TSI) graph for Keystone Lake<sup>vi</sup>

These data are displayed and analyzed on the Water Atlas as shown in Figure 7, Figure 8, and Figure 9 for Keystone Lake. The figures are graphs of: (1) the overall trophic state index (TSI)<sup>1</sup>, which is a method commonly used to characterize the productivity of a lake, and may be thought of as a lake's ability to support plant growth and a healthy food source for aquatic life; (2) the chlorophyll *a* concentration, which indicates the lake's algal concentration, and (3) the lake's Secchi Disk depth which is a measure of water visibility and depth of light penetration. These data are used to evaluate a lake's ecological health and to provide a method of ranking lakes and are indicators used by the US Environmental Protection Agency (USEPA) and the Florida Department of Environmental Protection (FDEP) to determine a lake's level of impairment. The chlorophyll *a* and Secchi Disk depth graphs include benchmarks which indicate the median values for the various parameters for a large number of Lakes in Florida expressed as percentiles.

Based on best available data, Keystone Lake has a color value determined as a platinum cobalt unit (pcu) value of 62 and is considered a Dark lake (has a mean color in pcu greater than 40). The FDEP and USEPA may classify a lake as impaired if the lake is a dark lake and has a TSI greater than 60, or is a clear lake (has a mean color in pcu less than or equal to 40) and has a TSI greater than 40. Keystone Lake has a TSI of 50 and does not meet the FDEP Impaired Waters Rule (IWR) criteria for impaired lakes. See also Table 7.

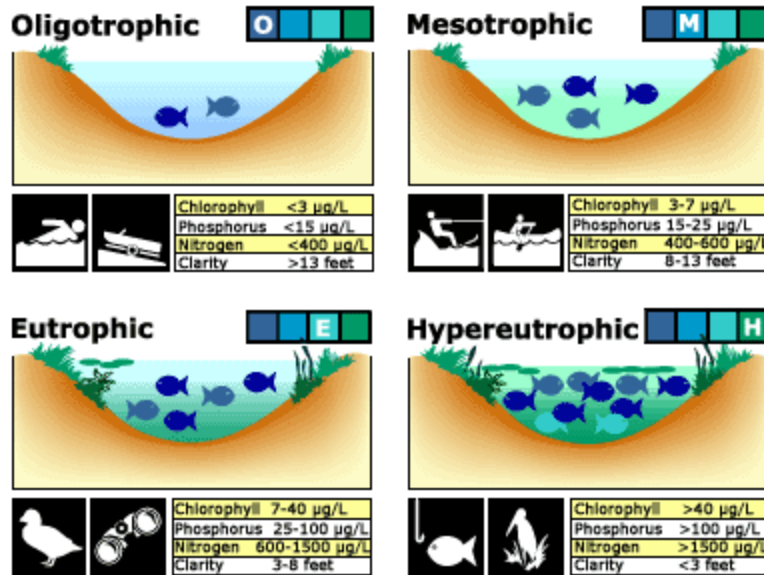
Figure 10. Tropic States

**Hypereutrophic** (HI-per-you-TROH-fik) where waterbodies have the highest level of biological productivity. The trophic state of a waterbody can also affect its use or perceived utility. Figure 10 illustrates this concept.

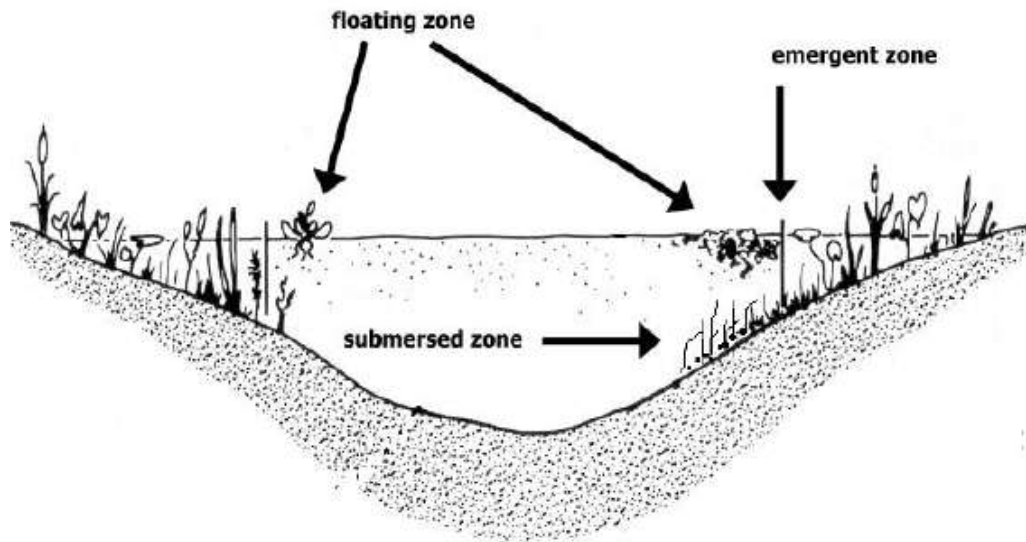
3. The three primary aquatic vegetation zones are shown below:

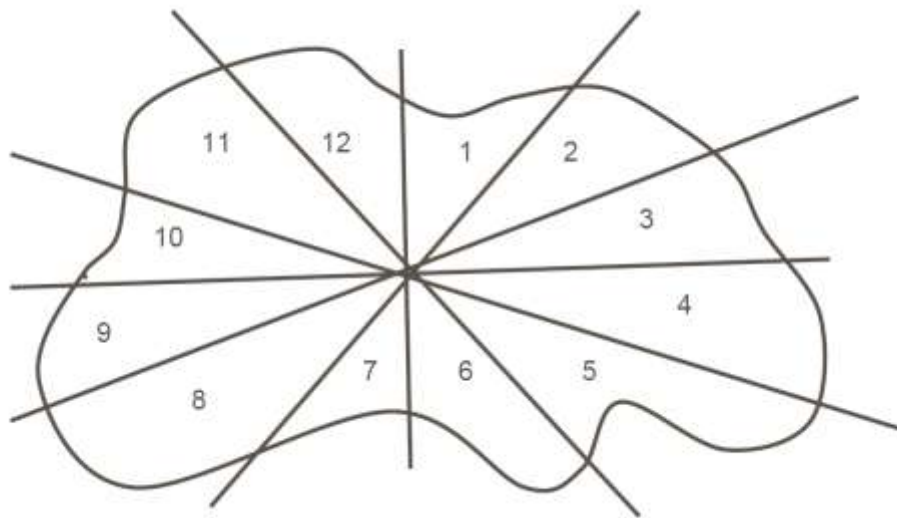
Diagram showing the method used to divide a typical lake into 12 sections for replicate sampling:
