Alderman Creek

STREAM HABITAT ASSESSMENT, STREAM CONDITIONS INDEX, LINEAR
VEGETATION SURVEY, RAPID PERIPHYTON SURVEY AND WATER QUALITY

David Eilers, Jordan Haselwood | USF Water Institute | April 4th, 2024

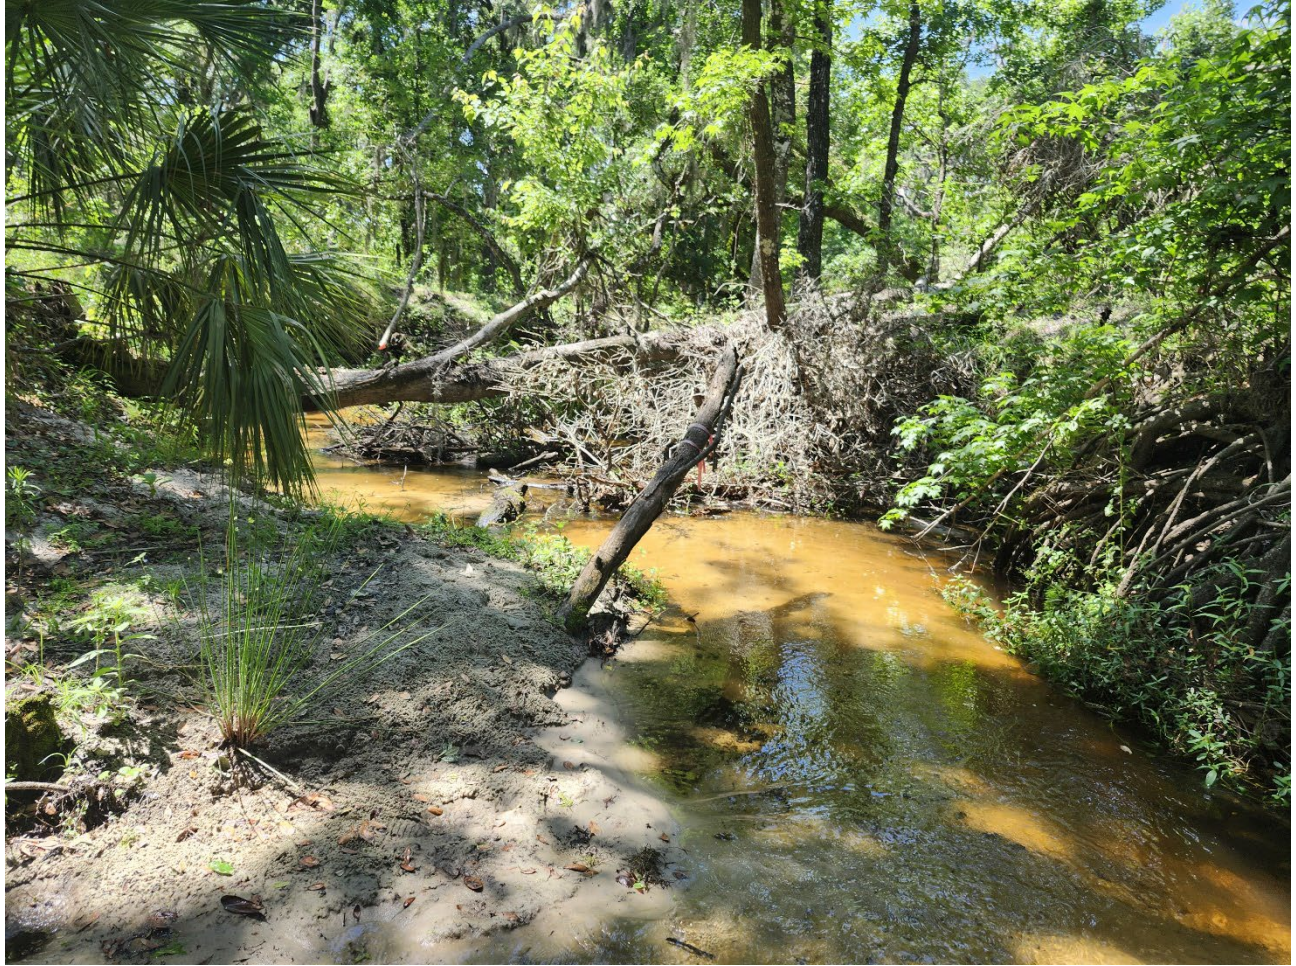
Figure 2 Photograph of the Alderman Creek Sample Site showing typical heavily sandy sedimentation and frequent fallen trees.

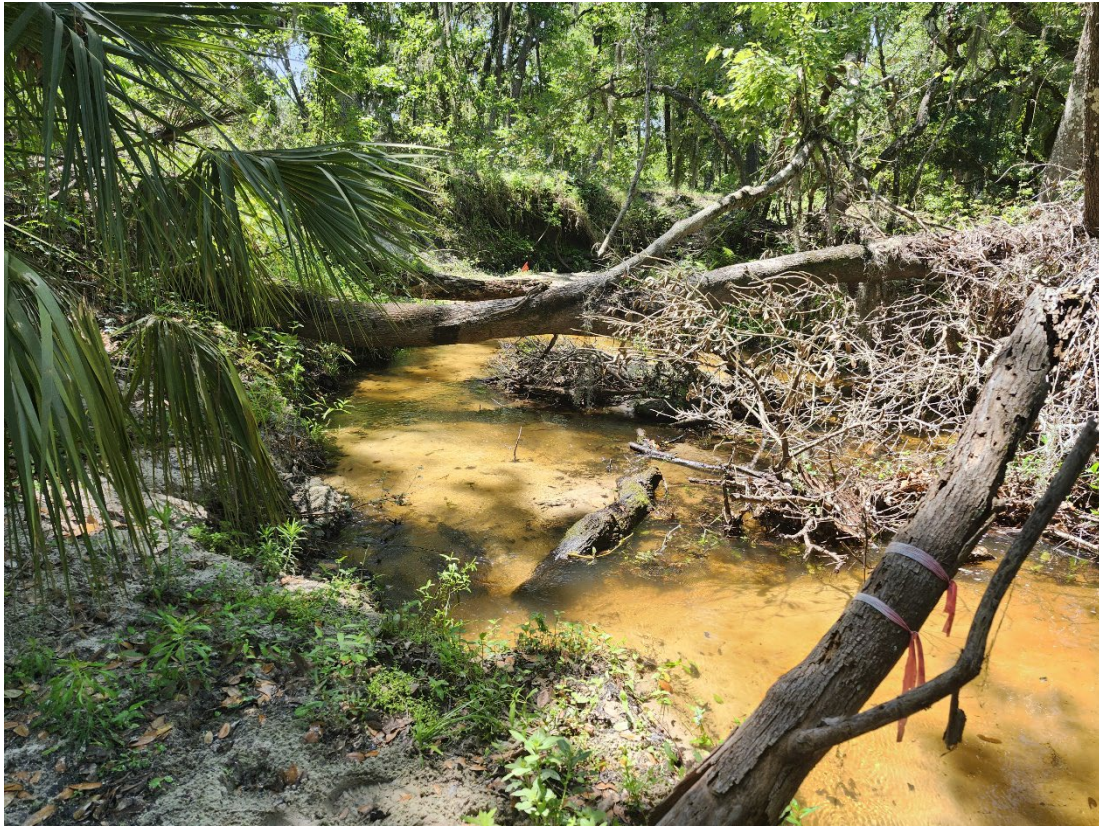
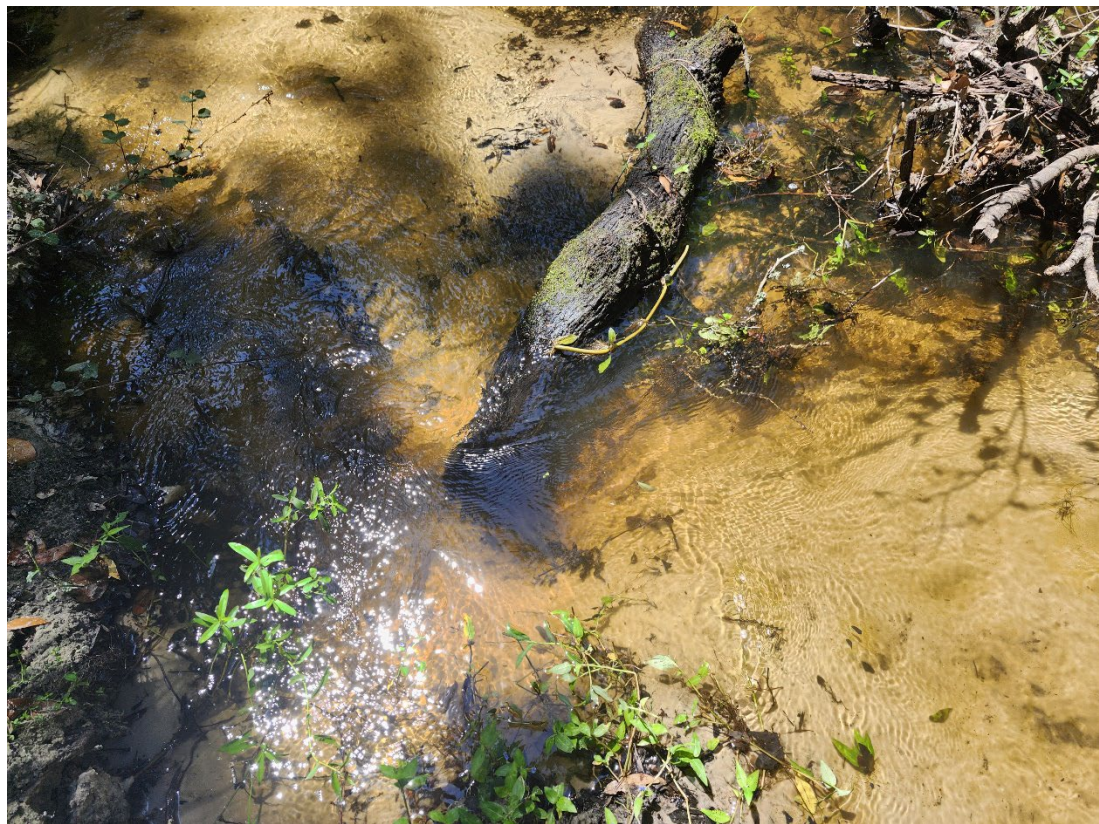
Figure 3-4, Photographs of snag (major productive habitat) in Alderman Creek.
