Lake Armistead

LAKE HABITAT ASSESSMENT, LAKE VEGETATION INDEX, SUBMERGED
VEGETATION SURVEY AND WATER QUALITY

David Eilers, Abigail Richardson | USF Water Institute | July 23, 2024

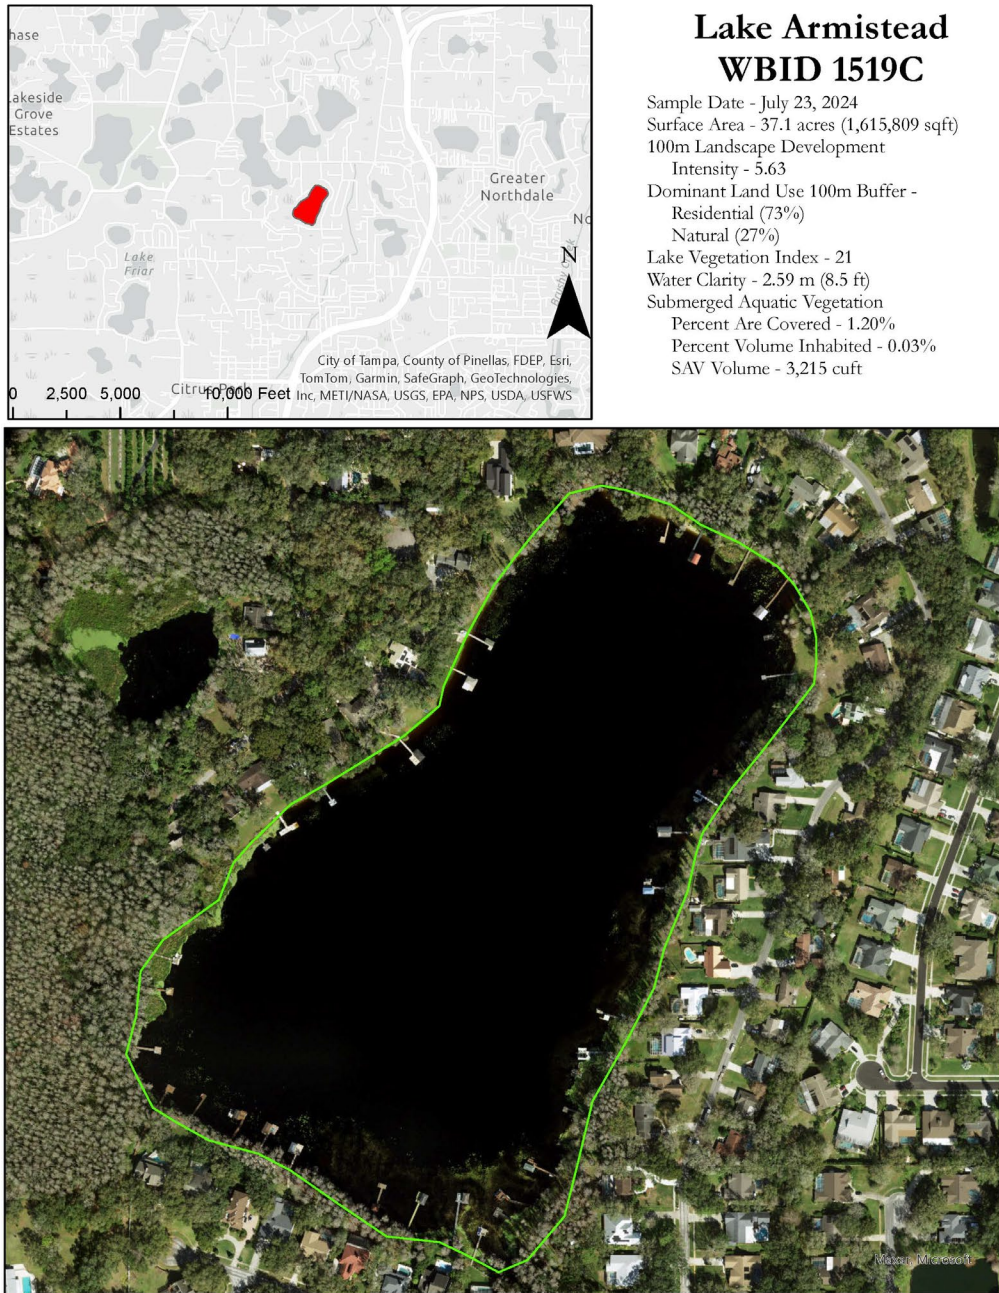
FIGURE 1: 2024 LAKE ARMISTEAD ASSESSMENT STUDY AREA MAP

Lake Armistead is located in the Coastal Old Tampa Bay Watershed in north-western Hillsborough County, Florida. The Landscape Development Intensity Index of the 100 meter buffer around Lake Armistead is dominated by residential (73%) and natural (27.4%) land uses. The resulting LDI value for the 100 meter buffer around Lake Armistead is 5.63.

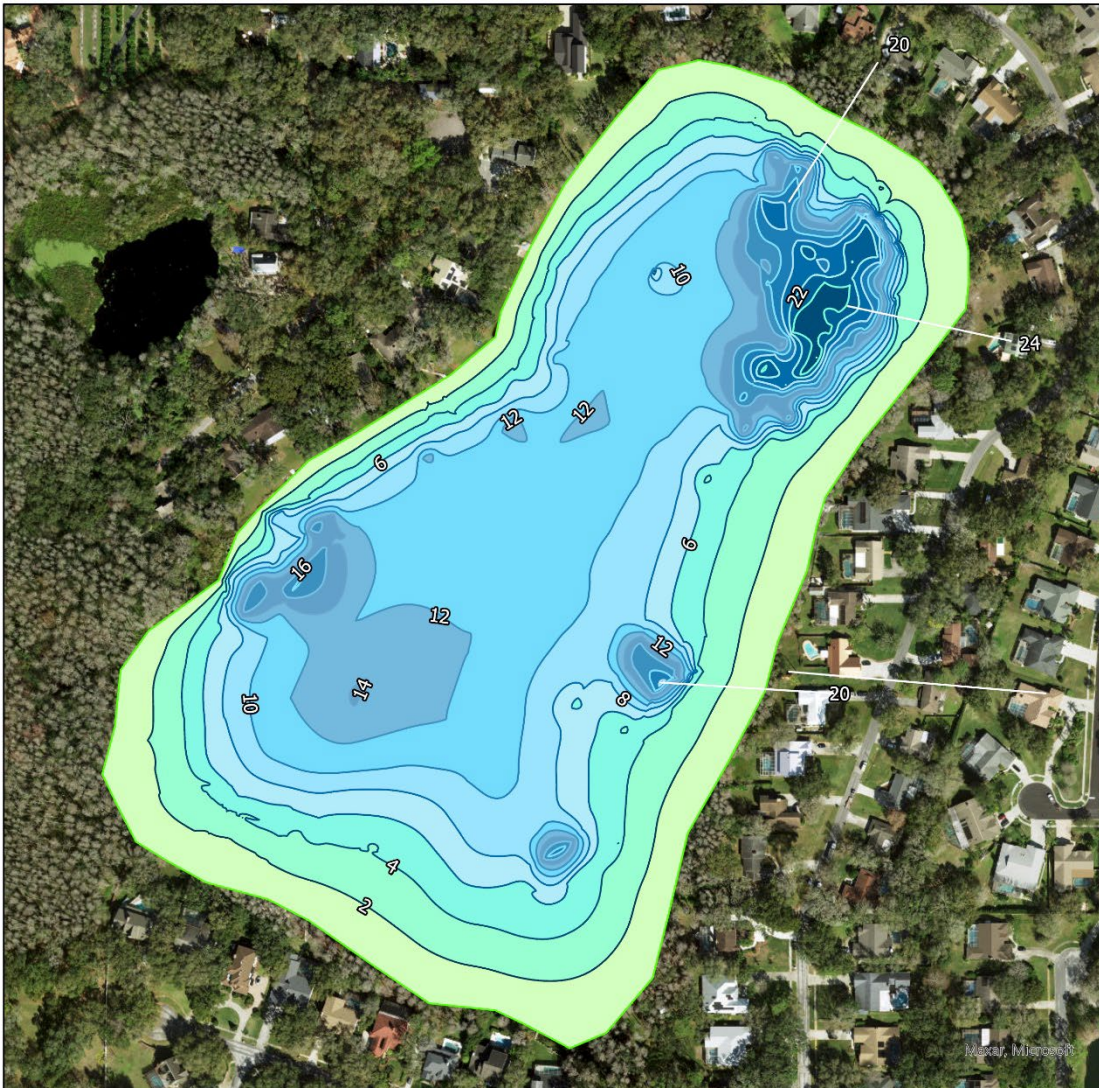
Figure 2: 2024 2-Foot Bathymetric Contour Map for Lake Armistead

At the time of the assessment, Lake Armistead was experiencing normal water levels (40.26 feet NAVD88 on staff gauge) resulting in a 37.1 acre water body. Lake Armistead at the time of the assessment had a mean water depth of 7.5 feet and a maximum observed depth of 26.05 feet. The volume at this time was approximately 90,641,522 gallons. Figure 2 shows the resulting bathymetric contour map for Lake Armistead from data collected on July 22, 2024. The collected data has been overlain the 2023 ESRI Basemap aerials.

EXPLANATION:
 Survey Date: July 23, 2024
 Water level was 40.26 ft NAVD88 at the time of the assessment.
 Contours are expressed in absolute depth below this level.

LAKE MORPHOLOGY:
 Perimeter 5,328 ft;
 Area 37.1 Acres;
 (1,615,809 Sqft)
 Mean Depth 7.5 ft;
 Volume 278.2 Acre-ft,
 (90,641,522 gallons);
 Deepest point 26.05 ft

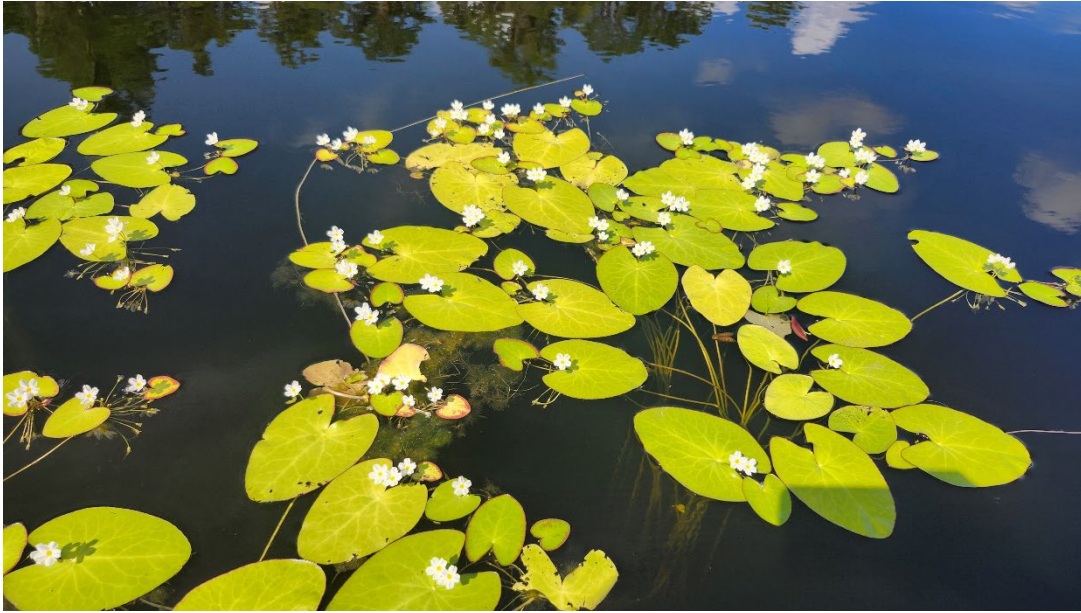
Figure 3 Overview photograph of Lake Armistead showing the dominate invasive species *Nymphoides cristata*.

The system does show impairment in the vegetation communities according to the Lake Vegetation Index with abundant invasive species (11) and an overall LVI score of 21. The non-native, invasive species *Nymphoides cristata* is largely responsible for the low LVI score due to being dominant in each of the four regions assessed. This species also shades out the littoral zone below, reducing submersed aquatic vegetation. The assessment revealed a submerged aquatic vegetation community comprising 5 species currently occupying only 1.2% of the surface area and 0.03% of the volume of Lake Armistead.

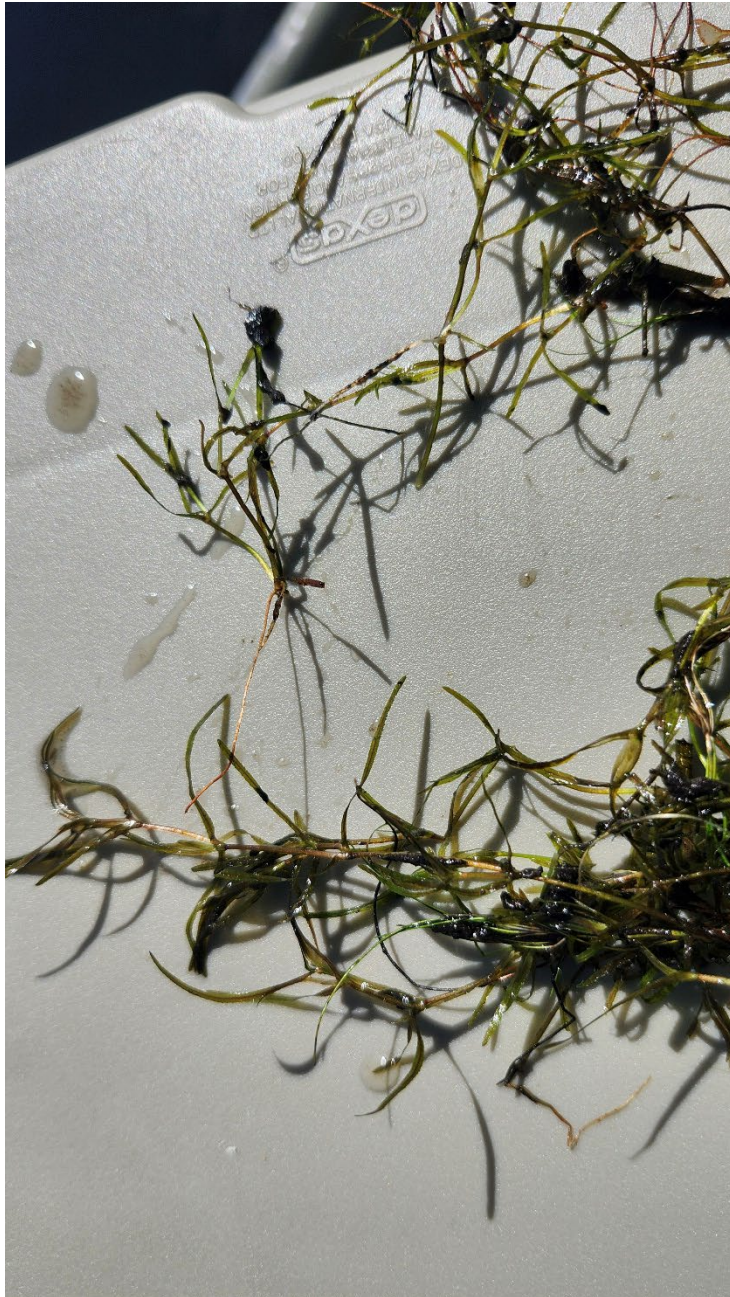
Figure 4 Najas guadalupensis was present in region 7 of the Lake Vegetation Index on Lake Armistead

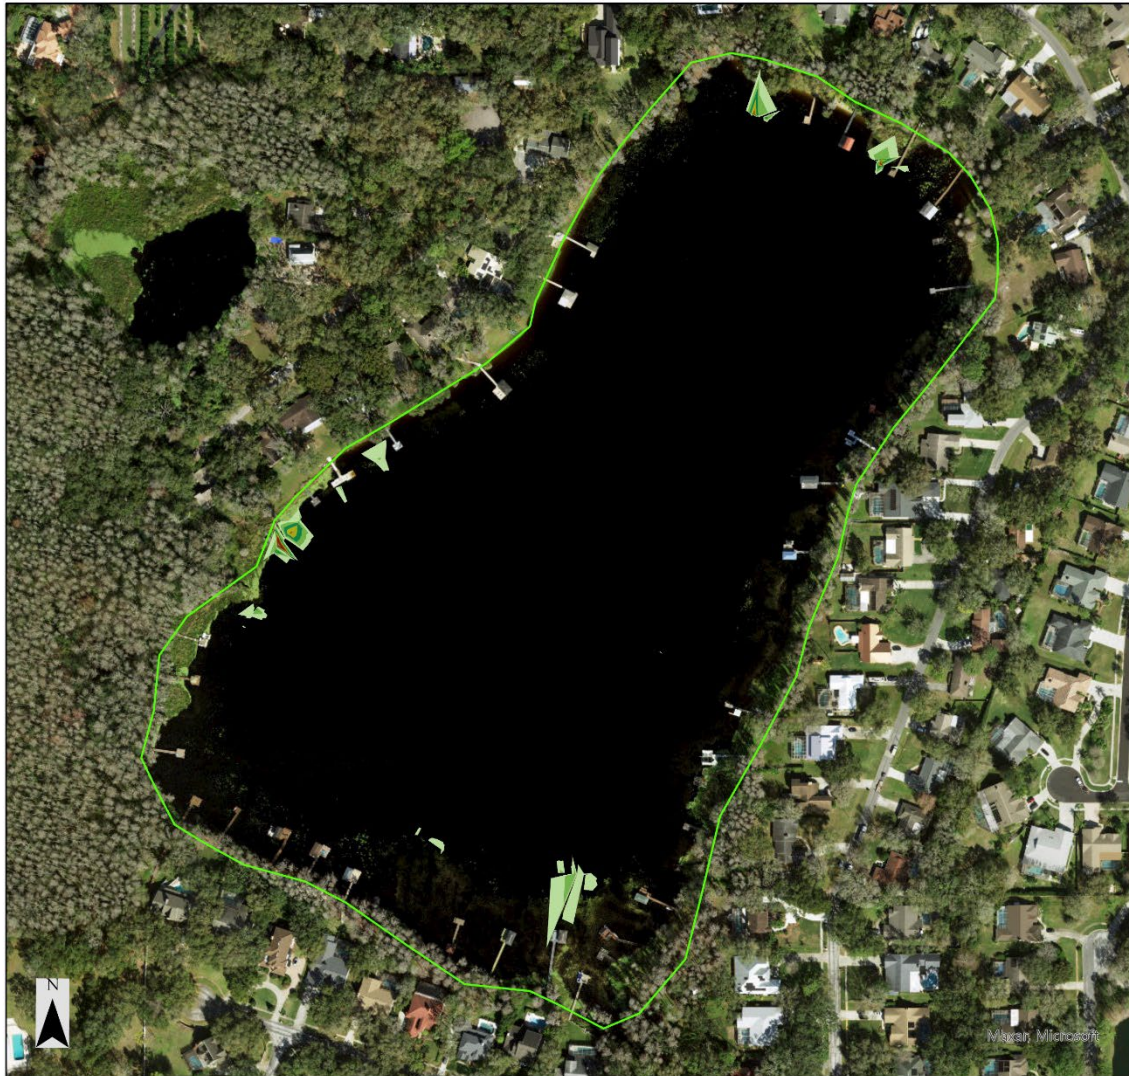
Figure 5 Lake Armistead Submerged Aquatic Vegetation Assessment Results

By analyzing the collected sonar chart, submerged aquatic vegetation potentially covered approximately 1.2% of the surface area of Lake Armistead. This submerged vegetation inhabits an estimated 0.03% of the water volume in Lake Armistead. Figure 5 shows the results of the SAV analysis indicating the location and height of SAV estimated from collected sonar readings.

Survey Date: July 23, 2024
 Water level was 40.26 ft NAVD88 at the time of the assessment. Submerged Aquatic Vegetation was analyzed from collected sonar data. The height of the SAV where present is shown in 1 foot increments.

Area 19,403 square ft; 0.4 Acres;
 (1.20% of Lake Surface Area)
 Mean SAV Height 0.2 ft;
 Volume 3,215 Cubic ft, (24,054 gallons);
 (0.03% of Lakes Volume)
