Avis Lake

Study Area

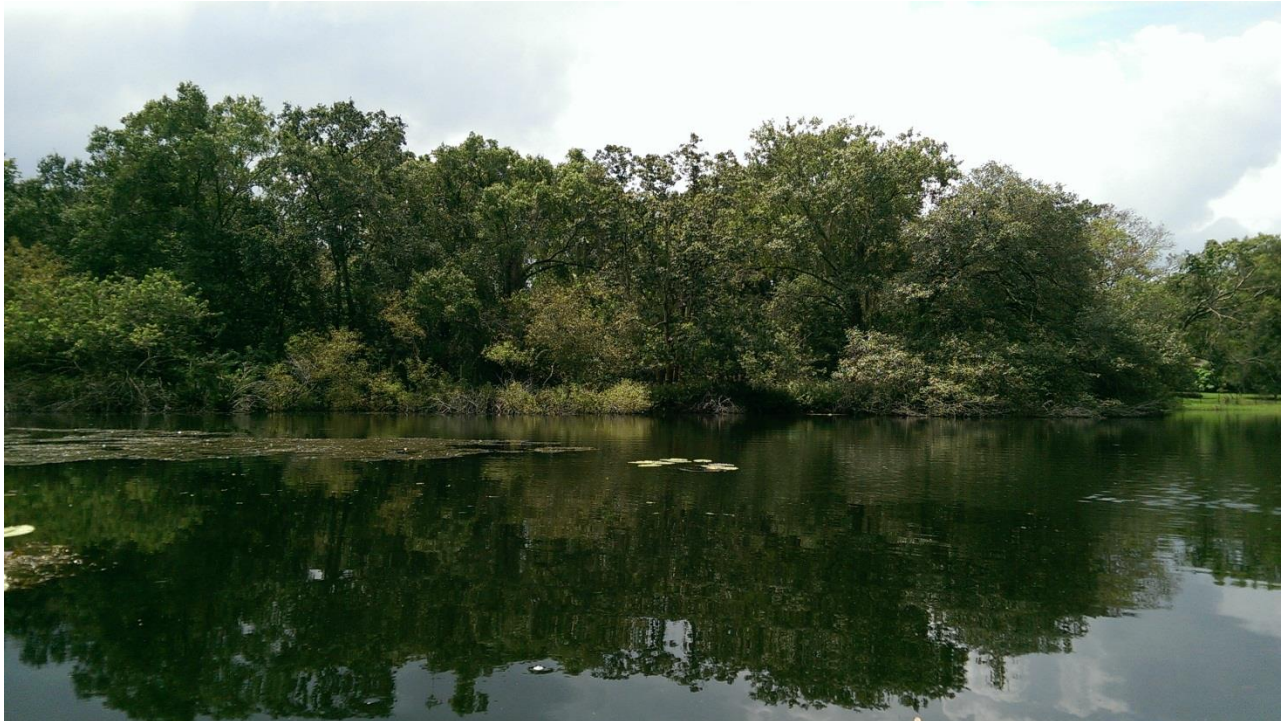
Figure 3 Overview photograph of Avis Lake

The lake assessment for Avis Lake was conducted on July 29, 2015. Avis Lake received a lake habitat assessment (FEDP form FD 9000-6) score of 66 due to marginal scores for Stormwater Inputs, Lakeside Adverse Human Alterations and Adverse Watershed Land Use. Poor scores were recorded for Upland Buffer Zone. Suboptimal scores were recorded for Secchi, Vegetation Quality and Bottom Substrate Quality.

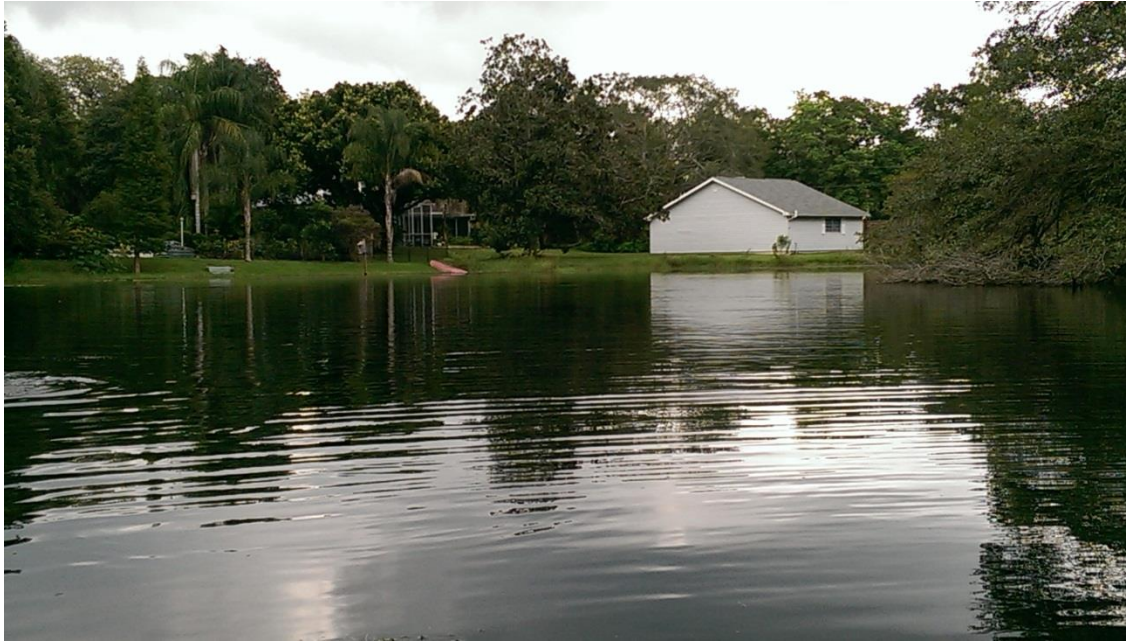
Figure 4 Much of the shoreline of Avis Lake was clearcut for turf grasses, removing the vegetation buffer surrounding the lake.

The results of the assessment of Avis Lake does not show impairment based on the FDEP numeric nutrient criteria threshold values for Chlorophyll-a, Nitrogen or Phosphorous based on the single sample from this assessment. Additional samples would be required to obtain NNC values per the FDEP. The system does show impairment in the vegetation communities according to the Lake Vegetation Index with a low number of individual species, a high percentage of FLEPPC type 1 plants and few sensitive species present with an overall LVI score of 23. Of concern in the vegetation communities is the presence of *hydrilla verticillata* in the submerged vegetation. This species has the ability to out-compete other native species and form a monoculture covering the majority of the lakes surface area. The vegetative community would also benefit from establishing a buffer zone between the turf grass lawns and the aquatic habitats of the lake.

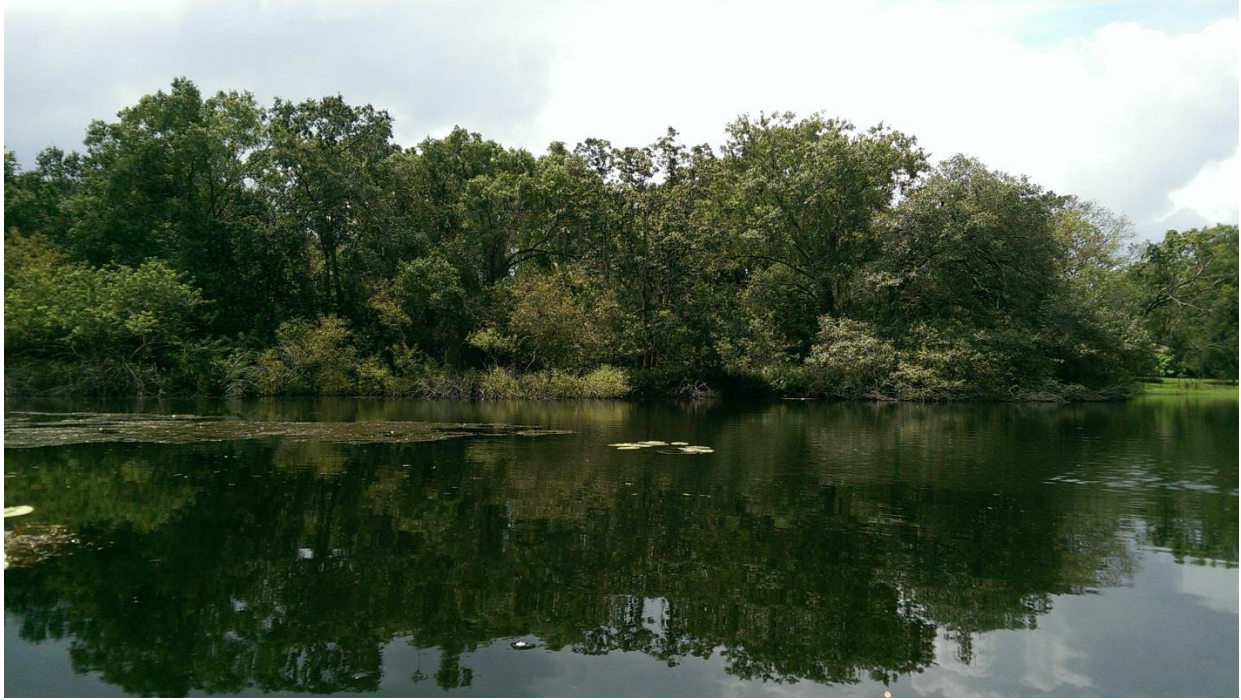
Figure 6 Floating algal mats were commonly observed on Avis Lake33
