LAKE ASSESSMENT REPORT FOR LAKE BRANT IN HILLSBOROUGH COUNTY FLORIDA

Date Assessed: June 12, 2007

Assessed by: Sarah Koenig and David Eilers

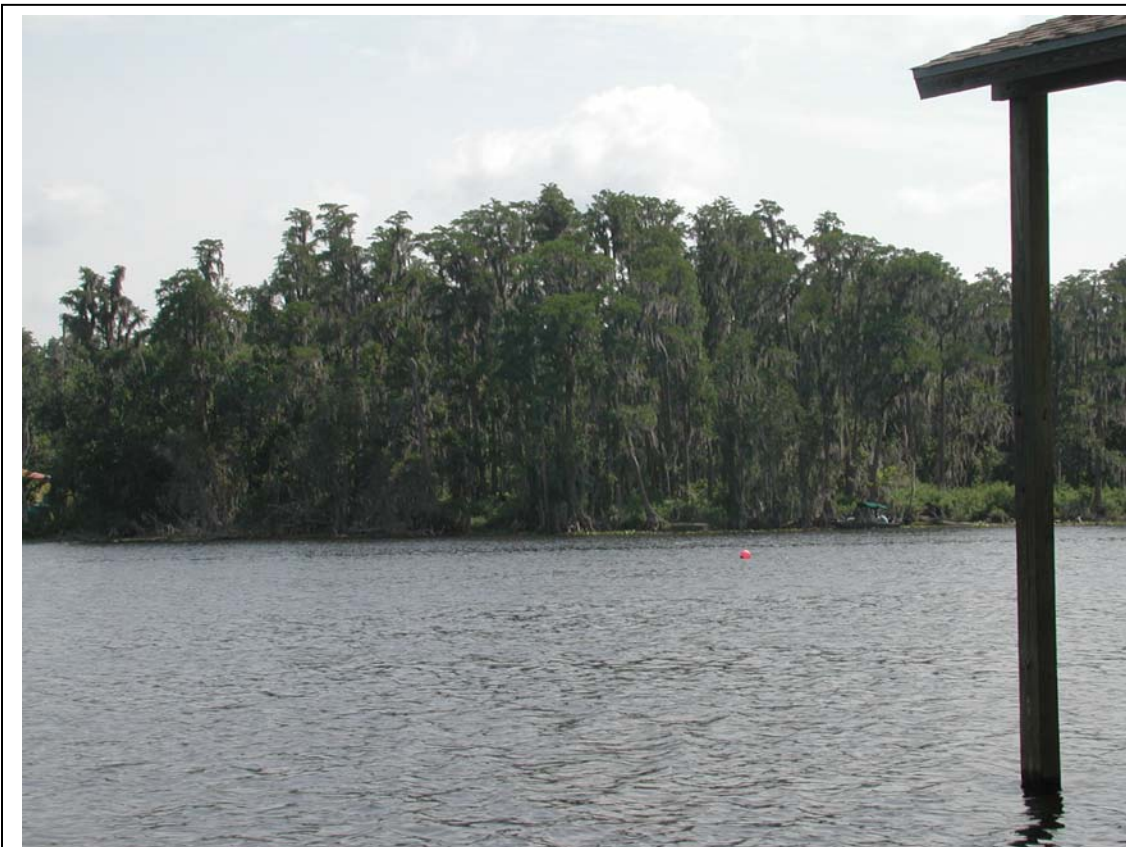
Figure 1. General photograph of Lake Brant taken on June 12, 2007.

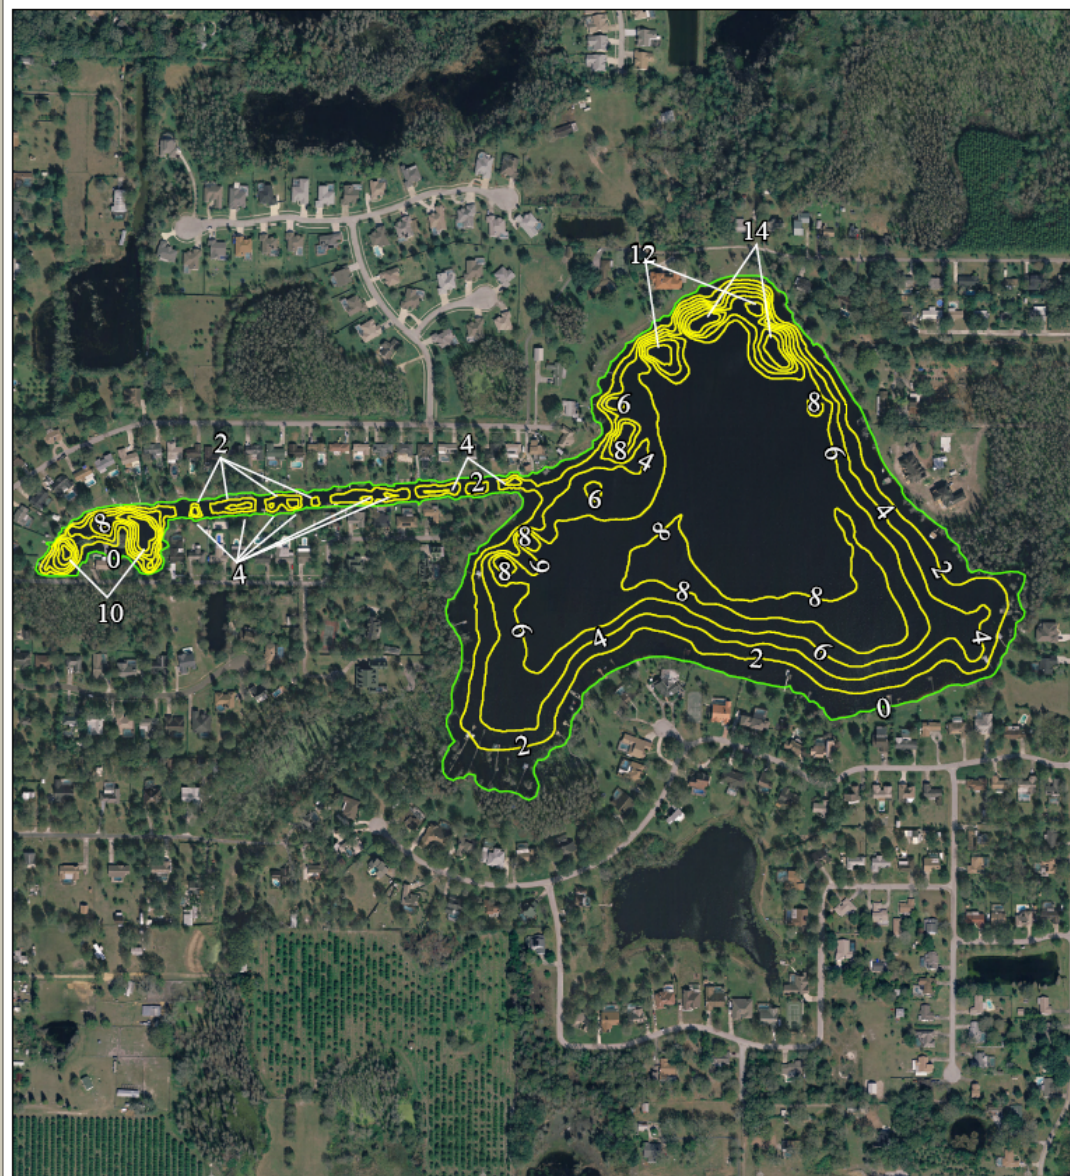
Lake Brant

Survey Date: June 12, 2007
Lake water level was 54.59 ft
above sea level at time of assessment.
Contours are expressed in absolute depth
below this level.

Perimeter 12,063 ft;
Area 60.6 Acres;
Mean Depth 5.61 ft;
Volume 311.85 Acre-ft, (101,616,511 gallons);
Deepest point 15.6 ft

Figure 2. Contour map for Lake Brant. The mapping technique used in 2007 employs a standard DGPS for horizontal position and a fathometer for depth.

Bathymetric Mapⁱⁱ. The bottom of the lake was mapped using a Lowrance LCX 26C HD Wide Area Augmentation System (WAAS)ⁱⁱⁱ enabled Global Positioning System (GPS) with fathometer (bottom sounder) to determine the boat's position, and bottom depth in a single measurement. The result is an estimate of the lake's area, mean and maximum depths, and volume and the creation of a bottom contour map (Figure 2). Besides pointing out the deeper fishing holes in the lake, the morphologic data derived from this part of the assessment can be valuable to overall management of the lake vegetation as well as providing flood storage data for flood models. Table 1 provides the lake's morphologic parameters in various units.

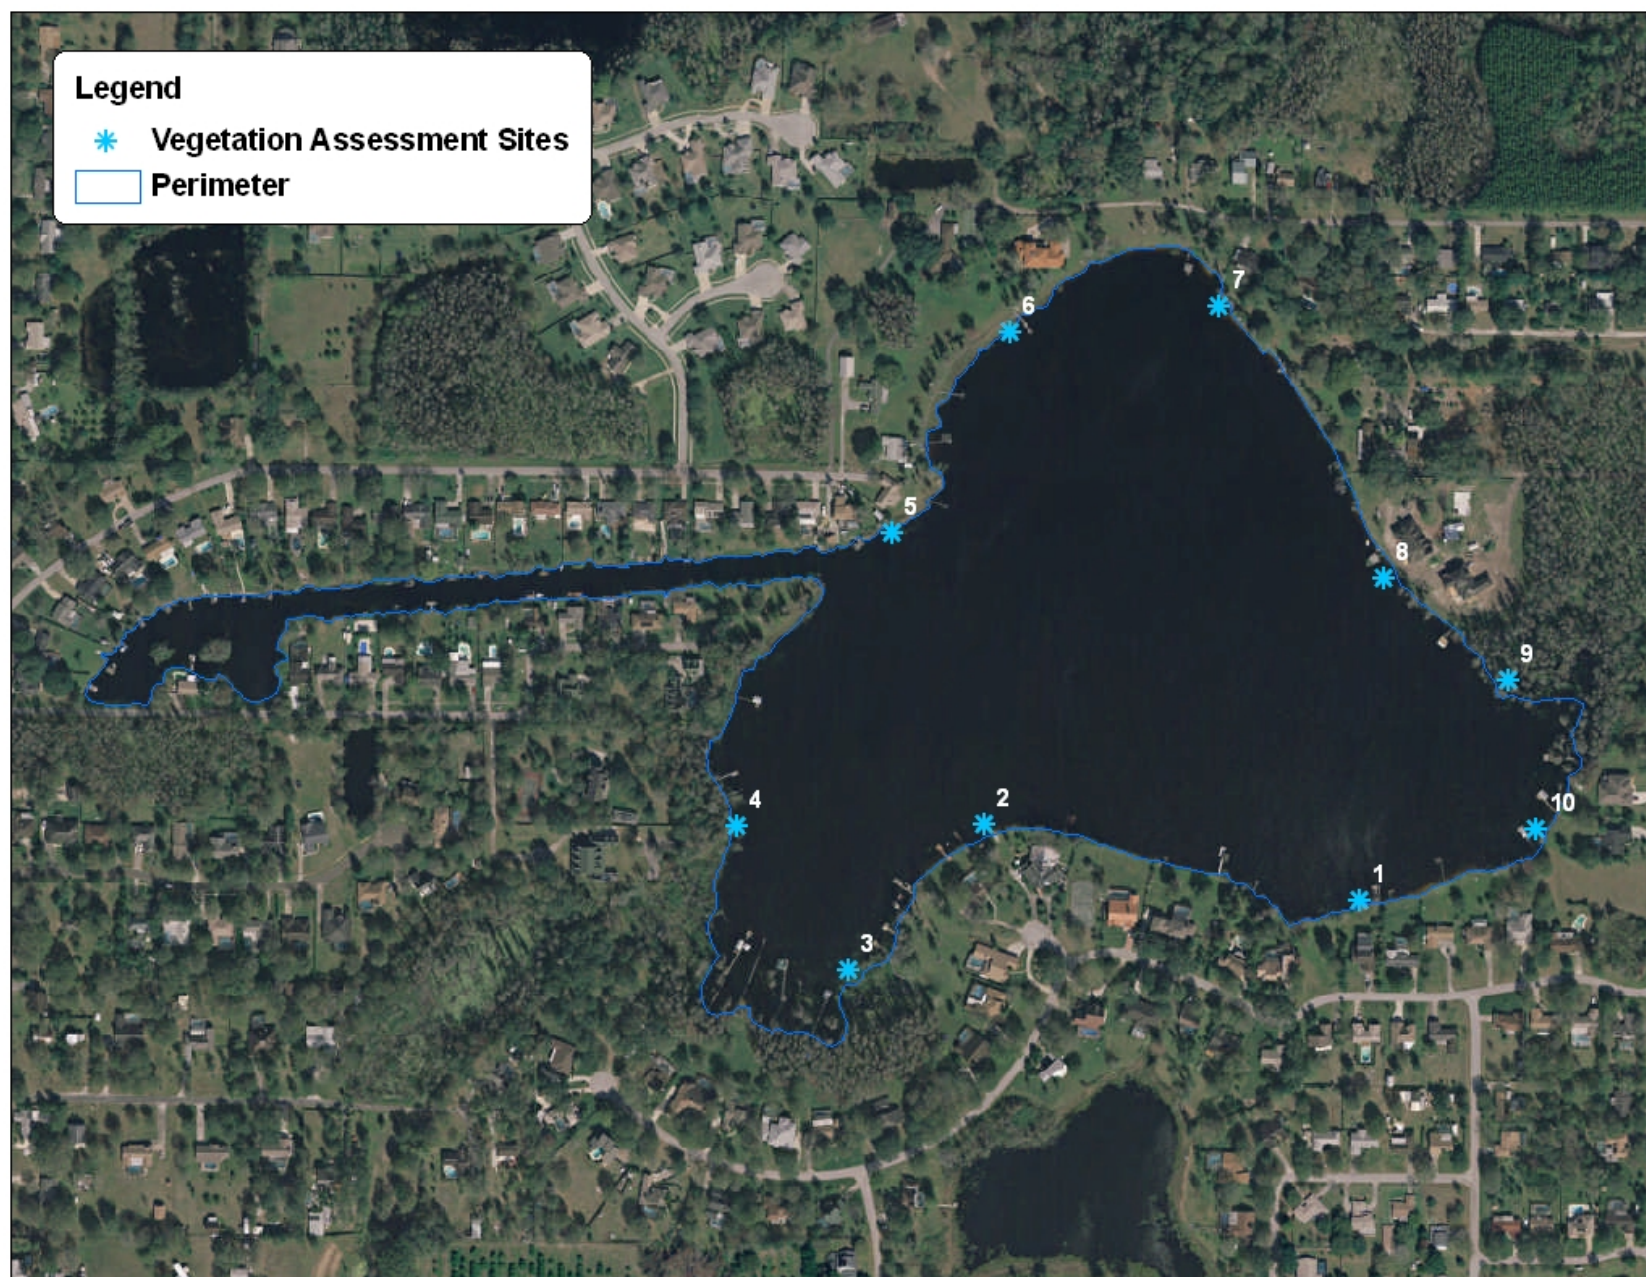
Figure 3. 2006 6-inch resolution aerial photograph showing vegetation assessment sites on Lake Brant. Major emergent and floating vegetation zones as well as structures such as docks are also observable in this aerial.

The lake's apparent vegetative cover and shoreline detail are evaluated using the latest lake aerial photograph as shown in Figure 3 and by use of WAAS enabled GPS. Submerged vegetation is determined from the analysis of bottom returns from the Lowrance 26c HD combined GPS/fathometer described earlier. As depicted in Figure 3, 10 vegetation assessment sites were chosen for intensive sampling based on the *Lake Assessment Protocol* (copy available on request) for a lake of this size. The site positions are set using GPS and then loaded into a GIS mapping program (ArcGIS) for display. Each site is sampled in the three primary vegetative zones (emergent, submerged and floating)^{iv}. The latest aerials high resolution aerial photos are used to provide shore details (docks, structures, vegetation zones) and to calculate the extent of surface vegetation coverage. The primary indices of submerged vegetation cover and biomass for the lake, percent area coverage (PAC) and percent volume infestation (PVI), are determined by transiting the lake by boat and employing a fathometer to collect "hard and soft return" data. These data are later analyzed for presence and absence of vegetation and to determine the height of vegetation if present. The PAC is determined from the presence and absence analysis of 100 sites in the lake and the PVI is determined by measuring the difference between hard returns (lake bottom) and soft returns (top of vegetation) for sites (within the 100 analyzed sites) where plants are determined present.

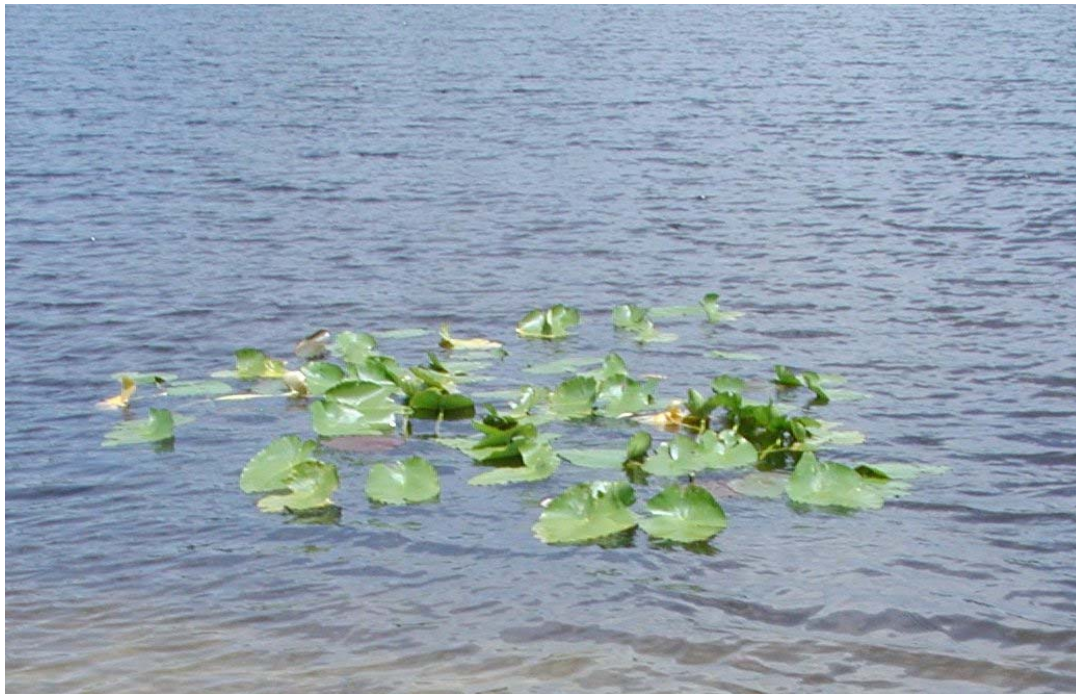
Figure 4. Nuphar lutea var. advena (Spatterdock), was the most common floating leaved vegetation found during the assessment of Lake Brant. Although native, Nuphar lutea advena can grow into dense mats covering the surface of the water resulting in its listing as a pest plant when found in high % occurrence.

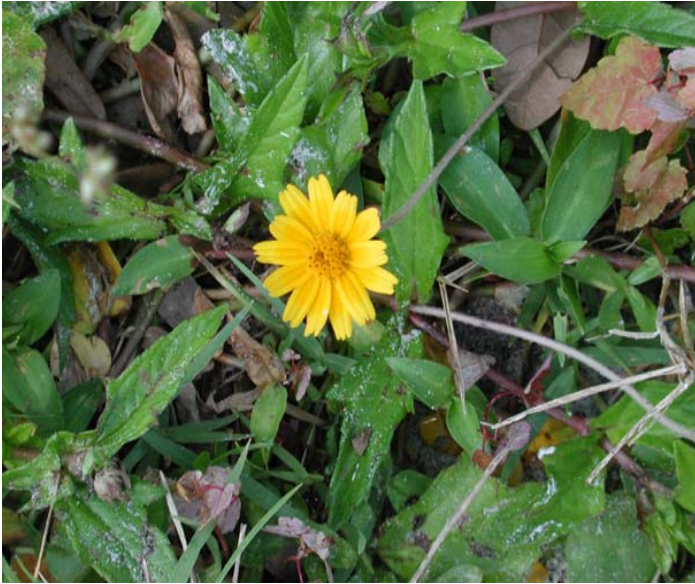
Figure 5. Creeping Oxeye, *Sphagneticola (Wedelia) trilobata*, is a common non-native invasive species in Florida.

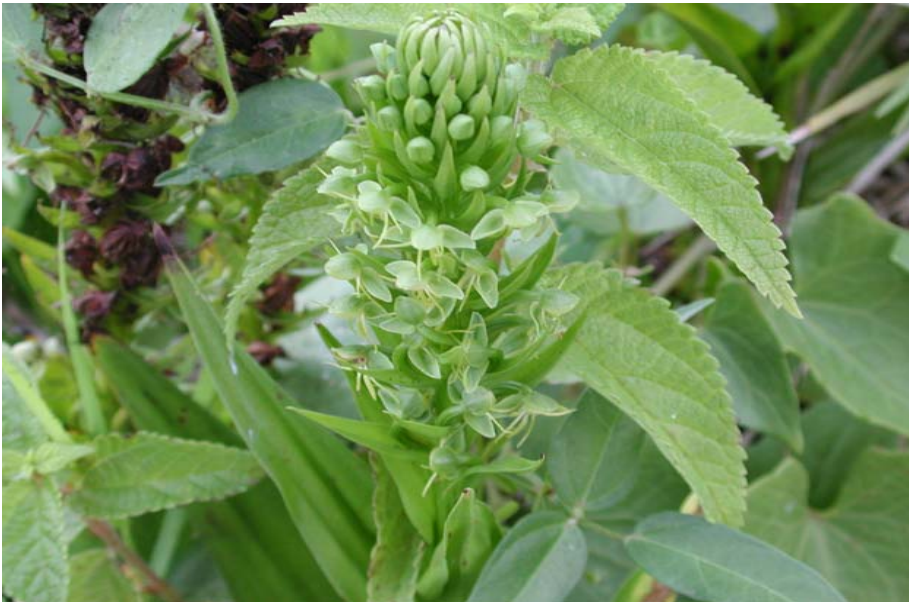
Figure 6. Waterspider False Reinorchid, *Habenaria repens*, is a native wetland ground orchid found on Lake Brant.

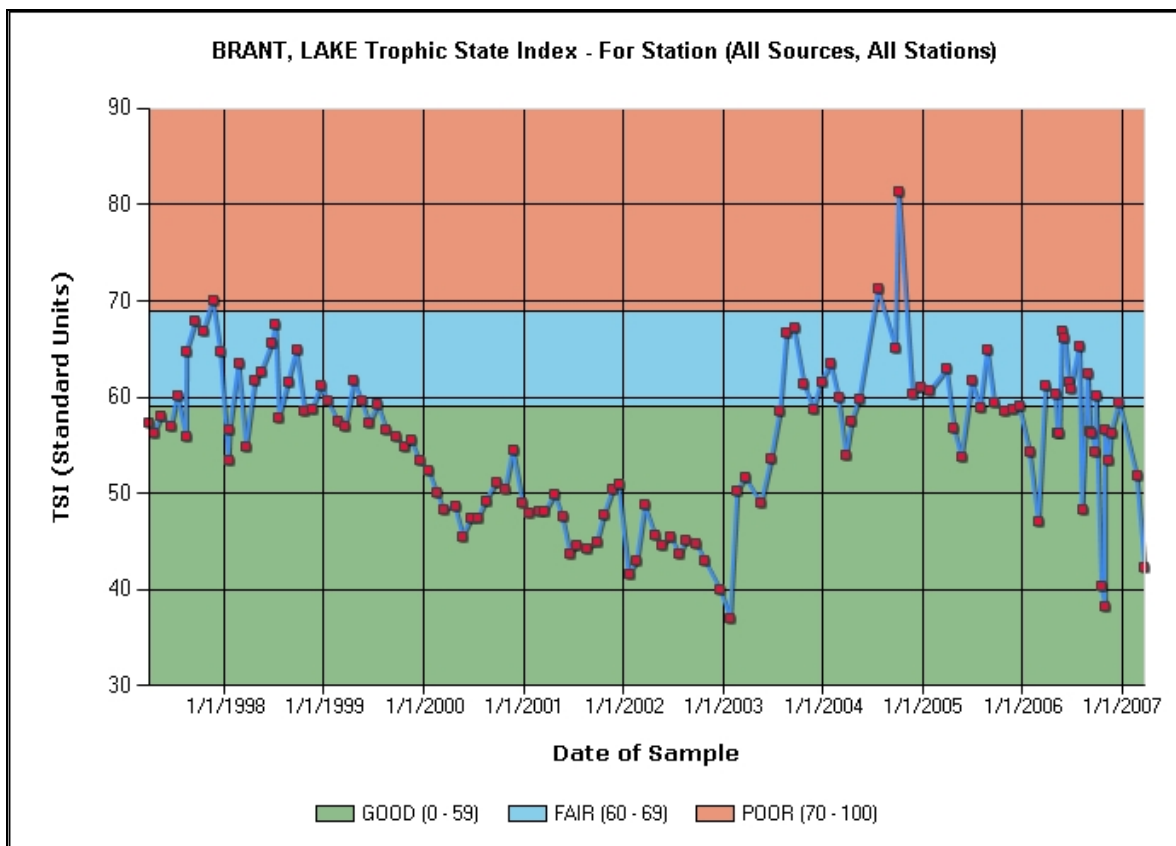
Figure 7. Recent Trophic State Index (TSI) graph from Hillsborough Watershed Atlas. For the latest date go to:

Note: The graph above includes benchmarks for using verbal descriptors of "good", "fair" and "poor". The verbal descriptors for these benchmarks are based on an early determination by stakeholders of the generally acceptable and understood terms for describing the state of lakes. The same benchmarks are used for nutrient graphs (Nitrogen and Phosphorus), chlorophyll graphs and trophic state index (TSI) graphs. The TSI is a calculated index of lake condition based on nutrient and chlorophyll (a) concentrations (please see "Learn more about Trophic State Index"). The benchmarks are established based on the TSI range that relates to a specific descriptor. The source for the TSI concentration relationships is the Florida Water Quality Assessment, 1996, 305(b) (Table 2-8).

A critical element in any lake assessment is the long-term water chemistry data set. The primary source of water quality trend data for Florida Lakes, is the Florida LAKEWATCH volunteer and the Florida LAKEWATCH water chemistry data. Hillsborough County is fortunate to have a large cadre of volunteers who have collected lake water samples for significant time period. These data are displayed and analyzed on the Water Atlas as shown in Figure 7 for Lake Brant. Additional data, when available, is also included on the Water Atlas; however, the LAKEWATCH data remains the primary source. By the trend data shown in the figure, the lake may be considered in fair to good healthy terms of the trophic state index. This lake is a clear water lake and as such it must maintain a TSI of below 40 to not be considered impaired by the State of Florida guidelines^v. The lake's long term water quality data indicates enough violations of these criteria to be classified by Florida DEP as impaired. The more recent trends indicate a possible downward trend; however, the overall TSI remains primarily above 40 and the lake should therefore be considered impaired for nutrient concentration.

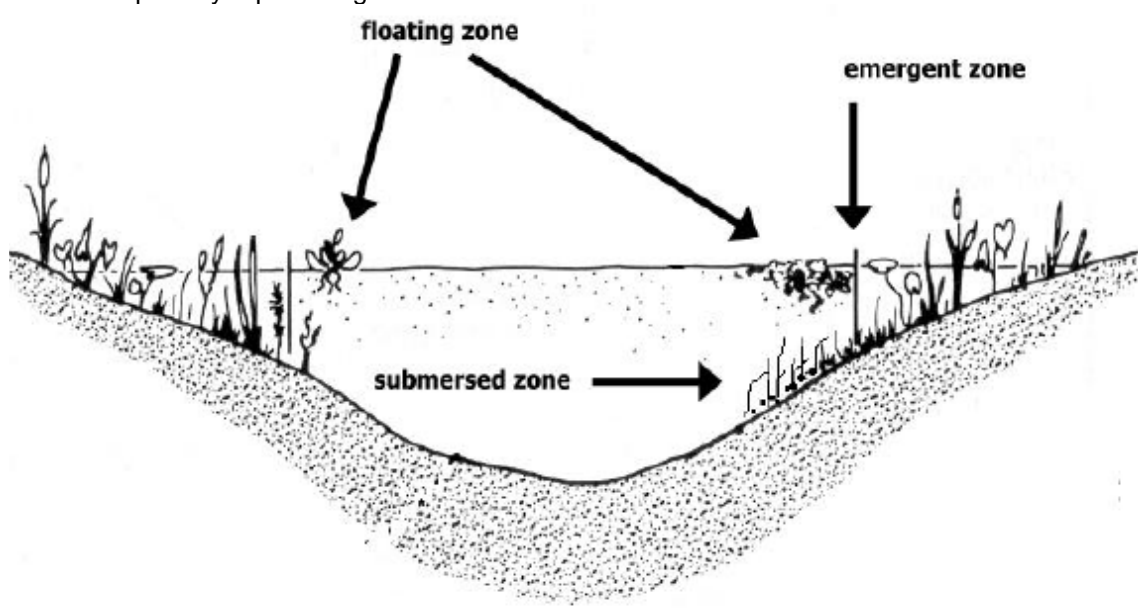
iv The tree primary aquatic vegetation zones are shown below:
