LAKE ASSESSMENT REPORT FOR BUCK LAKE IN HILLSBOROUGH COUNTY FLORIDA

Date Assessed: July 17, 2007

Assessed by: Sarah Koenig and David Eilers

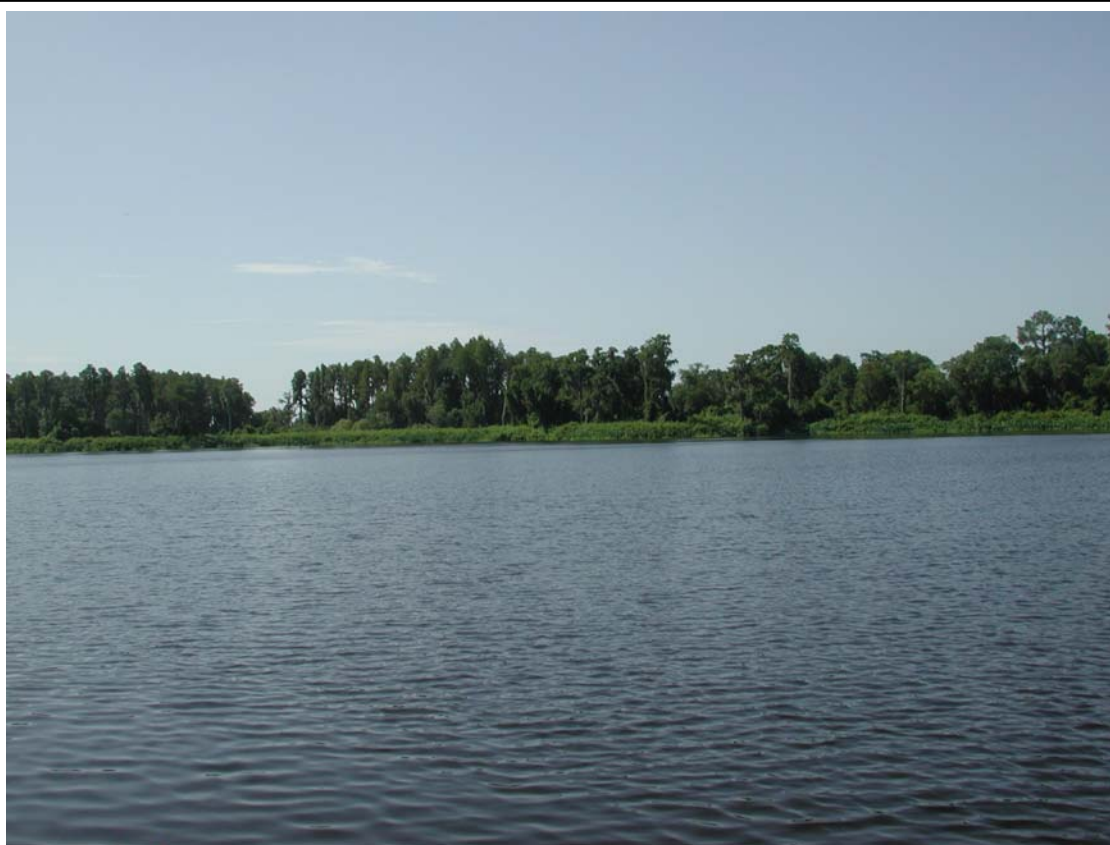
Figure 1. General photograph of Buck Lake taken on July 17, 2007.

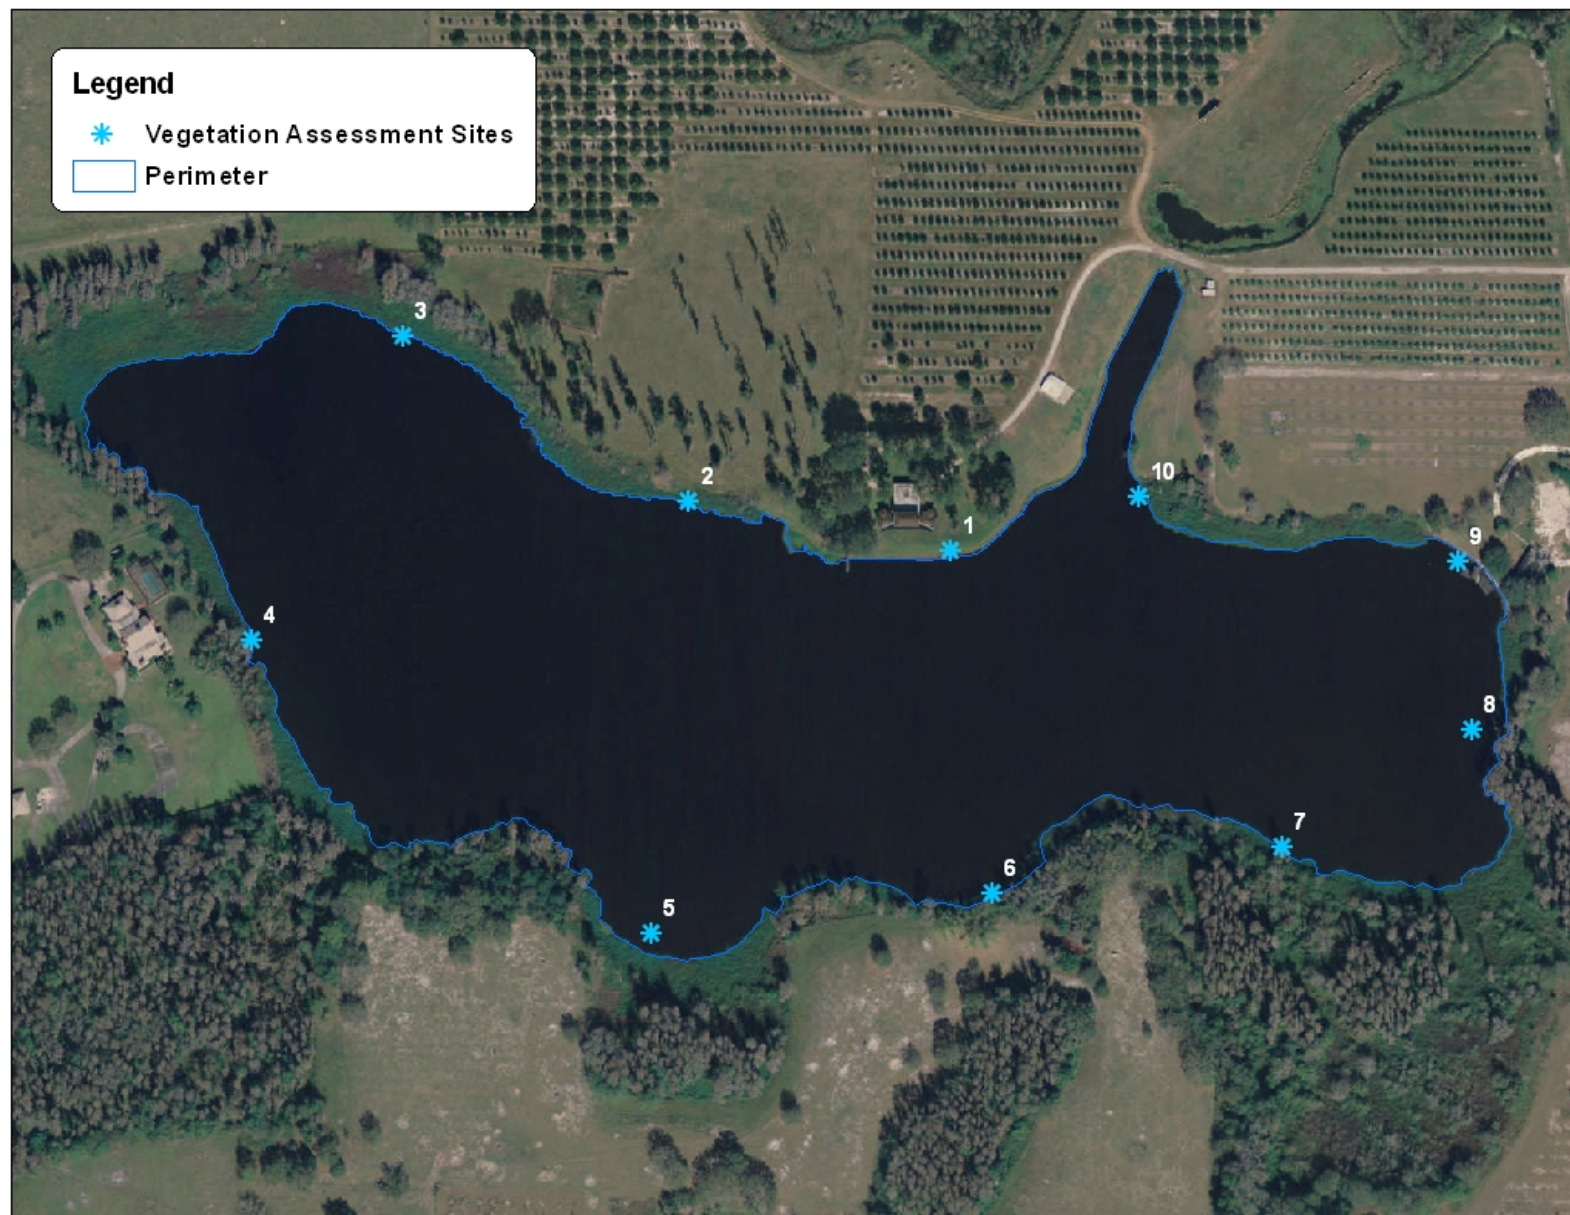
Figure 3. 2006 six-inch resolution aerial photograph showing location of vegetation assessment sites on Buck Lake. Major emergent and floating vegetation zones as well as structures such as docks are also observable in this aerial.

The lake's apparent vegetative cover and shoreline detail are evaluated using the latest lake aerial photograph as shown in Figure 3 and by use of WAAS enabled GPS. Submerged vegetation is determined from the analysis of bottom returns from the Lowrance 26c HD combined GPS/fathometer described earlier. As depicted in Figure 3, 10 vegetation assessment sites were chosen for intensive sampling based on the *Lake Assessment Protocol* (copy available on request) for a lake of this size. The site positions are set using GPS and then loaded into a GIS mapping program (ArcGIS) for display. Each site is sampled in the three primary vegetative zones (emergent, submerged and floating)^{iv}. The latest aerials, high resolution aerial photos, are used to provide shore details (docks, structures, vegetation zones) and to calculate the extent of surface vegetation coverage. The primary indices of submerged vegetation cover and biomass for the lake, percent area coverage (PAC) and percent volume infestation (PVI), are determined by transiting the lake by boat and employing a fathometer to collect "hard and soft return" data. These data are later analyzed for presence and absence of vegetation and to determine the height of vegetation if present. The PAC is determined from the presence and absence analysis of 100 sites in the lake and the PVI is determined by measuring the difference between hard returns (lake bottom) and soft returns (top of vegetation) for sites (within the 100 analyzed sites) where plants are determined present.

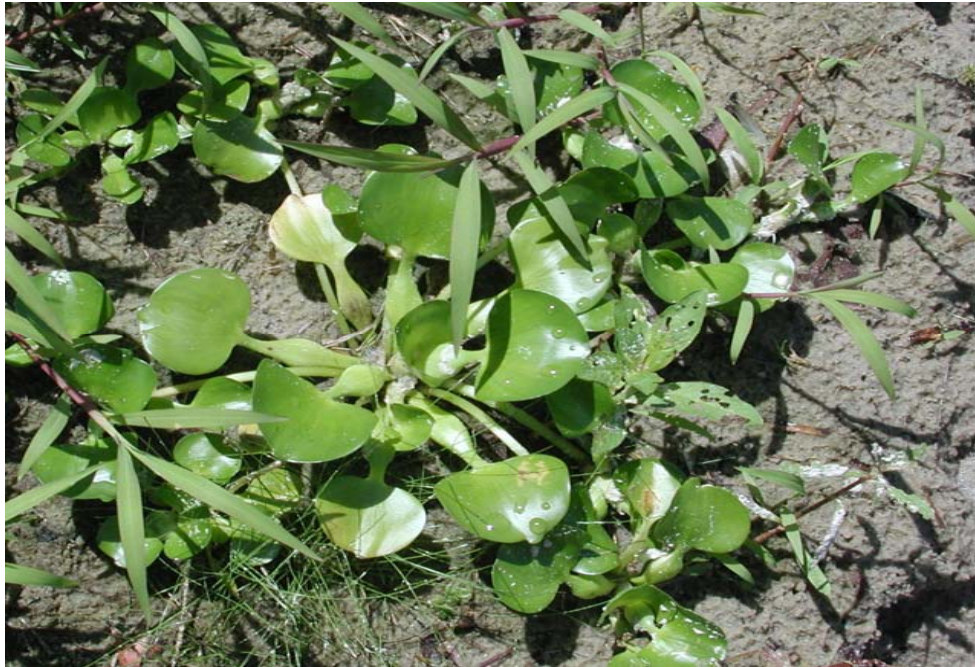
Figure 4. *Eichornia crassipes*, Water Hyacinth, is an invasive non-native species in Florida which can cause severe problems on our lakes. This picture shows the plant growing on dry ground due to the extremely low water levels we are currently experiencing.

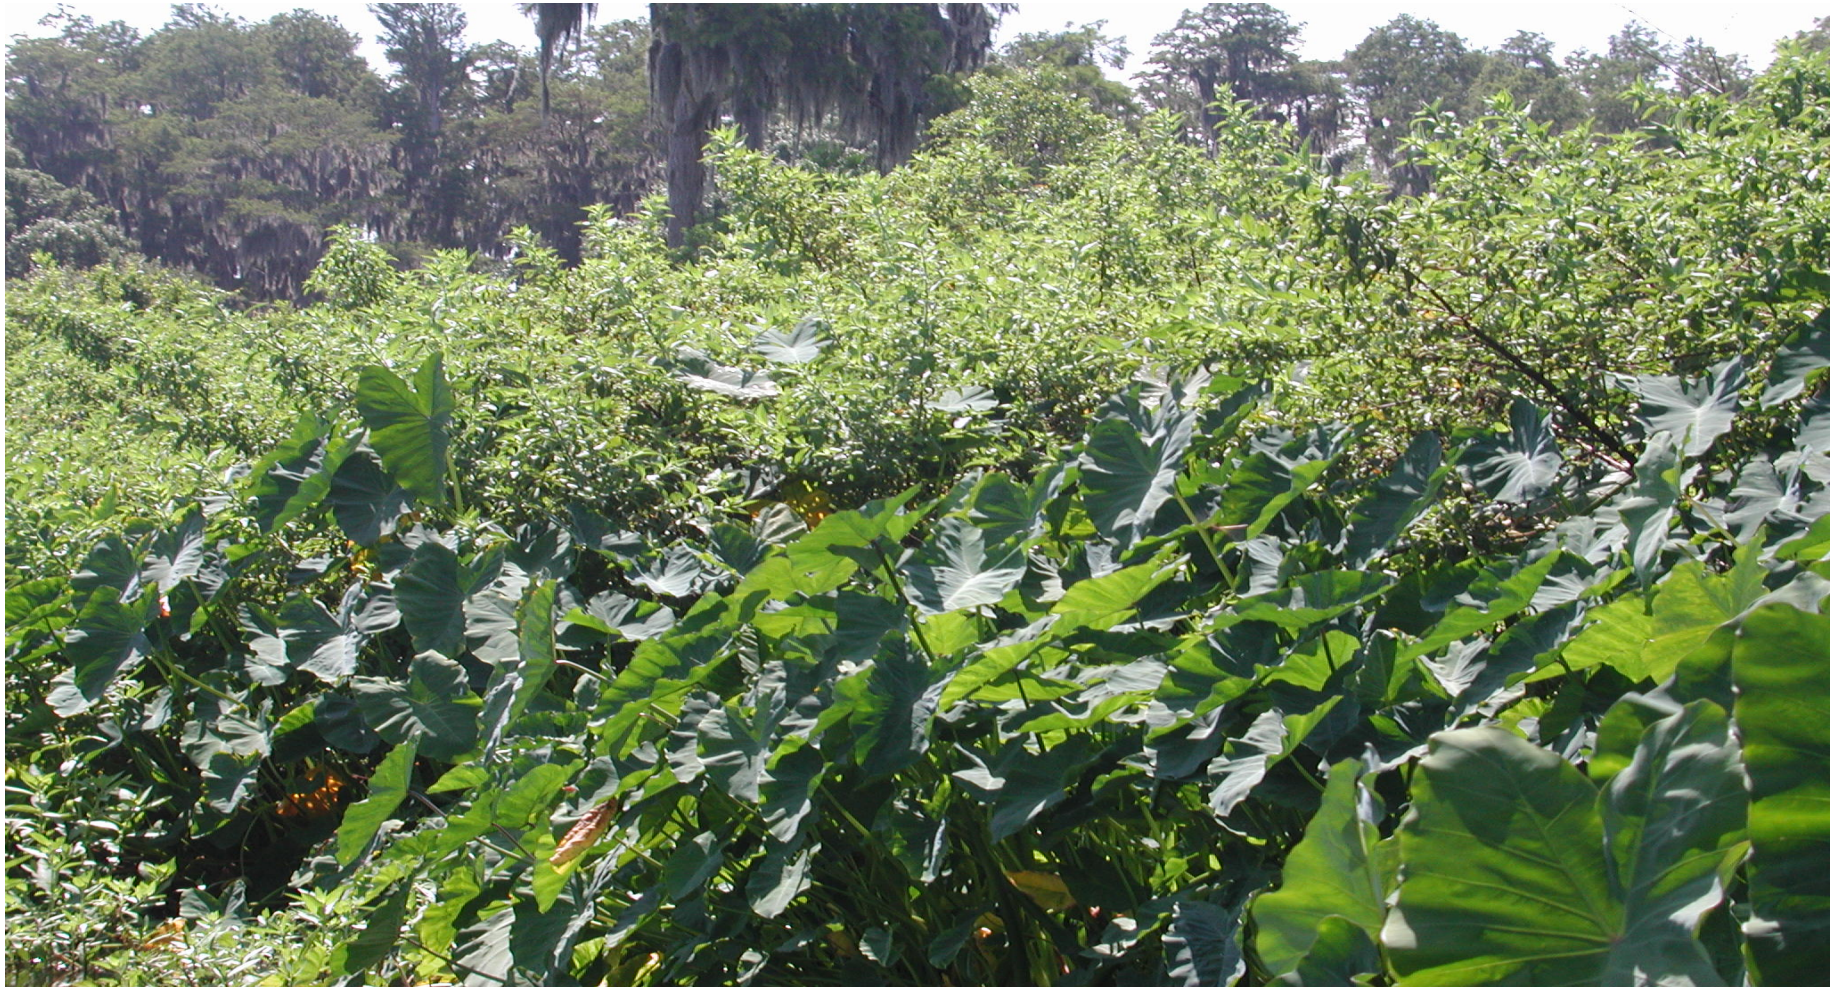
Figure 5. *Colocasia esculenta*, Wild Taro, is a common Invasive species sold as a landscaping plant. This species can crowd out natives along lake shores in Florida.

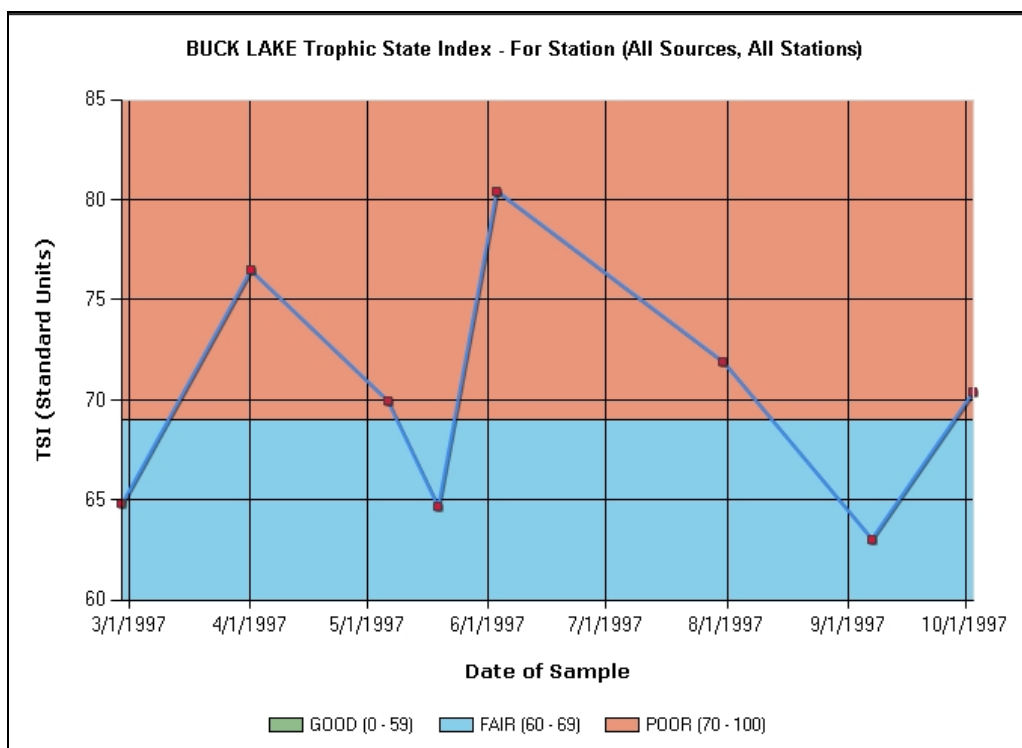
Figure 6. Recent Trophic State Index (TSI) graph from Hillsborough Watershed Atlas. For the latest date go to: (<http://www.hillsborough.wateratlas.usf.edu/lake/waterquality.asp?wbodyid=5129&wbodyatlas=lake>)

Note: The graph above includes benchmarks for using verbal descriptors of "good", "fair" and "poor". The verbal descriptors for these benchmarks are based on an early determination by stakeholders of the generally acceptable and understood terms for describing the state of lakes. The same benchmarks are used for nutrient graphs (Nitrogen and Phosphorus), chlorophyll graphs and trophic state index (TSI) graphs. The TSI is a calculated index of lake condition based on nutrient and chlorophyll (a) concentrations (please see "Learn more about Trophic State Index"). The benchmarks are established based on the TSI range that relates to a specific descriptor. The source for the TSI concentration relationships is the Florida Water Quality Assessment, 1996, 305(b) (Table 2-8).

A critical element in any lake assessment is the long-term water chemistry data set. The primary source of water quality trend data for Florida Lakes, is the Florida LAKEWATCH volunteer and the Florida LAKEWATCH water chemistry data. Hillsborough County is fortunate to have a large cadre of volunteers who have collected lake water samples for significant time period. These data are displayed and analyzed on the Water Atlas as shown in Figure 6 for Buck Lake. Additional data, when available, is also included on the Water Atlas; however, the LAKEWATCH data remains the primary source. By the trend data shown in the figure, the lake may be considered in generally poor health and impaired in terms of the trophic state index. This lake is a clear water lake and as such it must maintain a TSI of below 40 to not be considered impaired by the State of Florida guidelines^v. The lake's long term water quality data is not available but the little data available indicate that this lake should be considered impaired by the Florida DEP.
