Baker Creek

Habitat Assessment

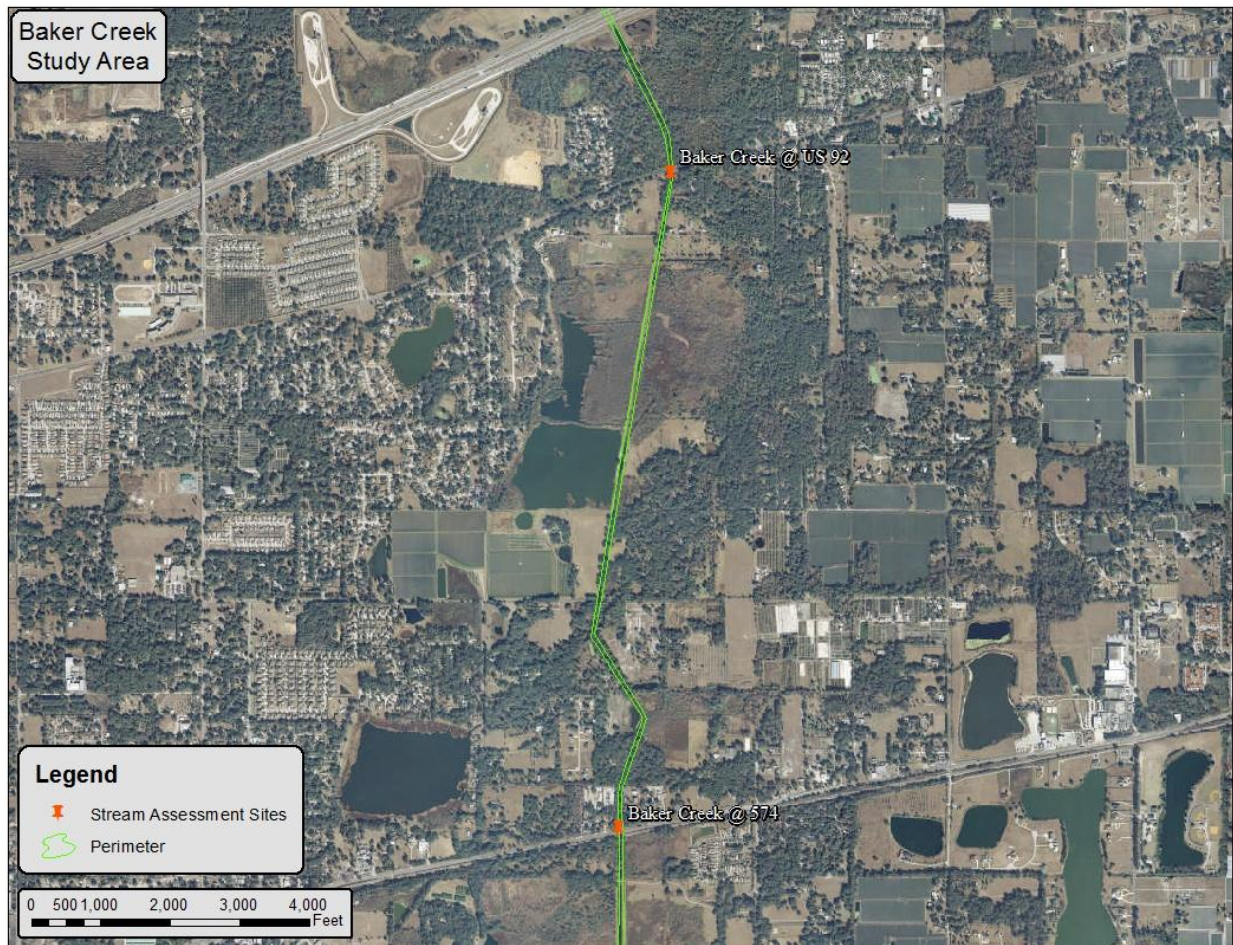
Figure 1 2014 Baker Creek Assessment Study Area Map

Baker Creek is located in Hillsborough County, Florida and was sampled at two locations on November 7, 2014. The first sampling location is located at US Highway 92 near Plant City at: 28.0132728 N and 82.2568693 W. The second location is located at MLK Boulevard with at 27.9868516 N and 82.2590939 W. Baker Creek discharges into Lake Thonotosassa. The watershed surrounding Baker Creek is dominated by Residential (47%), Natural Land/Open Water (15.15%), Pasture/Livestock (12.5%), and Crops/Tree Plantations (9.25%) land uses. The Landscape Development Intensity Index of the watershed is 26.97.

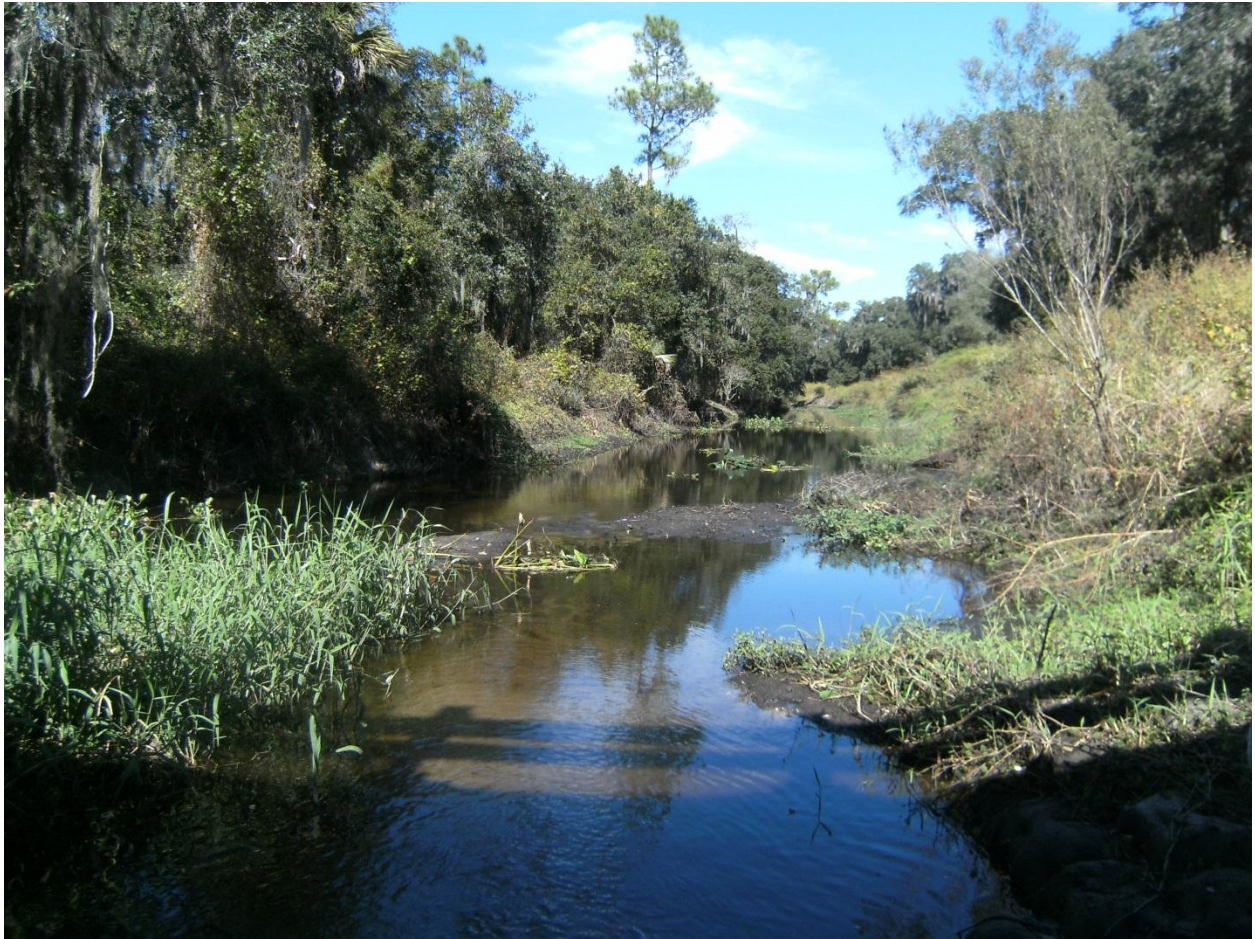
Figure 2 Overview photograph of Baker Creek at US Highway 92 sample site

Baker Creek at US 92 received a habitat assessment score of 97. The conditions contributing to this score are due to poor substrate diversity, marginal substrate availability, marginal habitat smothering, and marginal channelization. The observed lack of stable pools within the transect was most likely due to habitat smothering by silt, and the creek showed evidence of artificial straightening as there was not as much sinuosity as one would expect from a normal Coastal Plain flow regime. Bankfull was >60% throughout the creek, slope was <60 degrees through the majority of the creek, and armoring was optimal. Some undercutting was noted at the 10 m, 20 m, and 80 m marks and nearly 50% of the right bank contained exposed roots. Water velocity was measured at the 80 and 10 meter marks and had a velocity of (.14 m/s) and (.05 m/s) respectively. The riparian buffer zone width was >18 m and the riparian zone vegetation quality exhibited 80% surface cover of normal plant community. A metallic smell was observed emanating from the water.

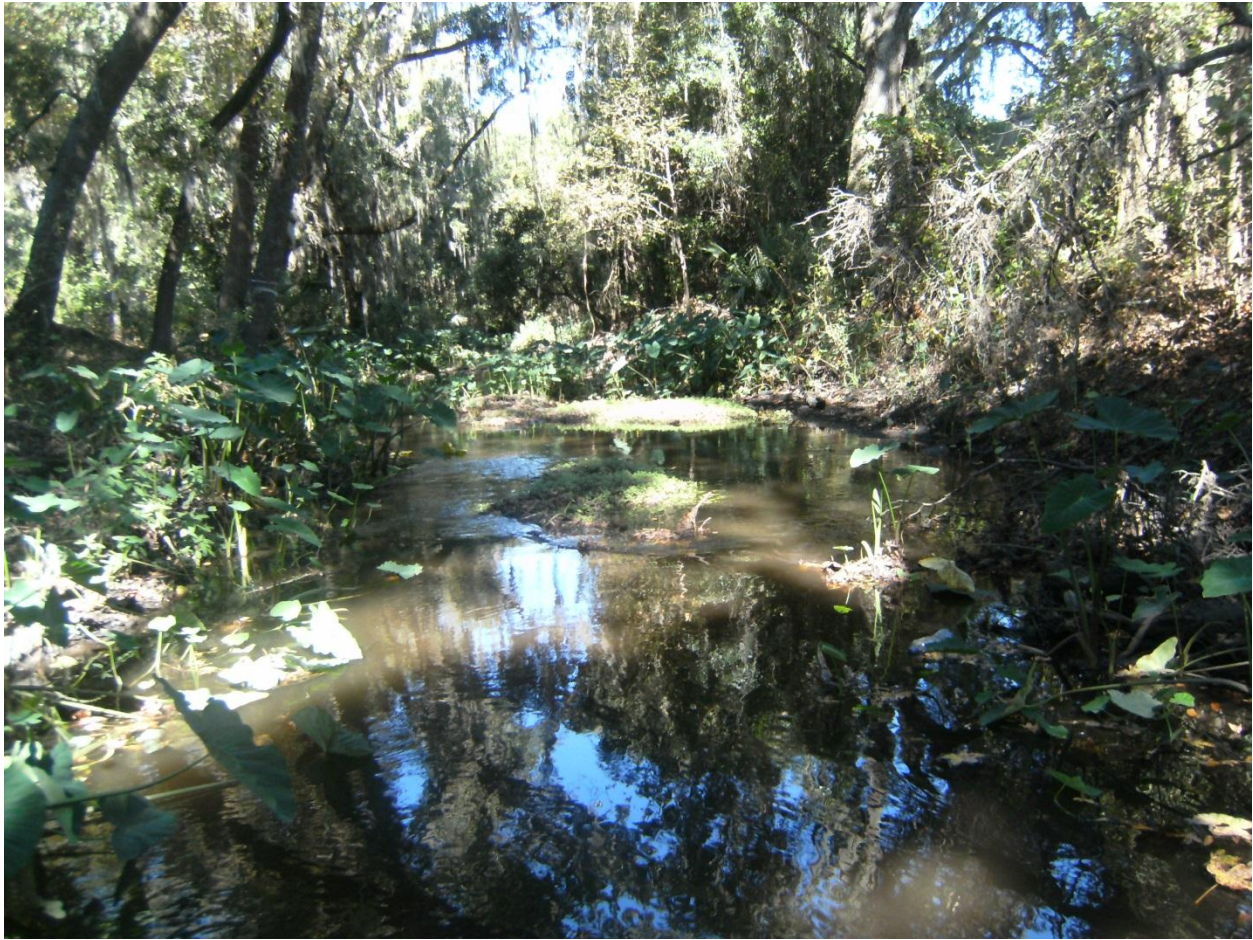
Figure 3 Overview photograph of Baker Creek at Martin Luther King Jr Blvd

Baker Creek at MLK received a habitat assessment score of 102. The conditions contributing to this score are due to marginal habitat smothering, marginal artificial channelization, and marginal riparian zone width and vegetation quality. A suboptimal number of stable pools were observed and there was evidence of artificial channelization with a small degree of sinuosity. Bank stability is optimal with bankfull >60% of bank height and slope <60 degrees. Good substrate diversity was observed including snags observed in every 10 m section. A good number of leaf packs were observed and the water was observed to have a metallic scent. Substrate availability was optimal. Water velocity was suboptimal and was measured at both the 80 m transect at (.16 m/s) and the 10 m transect at (.20 m/s). The riparian buffer width was between 6 m and 12 m, and the riparian zone vegetation quality was 25% to 50% undisturbed.
