Bell Creek

STREAM HABITAT ASSESSMENT, STREAM CONDITIONS INDEX, LINEAR
VEGETATION SURVEY, RAPID PERIPHYTON SURVEY AND WATER QUALITY

David Eilers, Karina Gonthier | USF Water Institute | March 21, 2023

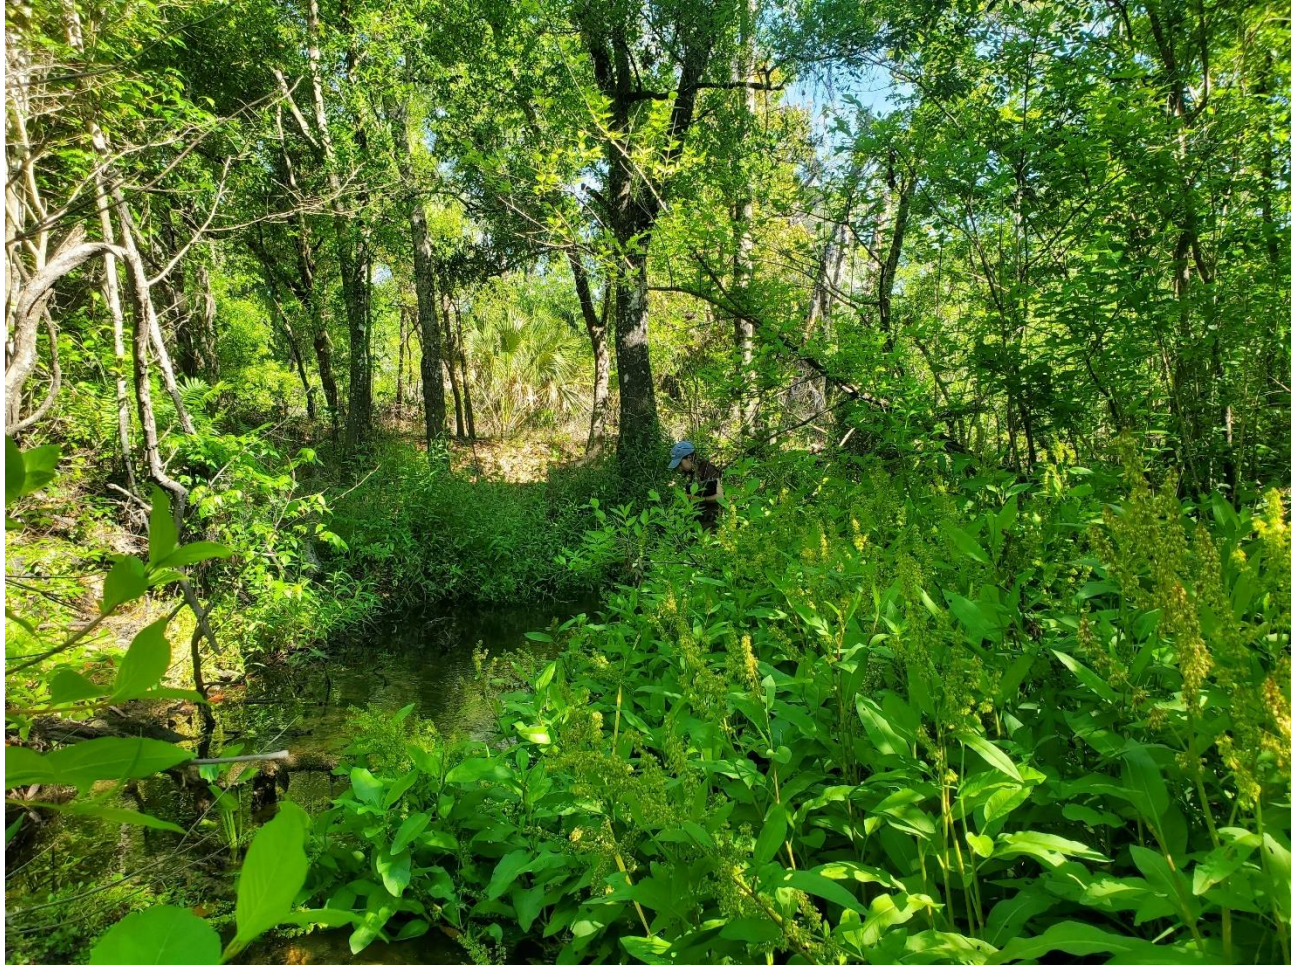
Figure 2 Photograph of the Bell Creek Sample Site showing the lush riparian vegetation.

The region of Bell Creek where the assessment was conducted is in a forested area just off of Rhodine Road. The region was moderately shaded with a mean canopy cover measurement of 64.5%. Bell Creek averaged 0.25 meters in depth and approximately 2.875 meters wide with a flow of 0.06 m/s.

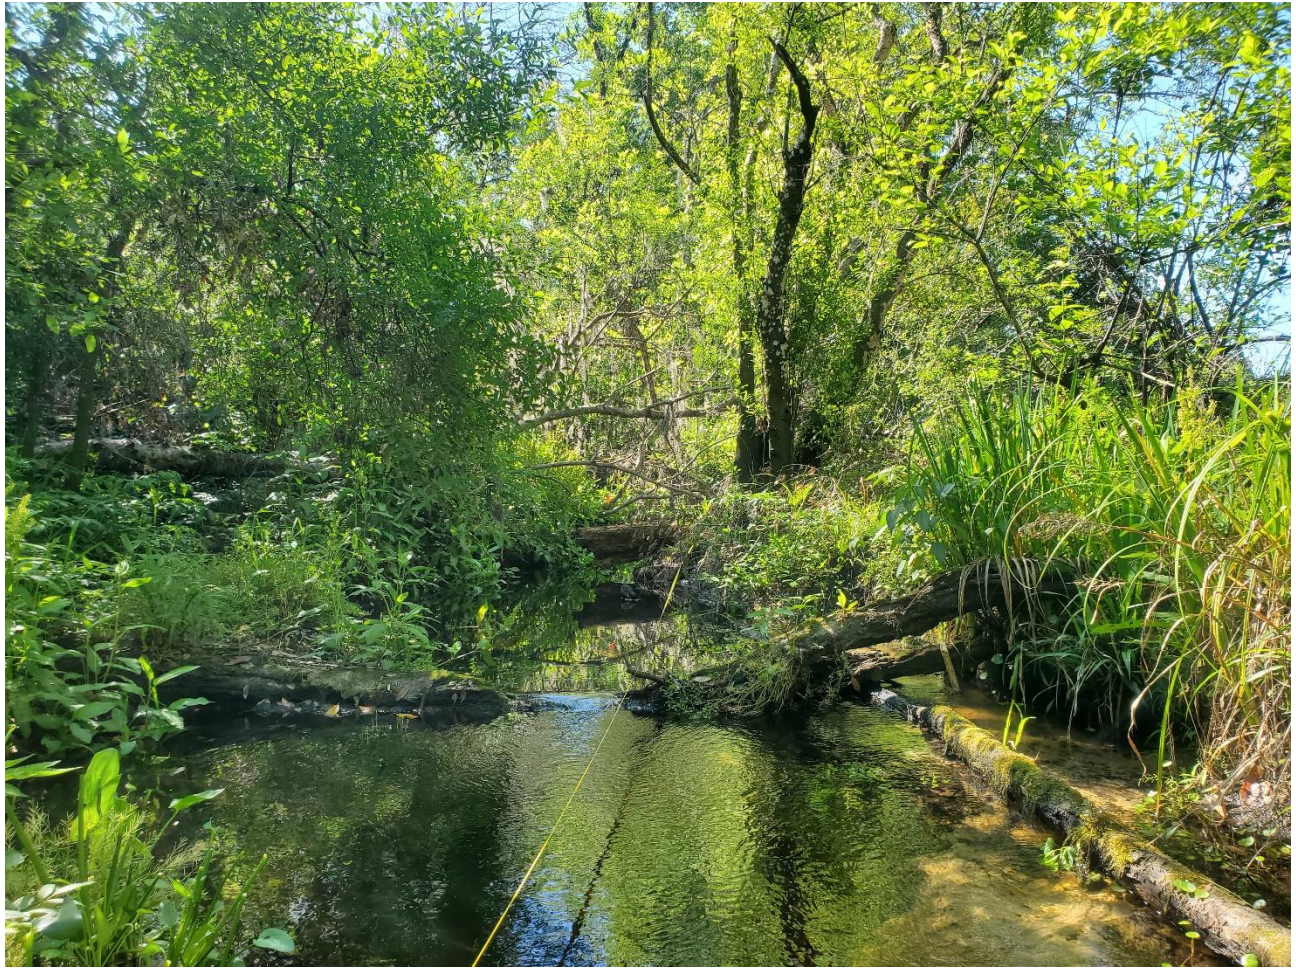
The primary habitat components of the FDEP Habitat Assessment focus on in-water habitats. The primary habitat components score in the suboptimal category for Habitat Smothering due to having an adequate number of stable pools with more than 25% of the habitats smothered by silt. Substrate Diversity (presence of two major productive habitats (snag, roots)) and Water Velocity (0.06 m/s) were scored as marginal. Substrate Availability was scored as poor for having major productive habitats in only 2.6% of the stream. Minor habitats included leaf packs/mats, aquatic macrophytes, and sand and silt deposits. The total score for the primary habitat components was a 29 out of 80.

Figure 3 Snag and roots were the most abundant major productive habitats in Bell Creek.
