# Bullfrog Creek

STREAM HABITAT ASSESSMENT, STREAM CONDITIONS INDEX, LINEAR  
VEGETATION SURVEY, RAPID PERIPHYTON SURVEY AND WATER QUALITY

David Eilers, Karina Gonthier | USF Water Institute | March 9, 2023

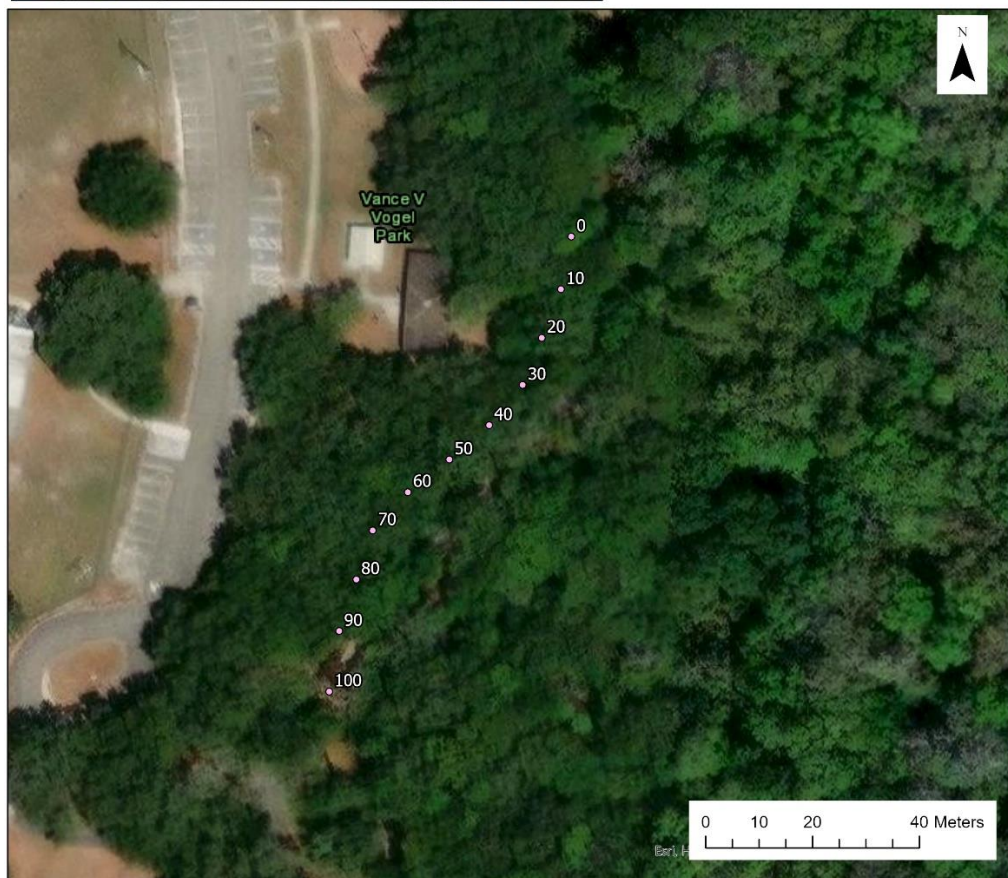
Figure 1 2023 Bullfrog Creek Study Area Map

Bullfrog Creek is located in south-central Hillsborough County in the Bullfrog Creek Watershed. Its headwaters are located west of Balm Wimauma Rd in Hillsborough County. The outfall of Bullfrog Creek is in Hillsborough Bay. The assessment of Bullfrog Creek was conducted on March 9<sup>th</sup>, 2023 and, at that time, the water levels were low but normal for the dry season. The Bullfrog Creek WBID covers 23.98 miles and is dominated by forest/natural (72.08%) and field/pasture (9.58%) land uses. The resulting calculated landscape development intensity index score was a 2.35.

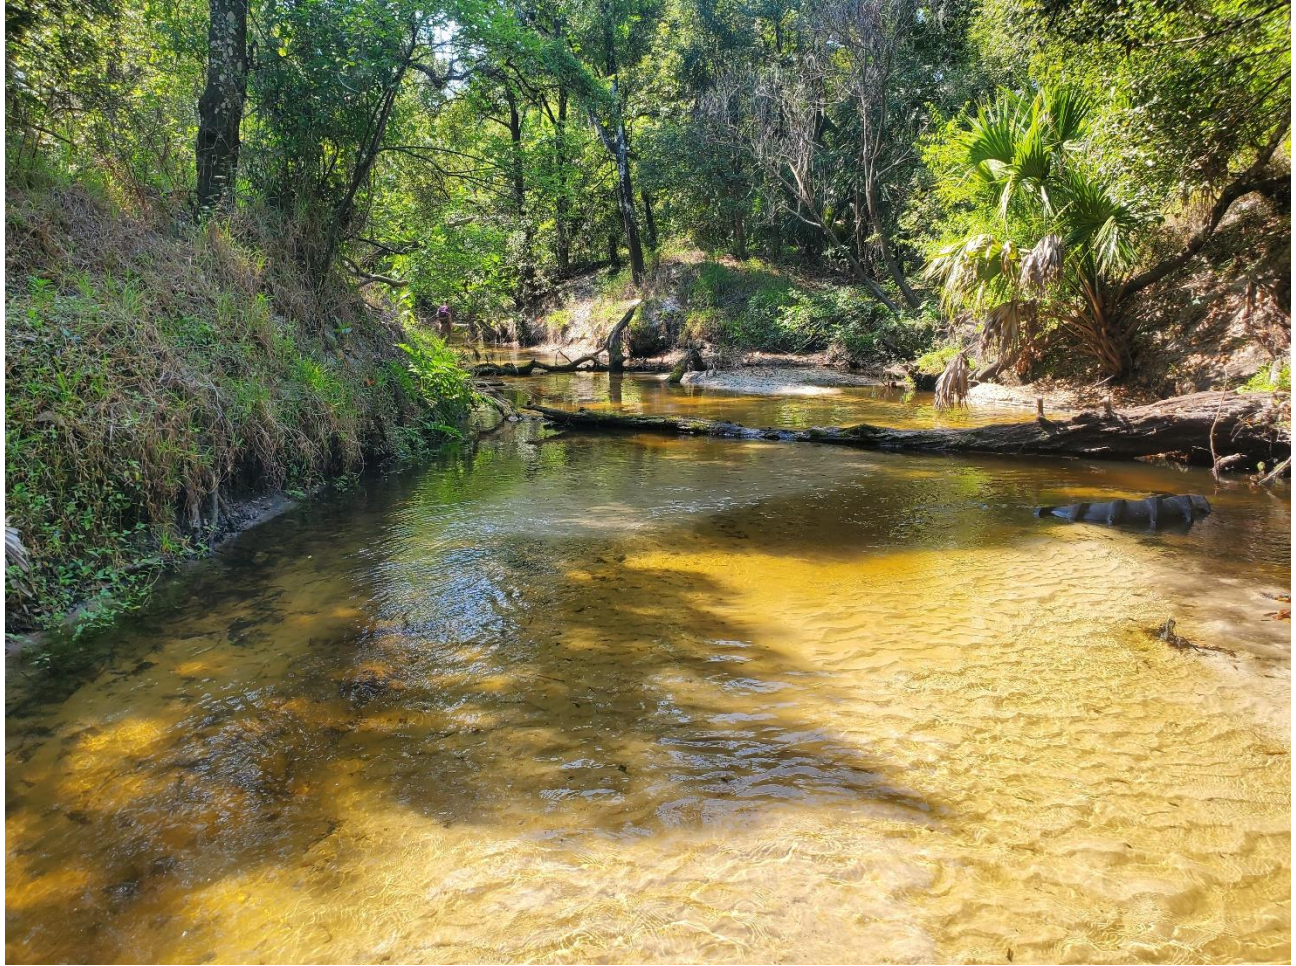
*Figure 2 Photograph of the Bullfrog Creek Sample Site showing the typical sandy sediment of the streambed and low water conditions.*

The region of Bullfrog Creek where the assessment was conducted is in Vance V Vogel Park just off of Bullfrog Creek Road. The region was moderately shaded with a mean canopy cover measurement of 67.2%. Bullfrog Creek averaged 0.25 meters in depth and approximately 6.78 meters wide with a flow of 0.25 m/s.

The primary habitat components of the FDEP Habitat Assessment focus on in-water habitat. The primary habitat components score in the suboptimal category for Water Velocity (0.25 m/s) and Habitat Smothering (adequate number of stable pools with many productive habitats affected by sand smothering). Substrate Diversity was scored in the marginal category for having two major productive habitats (snag, roots) present in the stream. Substrate Availability was scored as poor for having major productive habitats in only 1.7% of the stream. Minor habitats included leaf packs/mats and sand deposits. The total score for the primary habitat components was a 36 out of 80.

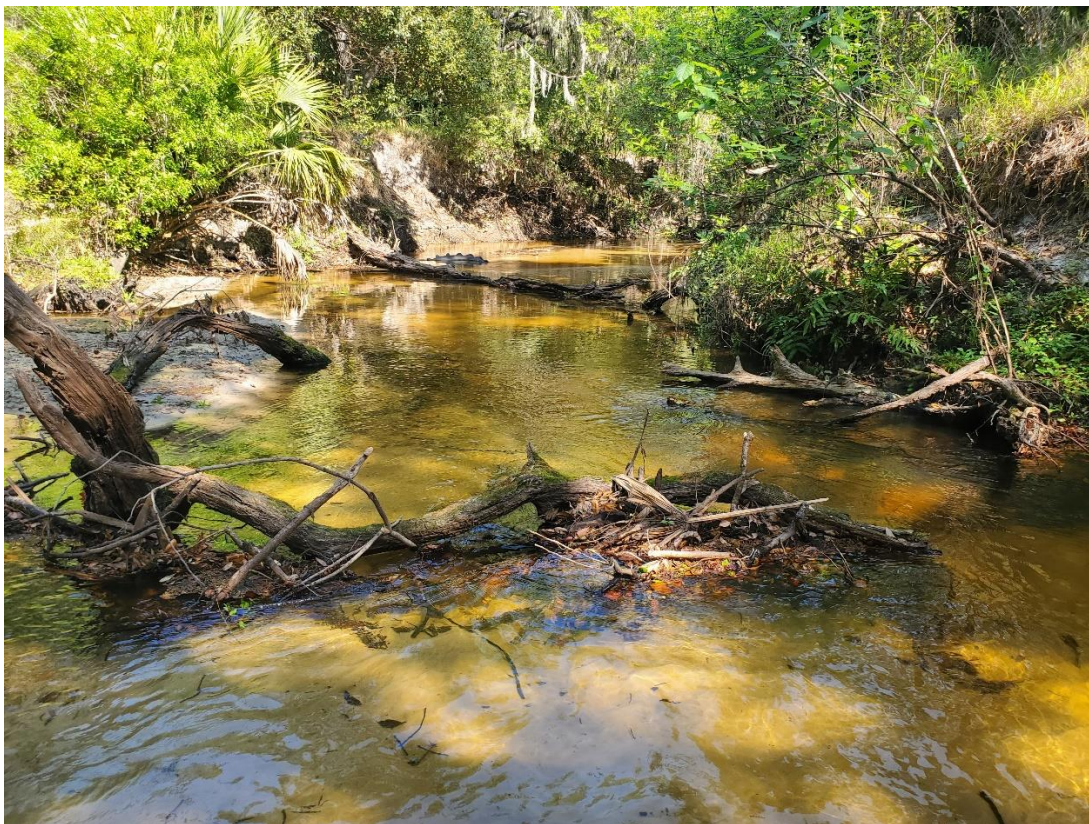
*Figure 3 A photograph of snag (major productive habitat) with leaf packs (minor habitat) in Bullfrog Creek.*

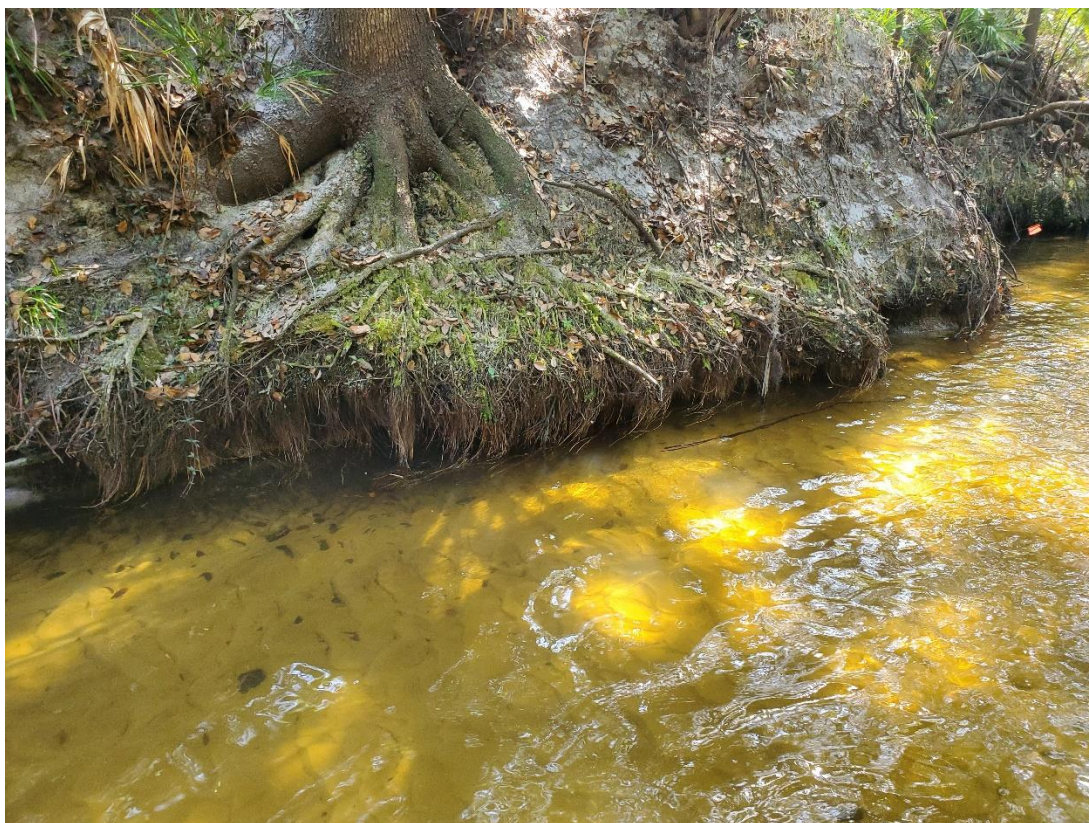
*Figure 4 Roots were a major productive habitat in Bullfrog Creek.*
