LAKE ASSESSMENT REPORT FOR BYRD LAKE IN HILLSBOROUGH COUNTY, FLORIDA

Date Assessed: August 20, 2008

Assessed by: Monetta Wilson and David Eilers

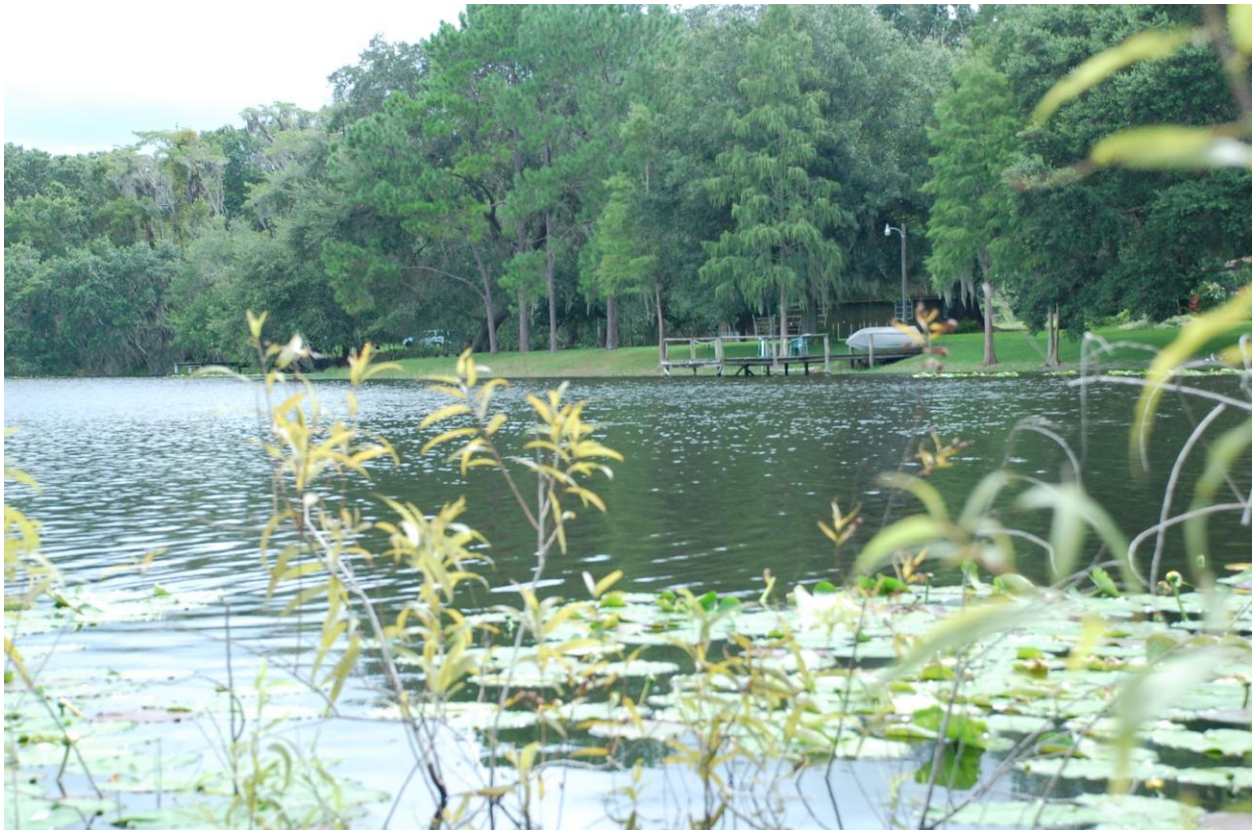
Figure 1. Photo of Byrd Lake, taken August 20, 2008.

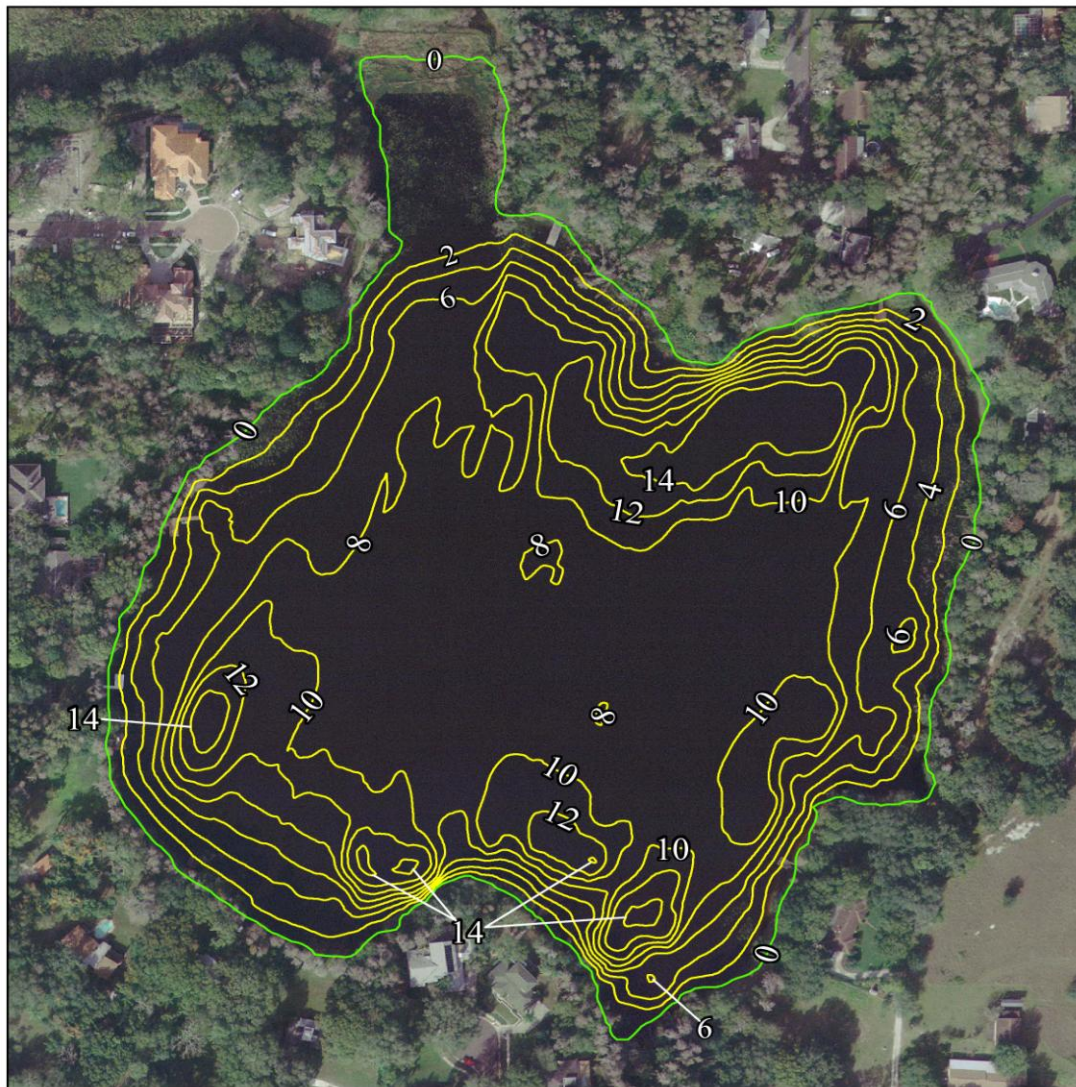
Survey Date: August 20, 2008
Lake water level was 49.32 ft
above sea level at time of assessment.
Contours are expressed in absolute depth
below this level.

Perimeter 4229.40 ft;
Area 17.73 Acres
Mean Depth 8.34 ft;
Volume 174.30 Acre-ft, (56796728.41 gallons);
Deepest point 15.75 ft

Figure 1. Contour map for Byrd Lake. The mapping technique used in 2008 employs a standard DGPS for horizontal position and a fathometer for depth.

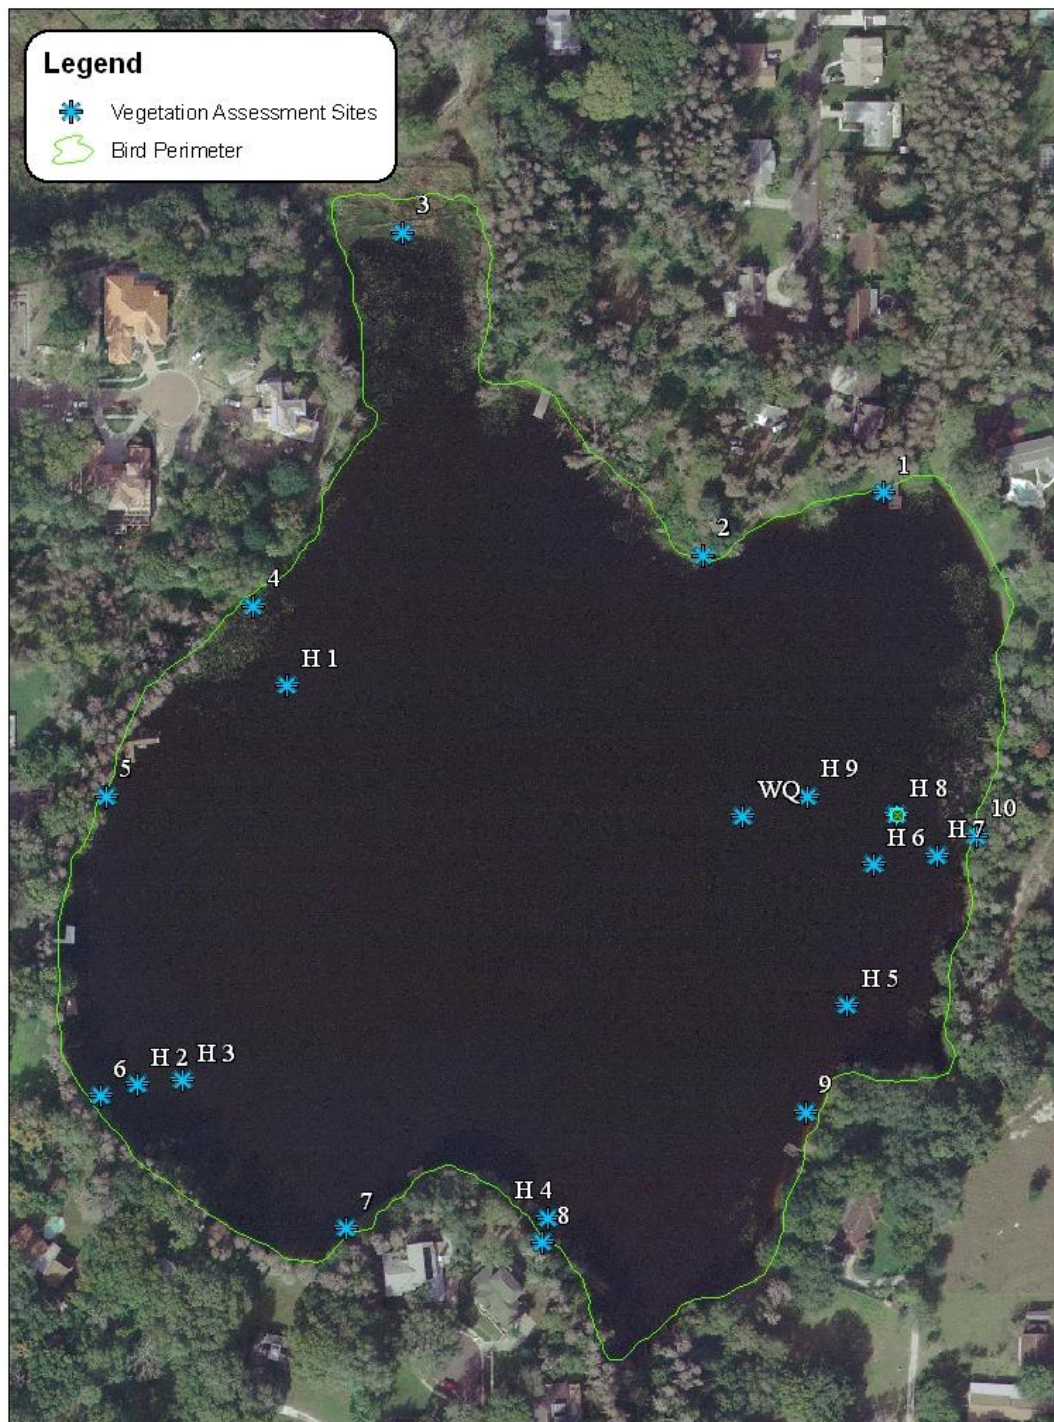
Figure 3. 2007 six-inch resolution aerial photograph showing location of vegetation assessment sites on Byrd Lake. Major emergent and floating vegetation zones as well as structures are also observable in this aerial.

The lake's apparent vegetative cover and shoreline detail are evaluated using the latest lake aerial photograph as shown in Figure 3 and by use of WAAS enabled GPS. Submerged vegetation is determined from the analysis of bottom returns from the Lowrance 28c HD combined GPS/fathometer described earlier. As depicted in Figure 3, ten vegetation assessment sites were chosen for intensive sampling based on the *Lake Assessment Protocol* (copy available on request) for a lake of this size. The site positions are set using GPS and then loaded into a GIS mapping program (ArcGIS) for display. Each site is sampled in the three primary vegetative zones (emergent, submerged and floating).^{iv} The latest high resolution aerial photos are used to provide shore details (docks, structures, vegetation zones) and to calculate the extent of surface vegetation coverage. The primary indices of submerged vegetation cover and biomass for the lake, percent area coverage (PAC) and percent volume infestation (PVI), are determined by transiting the lake by boat and employing a fathometer to collect "hard and soft return" data. These data are later analyzed for presence and absence of vegetation and to determine the height of vegetation if present. The PAC is determined from the presence and absence analysis of 100 sites in the lake and the PVI is determined by measuring the difference between hard returns (lake bottom) and soft returns (top of vegetation) for sites (within the 100 analyzed sites) where plants are determined present (Figure 6).

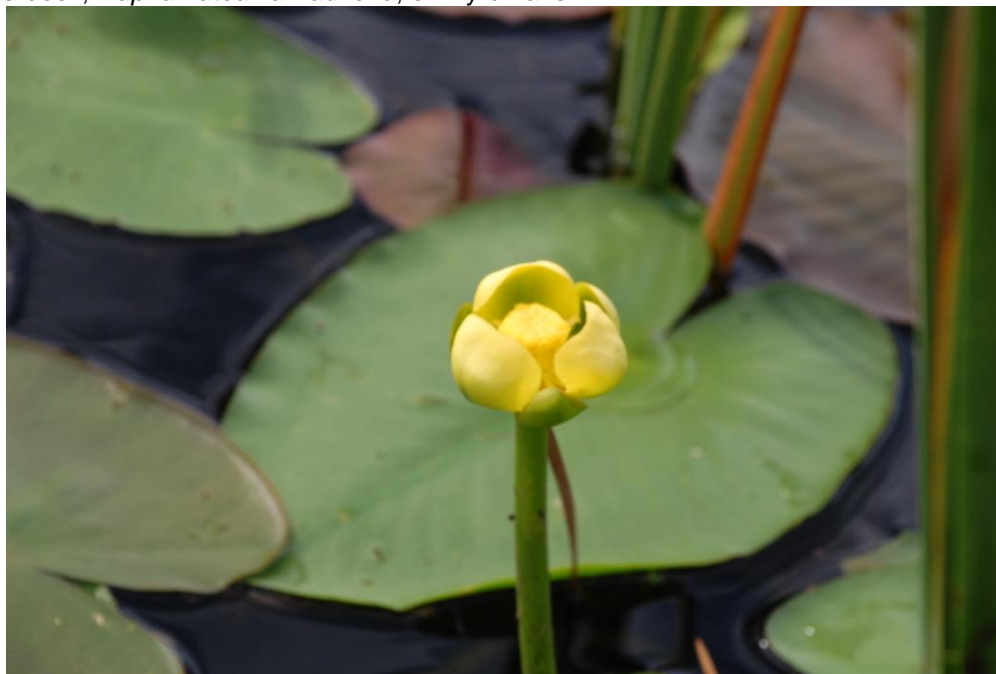
Figure 4. Photograph of Spatterdock, *Nuphar lutea* var. *advena*, on Byrd Lake.

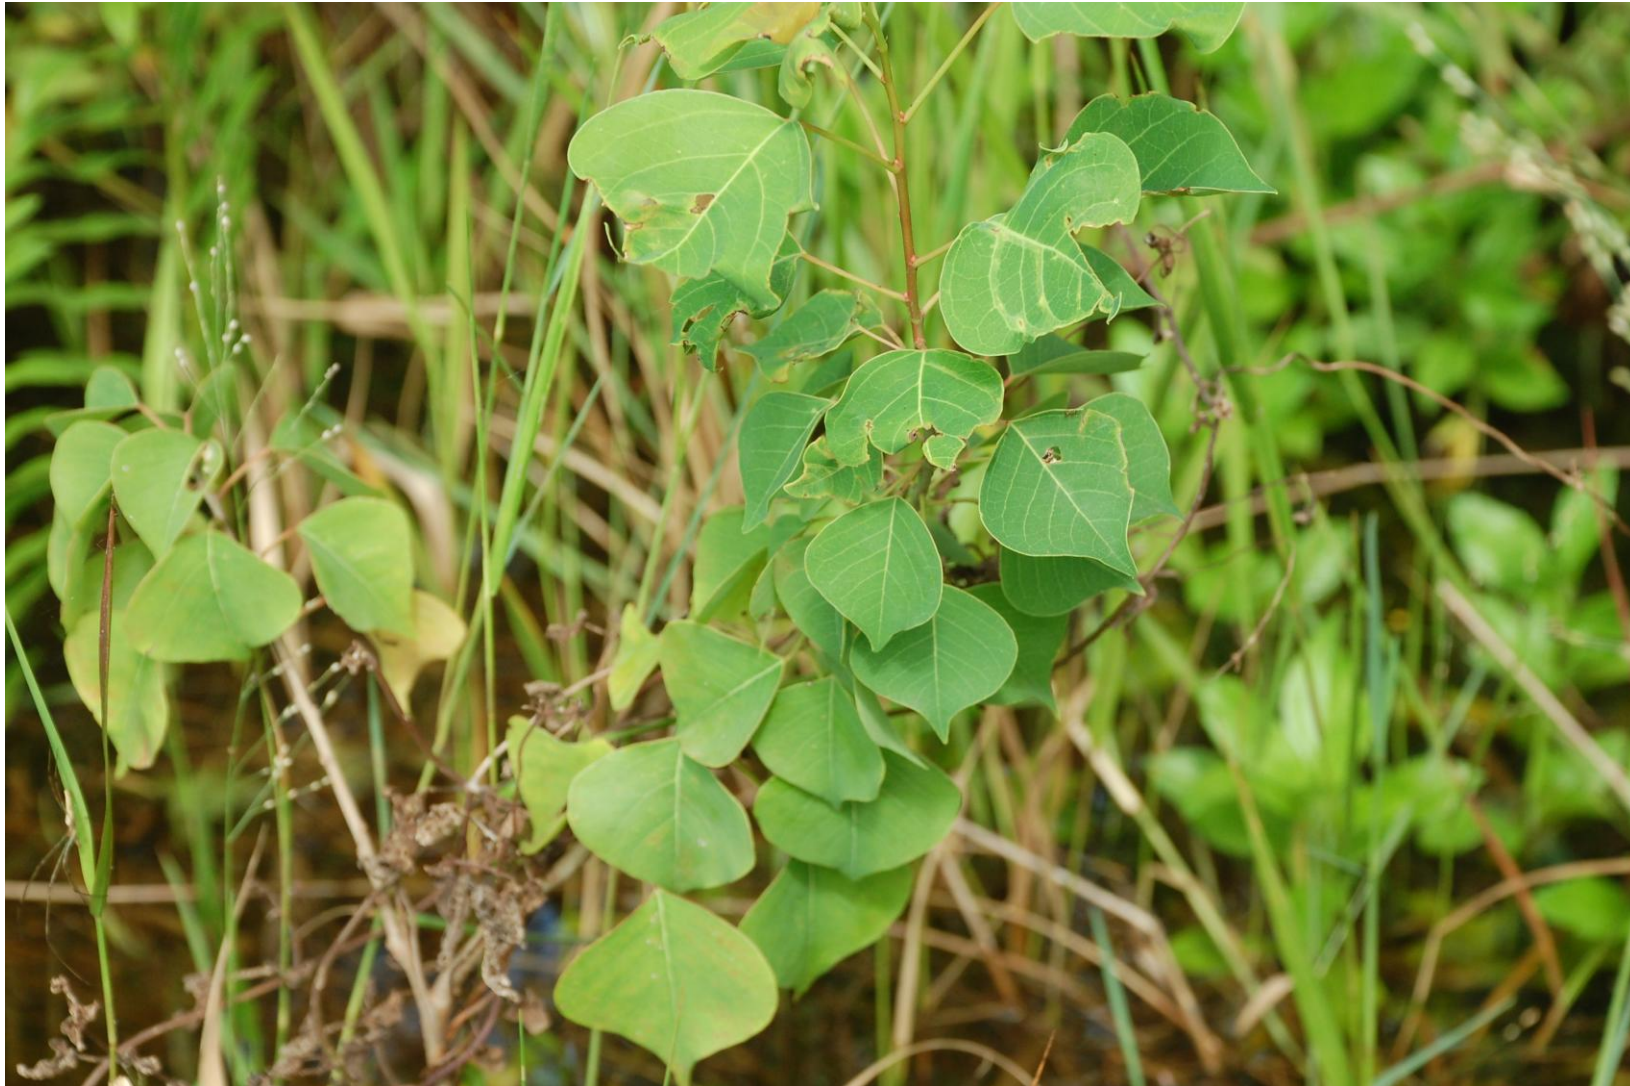
Figure 5. Photograph of a Chinese Tallow Tree, *Sapium sebiferum*, on Byrd Lake. Chinese Tallow is a non-native invasive species that displaces native tree species along Florida lake shorelines.

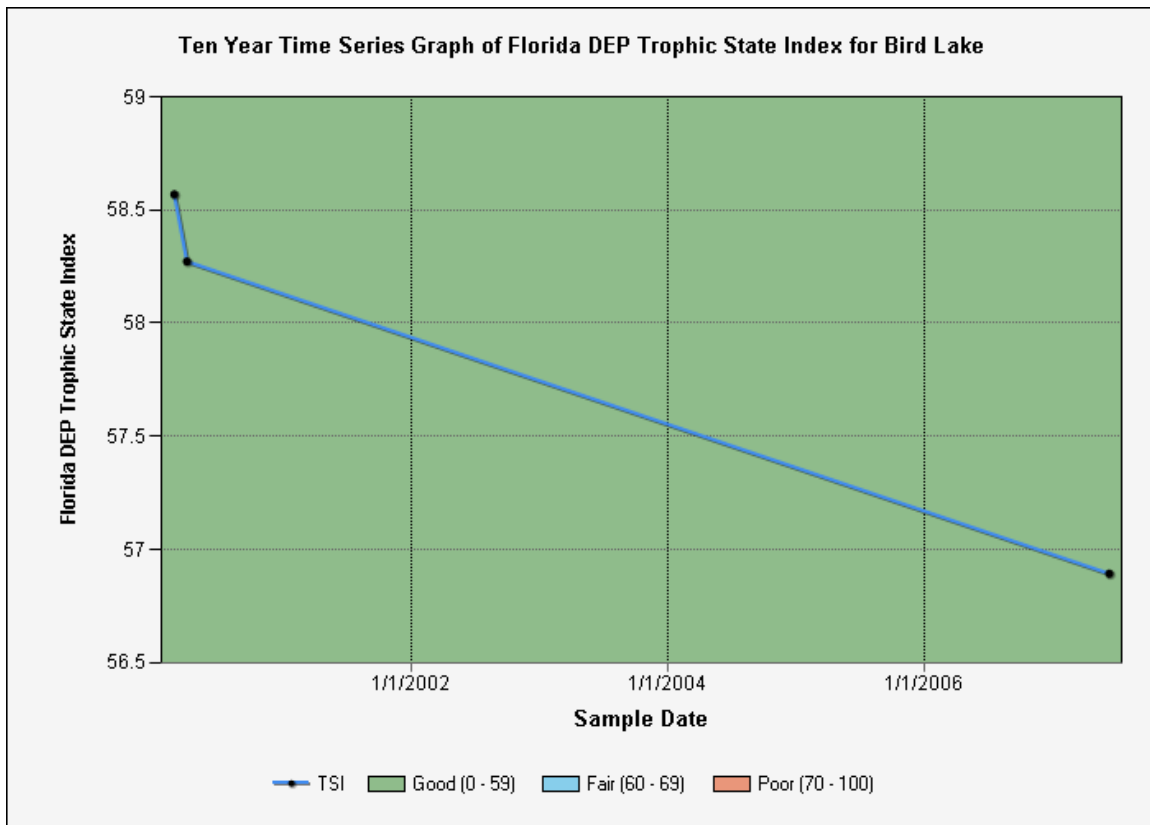
Figure 6. Recent Trophic State Index (TSI) graph from Hillsborough Watershed Atlas. For the latest data go to: (<http://www.hillsborough.wateratlas.usf.edu/lake/waterquality.asp?wbodid=5358&wbodiatlas=lake>)

Note: The graph above includes benchmarks for using verbal descriptors of "good", "fair" and "poor". The verbal descriptors for these benchmarks are based on an early determination by stakeholders of the generally acceptable and understood terms for describing the state of lakes. The same benchmarks are used for nutrient graphs (Nitrogen and Phosphorus), chlorophyll graphs and trophic state index (TSI) graphs. The TSI is a calculated index of lake condition based on nutrient and chlorophyll (a) concentrations (please see "Learn more about Trophic State Index"). The benchmarks are established based on the TSI range that relates to a specific descriptor. The source for the TSI concentration relationships is the Florida Water Quality Assessment, 1996, 305(b) (Table 2-8).

A critical element in any lake assessment is the long-term water chemistry data set. The primary source of water quality trend data for Florida Lakes is the Florida LAKEWATCH volunteer and the Florida LAKEWATCH water chemistry data. Hillsborough County is fortunate to have a large cadre of volunteers who have collected lake water samples for significant time period. These data are displayed and analyzed on the Water Atlas as shown in Figure 6 for Lake Virginia. Additional data, when available, is also included on the Water Atlas; however, the LAKEWATCH data remains the primary source. By the trend data shown in the figure, the lake may be considered in the mid-eutrophic (Good) range of lakes; however, there is insufficient trend data to fully understand the lake's water chemistry. The snapshot value from our lake assessment sampling resulted in a TSI of 57.66 which generally agrees with the three values in Figure 6 which seems to indicate that the lake remains in the mid-eutrophic range.

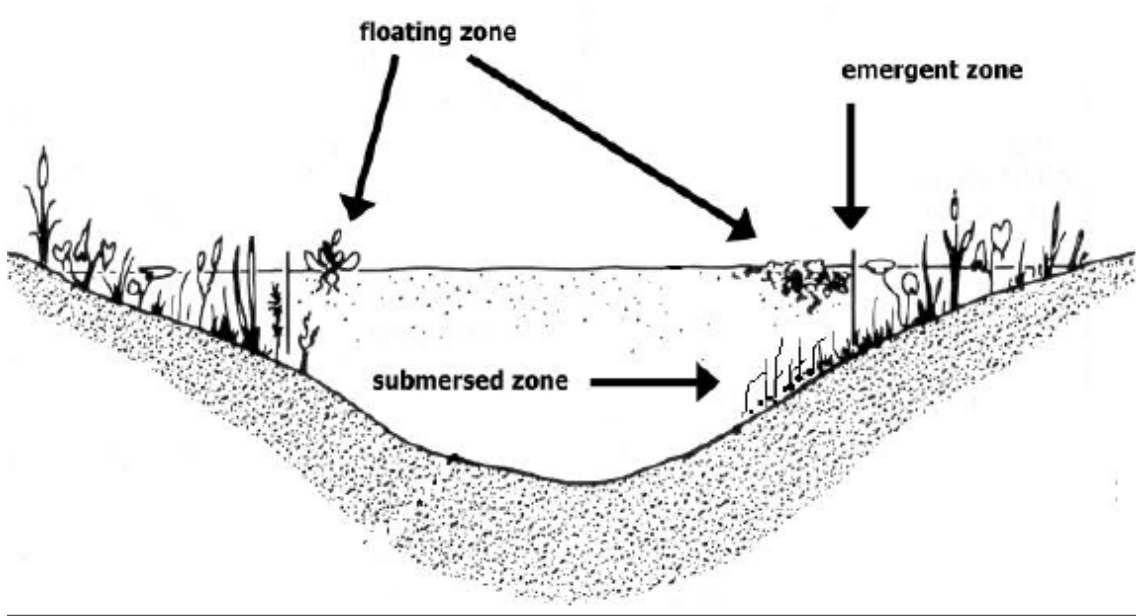
iv The three primary aquatic vegetation zones are shown below:
