LAKE ASSESSMENT REPORT FOR CHAPMAN LAKE IN HILLSBOROUGH COUNTY FLORIDA

Date Assessed: July 27, 2007

Assessed by: Sarah Koenig and David Eilers

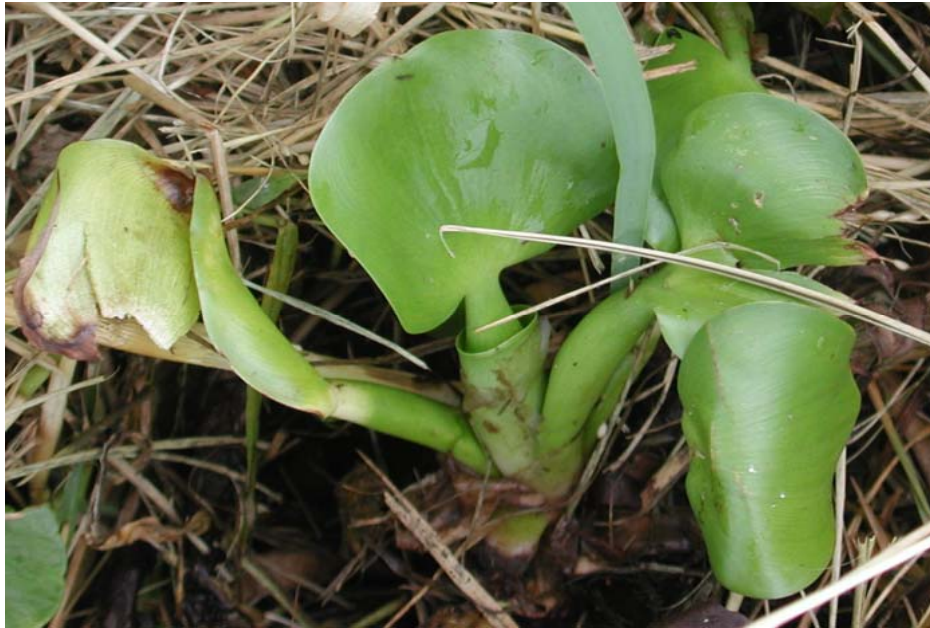
Figure 4. *Eichornia crassipes*, Water Hyacinth, is a non-native invasive species from South America. This species can dominate the waters surface and native floating vegetation.

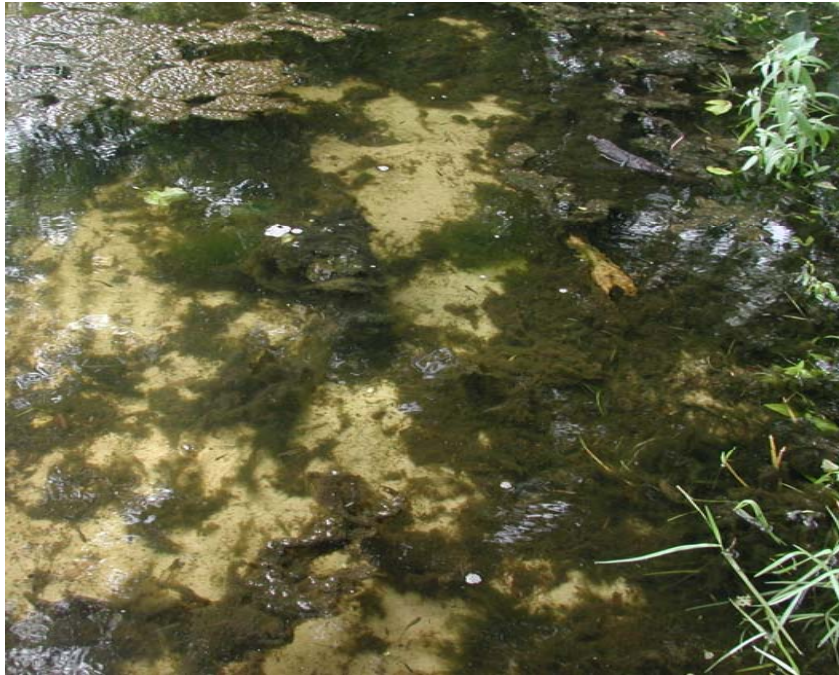
Figure 8. Algal species such as those pictured here may be native, but in the presence of excess nutrients such as those from runoff fertilizer it can grow unchecked covering more beneficial submerged vegetation. This is one reason that it is important to use caution in the application of fertilizers near bodies of water.

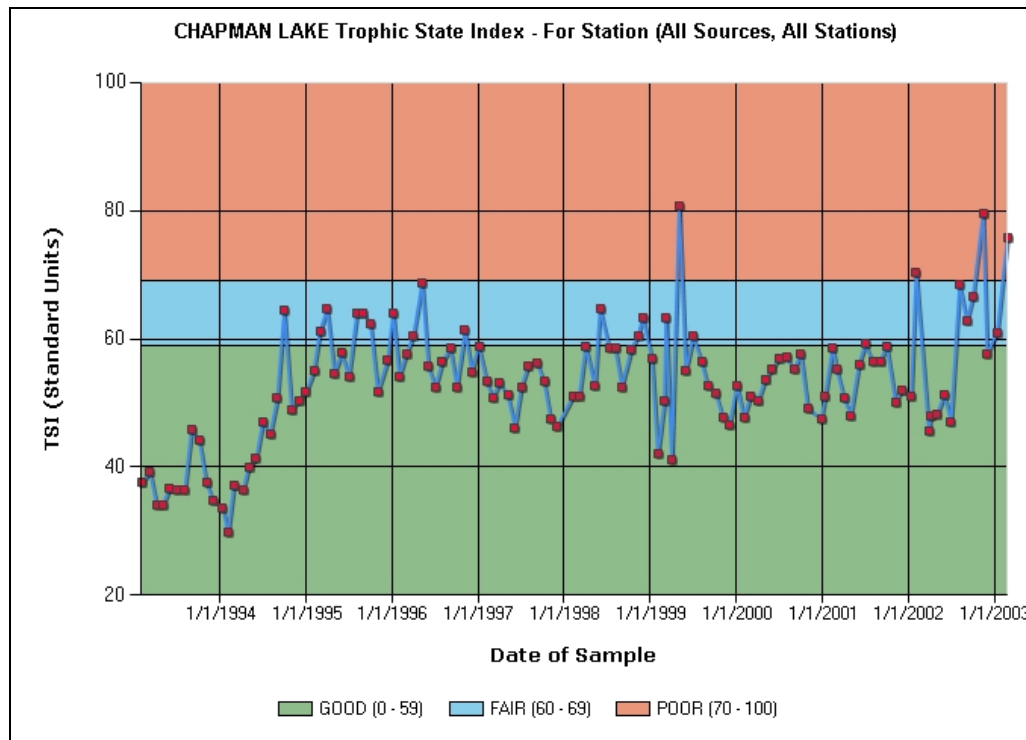
Figure 9. Recent Trophic State Index (TSI) graph from Hillsborough Watershed Atlas. For the latest date go to:

Note: The graph above includes benchmarks for using verbal descriptors of "good", "fair" and "poor". The verbal descriptors for these benchmarks are based on an early determination by stakeholders of the generally acceptable and understood terms for describing the state of lakes. The same benchmarks are used for nutrient graphs (Nitrogen and Phosphorus), chlorophyll graphs and trophic state index (TSI) graphs. The TSI is a calculated index of lake condition based on nutrient and chlorophyll (a) concentrations (please see "Learn more about Trophic State Index"). The benchmarks are established based on the TSI range that relates to a specific descriptor. The source for the TSI concentration relationships is the Florida Water Quality Assessment, 1996, 305(b) (Table 2-8).
