# LAKE ASSESSMENT REPORT FOR CHURCH LAKE IN HILLSBOROUGH COUNTY FLORIDA

Date Assessed: May 2, 2007

Assessed by: Sarah Koenig and David Eilers

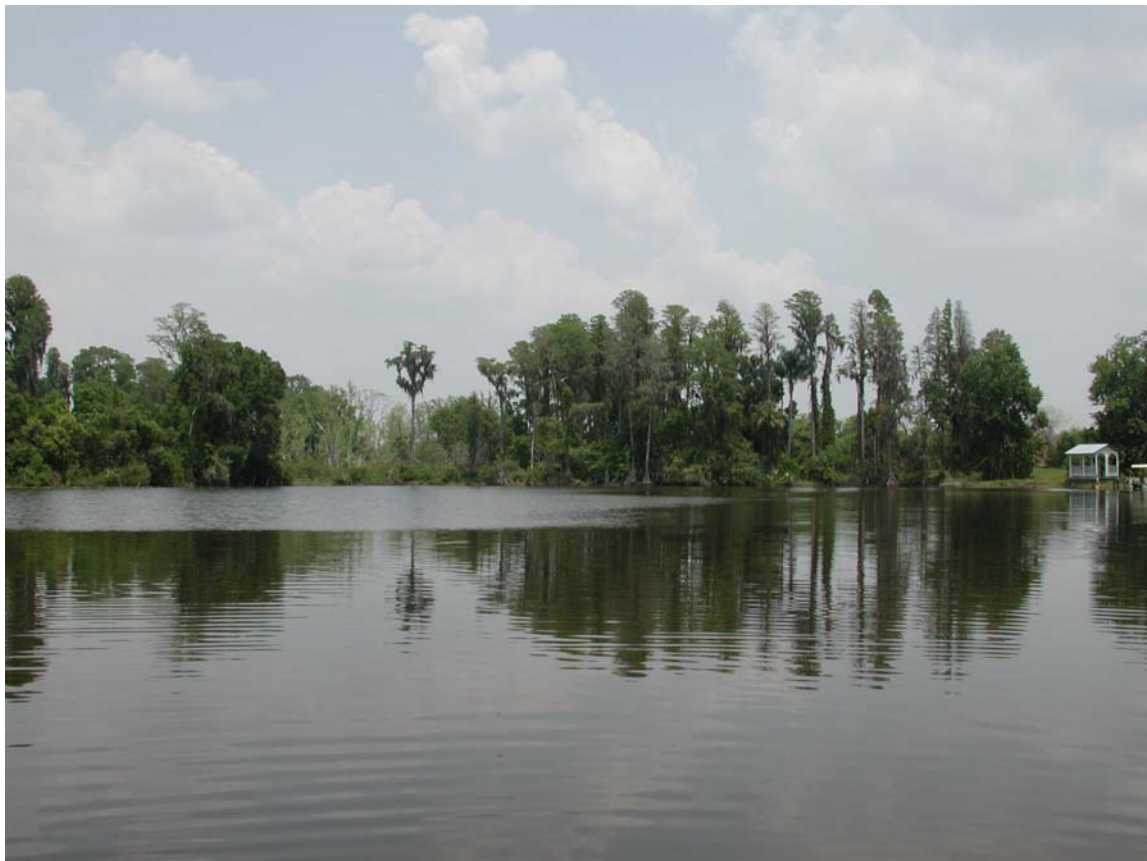
**Figure 1. General photograph of Church Lake taken on May 2, 2007.**

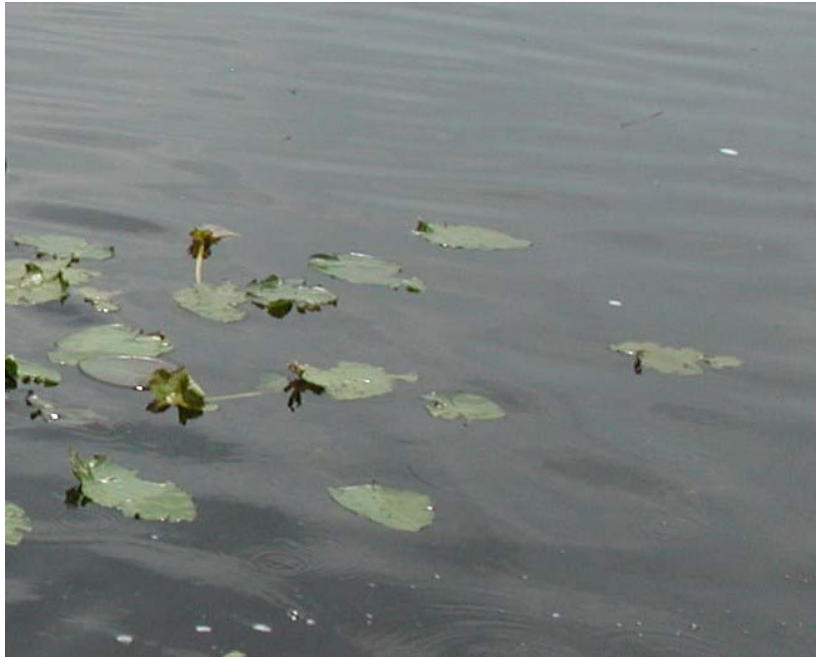
**Figure 4**

**Figure 4.** *Nuphar lutea* var. *advena*, Spatterdock, Yellow Pondlily, is a common plant in Florida lakes that provides shelter for developing fish and invertebrates, however when this species population reaches high levels in lakes it is considered a pest plant species due to the shading of submerged plant species and the increased difficulty for navigation for boaters.

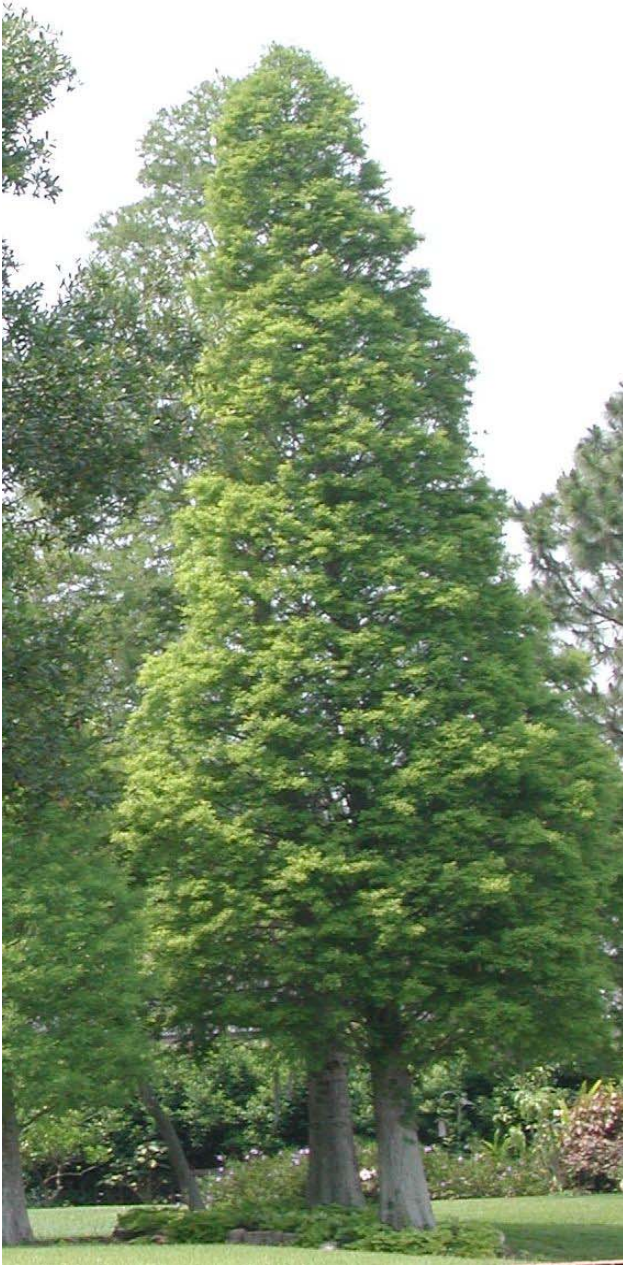
Figure 5 *Taxodium ascendens*, Pond Cypress, is an important native tree in Florida. Nearly all of the Cypress forests in Florida have been harvested at some point for high end lumber for the flooring and furniture industries. They are a highly protected species and should not be removed from Florida wetlands as they serve as an important habitat for native birds and other organisms.

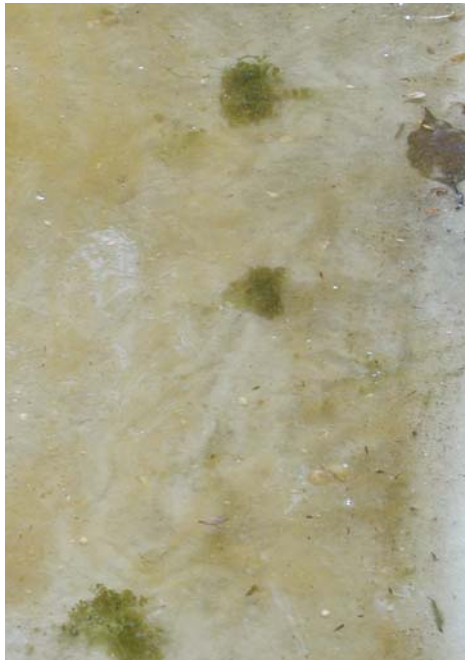
**Figure 6**

Figure 6. *Utricularia* spp., Bladderwort, was observed in small amounts at 3 vegetation sites on Church Lake. This plant species are a submersed, carnivorous plant without true root structures. Most of the members of *Utricularia* bear small bladders that trap and ingest small plankton.

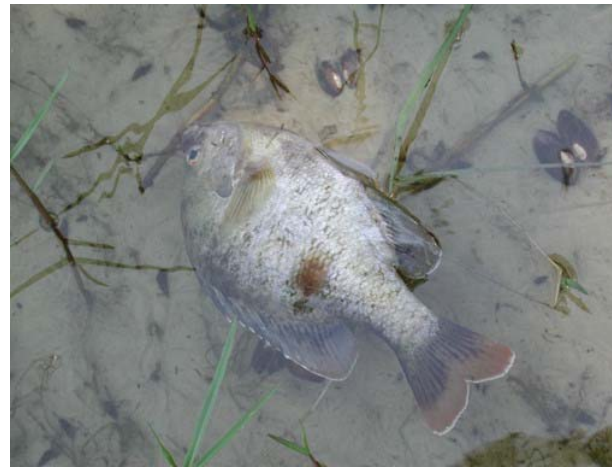
**Figure 7**

Figure 7. A fish kill was observed on Church Lake the day of our assessment.

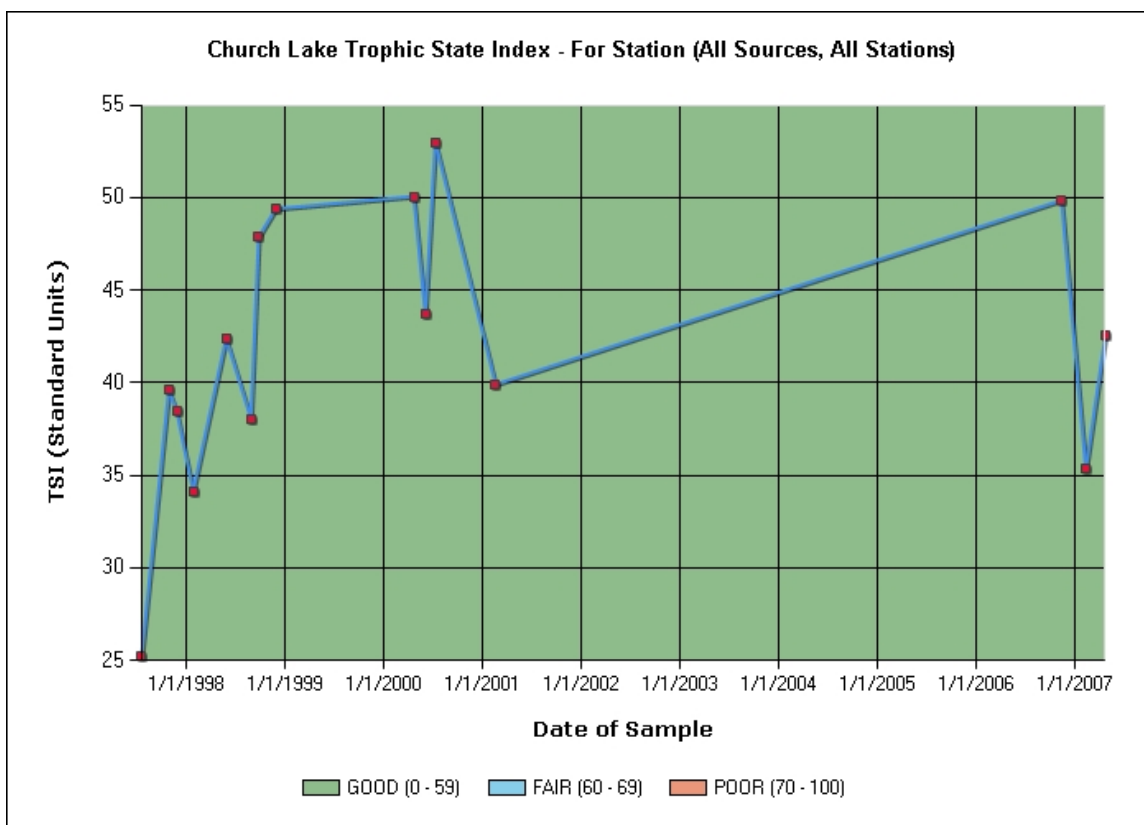
Figure 8

**Figure 8. Recent Trophic State Index (TSI) graph from Hillsborough Watershed Atlas.**  
For the latest date go to:

Note: The graph above includes benchmarks for using verbal descriptors of "good", "fair" and "poor". The verbal descriptors for these benchmarks are based on an early determination by stakeholders of the generally acceptable and understood terms for describing the state of lakes. The same benchmarks are used for nutrient graphs (Nitrogen and Phosphorus), chlorophyll graphs and trophic state index (TSI) graphs. The TSI is a calculated index of lake condition based on nutrient and chlorophyll (a) concentrations (please see "Learn more about Trophic State Index"). The benchmarks are established based on the TSI range that relates to a specific descriptor. The source for the TSI concentration relationships is the Florida Water Quality Assessment, 1996, 305(b) (Table 2-8).

As part of the lake assessment the physical water quality and chemical water chemistry of a lake are measured. These data only indicate a snap shot of the lakes water quality; however they are useful when compared to the trend data available from LAKEWATCH or other sources. Table 8 contains the summary water quality data and index values and adjusted values calculated from these data. The total phosphorus (TP), total nitrogen (TN) and chlorophyll (a) water chemistry sample data are the results of chemical analysis of samples taken during the assessment and analyzed by the Hillsborough County Environmental Protection Commission laboratory. These data is comparable with the mean data from the LAKEWATCH data set for the lake. The trophic state index (TSI) calculated from the sample data (48.53) is well within the values shown in the figure above.

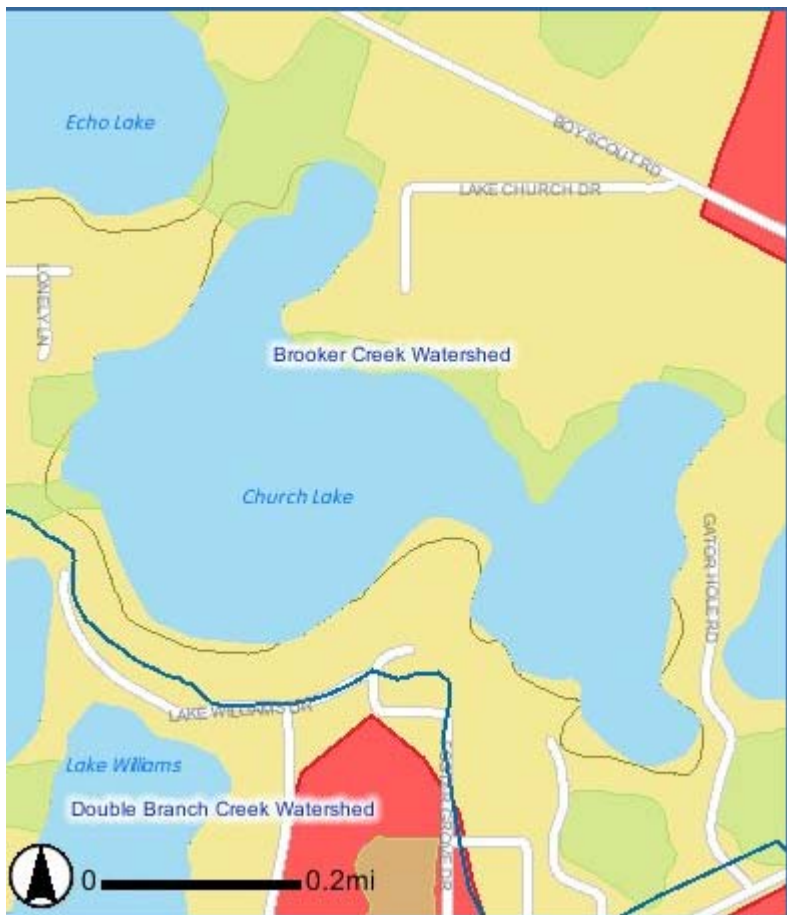
**Figure 9. Church Lake is not presently listed as impaired**

A critical element in any lake assessment is the long-term water chemistry data set. The primary source of water quality trend data for Florida Lakes is the Florida LAKEWATCH volunteer and the Florida LAKEWATCH water chemistry data. Hillsborough County is fortunate to have a large cadre of volunteers who have collected lake water samples for significant time period. These data are displayed and analyzed on the Water Atlas as shown in Figure 8 for Church Lake. Additional data, when available, is also included on the Water Atlas; however, the LAKEWATCH data remains the primary source. By the trend data shown in the figure, the lake may be considered good terms of the trophic state index. This lake is a clear (color < 40 pcu) water lake and as such it must maintain a TSI of below 40 to not be considered impaired by the State of Florida guidelines<sup>v</sup>. The lake's long term water quality data indicates enough violations of these criteria to be classified by Florida DEP as impaired. The more recent trends indicates similar conditions. At the present time, this lake is not listed as impaired as shown in Figure 9.

v A lake is impaired if " (2) For lakes with a mean color less than or equal to 40 platinum cobalt units, the annual mean TSI for the lake exceeds 40, unless paleolimnological information indicates the lake was naturally greater than 40, or For any lake, data indicate that annual mean TSIs have increased over the assessment period, as indicated by a positive slope in the means plotted versus time, or the annual mean TSI has

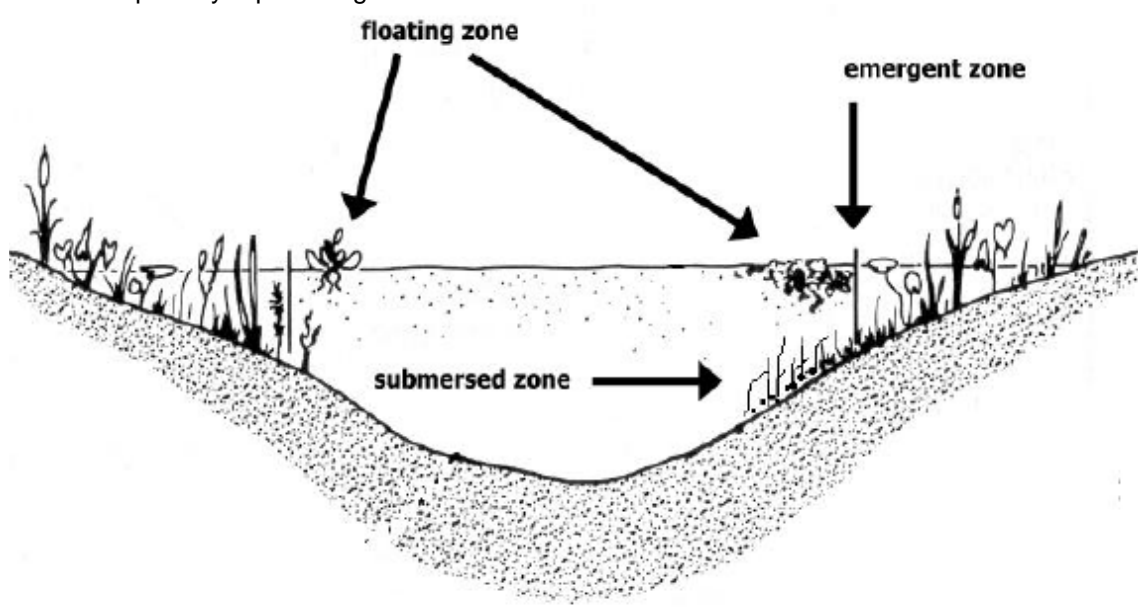
iv The tree primary aquatic vegetation zones are shown below:
