LAKE ASSESSMENT REPORT FOR LAKE CRENSHAW IN HILLSBOROUGH COUNTY FLORIDA

Date Assessed: June 20, 2007

Assessed by: Sarah Koenig and David Eilers

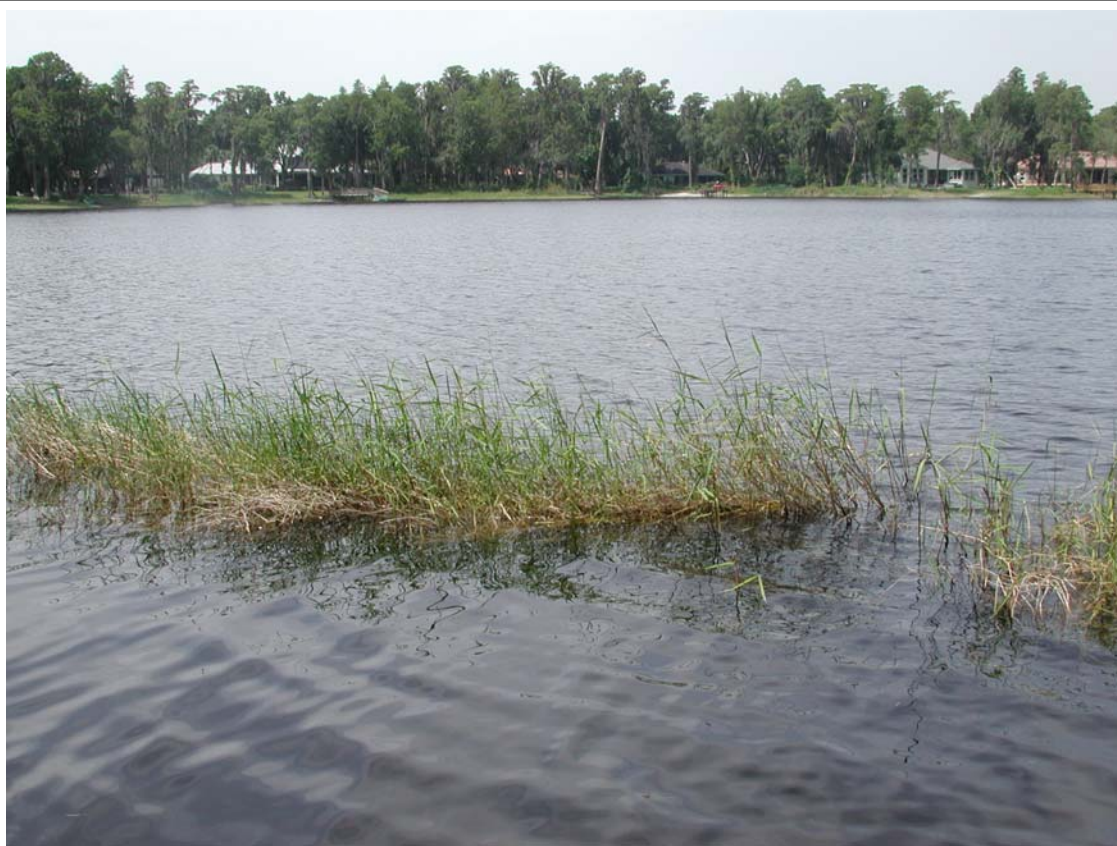
Figure 1. General photograph of Lake Crenshaw taken on June 20, 2007.

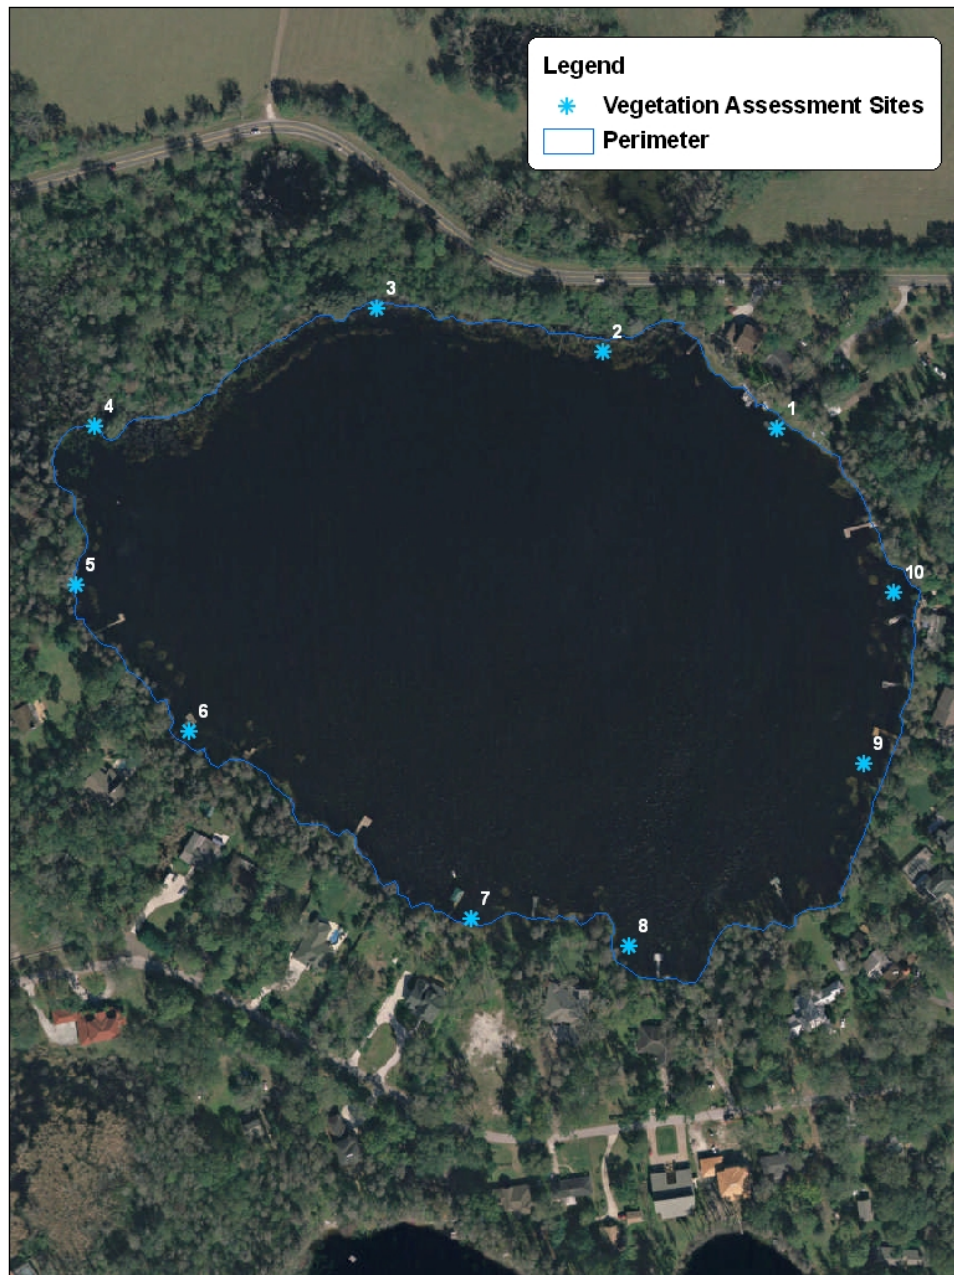
Figure 3. 2006 six-inch resolution aerial photograph showing location of vegetation assessment sites on Lake Crenshaw. Major emergent and floating vegetation zones as well as structures such as docks are also observable in this aerial.

The lake's apparent vegetative cover and shoreline detail are evaluated using the latest lake aerial photograph as shown in Figure 3 and by use of WAAS enabled GPS. Submerged vegetation is determined from the analysis of bottom returns from the Lowrance 26c HD combined GPS/fathometer described earlier. As depicted in Figure 3, ten vegetation assessment sites were chosen for intensive sampling based on the *Lake Assessment Protocol* (copy available on request) for a lake of this size. The site positions are set using GPS and then loaded into a GIS mapping program (ArcGIS) for display. Each site is sampled in the three primary vegetative zones (emergent, submerged and floating)^{iv}. The latest aerials high resolution aerial photos are used to provide shore details (docks, structures, vegetation zones) and to calculate the extent of surface vegetation coverage. The primary indices of submerged vegetation cover and biomass for the lake, percent area coverage (PAC) and percent volume infestation (PVI), are determined by transiting the lake by boat and employing a fathometer to collect "hard and soft return" data. These data are later analyzed for presence and absence of vegetation and to determine the height of vegetation if present. The PAC is determined from the presence and absence analysis of 100 sites in the lake and the PVI is determined by measuring the difference between hard returns (lake bottom) and soft returns (top of vegetation) for sites (within the 100 analyzed sites) where plants are determined present.

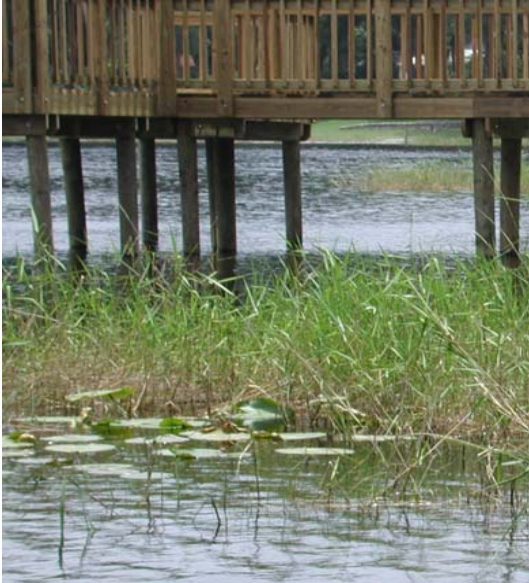
Figure 4. *Nuphar lutea var. advena*, Spatterdock, is the floating lily pictured here in front of a stand of *Panicum hemitomon*, Maidencane. Both of these species are native inhabitants of Florida lakes. They are important sources of shelter to juvenile fish and invertebrates including several recreationally important species of game fish.

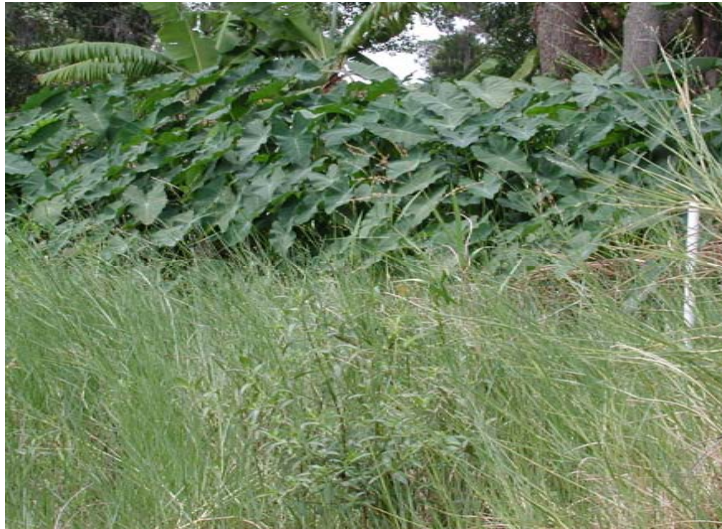
Figure 5. *Panicum repens*, Torpedo Grass, foreground, and *Colocasia esculenta*, Wild Taro, background, are both highly invasive, non-native plants which dominate native vegetation along Florida lakes.

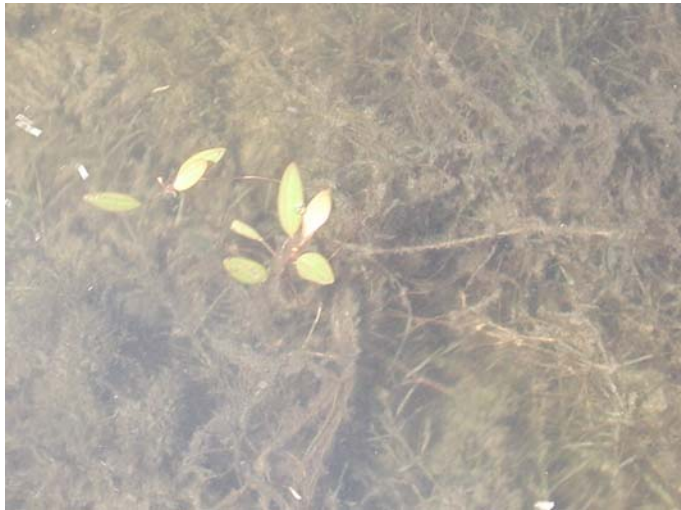
Figure 6. *Potamogeton diversifolius*, Water Thread Pond Weed, is a native submerged plant with two distinct leaf shapes. This species possesses both floating leaves and submerged leaves. The floating leaves are visible in this photograph as the bright green elliptic leaves. The submerged leaves are linear and thread like.

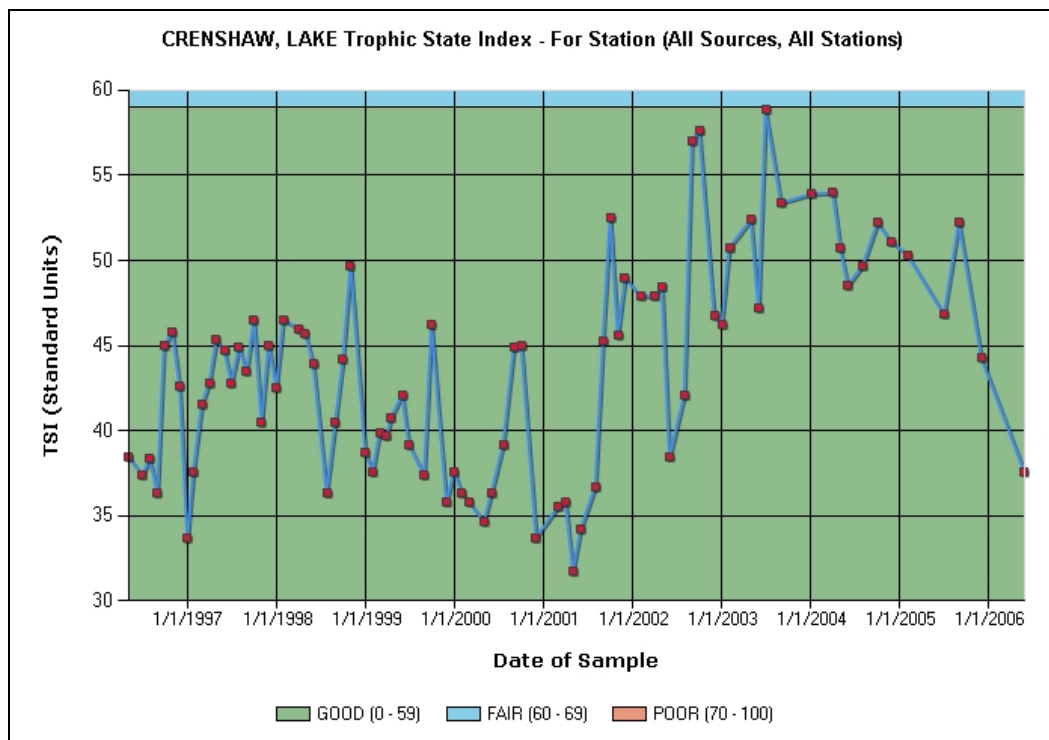
Figure 7. Recent Trophic State Index (TSI) graph from Hillsborough Watershed Atlas. For the latest date go to:

Note: The graph above includes benchmarks for using verbal descriptors of "good", "fair" and "poor". The verbal descriptors for these benchmarks are based on an early determination by stakeholders of the generally acceptable and understood terms for describing the state of lakes. The same benchmarks are used for nutrient graphs (Nitrogen and Phosphorus), chlorophyll graphs and trophic state index (TSI) graphs. The TSI is a calculated index of lake condition based on nutrient and chlorophyll (a) concentrations (please see "Learn more about Trophic State Index"). The benchmarks are established based on the TSI range that relates to a specific descriptor. The source for the TSI concentration relationships is the Florida Water Quality Assessment, 1996, 305(b) (Table 2-8).

useful when compared to the trend data available from LAKEWATCH or other sources. Table 8 contains the summary water quality data and index values and adjusted values calculated from these data. The total phosphorus (TP), total nitrogen (TN) and chlorophyll (a) water chemistry sample data are the results of chemical analysis of samples taken during the assessment and analyzed by the Hillsborough County Environmental Protection Commission laboratory. These data compare reasonably well with the mean data from the LAKEWATCH data set for the lake. The trophic state index (TSI) calculated from the sample data (45.75) is well within the values shown in the figure above.
