# **CEDAR COVE CANAL SEDIMENT ABATEMENT STUDY**

**Prepared for  
Sarasota County  
Water Resources**

**Prepared by  
Berryman & Henigar, Inc.  
1412 Tech Blvd  
Tampa, Florida 33619-7865**

**April 2005**

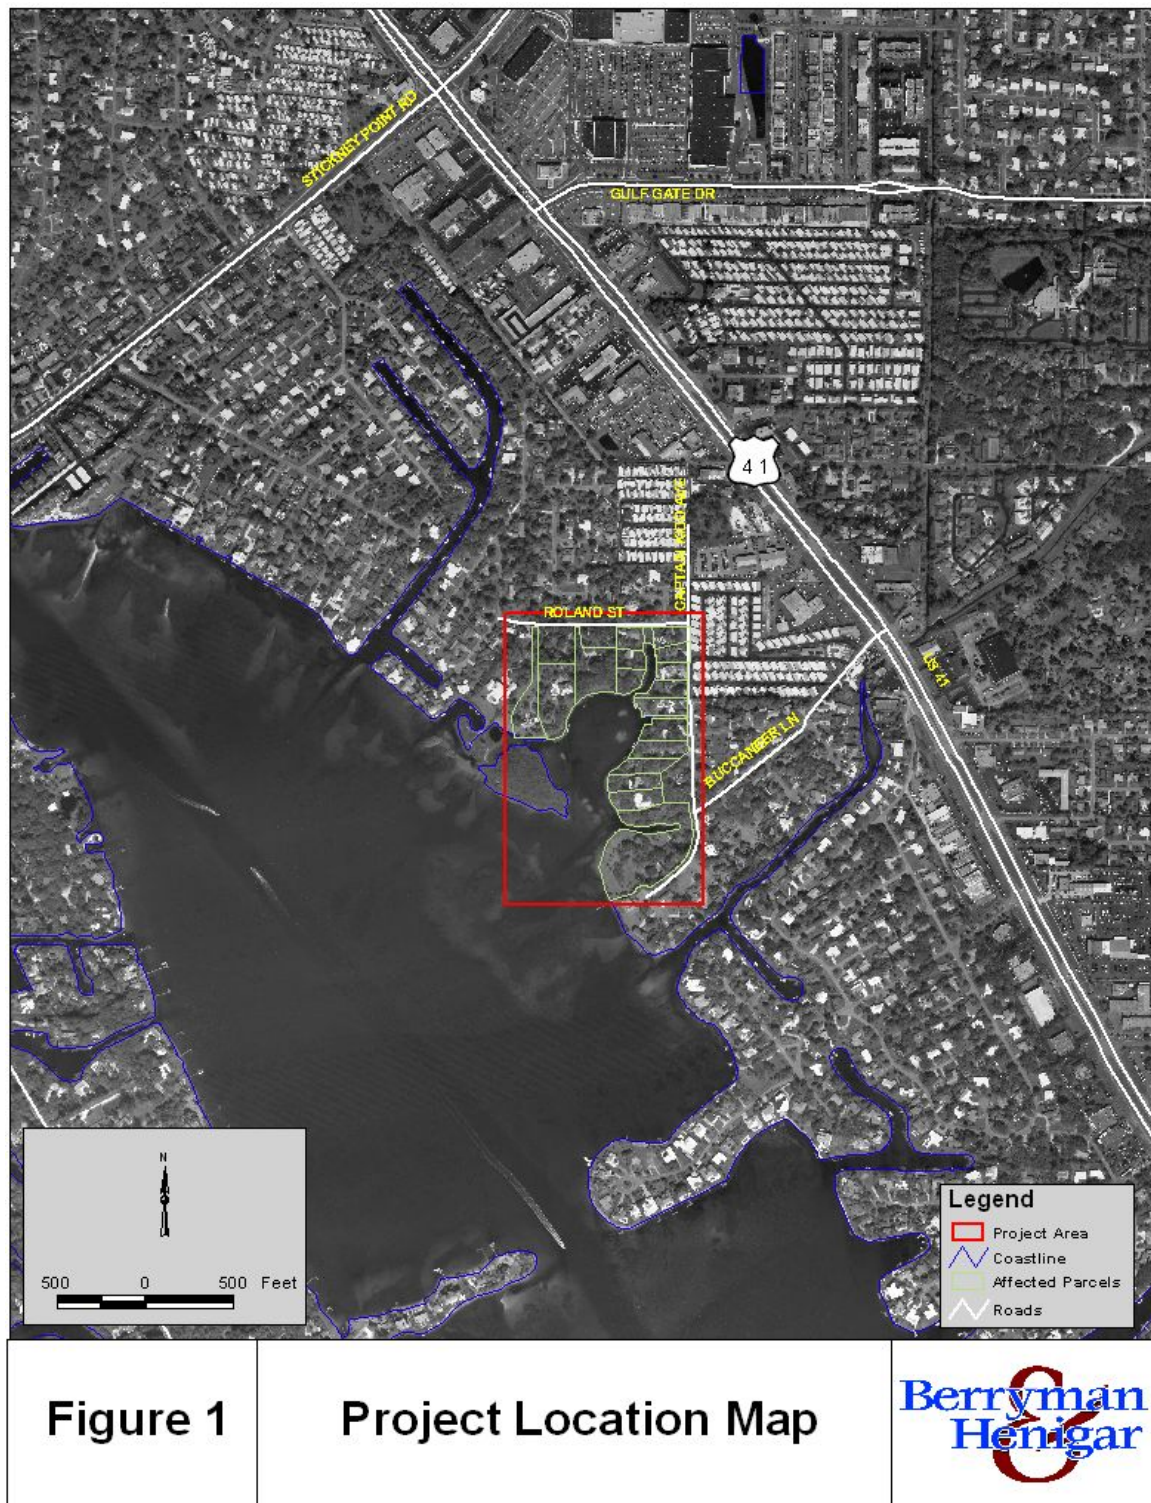
The drainage basin for the canal is generally bordered by 1<sup>st</sup> Street on the north, Matheny Creek on the south, US 41 on the east, and Baywood Way on the west. The overall drainage basin consists of almost 68 acres of low density residential, single family and multi family residential, commercial, and open space property. See Figure 2, which shows subbasins within the study area.

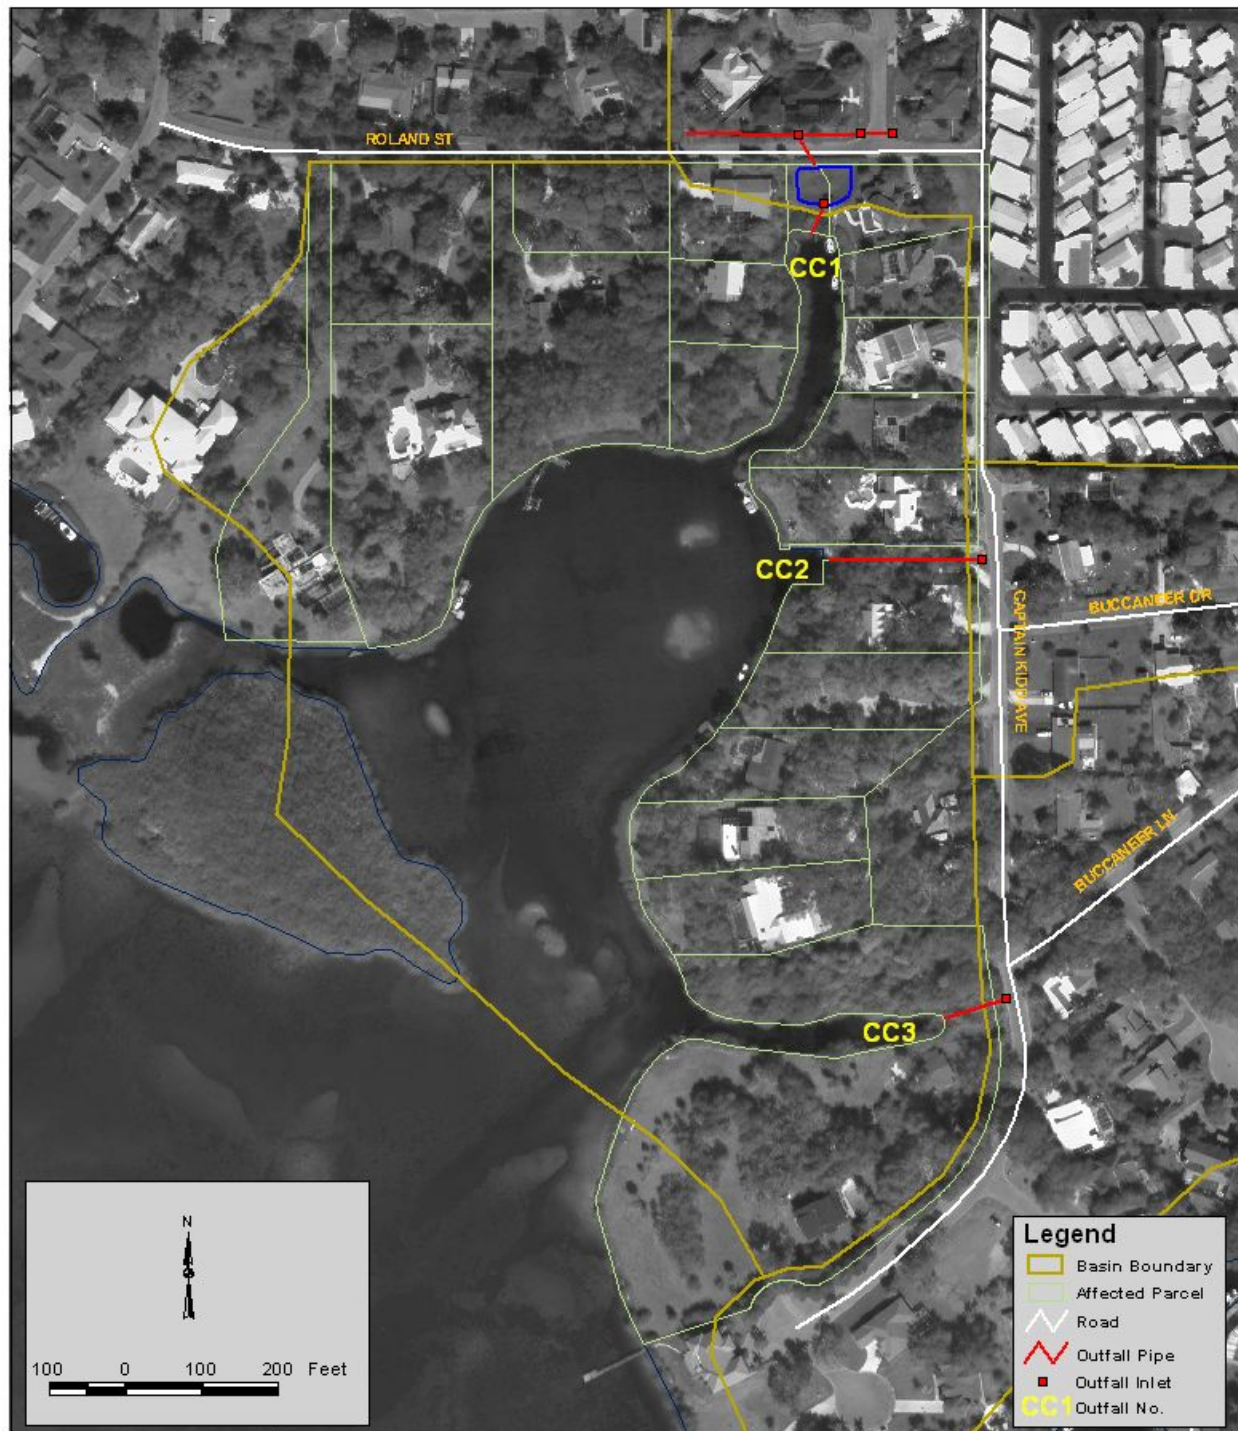
**Figure 3**

There are three stormwater pipes that discharge to the canal. The pipes are shown on the Existing Conditions Outfall Map, Figure 3. Each outfall is identified and discussed below.

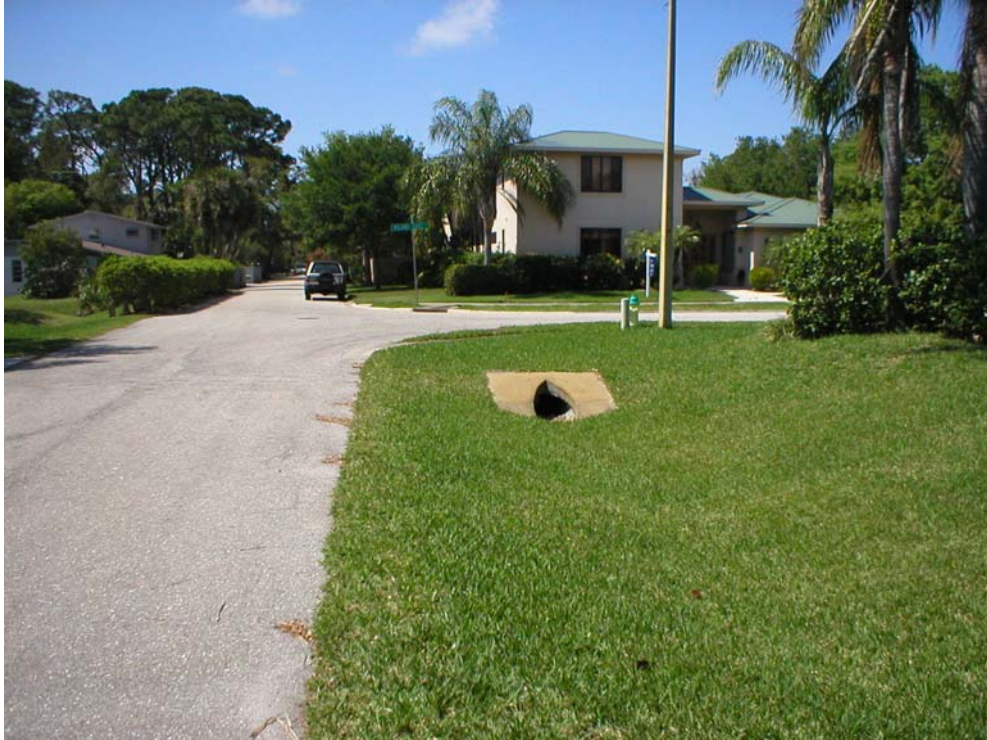
Outfall CC1 discharges through a series of inlets along Roland Street to the uppermost portion of the canal. This outfall serves the largest drainage basin discharging to the canal, and drains almost over 26 acres of commercial, low density and multi family residential property from a pond just south of Roland Street (Figures 4 to 6). The pipe discharges above the water line and there was no sediment build up observed at the outfall.

**Figure 4.**  
**Roland St. looking west in Basin B1. Note shallow swale.**

This is the largest drainage basin (B1) discharging to the canal and although it has a dry retention pond it does not provide adequate treatment for the basin. BHI recommends a series of BMPs due to the large drainage basin size. There are several vault types of BMPs available which are effective in removing sediment, but an enhanced nutrient separating baffle box just upstream of the dry retention pond is being recommended for this outfall. This BMP has an added benefit of reducing nutrient loads by trapping grass, leaves, and organic debris and keeping this material dry so that the nutrients do not leach out into the stormwater (BHI, 2004). Other vault-type BMPs do not have this feature. An added feature of using this second BMP is that it would help the County achieve nutrient reductions recommended for Sarasota Bay.

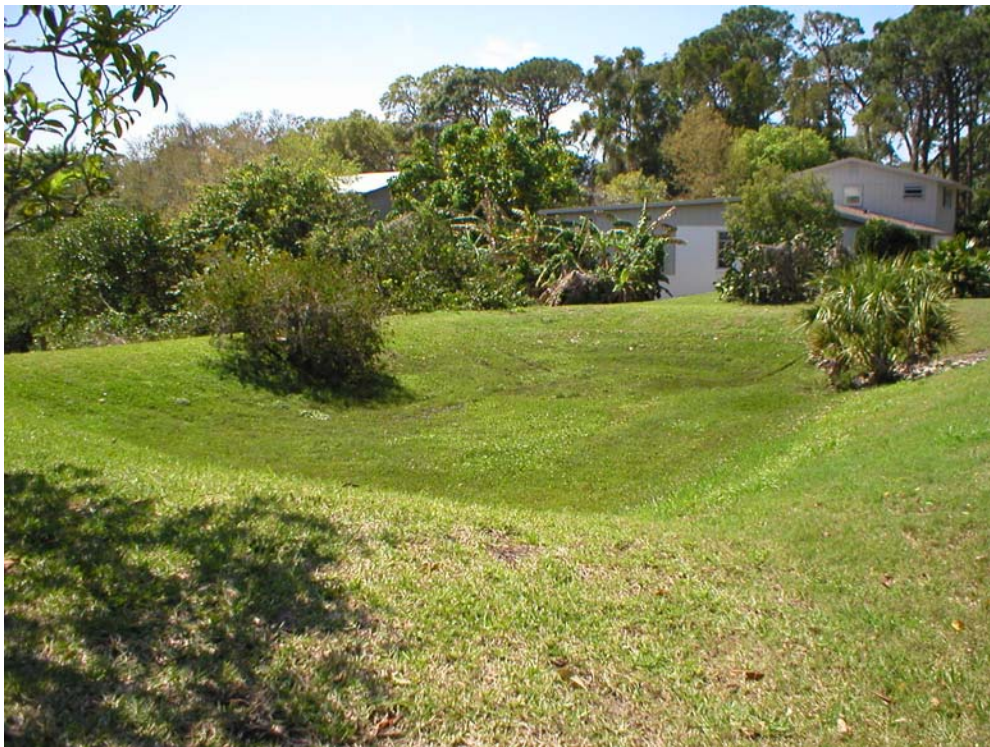
**Figure 5.**  
**Dry Retention Pond upstream of outfall CC1.**

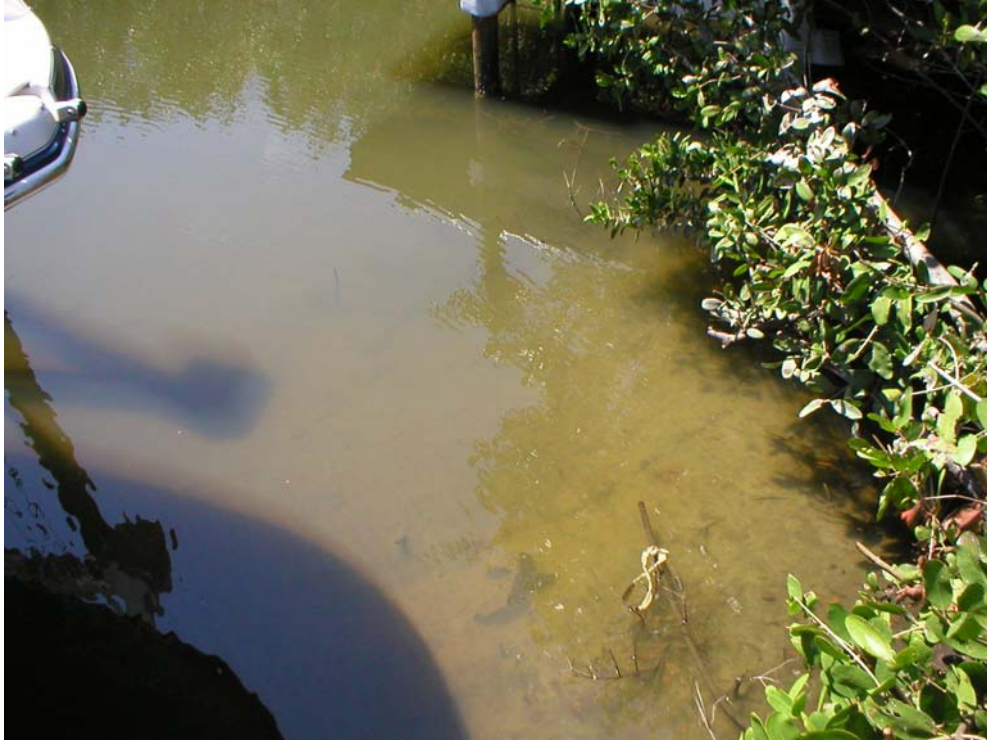
**Figure 6.**  
**Canal at outlet CC1.**

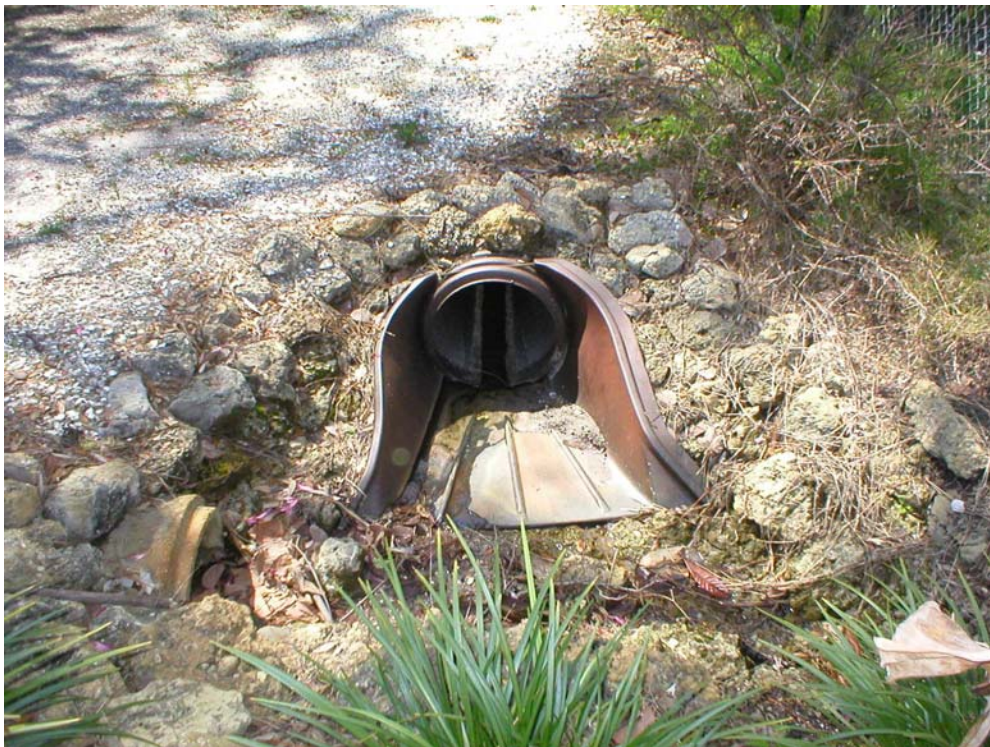
Outfall CC2 is a small pipe discharging to the middle portion of the canal. This pipe drains a little over 4 acres of low density, single family and multi family residential property along Buccaneer Drive and part of Captain Kidd Avenue (Figures 7 and 8). This drainage basin area has no stormwater treatment system. There was no sediment build up observed along the shoreline at this outfall.

**Figure 7.**  
**Outlet CC2 - mitered end on Captain Kidd Ave.**

Captain Kidd Avenue has a small pipe that drains to the middle portion of the canal through Outfall CC2. No new BMPs are recommended for this outfall because of the small basin size.

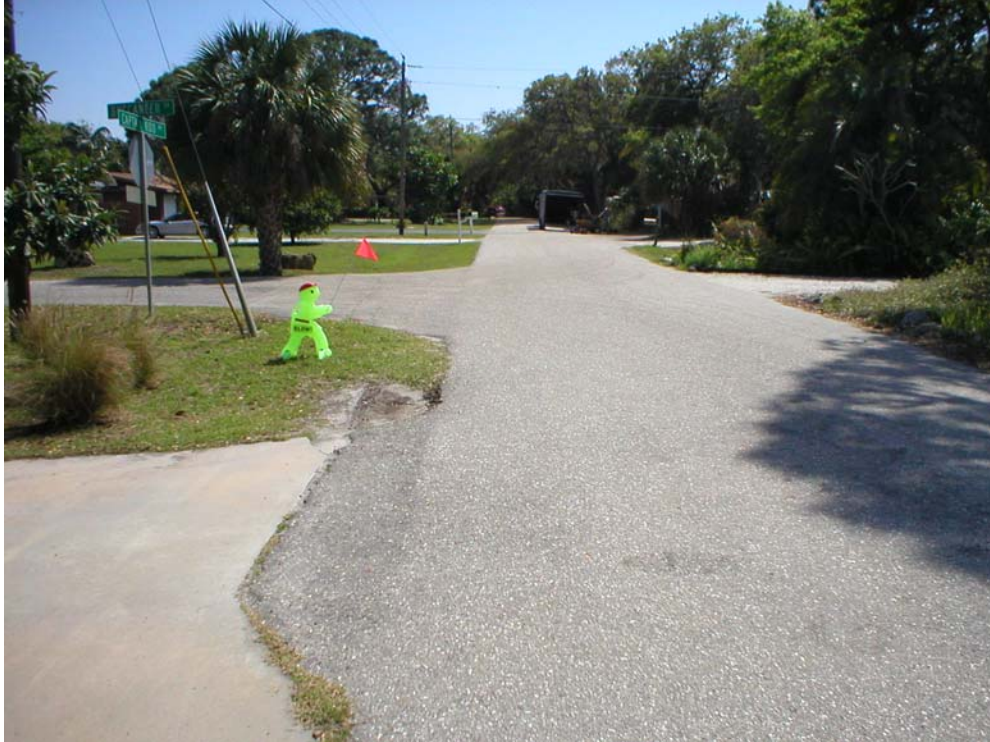
**Figure 8.**  
**Captain Kidd Ave. looking south in Basin B2.**

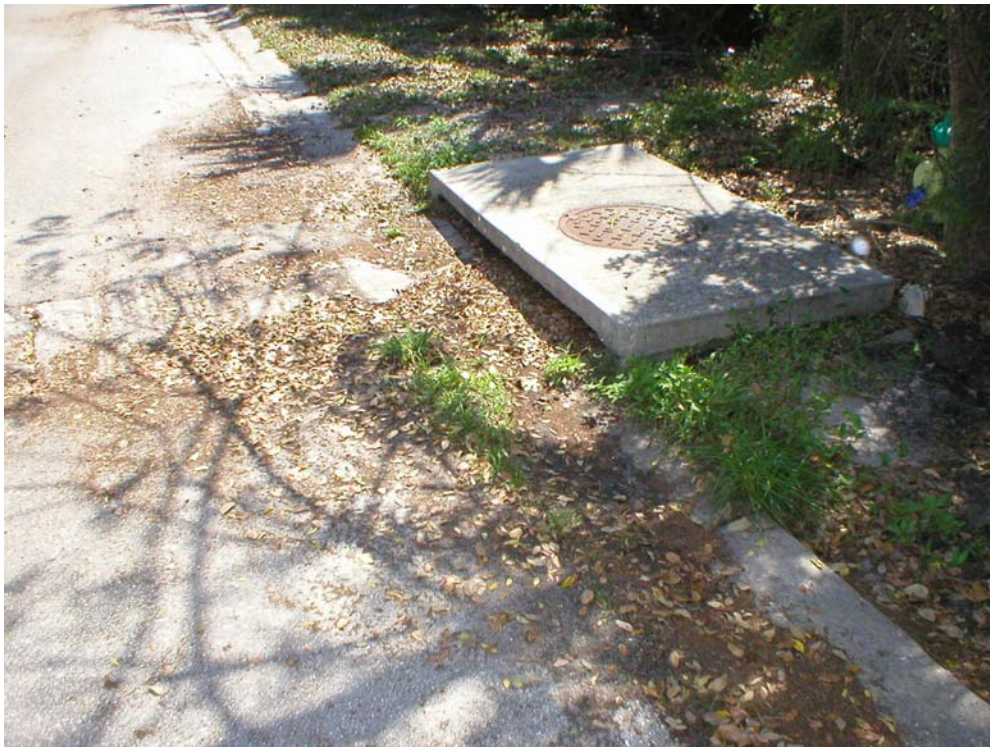
**Figure 9.**  
**CC3 - Inlet on west side of Captain Kidd Ave. in Basin B3. Note leaf loads.**

Outfall CC3 is a pipe discharging to the lower portion of the canal. This pipe drains 12.45 acres of low density and single family residential property into an inlet just south of the intersection of Buccaneer Lane and Captain Kidd Avenue (Figures 9 to 11). This drainage basin area has no stormwater treatment system. Sediment on the curb across the street from the inlet, and leaf loads around the inlet were found during the field visit. Sediment build-up along the shoreline at this outfall was not verified due to the lack of access to the outfall.

Just south of the intersection of Buccaneer Lane and Captain Kidd Avenue there is an inlet that drains to the lower portion of the canal through Outfall CC3. Sediment on the curb across the street from the inlet, and leaf loads around the inlet were found during the field visit. BHI recommends an inlet device to be installed for this outfall.

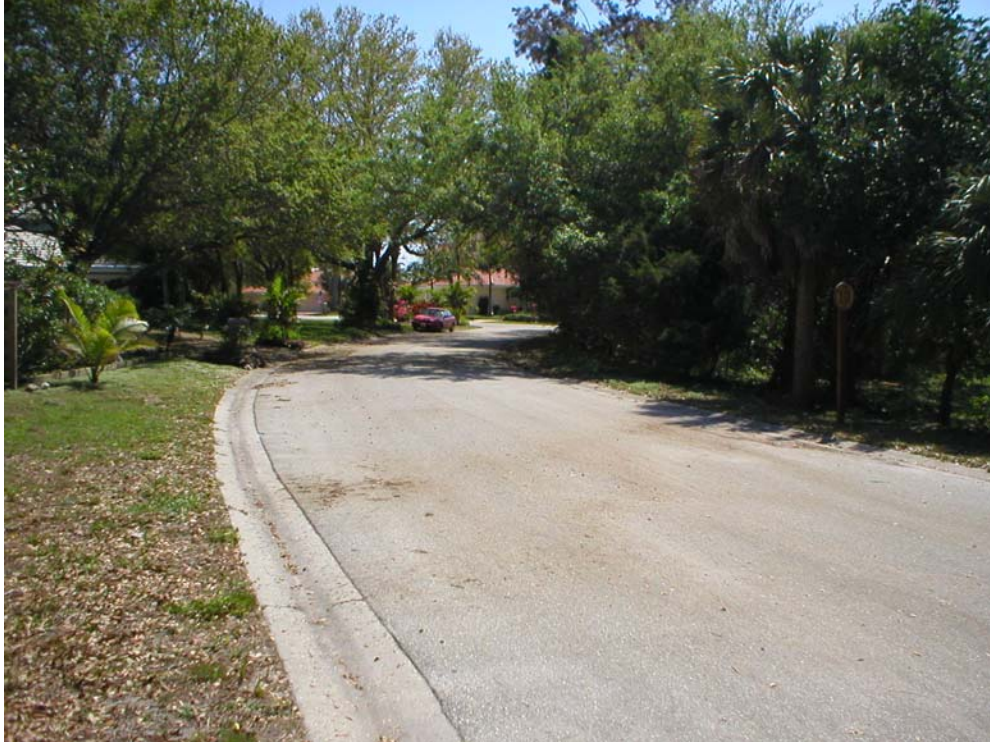
**Figure 10.**  
**Captain Kidd Ave. looking south in Basin B3.**

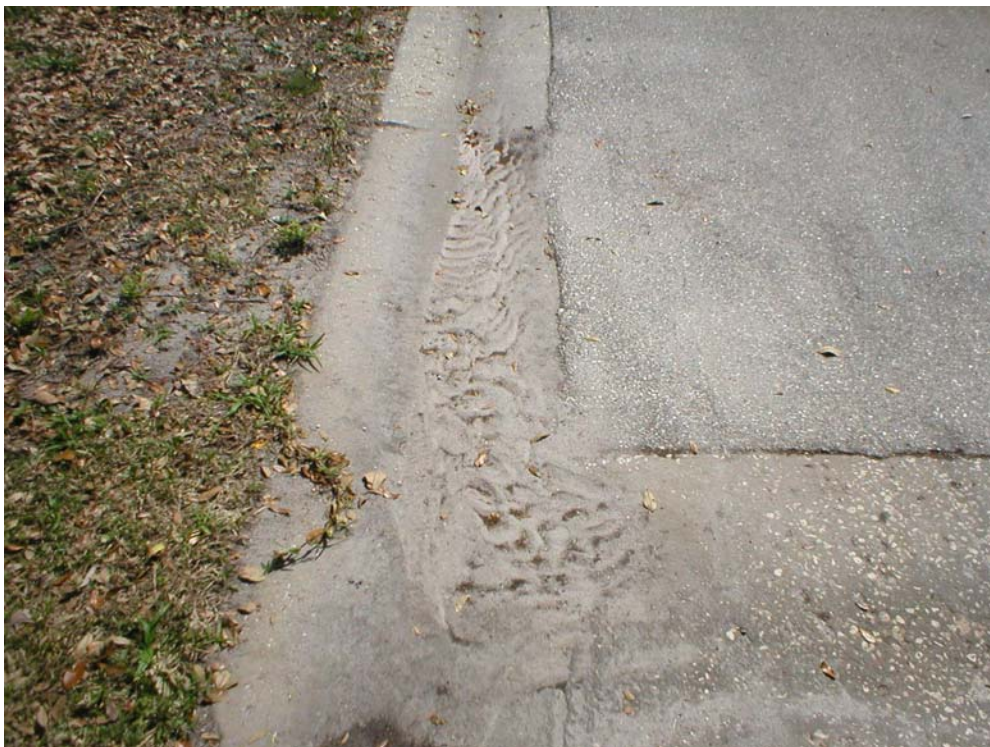
**Figure 11.**  
**Sediment on curb across the street of outlet CC3.**

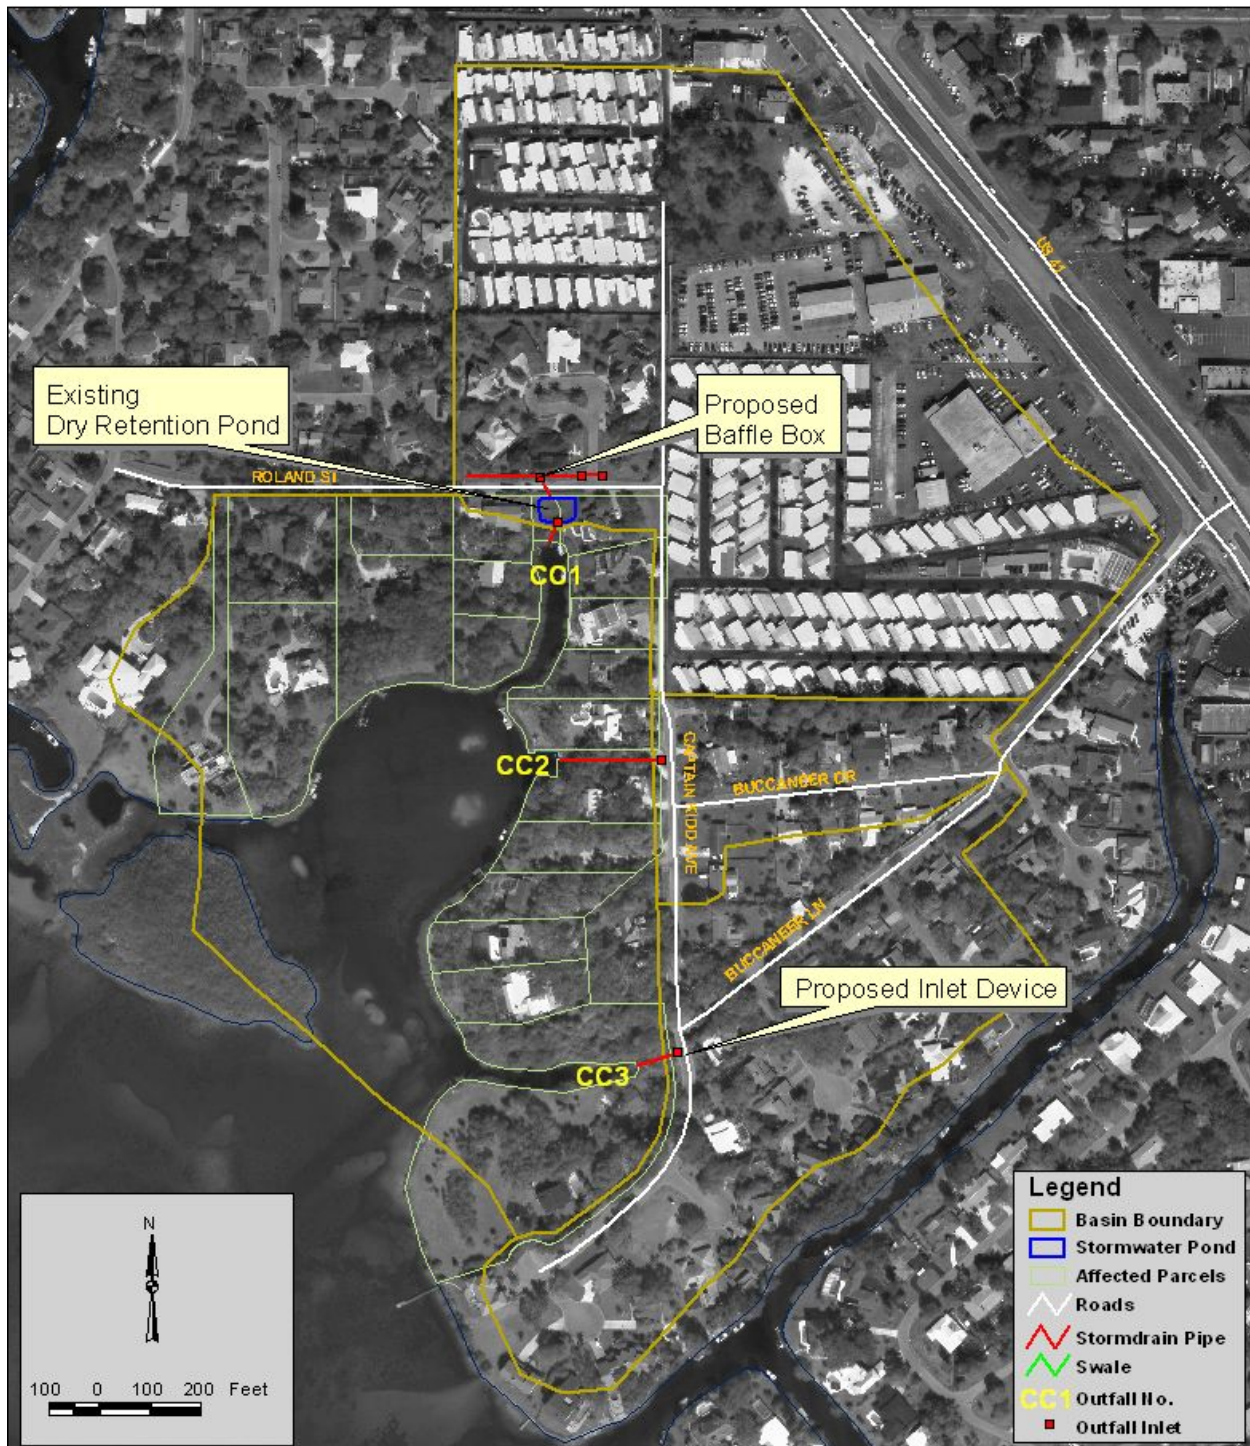
**Figure 12**

Most of the residential basins were small but had no treatment system in place. Recommendations are summarized in Figure 12.

## Recommended Sediment Abatement Facilities

There are three stormwater outfalls to the canal. Based on the field investigations and analysis in this report, it is recommended that one baffle box be constructed just upstream of the exiting dry retention pond at outfall CC1, and that an inlet device be installed at outfall CC3.
