Church Lake

LAKE HABITAT ASSESSMENT, LAKE VEGETATION INDEX, SUBMERGED
VEGETATION SURVEY AND WATER QUALITY

David Eilers, Karina Gonthier | USF Water Institute | August 14, 2023

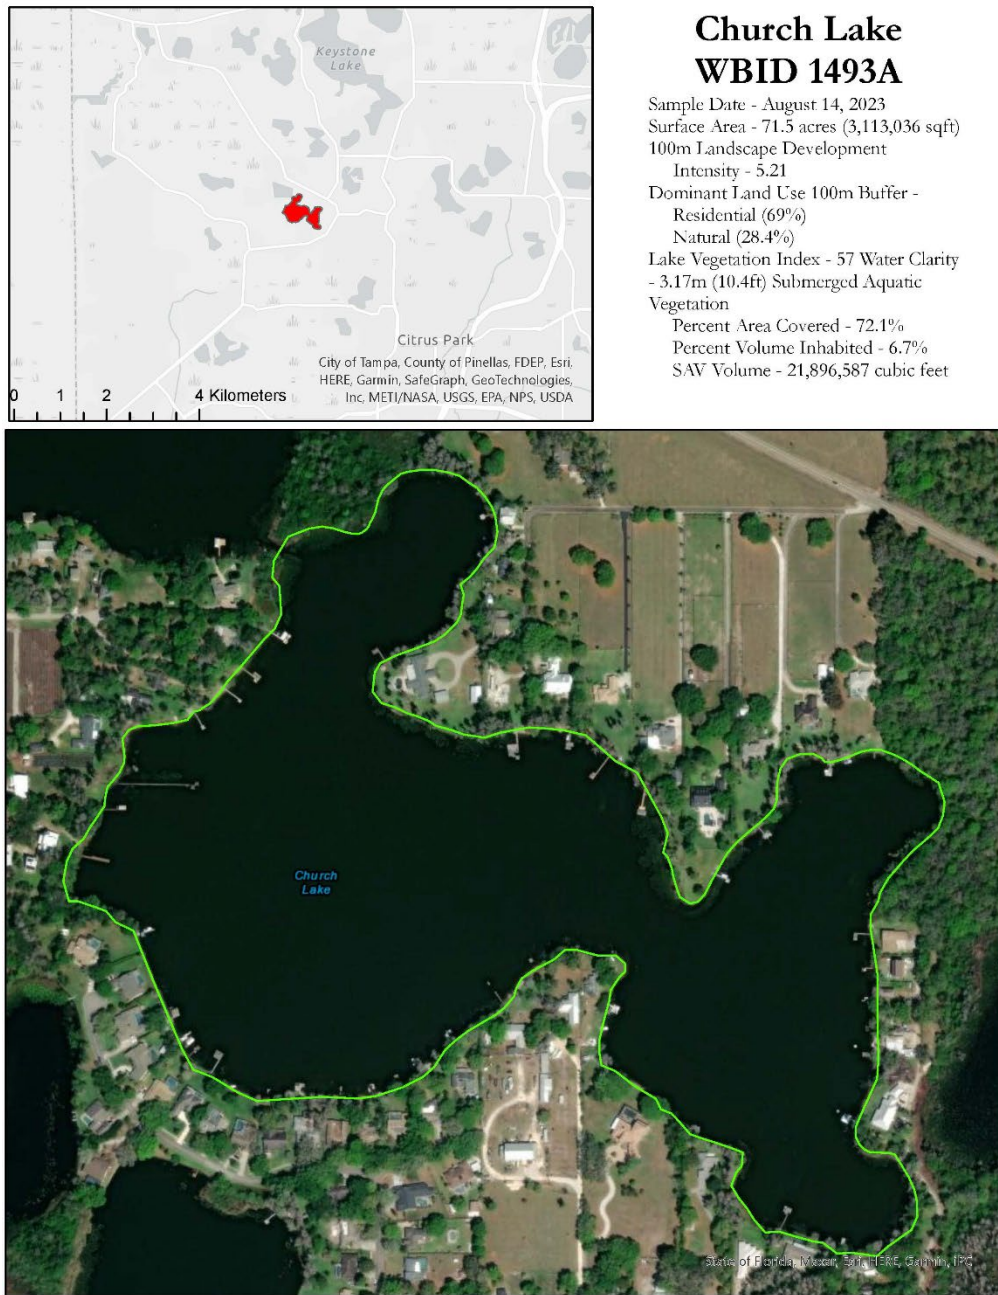
FIGURE 1: 2023 Church Lake ASSESSMENT STUDY AREA MAP

Church Lake is located in the Coastal Old Tampa Bay Watershed in north-western Hillsborough County, Florida. The Landscape Development Intensity Index of the 100 meter buffer around Church Lake is dominated by residential (69%) and natural (28.4%) land uses. The resulting LDI value for the 100 meter buffer around Church Lake is 5.21.

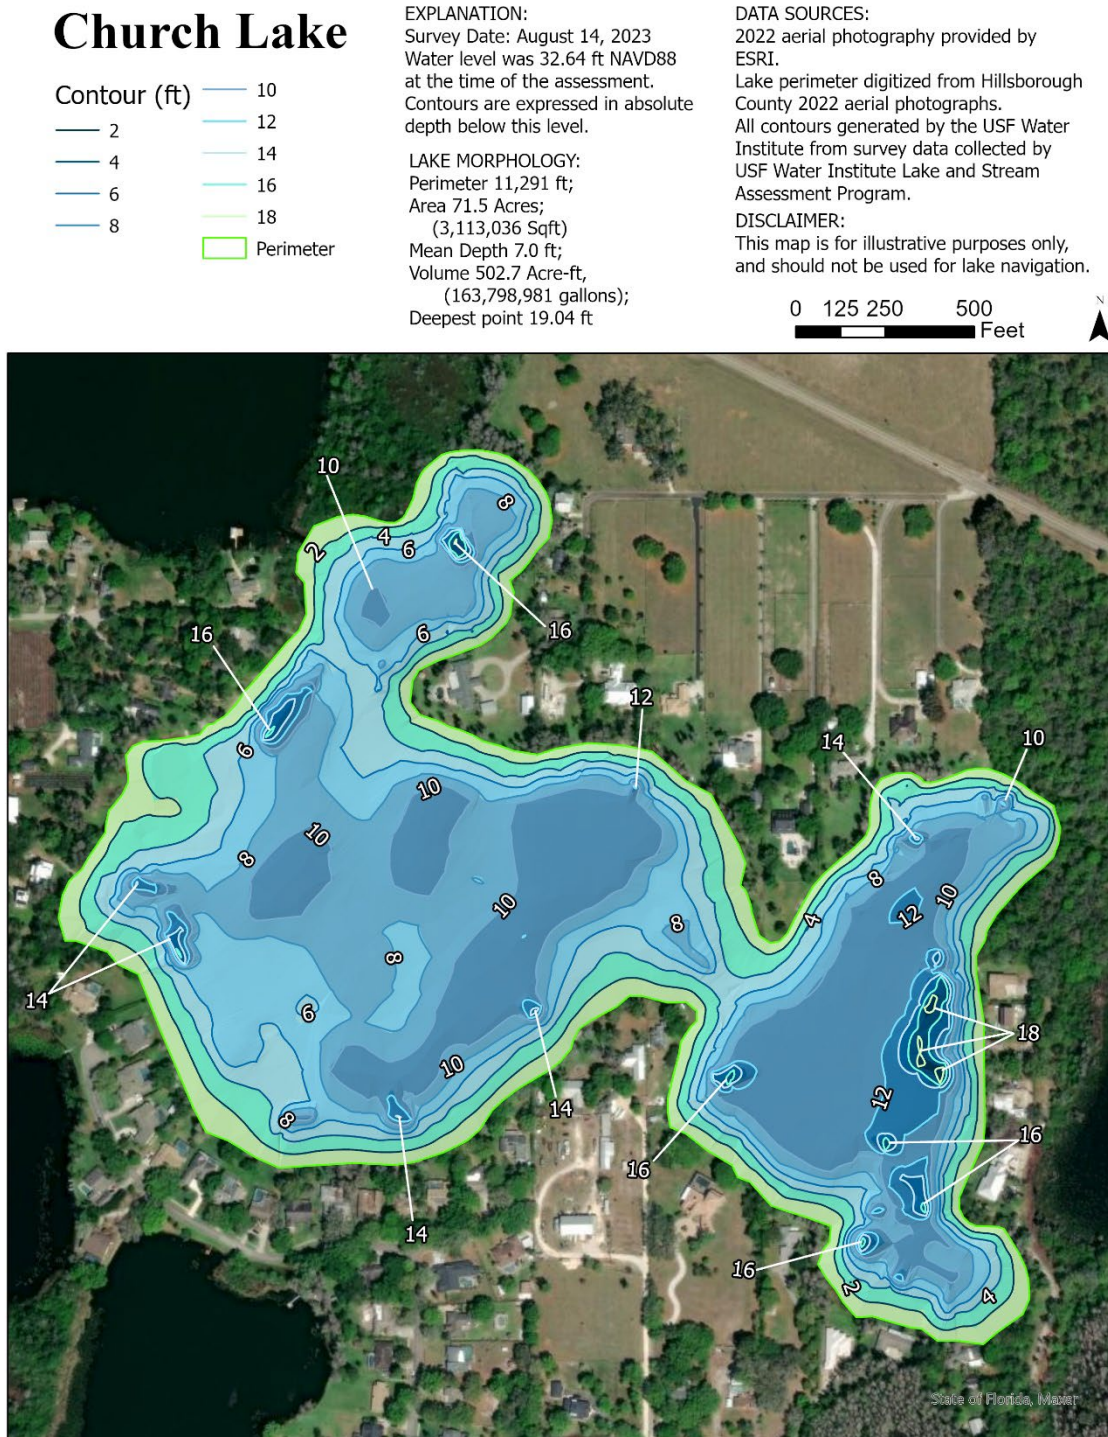
Figure 2: 2023 2-Foot Bathymetric Contour Map for Church Lake

At the time of the assessment, Church Lake was experiencing normal water levels (32.64 feet NAVD88 on staff gauge) resulting in a 71.5 acre water body. Church Lake at the time of the assessment had a mean water depth of 7.0 feet and a maximum observed depth of 19.04 feet. The volume at this time was approximately 163,798,981 gallons. Figure 2 shows the resulting bathymetric contour map for Church Lake from data collected on August 14, 2023. The collected data has been overlain the 2022 ESRI Basemap aerials.

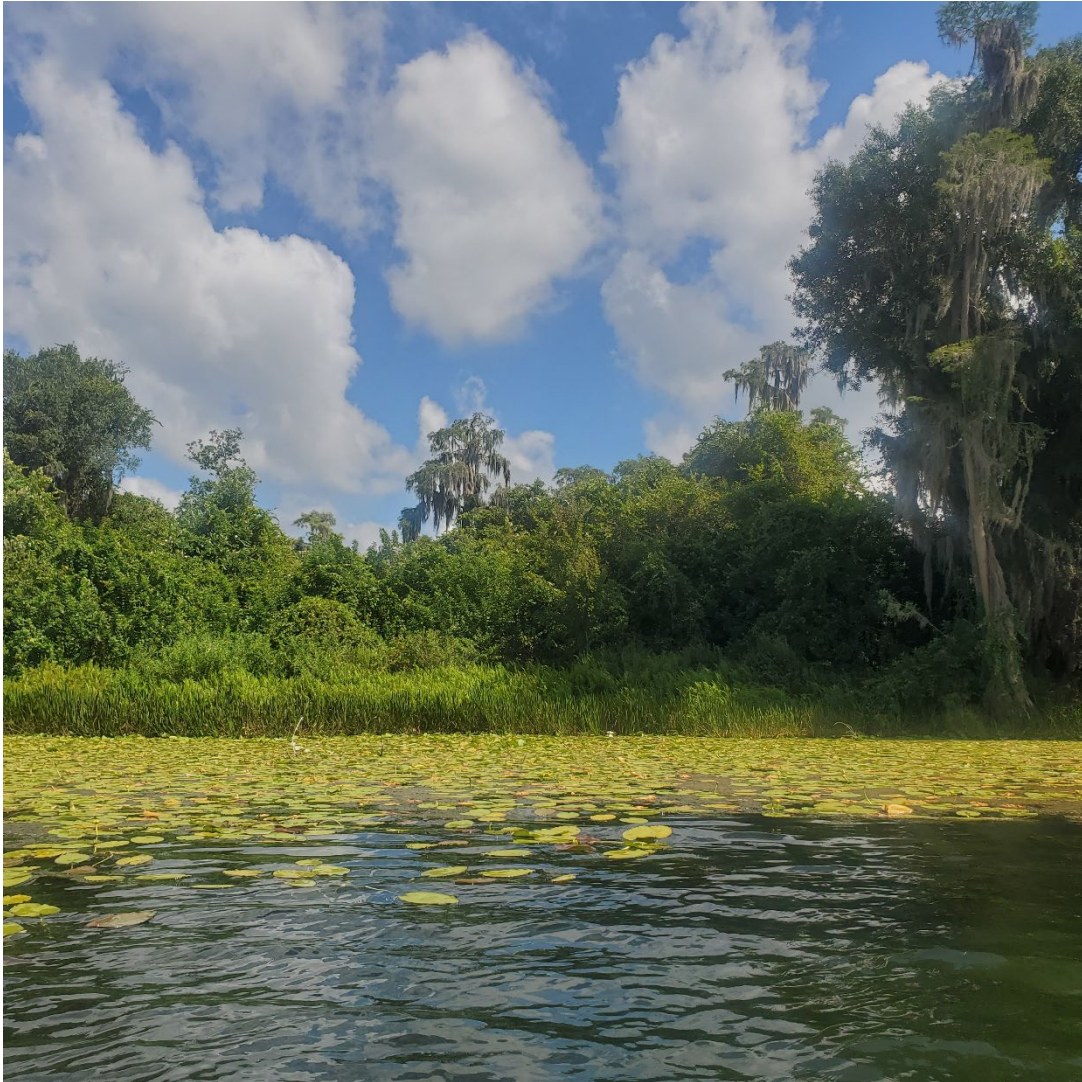
Figure 3 Overview photograph of Church Lake showing the undeveloped portion of shoreline along region 11 of the Lake Vegetation Index.

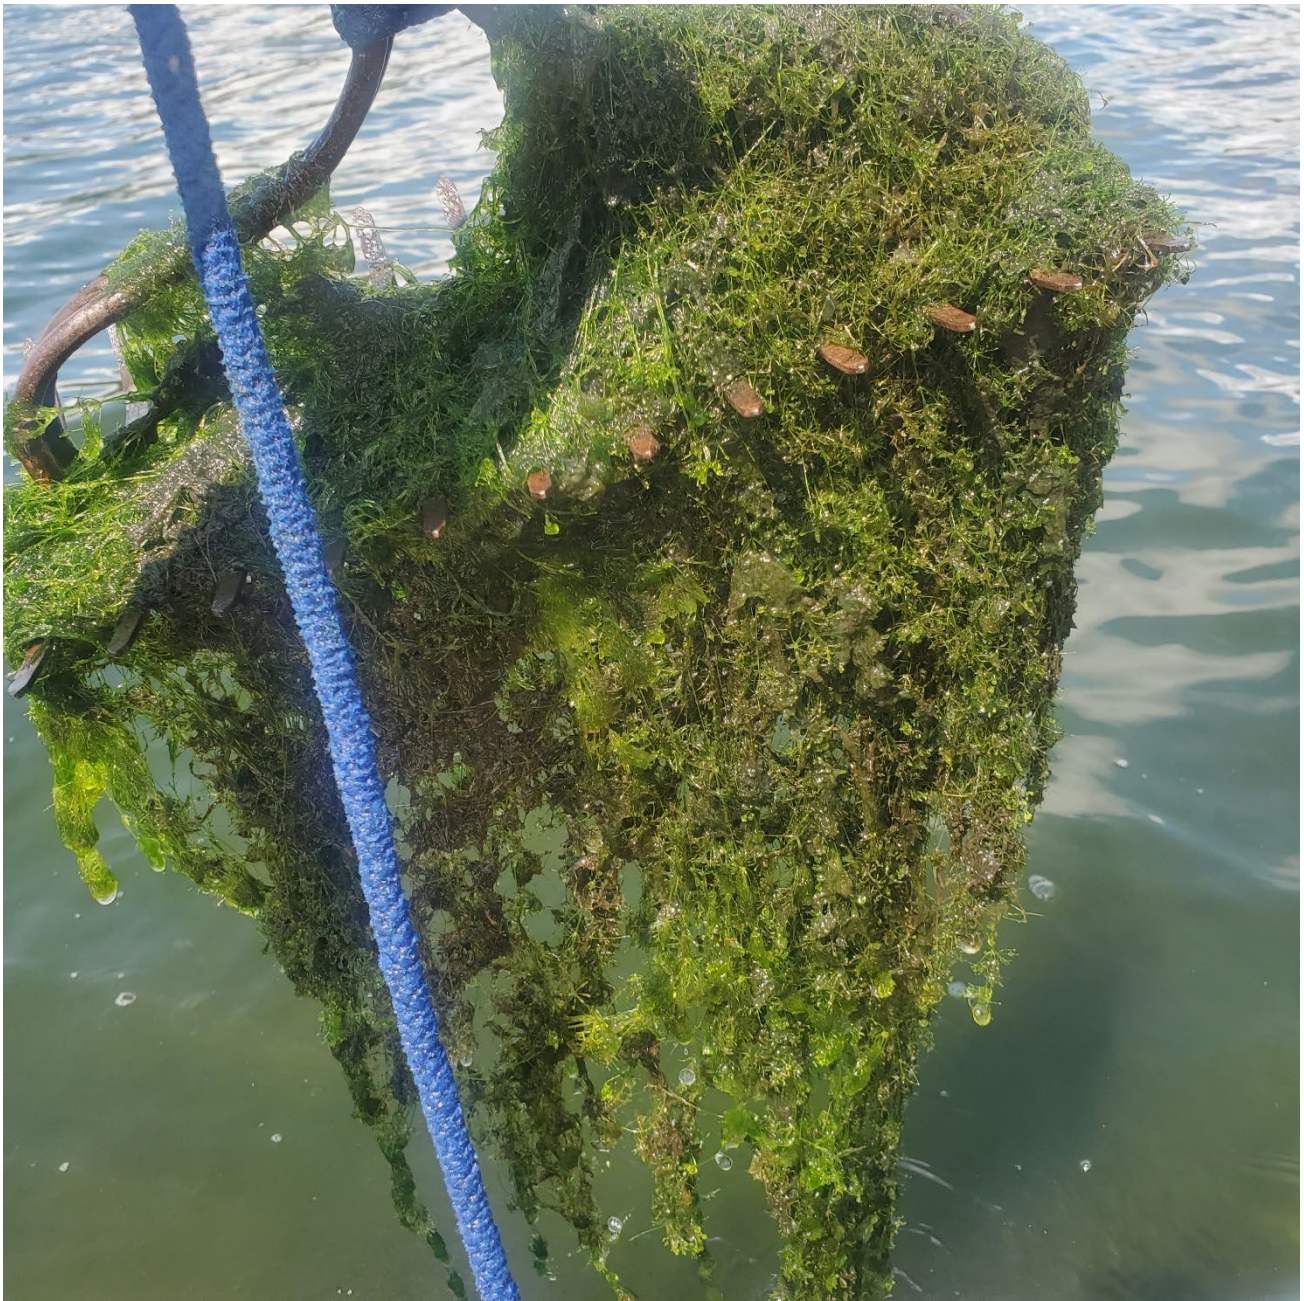
Figure 4 An abundant sample of Nitella from Church Lake. This species of macroalgae was dominant or codominant in all 4 regions of the LVI.

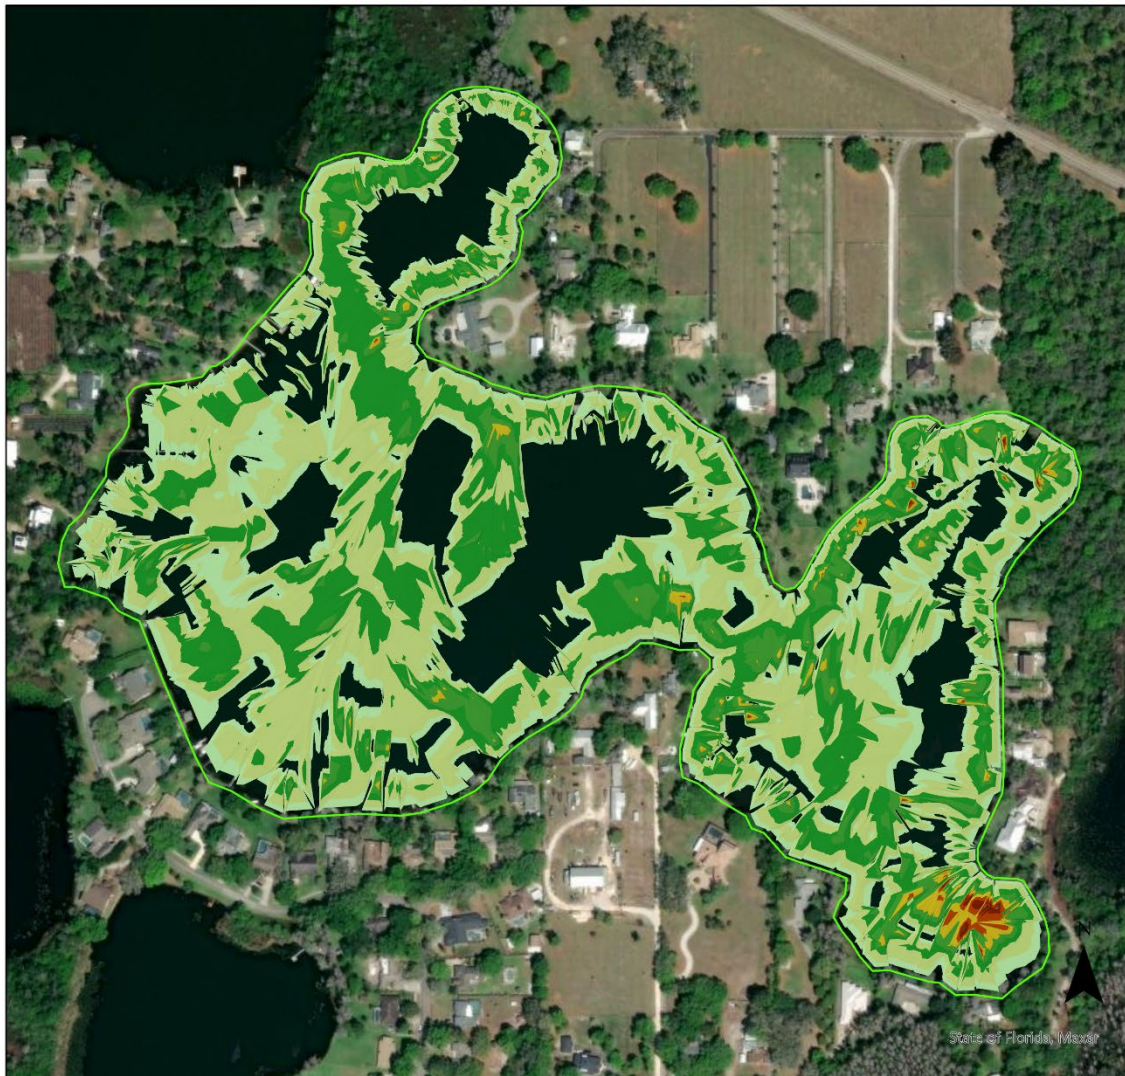
Figure 5 Church Lake Submerged Aquatic Vegetation Assessment Results

By analyzing the collected sonar chart, submerged aquatic vegetation potentially covered approximately 72.4% of the surface area of Church Lake. This submerged vegetation inhabits an estimated 6.72% of the water volume in Church Lake. Figure 5 shows the results of the SAV analysis indicating the location and height of SAV estimated from collected sonar readings.

Survey Date: August 14, 2023
Water level was 32.64 ft at the time of the assessment. Submerged Aquatic Vegetation was analyzed from collected sonar data. The height of the SAV where present is shown in 0.5 foot increments.

Area 2,245,721 square ft; 51.6 Acres;
(72.14% of Lake Surface Area)
Mean SAV Height 0.7 ft;
Volume 1,470,454 Cubic ft, (10,999,840 gallons);
(6.72% of Lakes Volume)

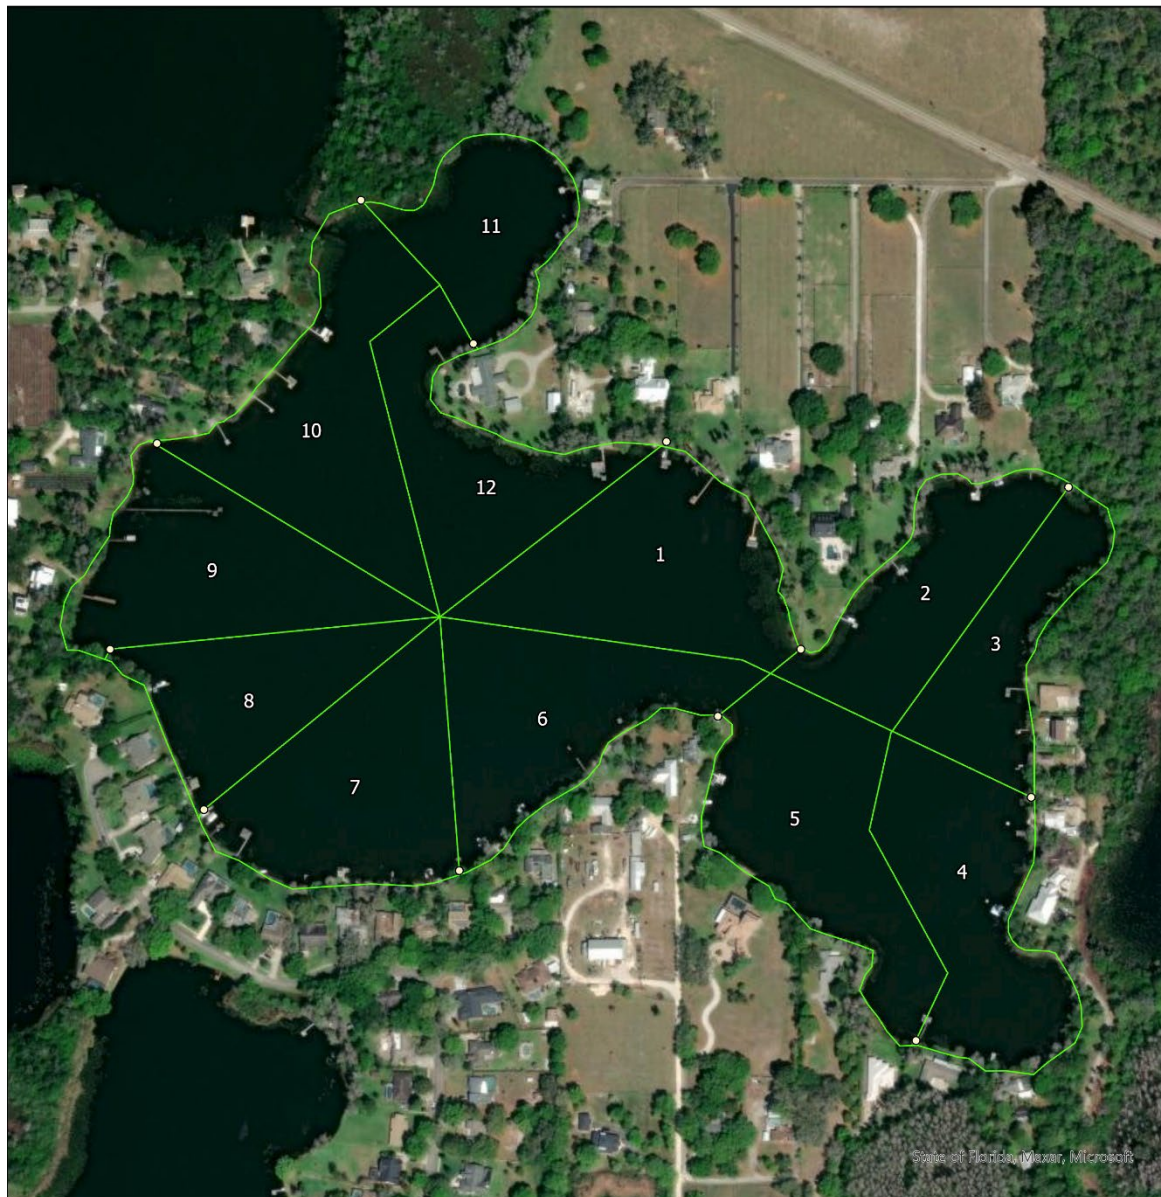
Figure 6: Lake Vegetation Index region map for Church Lake

The calculated LVI score for Church Lake was 57, above the impairment threshold of 43 indicating the vegetation community is showing evidence of being “Healthy”. Figure 6 shows the map of Church Lake detailing the LVI regions used for the assessment (Regions 2, 5, 8, 11). Table 2 details the species list results of the Lake Vegetation Index. Table 3 details the scoring result for the Lake Vegetation Index.

Sample Date - August 14, 2023
Regions Assessed - 2, 5, 8, 11
Dominant Species per Region -
2 - *Najas guadalupensis*,
Nitella
5 - *Najas guadalupensis*,
Nitella
8 - Nitella
11 - *Najas guadalupensis*,
Nitella

Lake Description
Water Clarity - 3.17 m (10.4 ft)
Color - Clear
Sediment Types - Sandy, CPOM,
Vegetated
Lake Vegetation Index - 57
