Cooper Lake

LAKE HABITAT ASSESSMENT, LAKE VEGETATION INDEX, SUBMERGED
VEGETATION SURVEY AND WATER QUALITY

David Eilers, Karina Gonthier | USF Water Institute | June 22, 2023

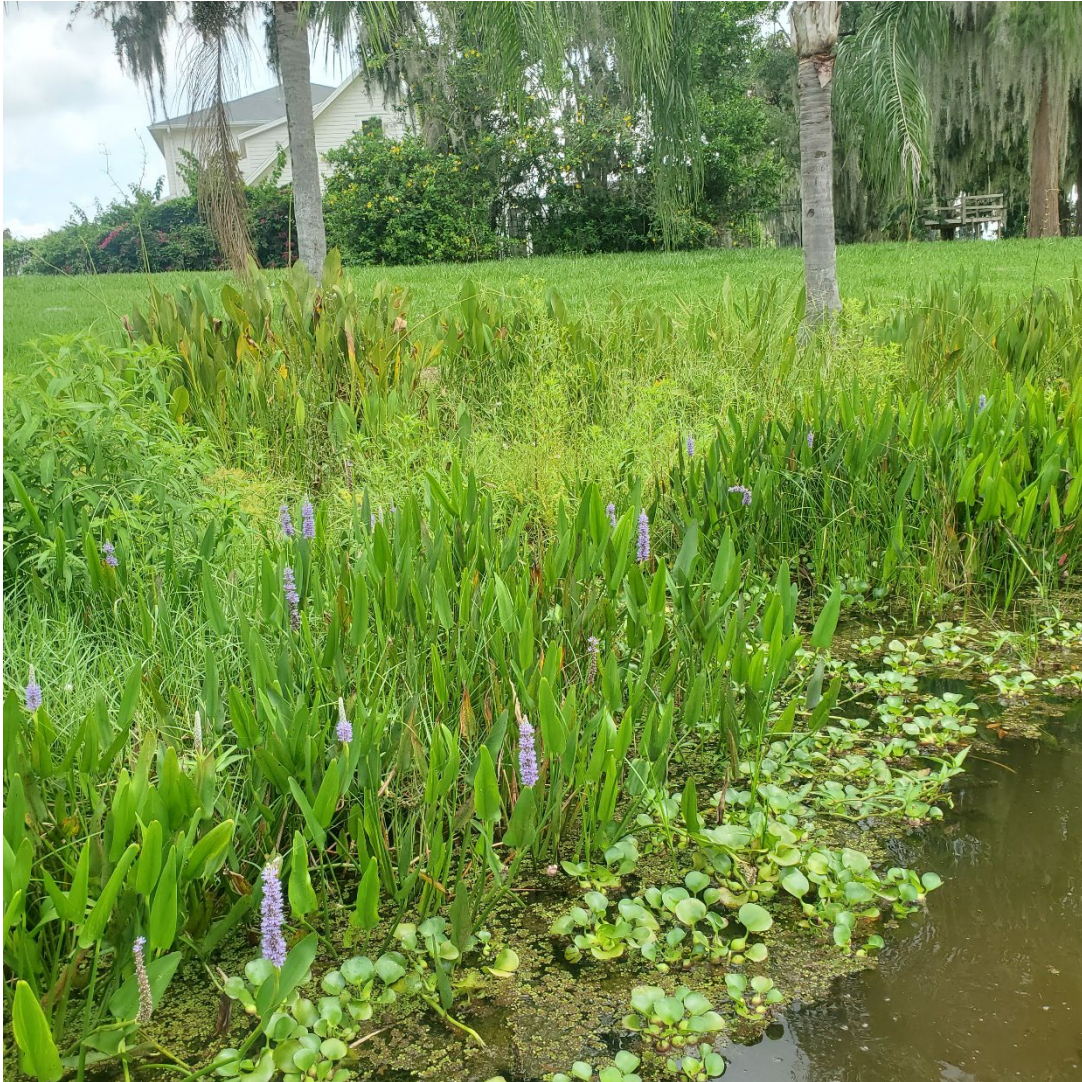
Figure 3 Overview photograph of Cooper Lake showing the typical residential portion of shoreline along region 2 of the Lake Vegetation Index.

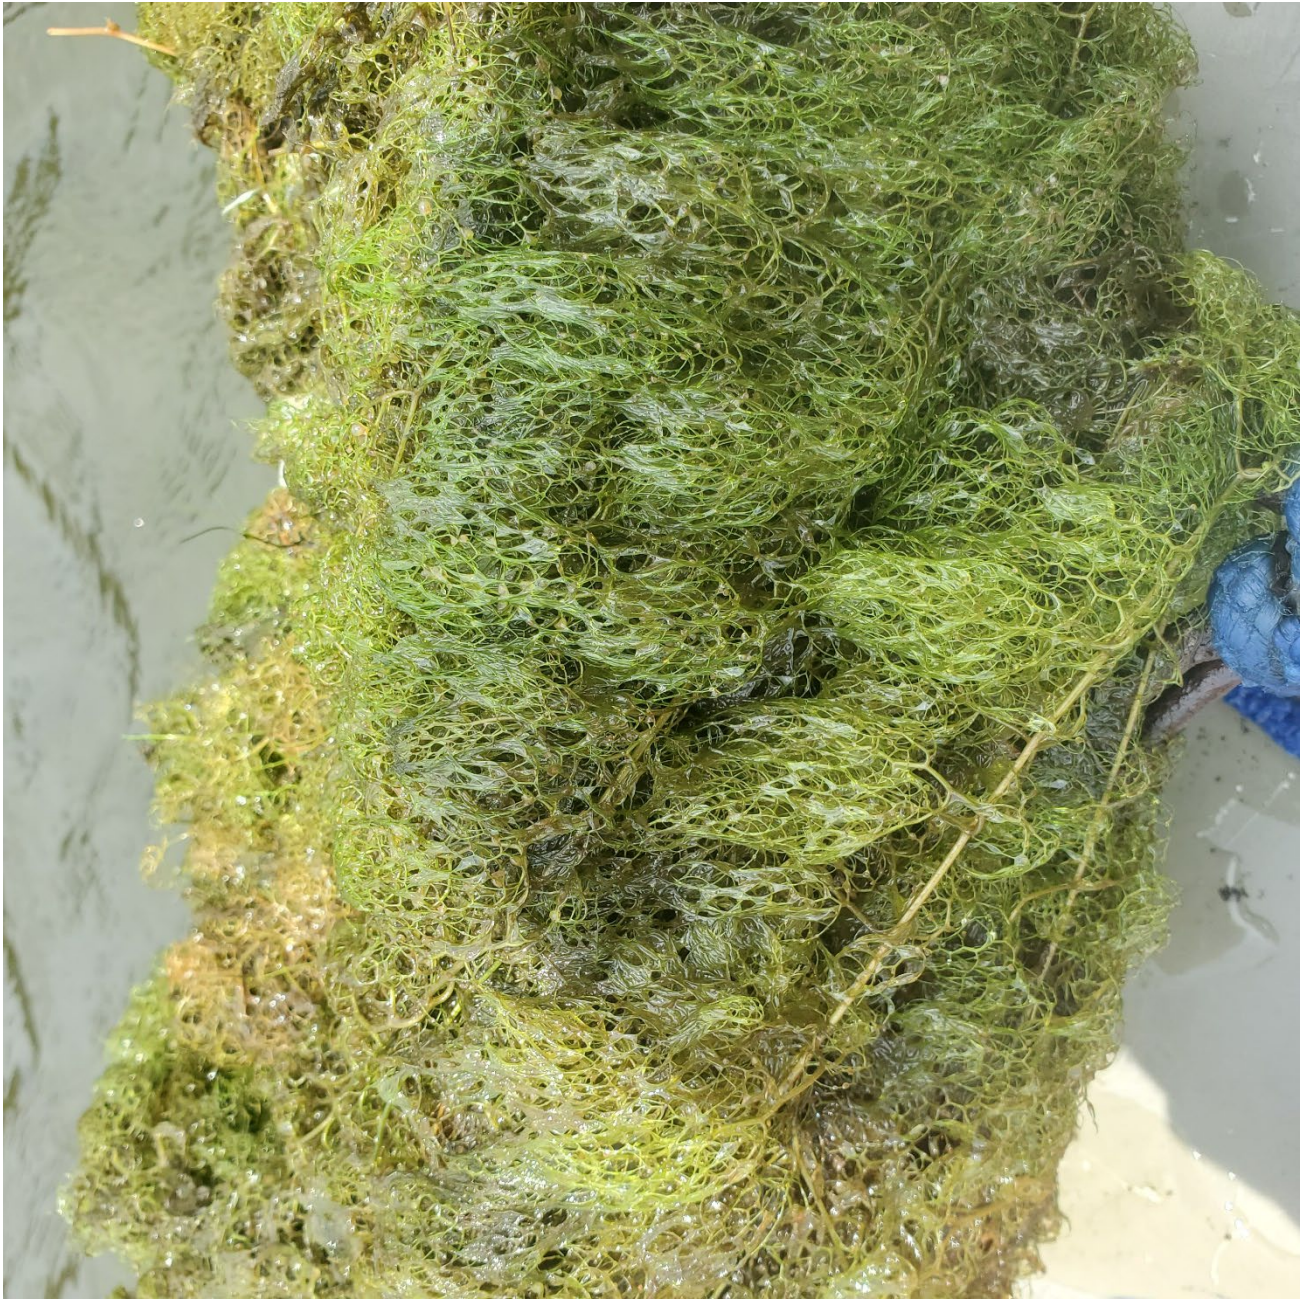
Figure 4 Utricularia inflata was co-dominant in region 8 and dominant in regions 5 and 11 of the Lake Vegetation Index

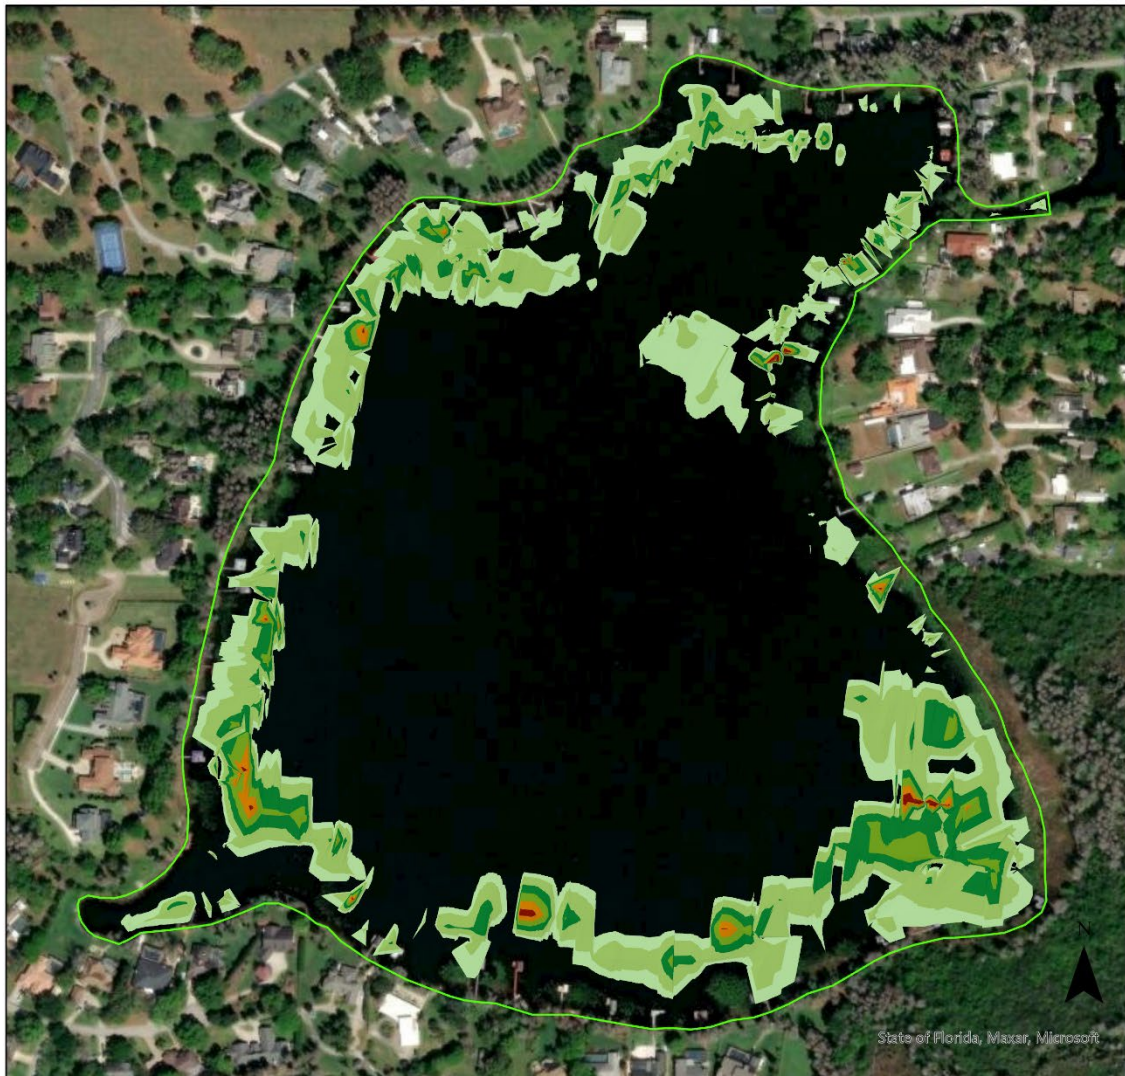
Figure 5 Cooper Lake Submerged Aquatic Vegetation Assessment Results

By analyzing the collected sonar chart, submerged aquatic vegetation potentially covered approximately 23.94% of the surface area of Cooper Lake. This submerged vegetation inhabits an estimated 1.32% of the water volume in Cooper Lake. Figure 5 shows the results of the SAV analysis indicating the location and height of SAV estimated from collected sonar readings.

Survey Date: June 22, 2023
Water level was 57.96 ft
at the time of the assessment.
Submerged Aquatic Vegetation was
analyzed from collected sonar data.
The height of the SAV where present
is shown in 0.5 foot increments.

Area 822,039 square ft; 18.9 Acres;
(23.94% of Lake Surface Area)
Mean SAV Height 0.5 ft;
Volume 390,357 Cubic ft, (2,920,095
gallons);
(1.32% of Lakes Volume)

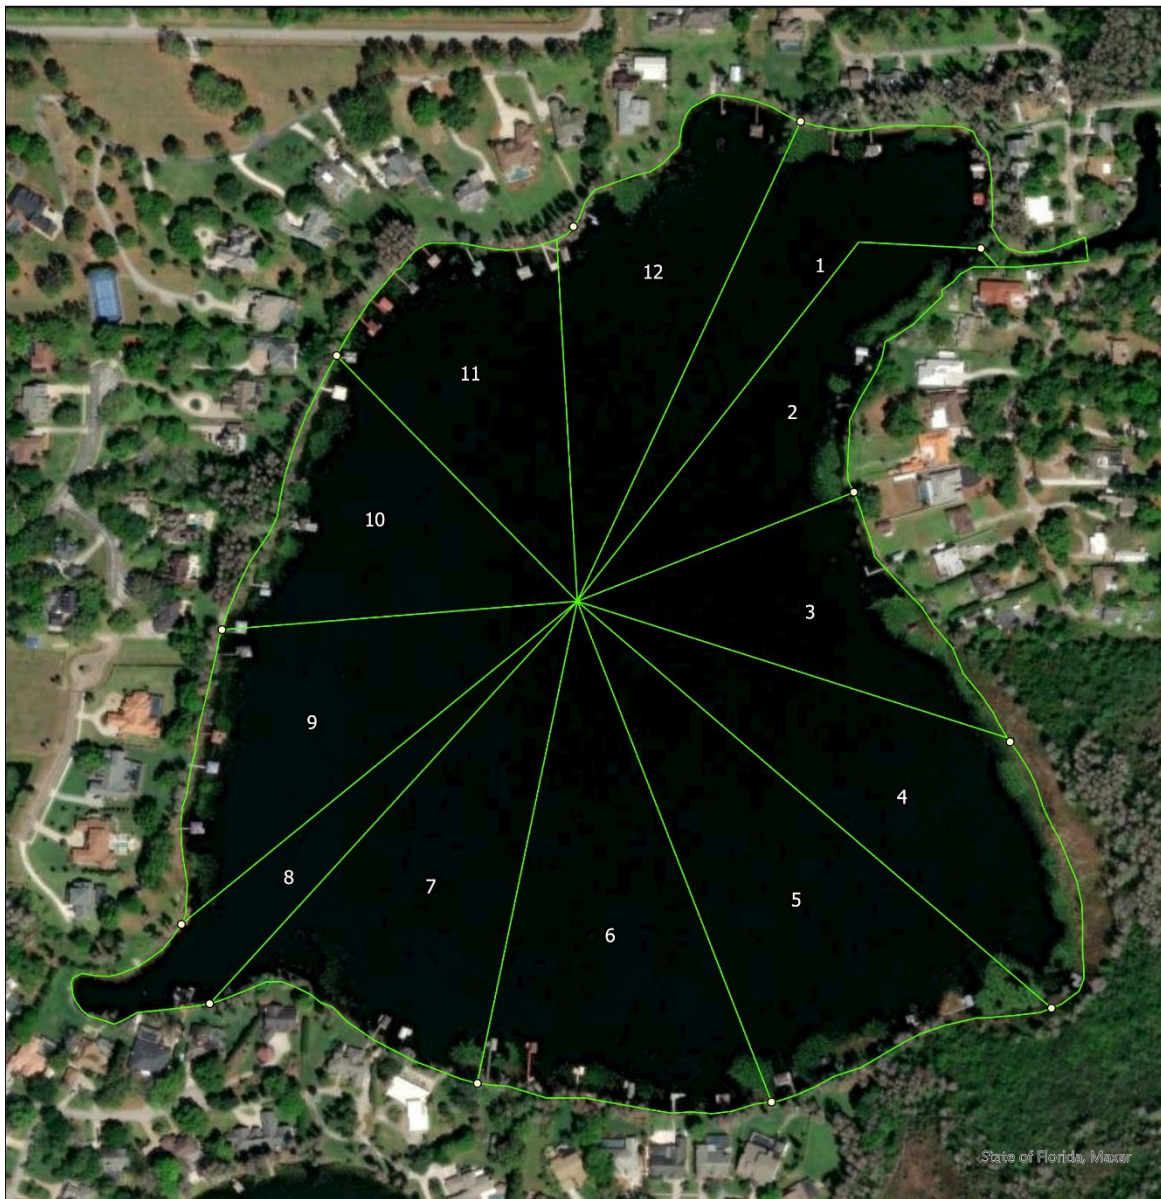
Figure 6: Lake Vegetation Index region map for Cooper Lake

The calculated LVI score for Cooper Lake was 60, above the impairment threshold of 43 indicating the vegetation community is showing evidence of being “Healthy”. Figure 6 shows the map of Cooper Lake detailing the LVI regions used for the assessment (Regions 2, 5, 8, 11). Table 2 details the species list results of the Lake Vegetation Index. Table 3 details the scoring result for the Lake Vegetation Index.

Sample Date - June 22, 2023
Regions Assessed - 2, 5, 8, 11
Dominant Species per Region -
2 - *Najas guadalupensis*,
Nymphaea odorata
5 - *Utricularia inflata*
8 - *Chara*,
Utricularia inflata
11 - *Utricularia inflata*

Lake Description
Water Clarity - 1.2 m (3.8 ft)
Color - Turbid, Tannic
Sediment Types - Sandy, CPOM,
Vegetated
Lake Vegetation Index - 60
