**Subject**            **Crescent Lake Management Plan**

**Attention**        City of St. Petersburg

**From**             Jacobs Engineering Group, Inc.

**Date**             January 31, 2020

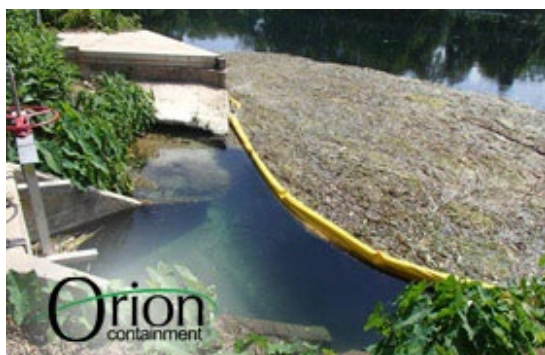
**Example of Litter Collection System Containing Debris**  
**Source: Orion Containment 2019**

Most debris and nutrients enter Crescent Lake through stormwater inlets. To reduce the trash and nutrient input, it is recommended that the City apply a two-step inlet pollutant removal system approach. The first step applies a floating litter collection system. This system uses flotation devices, or pipe traps, coupled together to contain any floating trash from floating into Crescent Lake. To prevent smaller or submerged litter from entering the lake, the collection systems include an aluminum mesh skirt that attaches to the bottom side of the floating devices and is draped down using weights to ensure the skirt cleans the desired water column. The litter collection system is then manually cleaned as needed. The recommended orientation of the floating litter collection system (Figure 17) allows for proper interception of trash from the inlets while providing an ability to reach the flotation devices to clean out the litter collection system. There are many different manufacturers of litter collection systems including Watergoat, Elastec Trash and Debris Booms, Bandalong Boom Systems, and Orion Floating Debris Booms (pictured below) each with unique adaptations of the litter collection system that can be adapted to the needs of Crescent Lake. Education programs can be started around the litter collection system to increase awareness of the community to the different types of trash and volume of trash that enters the waterways.

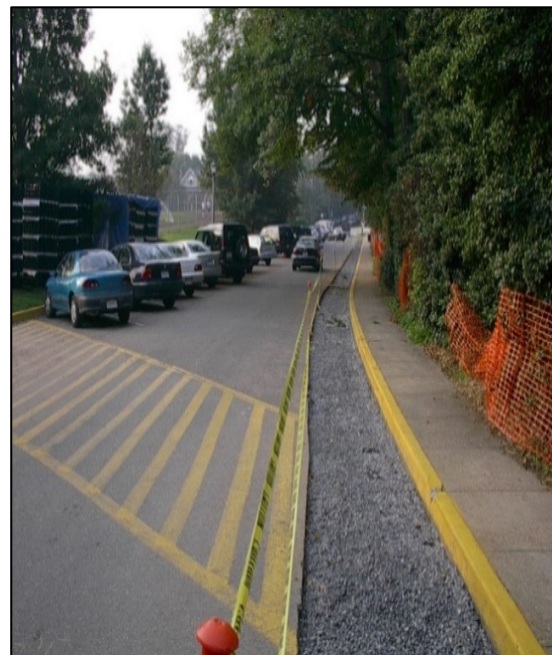
Infiltration trenches are channels or depressed areas with side slopes filled with vegetation or gravel that intercept runoff from upslope impervious areas. Infiltration trenches are similar in function to bioretention facilities but differ in their placement and appearance. Bioretention facilities are open to the surface while infiltration trenches are typically underneath an impervious surface with a surface inlet to allow the runoff to enter the trench. Infiltration trenches provide storage capacity during rainfall and allow the captured stormwater to infiltrate into the native subgrade soil below. Trenches are typically filled with an appropriate, clean, uniformly graded aggregate that provides adequate void spaces to store and filter stormwater prior to infiltration. Trenches can also include sand based structural soil to provide support under pavements while continuing to allow optimal storage capacity and rooting volume for trees. Alternatively, there are various manufactured storage media units that can be used in space-constrained areas to maximize runoff storage with high void percentages. Infiltration trenches are optimal for reducing runoff volume, attenuating flow, and facilitating direct groundwater recharge. Infiltration trenches applications include:

**Example of Infiltration Trench Being Constructed along the Edge of a Street**
