Dead Lady Lake

LAKE HABITAT ASSESSMENT, LAKE VEGETATION INDEX, SUBMERGED
VEGETATION SURVEY AND WATER QUALITY

David Eilers, Karina Gonthier | USF Water Institute | July 3, 2023

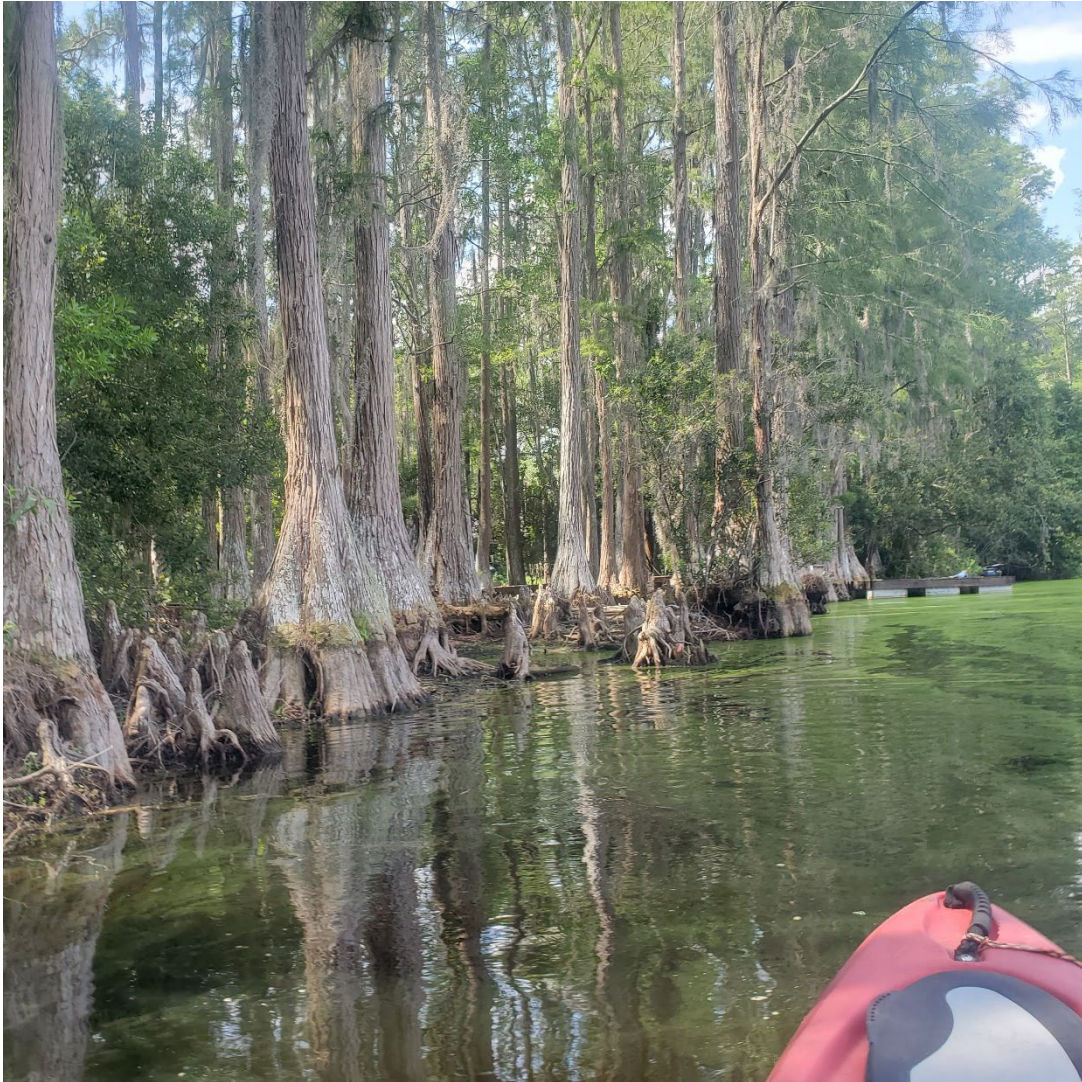
Figure 3 Overview photograph of Dead Lady Lake showing the undeveloped portion of shoreline along region 4 of the Lake Vegetation Index.

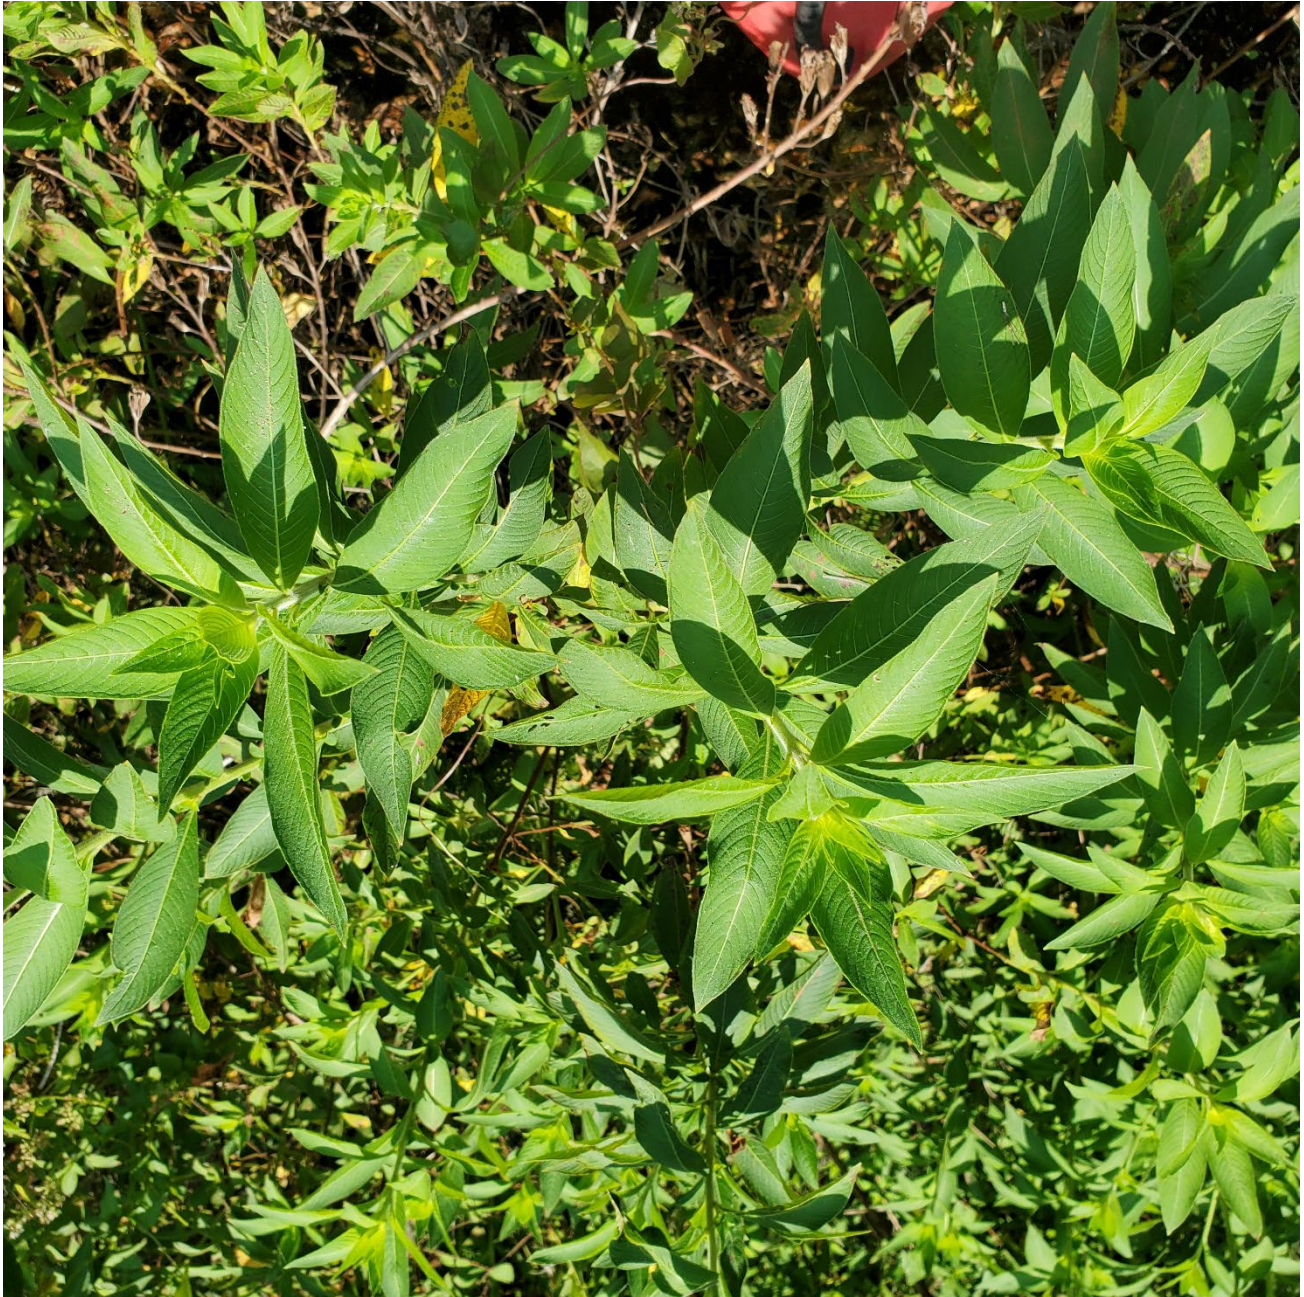
Figure 4 Ludwigia peruviana was the only non-native species to be classified as codominant in a LVI region during the assessment of Dead Lady Lake.

The Lake Vegetation Index identified 25 species of wetland vegetation growing in the four selected sections along Dead Lady Lake. The majority of these species (20) are native species. The remaining 5 species (*shown in **bold** in Table 2*) are non- native or invasive to this region. The vegetation community along the shorelines of Dead Lady Lake is dominated by a *Taxodium* canopy and an understory of *Cephalanthus occidentalis* and *Blechum serrulatum*. At the time of the assessment the water transparency was 1.55 m (5.1 ft).The high tannins and surrounding canopy cover prevents significant submersed vegetation growth. One species of submersed aquatic vegetation was observed during the lake vegetation index. The submersed *Eleocharis* was observed growing most as an emergent on the shoreline as well as submersed in shallow water. The floating leaved vegetation community had a single species, the non-native invasive *Salvinia minima*.

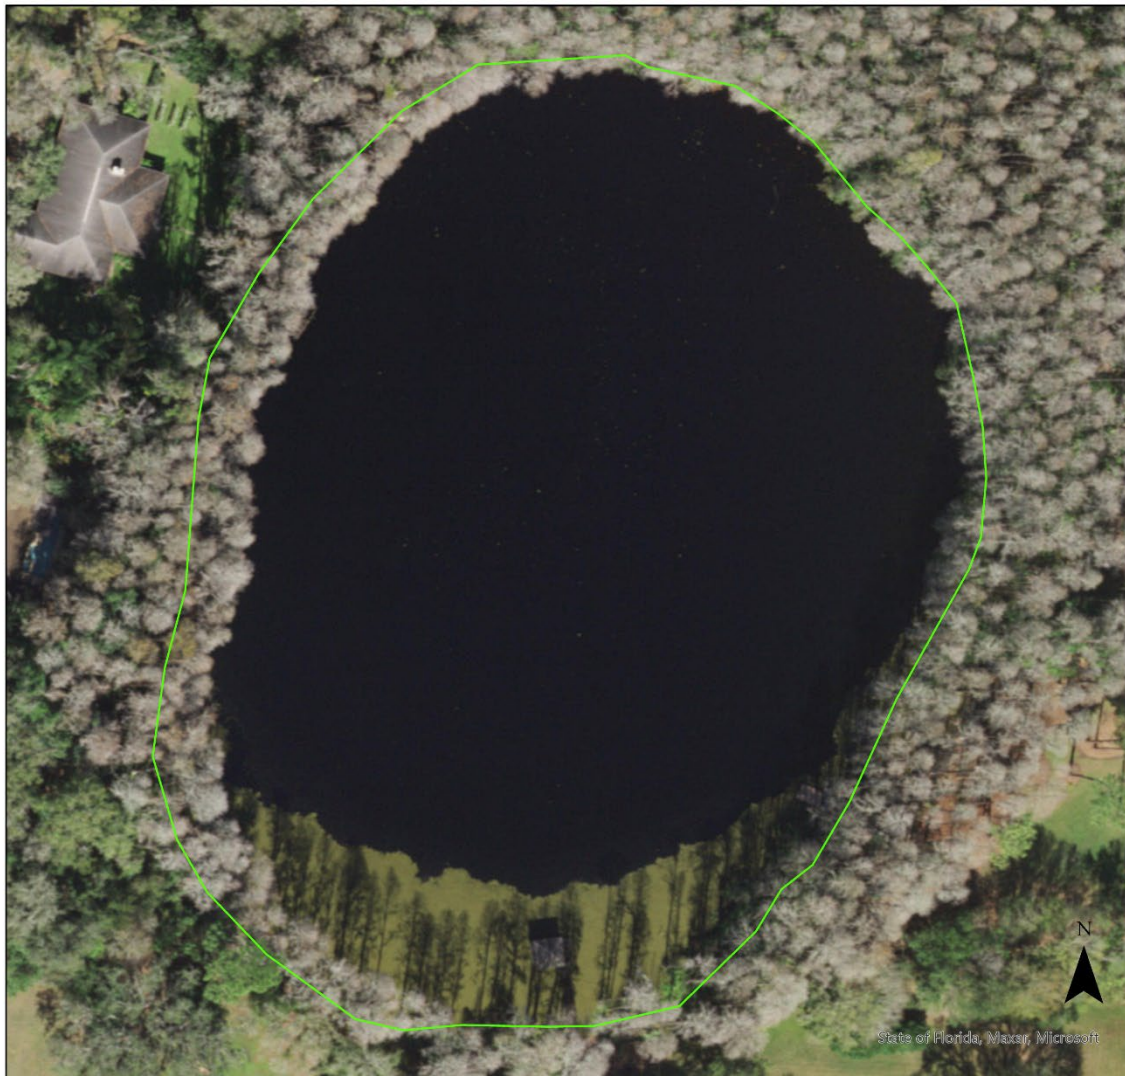
Figure 5 Dead Lady Lake Submerged Aquatic Vegetation Assessment Results

By analyzing the collected sonar chart, submerged aquatic vegetation potentially covered approximately 0.0% of the surface area of Dead Lady Lake. This submerged vegetation inhabits an estimated 0.0% of the water volume in Dead Lady Lake. The observed submerged aquatic vegetation was located in water shallower than the sonar system can reliably detect, typically around 1.5 ft of depth. Figure 5 shows the results of the SAV analysis indicating the location and height of SAV estimated from collected sonar readings.

Survey Date: July 3, 2023
Water level was unknown at the time of the assessment. Submerged Aquatic Vegetation was analyzed from collected sonar data. The height of the SAV where present is shown in 0.5 foot increments.

Area 0 square ft; 0 Acres;
(0% of Lake Surface Area)
Mean SAV Height 0.0 ft;
Volume 0 Cubic ft, (0 gallons);
(0% of Lakes Volume)

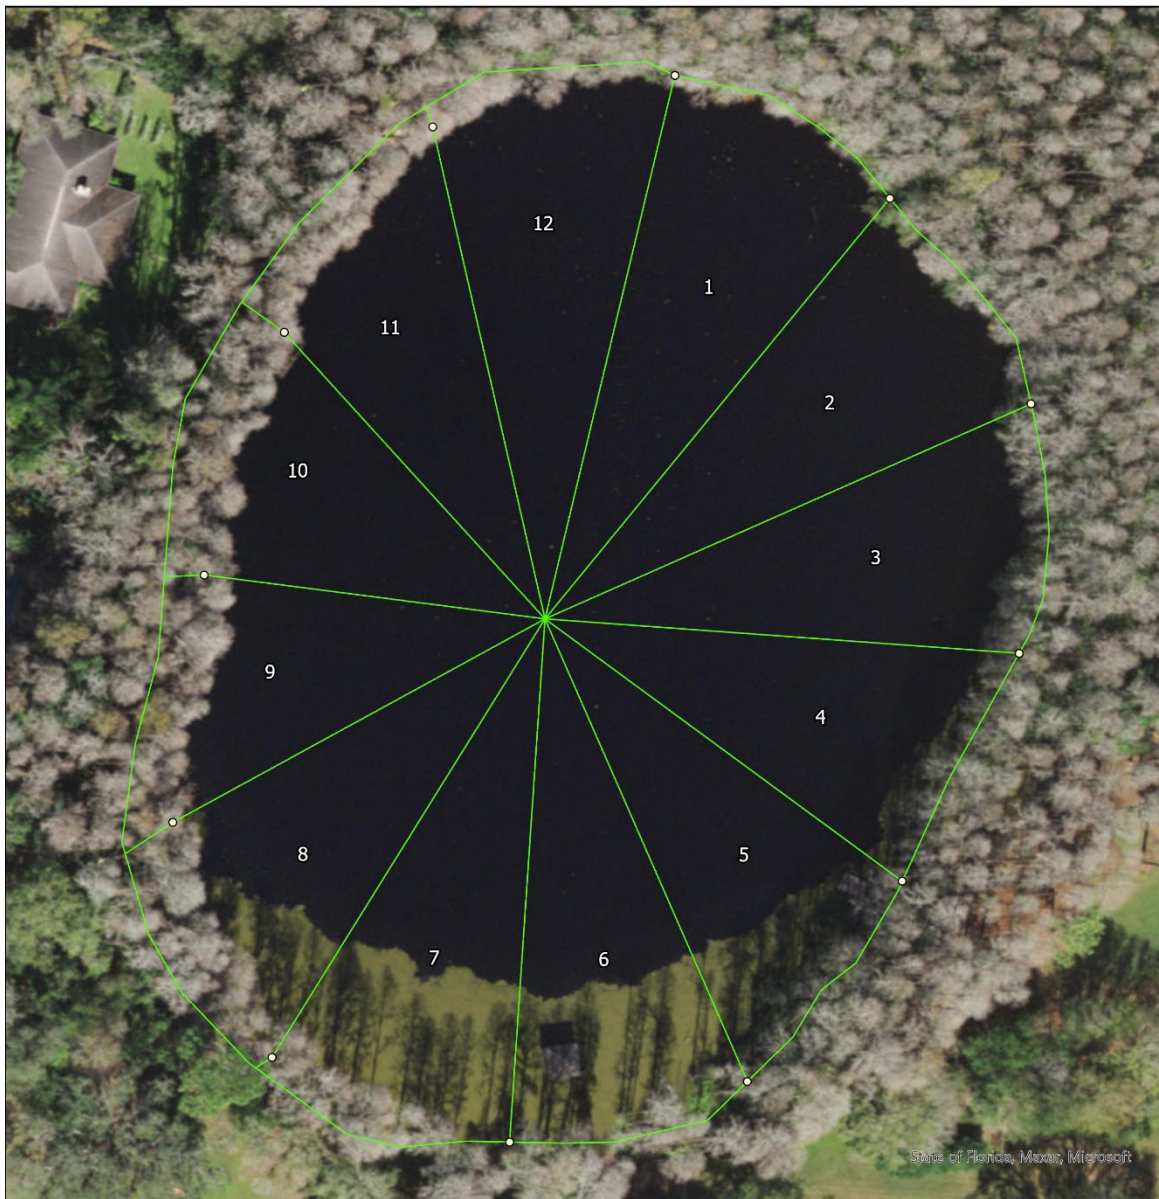
Figure 6: Lake Vegetation Index region map for Dead Lady Lake

The calculated LVI score for Dead Lady Lake was 68, above the impairment threshold of 43 indicating the vegetation community is showing evidence of being “Healthy”. Figure 6 shows the map of Dead Lady Lake detailing the LVI regions used for the assessment (Regions 1, 4, 7, 10). Table 2 details the species list results of the Lake Vegetation Index. Table 3 details the scoring result for the Lake Vegetation Index where it is apparent that region 4 had a large part in increasing the total LVI score for Dead Lady Lake.

Sample Date - July 3, 2023
 Regions Assessed - 1, 4, 7, 10
 Dominant Species per Region -
 1 - Taxodium
 4 - Taxodium
 7 - Taxodium
 10 - Ludwigia peruviana,
 Taxodium

Lake Description
 Water Clarity - 1.6 m (5.1 ft)
 Color - Slightly Turbid, Tannic
 Sediment Types - Sandy/Silt, Muck
 Lake Vegetation Index - 68
