Delaney Creek Tributary

Study Area Analysis

Study Area

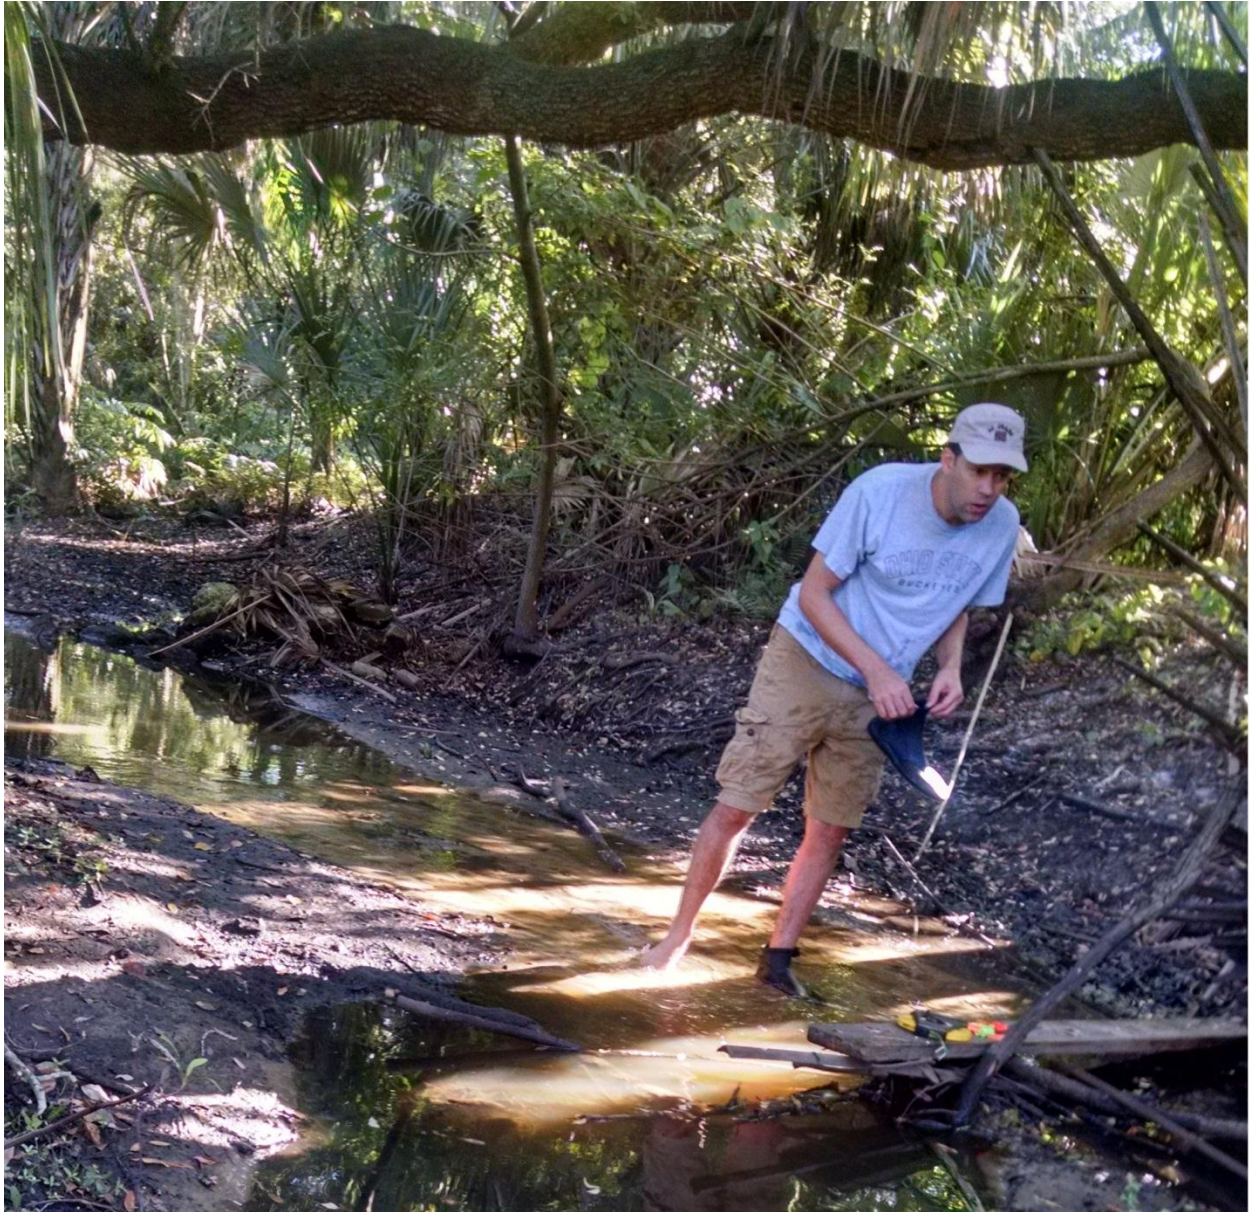
Figure 2 USF Water Institute staff conducting the Linear Vegetation Survey on Delaney Creek at Causeway Blvd sample site

Delaney Creek Tributary at Causeway Boulevard received a habitat assessment score of 114 due to good substrate diversity and availability but with a lack of the necessary number of stable pools due to smothering by silt. Plant communities present were dominated by non-native species. Given the overall small size of the creek bank slopes were for the most part not steep save a few notable spots

along the left bank. Bankful was >60% of bank height for a fair number of sections but was actually <60% for about half of the length of the left side. Bank slope was <60° for the majority of the sampled section. Productive habitats noted included a small number of pools, leaf packs, snags, and rocks. Water velocity was measured at the 85 meter mark and falls within the suboptimal range (0.17 m/s) at the time of assessment. The riparian buffer zone was variable being 20-30 m on the left bank and anywhere from 15-75 m on the right bank.

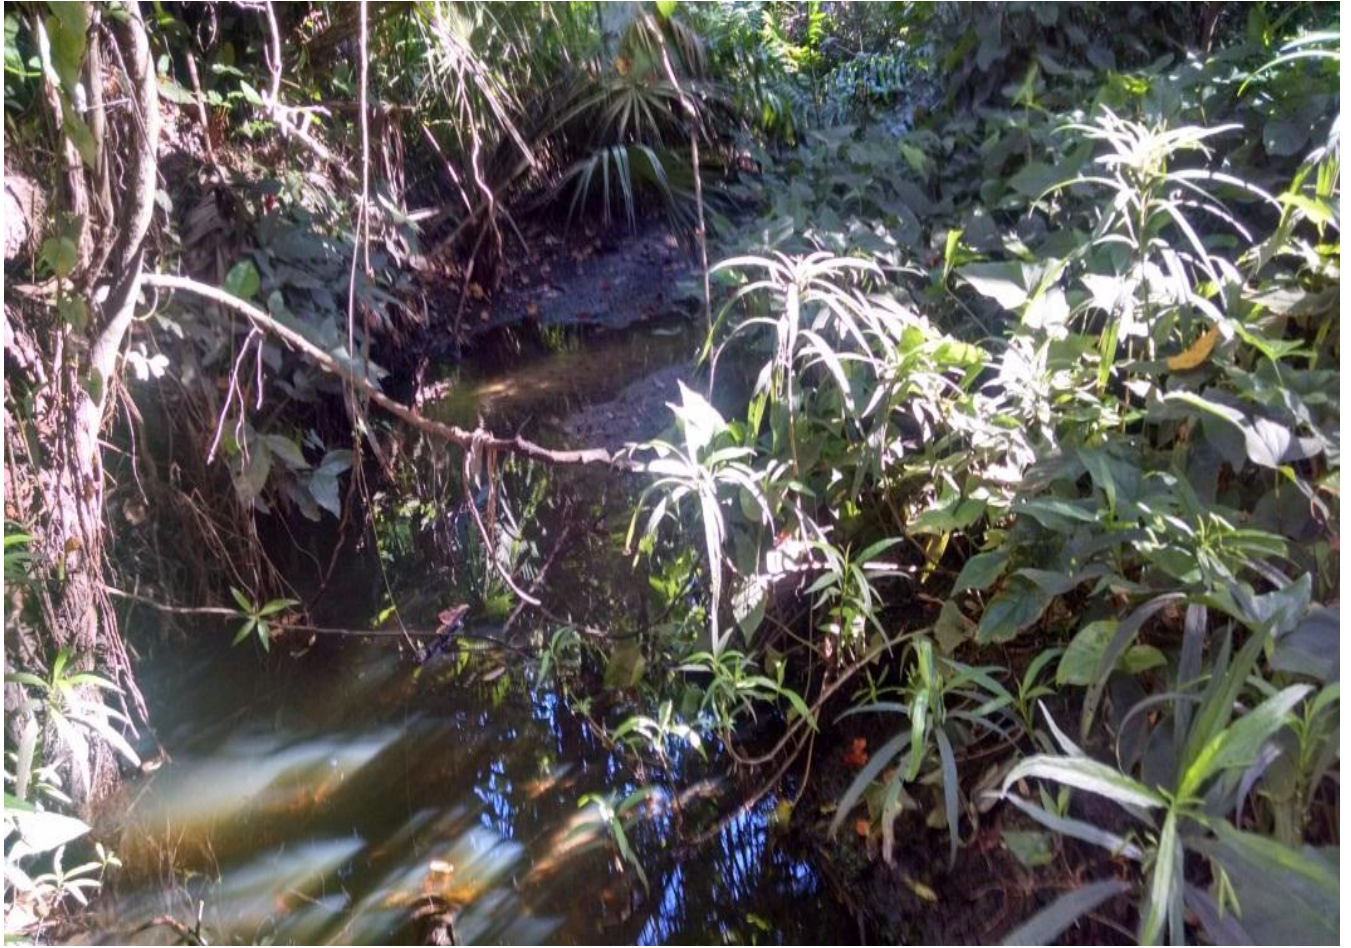
Figure 3 Vegetation along the banks of Delaney Creek @ Causeway

The Linear Vegetation Survey identified 7 species rooted in the water at the time of the assessment. There were a total of 33 species observations in the 100 meter study area. The mean Coefficient of Conservatism (CoC) metric for the study area was .71 and the % FLEPPC metric for the study area was 69.7%. The native species present in the most abundance were the American Evergreen (*Sygonium podophyllum*) and the Marsh Pennywort (*Hydrocotyl sp.*). The overall vegetation was dominated by Wild Taro (*Colocasia esculenta*) and Britons Wild Petunia (*Ruellia simplex*). The vegetation present is indicative of a disturbed habitat with some recovery. Of the plants present within each study site, no one plant was clearly dominant over other species present.

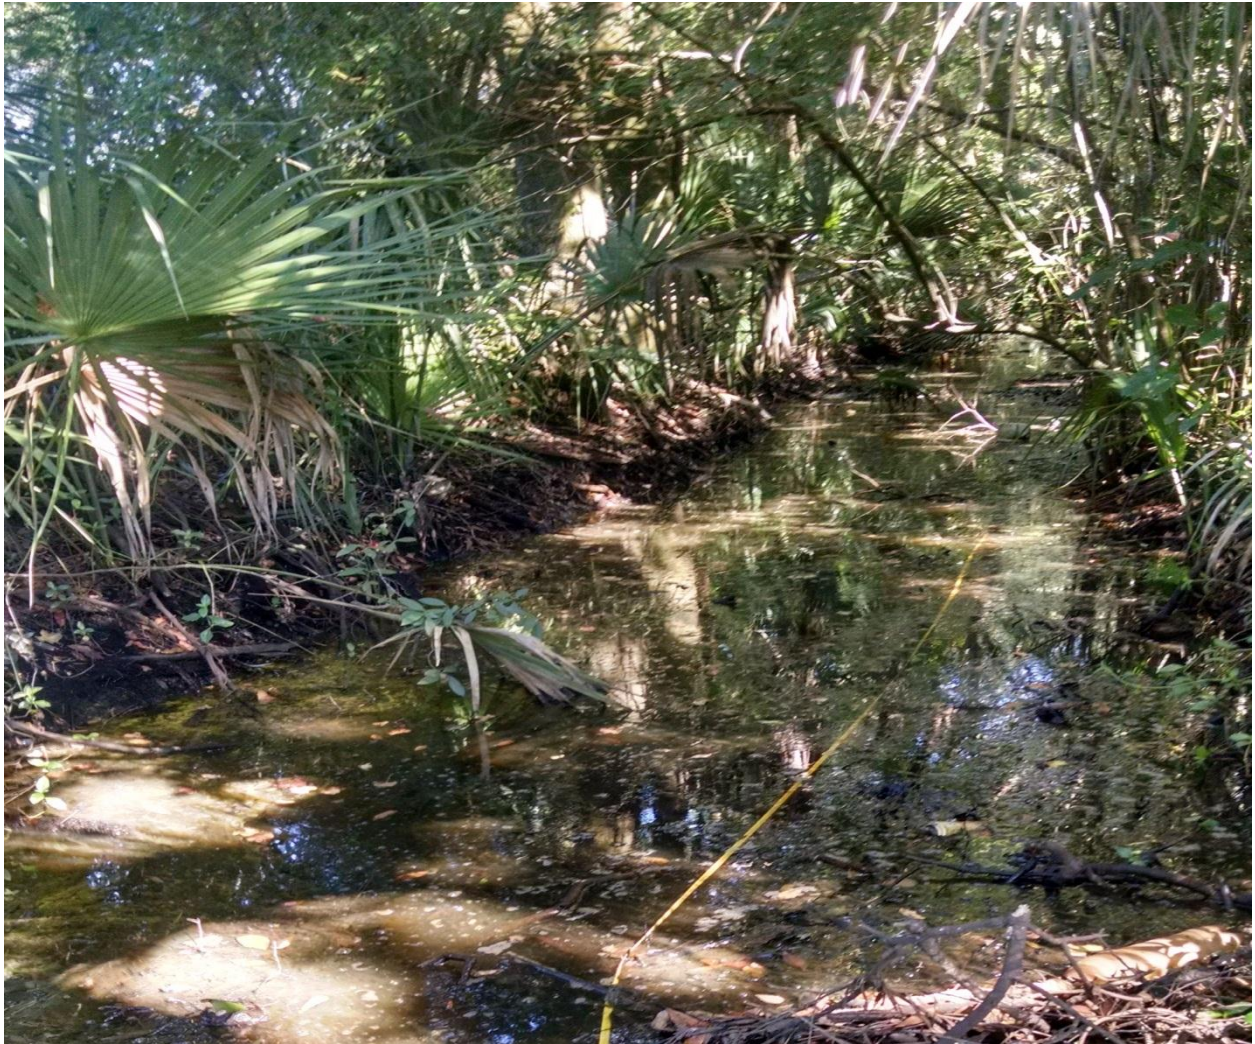
Figure 4 Overview photograph of Delaney Creek at 16th Avenue

Delaney Creek Tributary at 16th Avenue received a habitat assessment score of 43 due to unavailability of productive habitats, a lack of flow, and habitats completely smothered by rotting leaves and silt. Abundance of aquatic vegetation along the 16th Avenue section was very low. Bank stability met two of the requirements for stable banks. Notably the water level was <60% of bankfull and the banks, despite lack of aquatic vegetation were well armored and not >60° in slope angle. Productive habitat was not present. The entire bottom consisted of mostly leaf litter and silt which often smelled of sulphur or fecal matter when examined and methane release upon placing foot on bottom was a common occurrence. There was no observed movement in the water along the sections and water velocity was determined to be 0 m/s. Riparian buffer was 10-15 m on the left bank and 20 m on the right bank.

During the Rapid Periphyton Survey, no periphyton was observed. The average canopy cover in the 100 meter region was 93%. The Secchi Disk Depth was measured as 1.0' at the 50 meter mark. The average water depth in the study area was 1.5' at the time of the assessment.

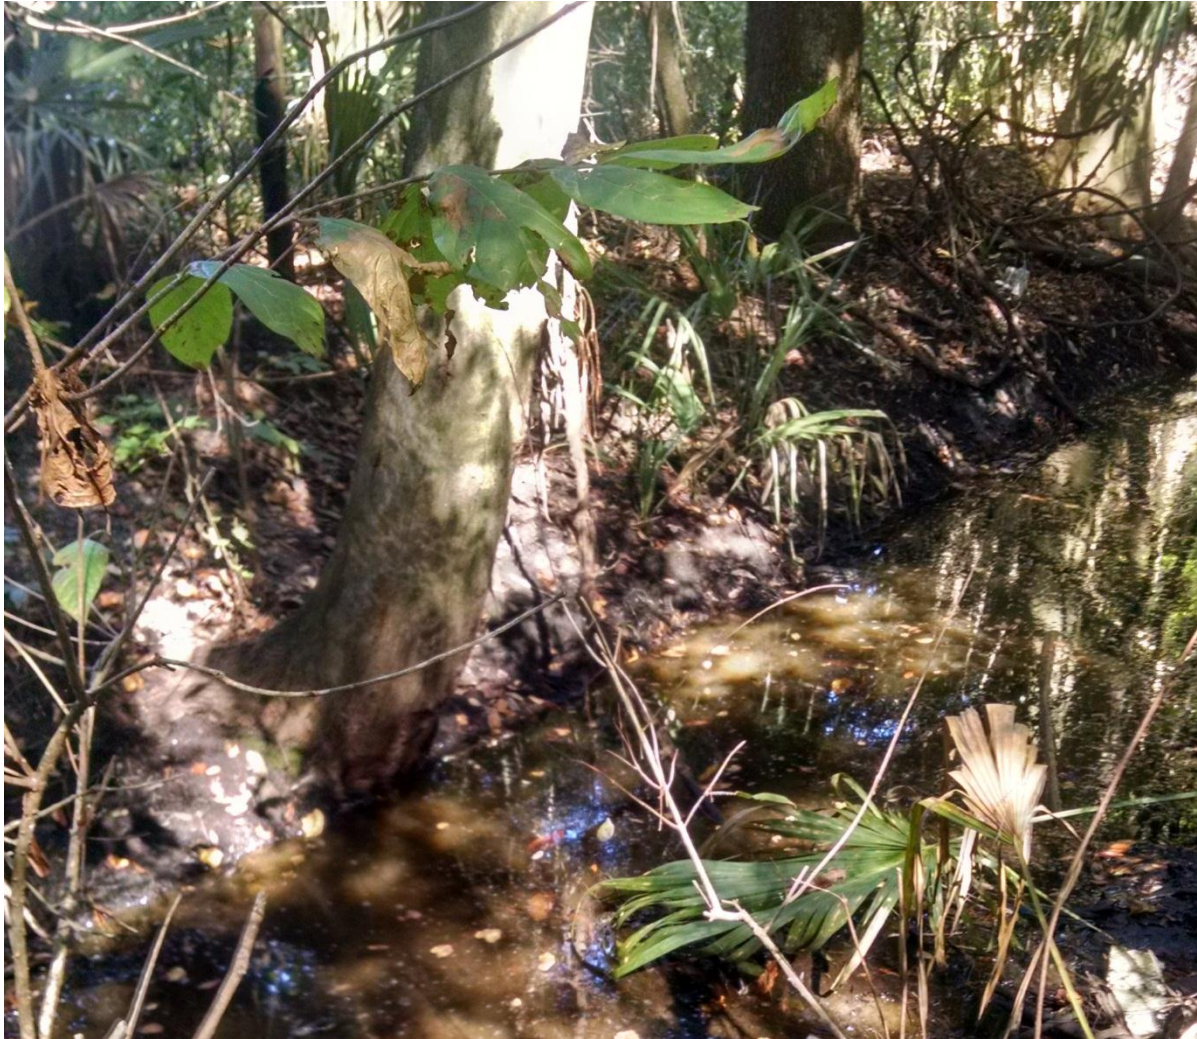
Figure 5 Diversity of aquatic plants rooted in the water at 16th Avenue was very low.

The Linear Vegetation Survey identified 3 species rooted in the water at the time of the assessment. There were a total of 6 species observations in the 100 meter study area. The mean Coefficient of Conservatism (CoC) metric for the study area was 0.15 and the % FLEPPC metric for the study area was 33.33%. Plant communities at 16th Avenue were of low diversity and very sparse. The vegetation present is indicative of a disturbed habitat and possibly a straight drainage channel dug through an established hardwood forest. Of the plants present within each study site, no one plant was clearly dominant over other species present.
