Double Branch Creek

STREAM HABITAT ASSESSMENT, STREAM CONDITIONS INDEX, LINEAR
VEGETATION SURVEY, RAPID PERIPHYTON SURVEY AND WATER QUALITY

David Eilers, Karina Gonthier | USF Water Institute | March 20, 2023

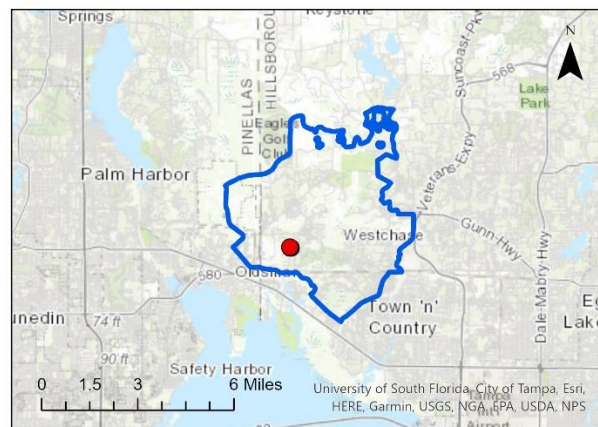
Double Branch Creek WBID 1513E

Mouth - Old Tampa Bay
Area - 5,657.6 Acres (8.84 Sq Miles)
Landscape Development
Intensity - 4.37
Stream Habitat Assessment - 74
Rapid Peiphyton Survey -
% ranked 4-6 - 5%
Linear Vegetation Survey
Mean Coefficient of Conservatism - 0.22
% FLEPPC - 88.9%
Stream Condition Index - 59

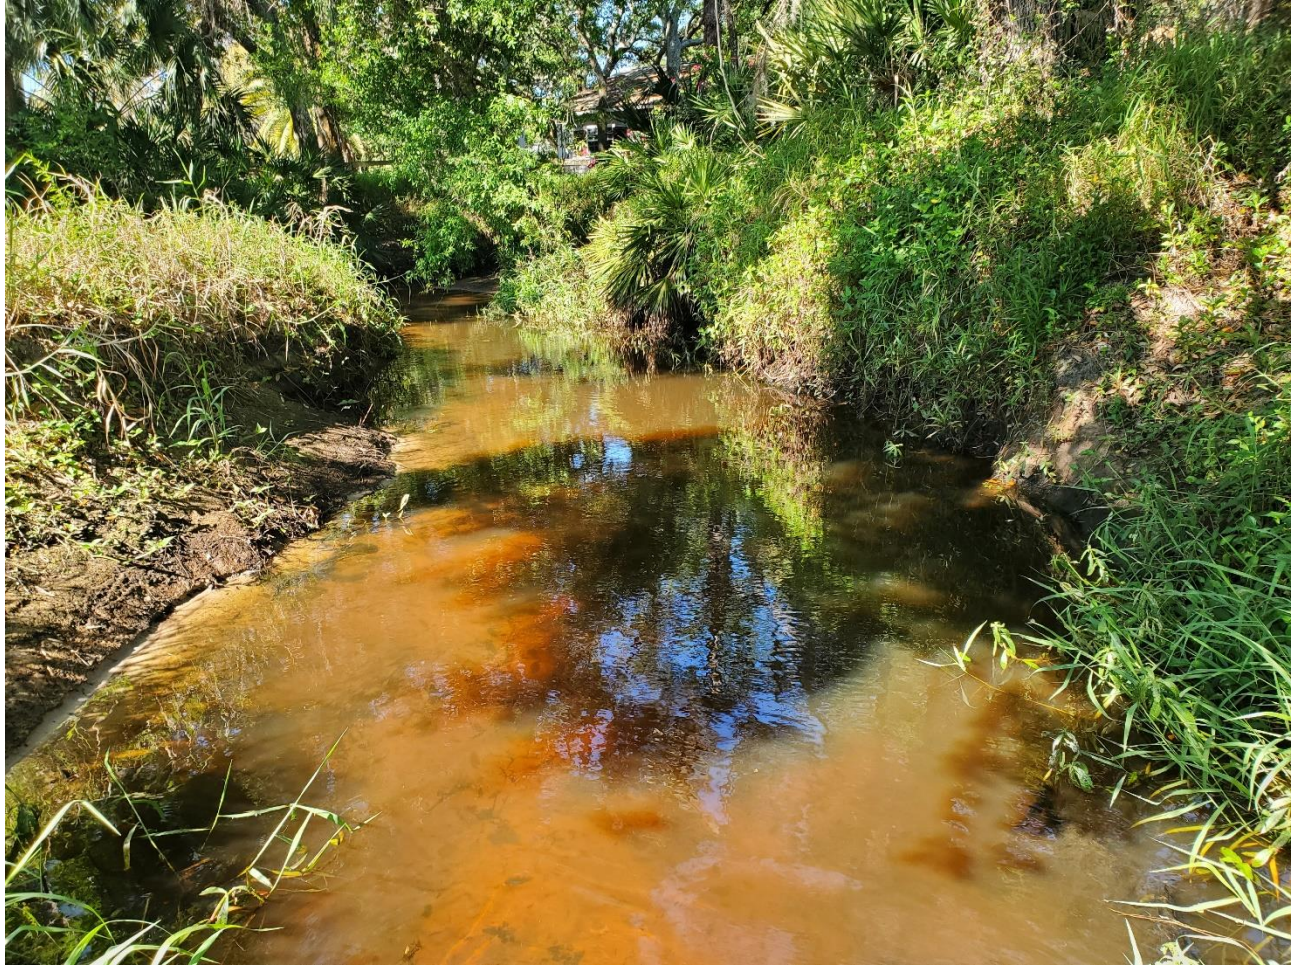
Figure 2 Overview photograph of the Double Branch Creek Sample Site showing the vegetated riparian zone and the heavy sand/silt smothering conditions.

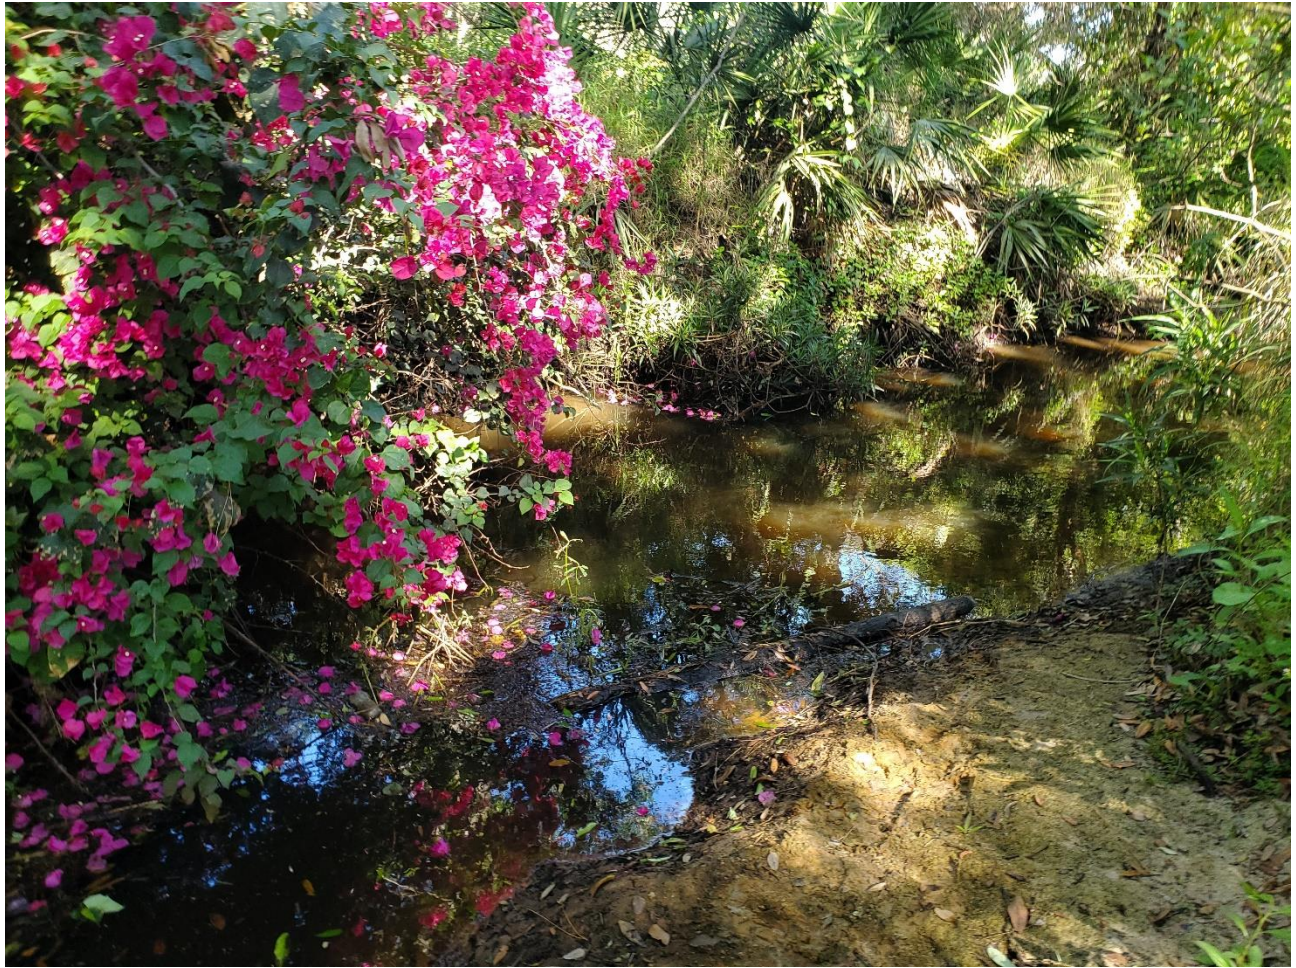
Figure 3 Snag and roots were the most abundant major productive habitats in Double Branch Creek.
