Double Branch Creek Stream Assessment

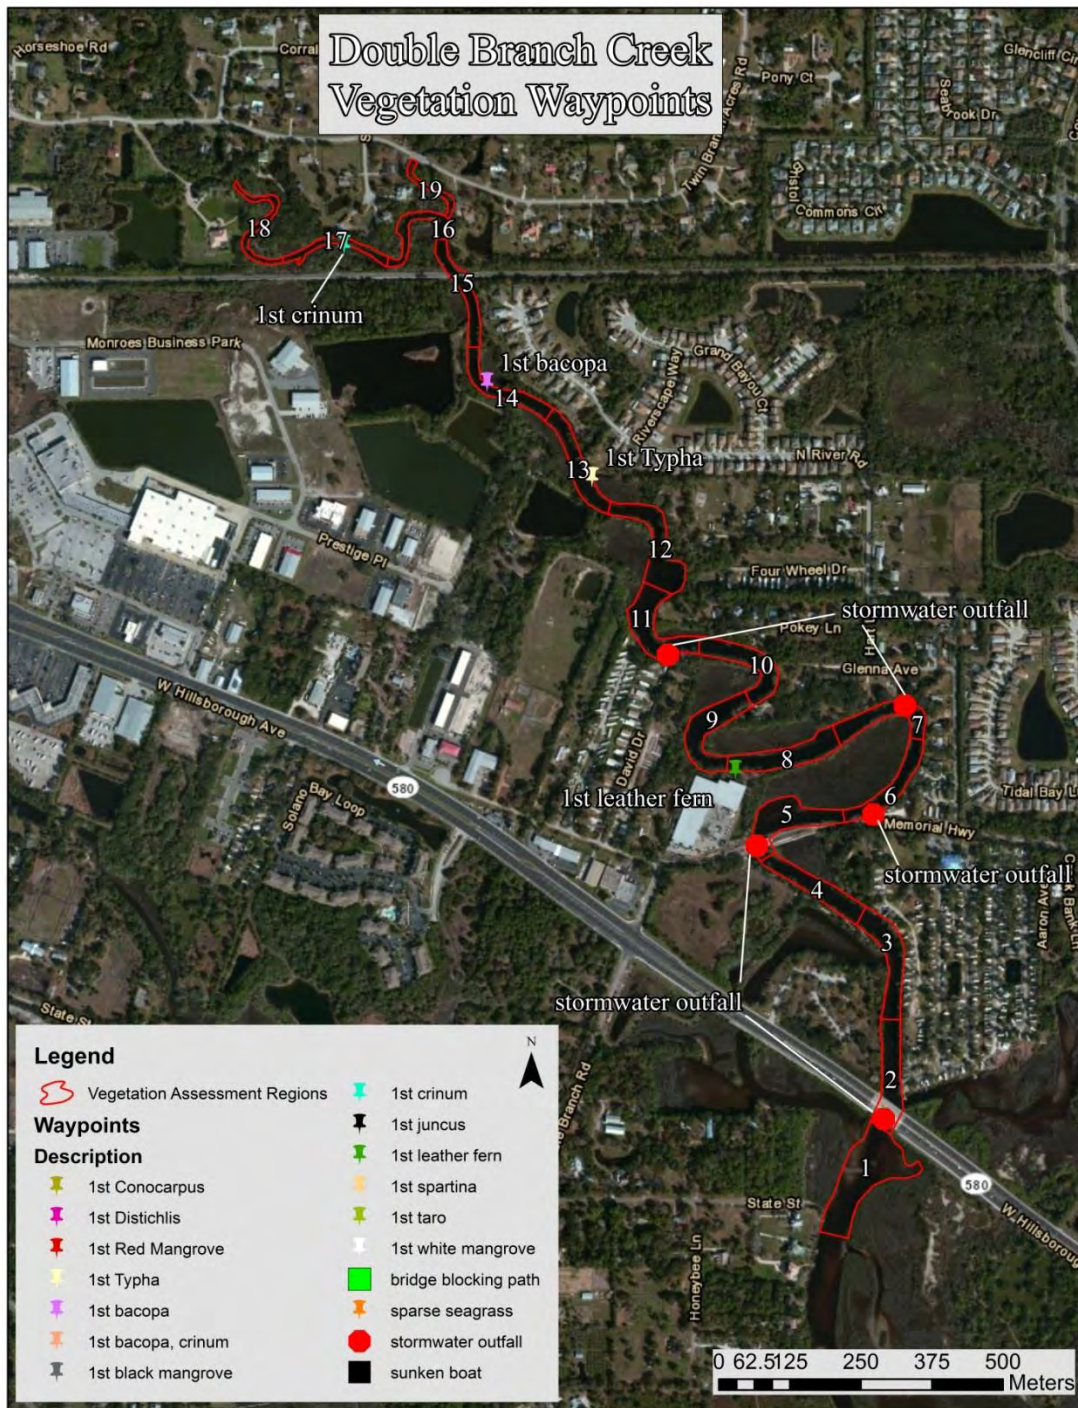
Figure 13. Double Branch Creek Vegetation Waypoints

Figure 13 shows the vegetation transition zone of Double Branch Creek indicating the most downstream Leather Fern, *Bacopa*, *Crinum* and *Typha*. Based on the vegetation assessment data for Double Branch Creek, regions 1 through 8 would comprise the highest salinity and tidal influence zone, regions 9 through 14 would comprise the “mixing” zone and regions 15 through 19 would comprise the freshwater dominant zone. The vegetation assessment species lists are shown in Table 3.

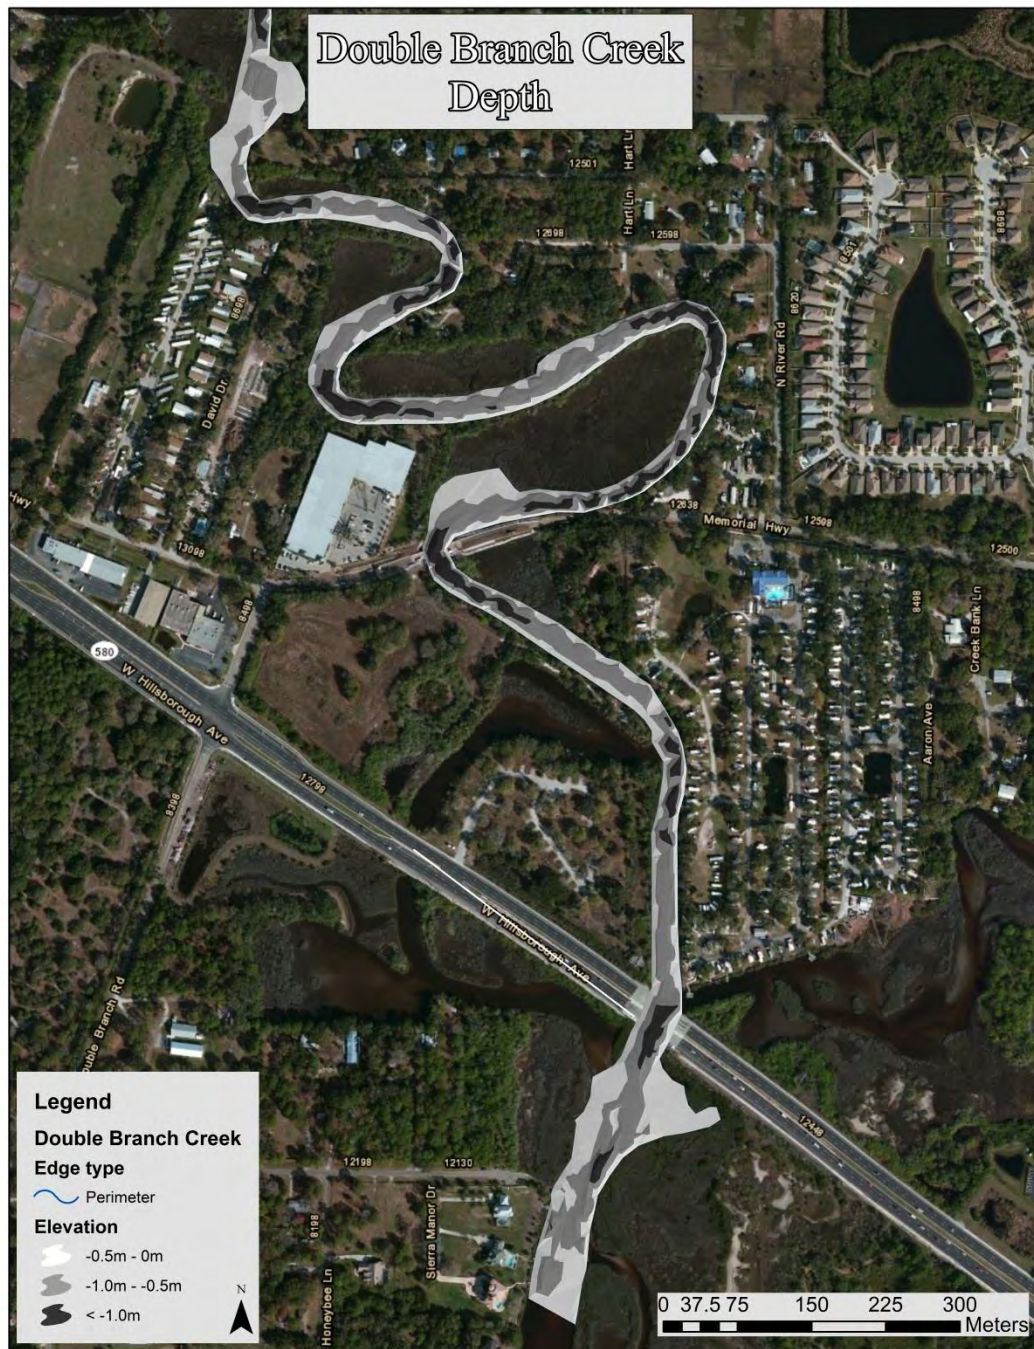
Figure 15. Double Branch Creek Bathymetric Stratum Map (1 of 2)

In the study area, Double Branch Creek had a mean depth of 3.43 feet and a maximum depth of 12.53 feet. A total of 25.64 acres of creek was mapped during the assessment. At the time of assessment, Double Branch Creek contained an estimated 15,610,182 gallons of water in the study area. Figure 15 and Figure 16 detail the bathymetric mapping for Double Branch Creek showing the three depth stratum.
