## **CHAPTER 11: WATER QUALITY TREATMENT LEVEL OF SERVICE**

This chapter describes the results of the pollutant loading analysis performed in Chapter 10. Based on these results, a water quality treatment level of service was determined at the subbasin and watershed levels within the Double Branch Creek watershed. This type of analysis will facilitate prioritization of water quality improvement alternatives (projects) for the Double Branch Creek watershed.

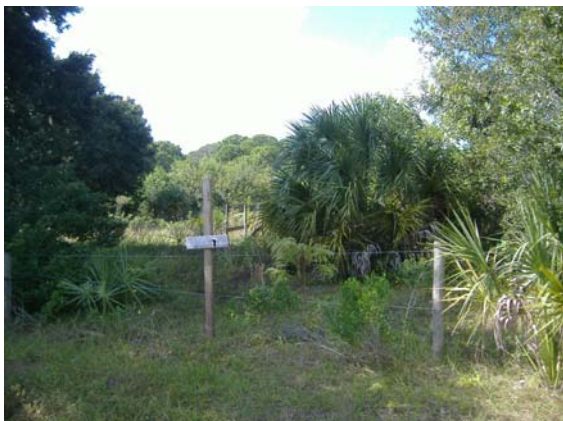
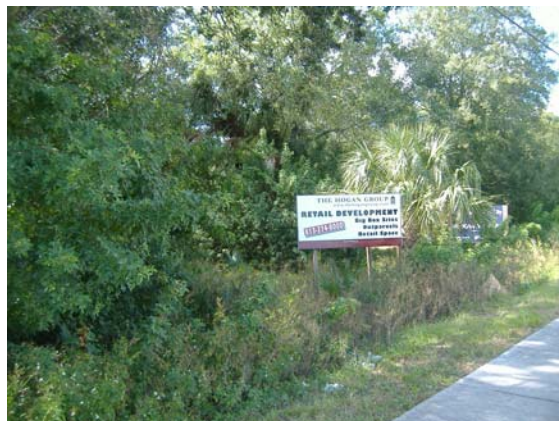
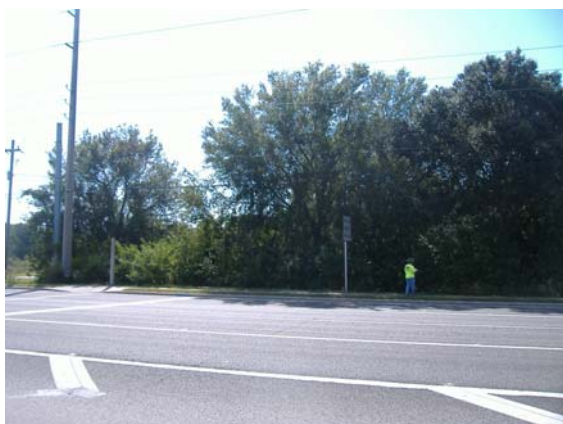
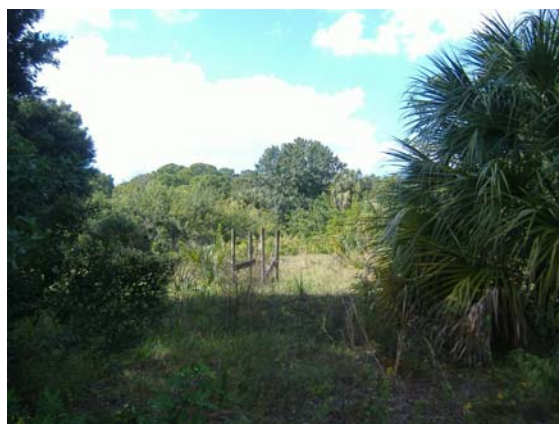
This parcel is located at the corner of Double Branch Road and Hillsborough Avenue. Field inspection identified it as a very large undeveloped and heavily wooded parcel. An open land area is visible in the center of the parcel. There is no visible sign of a wetland feature, therefore wetland improvement / expansion project would not be possible. Billboards and signs located on the property indicate that it may be zoned for commercial development. There are also signs of some exotic plants (Brazilian pepper) on the premises.

Although this site is privately owned and land acquisition costs may be substantial, it should be considered as a potential water quality project improvement location. The size of the site and its openness would allow for construction of a substantially sized retention pond.

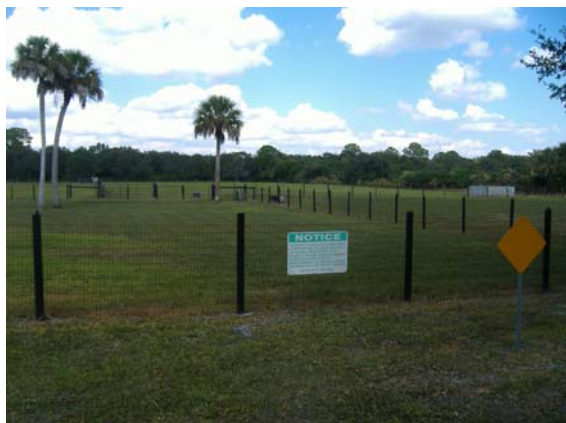
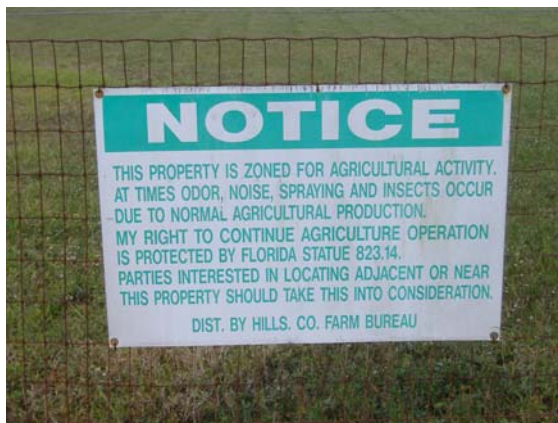
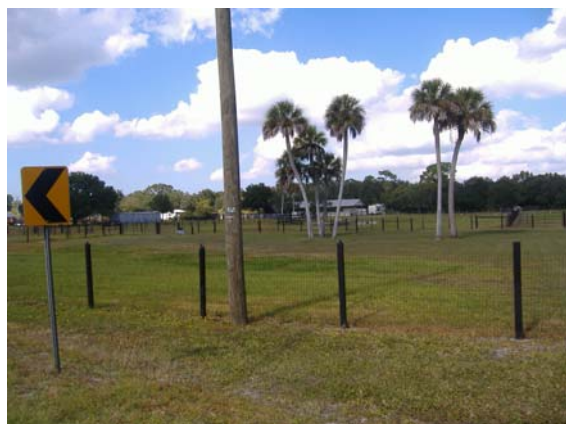
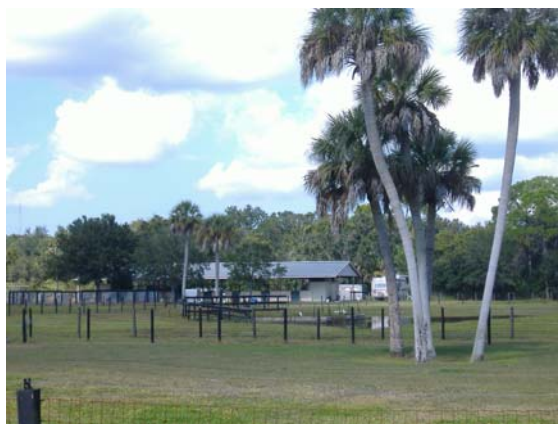
### 14.3.2 Potential Project Site 2: River

This parcel is located at the corner of North River Road and Four Wheel Drive. Field inspection identified it as a large parcel utilized for agricultural and pasture purposes. The land is mostly open with a small wetland feature in the center of the property. The area is fenced out; what appears to be a stable is located to the west of the property. This site is surrounded by a number of residential subdivisions that contribute various pollutants into the watershed's surface waters.

Although this site is privately owned and land acquisition costs may be substantial, it should be considered as a potential water quality project improvement location. The size of the site and its openness would allow for construction of a substantially sized retention pond.

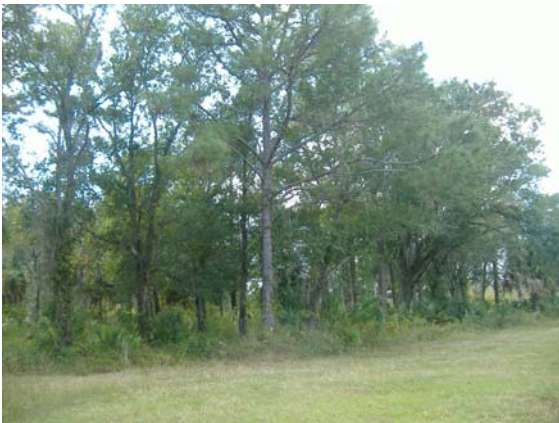
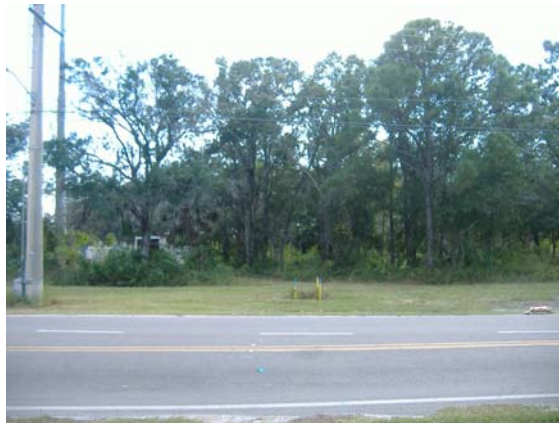
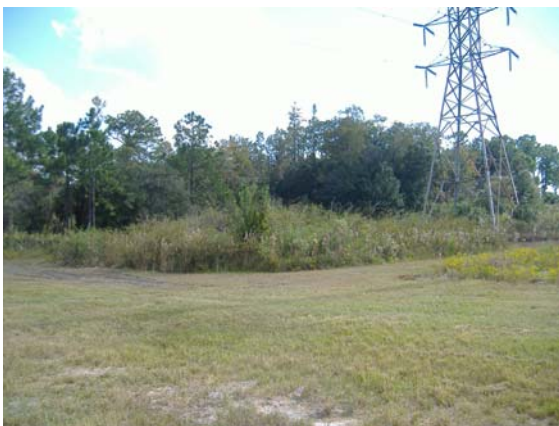
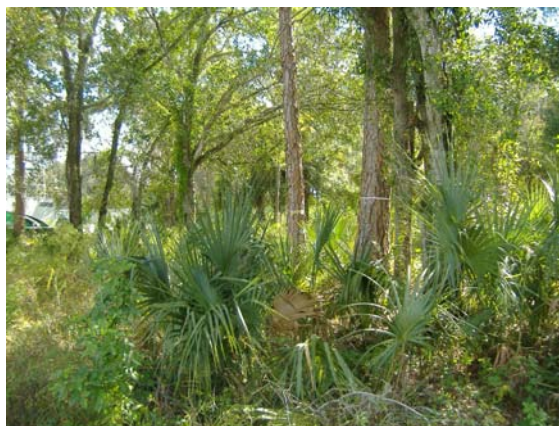
### 14.3.3 Potential Project Site 3: Douglas

This parcel is located at the corner of Douglas Road and Race Track Road. Field inspection identified it as a small undeveloped and heavily wooded parcel (pine and live/water oak present). An open land area is visible in the center of the parcel and a small wetland feature appears on edge of the property (bald cypress dome is present). This location may have been zoned for development. The location is in close proximity to a small power transfer station.

Although this site may be privately owned and land acquisition may be required, this site should be considered as a potential water quality improvement project location. The size of the site and its openness would allow for a water retention system or a wetland improvement/expansion project.

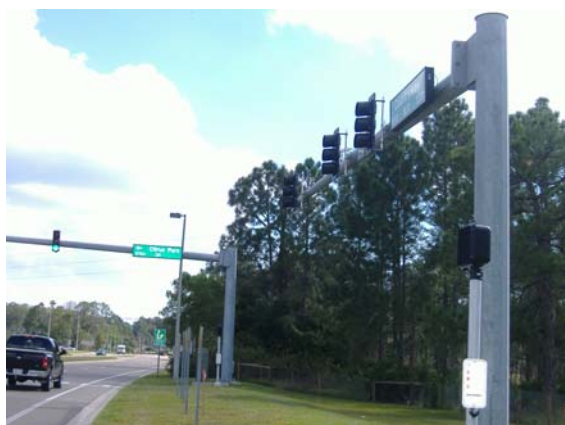
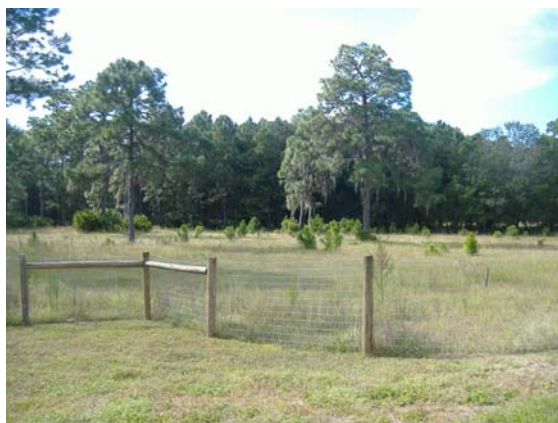
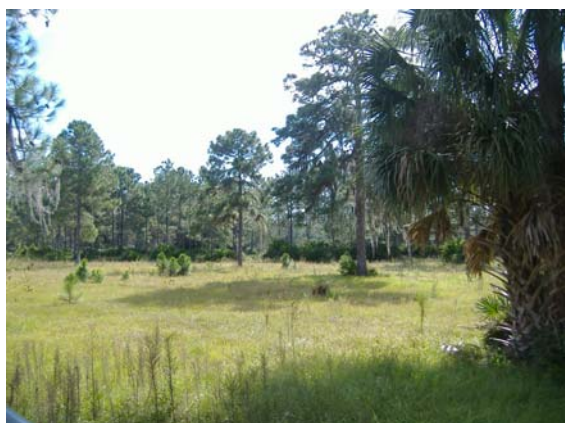
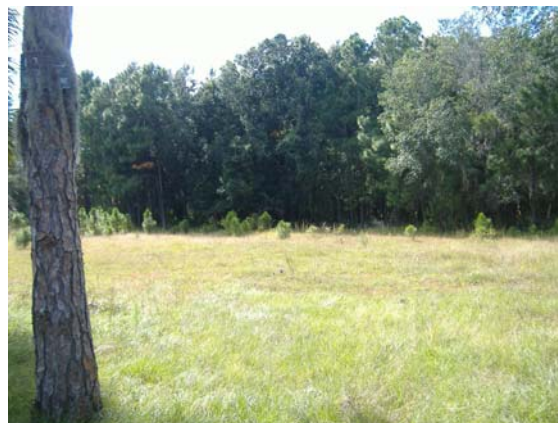
#### 14.3.4 Potential Project Site 4: Citrus/Country

This site is located at the intersection of Countryway Boulevard and Citrus Park Drive. This is a large upland tract that could easily encompass a structural BMP. The parcel is partially wooded with pines, palmetto, and underbrush. The size and location of the parcel make it a perfect location for a large treatment pond. In addition, a small wetland is located in the center of the site. The area is fenced out and is privately owned; however, the size of the site, the lack of built-up features, and its proximity to the stream network make it a good choice for a potential water quality structural alternative.

The size of the site allows for construction of a large retention/treatment pond and existence of a small wetland offers a possibility of a wetland improvement project. This site is also surrounded by many residential neighborhoods and may provide much needed water quality improvement to the surrounding areas.

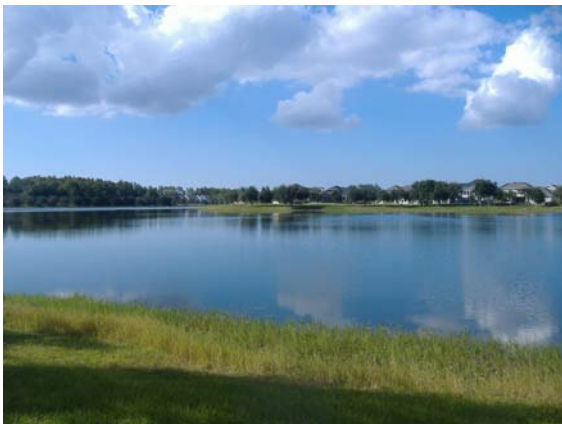
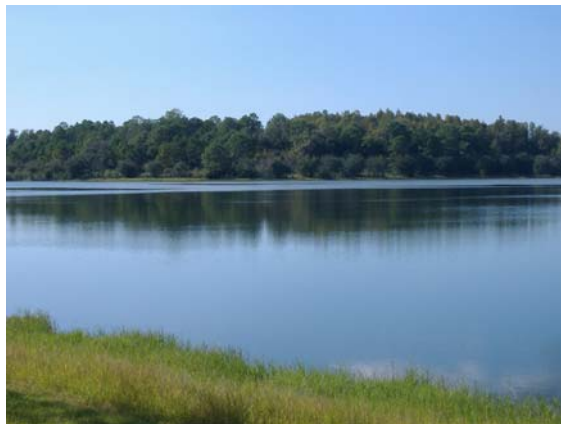
### 14.3.6 Potential Project Site 6: Countyway 2

While aerial photography inspection identified this location as an acceptable site for a structural alternative, field inspection determined the site is difficult to access and is located in close proximity to a large existing pond. This location will not be further considered for a potential water treatment site.

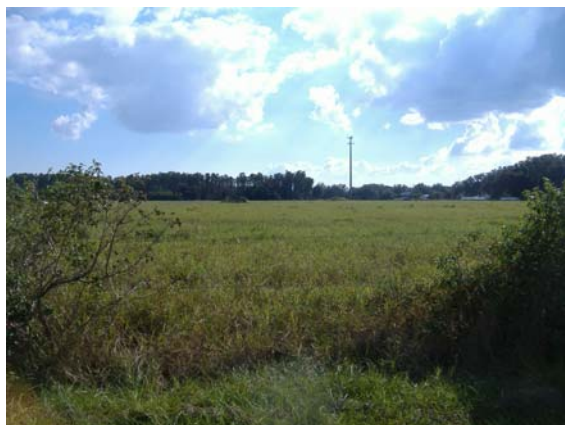
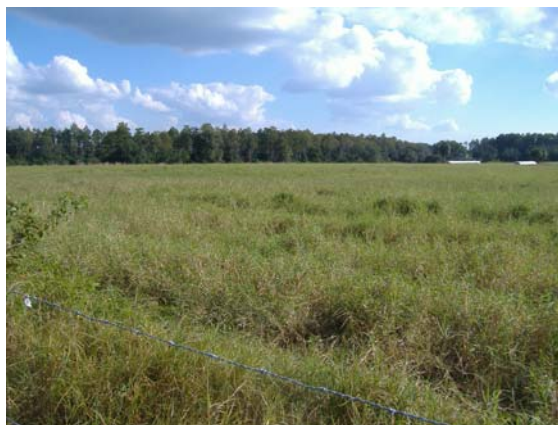
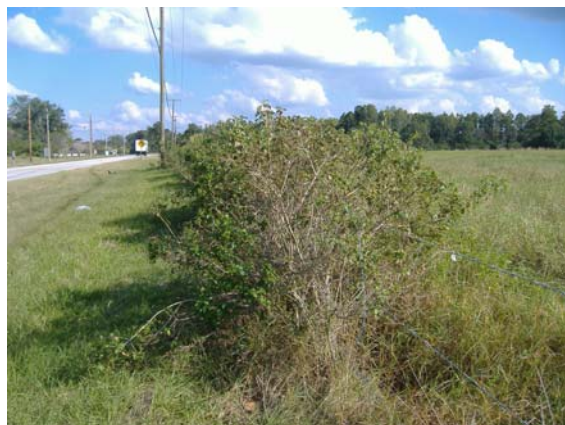
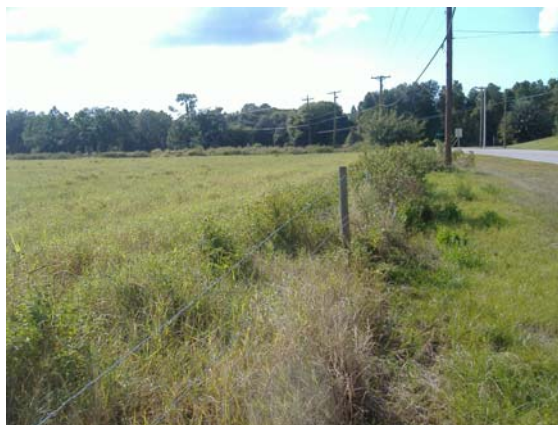
### 14.3.7 Potential Project Site 7: Race Track

This site is located at the intersection of Race Track Road and Patterson Road. This is a large open parcel that could easily encompass a structural BMP. The parcel is cleared and undeveloped, designated as pasture land. The size and location of the parcel make it a favorable area for a large treatment pond. No wetland features are visible on the site. The area is fenced out and is privately owned; however, the sized of the site, the lack of built-up features, and its proximity to stream network make it a good choice for a potential water quality structural alternative.

This site is located in the northern part of the Double Branch watershed – an area dominated by agricultural lands contributing large amounts of nutrients into the watershed’s surface waters. A retention/treatment pond would provide much needed water quality improvement to the surrounding areas.

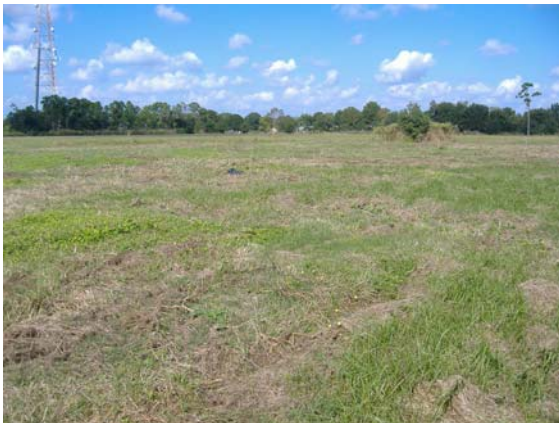
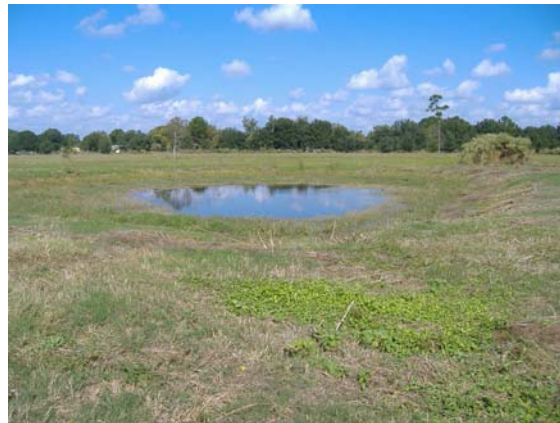
#### **Site 1**

This site is located at the intersection of Lake Sunset Drive and Sheldon Road. This is a large open parcel that could easily encompass a structural BMP. The parcel is cleared and undeveloped. Land designation of this purpose is unclear, however the size and location of the parcel make it a favorable site for a large treatment pond. A small water feature is located in the middle of the site. The area is privately owned; however, the sized of the site, the lack of built-up features, and its proximity to a stream network make it a good choice for a potential water quality structural alternative.

This site is located to the east of the Double Branch watershed – an area dominated by residential and built-up lands contributing large amounts of pollutants into the watershed’s surface waters. This particular site is adjacent to a two residential communities. A retention/treatment pond would provide much needed water quality improvement to the surrounding areas.

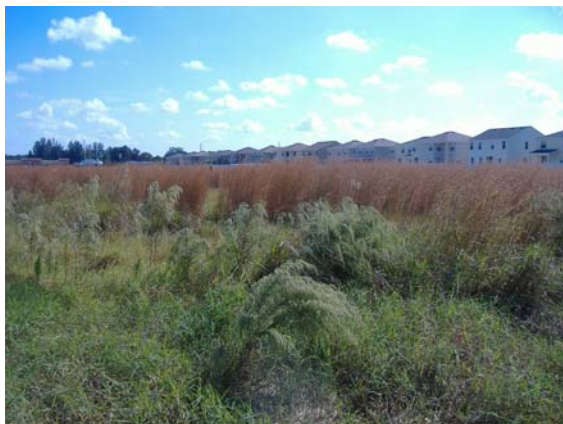
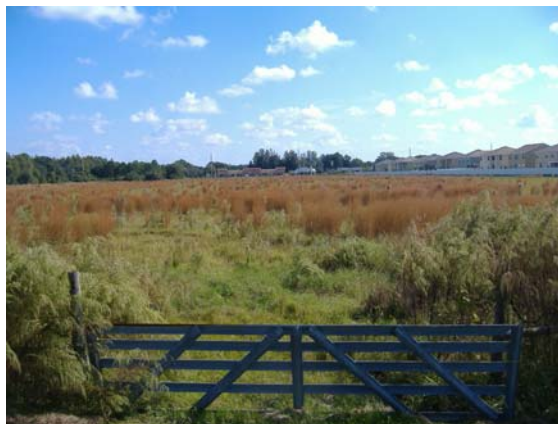
## Site 2

This area is attached to the previous site. It is located on the other side of a residential neighborhood, directly along the Sheldon Road. Similarly to the previous parcel, this site is large in size, open (no built-up features visible), and is located in an area that is in need for water quality improvement. This site is large enough to encompass a substantial structural BMP, capable of providing the necessary water quality treatment.

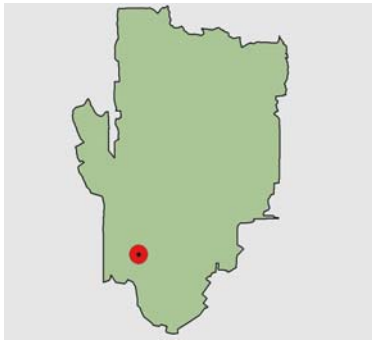
This parcel is located at the corner of Double Branch Road and Hillsborough Avenue. Field inspection identified it as a very large undeveloped and heavily wooded parcel. An open land area is visible in the center of the parcel. There is no visible signs of a wetland feature, therefore wetland improvement / expansion project would not be possible. Billboards and signs located on the property indicate that it may be zoned for commercial development. There are also signs of some exotic plants (Brazilian pepper) on the premises.

Although this site is privately owned and land acquisition costs may be substantial, it should be considered as a potential water quality project improvement location. The size of the site and its openness would allow for construction of a substantially sized retention pond.

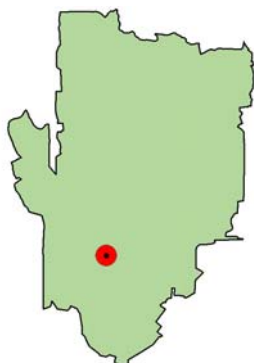
This parcel is located at the corner of North River Road and Four Wheel Drive. Field inspection identified it as a large parcel utilized for agricultural and pasture purposes. The land is mostly open with a small wetland feature in the center of the property. The area is fenced out; what appears to be a stable is located to the west of the property. This site is surrounded by a number of residential subdivisions that contribute various pollutants into the watershed's surface waters.

Although this site is privately owned and land acquisition costs may be substantial, it should be considered as a potential water quality project improvement location. The size of the site and its openness would allow for construction of a substantially sized retention pond.
