East Lake Outfall

Habitat Assessment

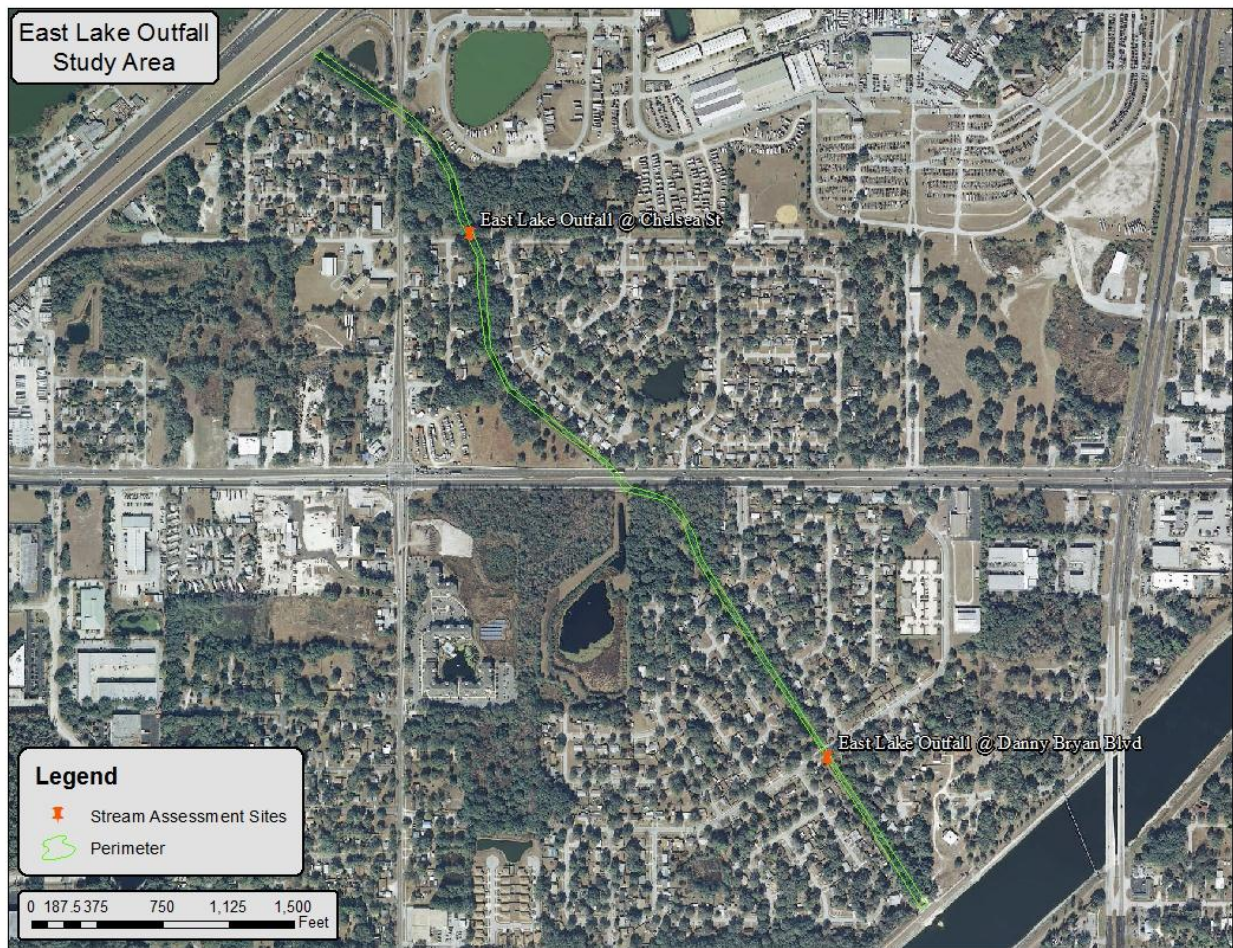
Figure 1 2014 East Lake Outfall Assessment Study Area Map

East Lake Outfall located in Hillsborough County Florida was sampled at two localities on separate dates. The first sampling locality was sampled on 8/22/2014 and is located near Chelsea Avenue in the city of Tampa Florida at: N 27.9862438, W 82.372138. The second sampling locality was sampled on 9/22/2014 and is located near Danny Bryan Blvd at: N 27.9771235, W 82.3654895. East Lake Outfall drains from East Lake and discharges into the Tampa Bypass Canal. The watershed surrounding East Lake Outfall is dominated by Residential High Density (24.92%), Commercial (16.92%), Natural Land/Open Water (14.28%) and Industrial (10.82%) land uses. The Landscape Development Intensity Index of the watershed is 34.04.

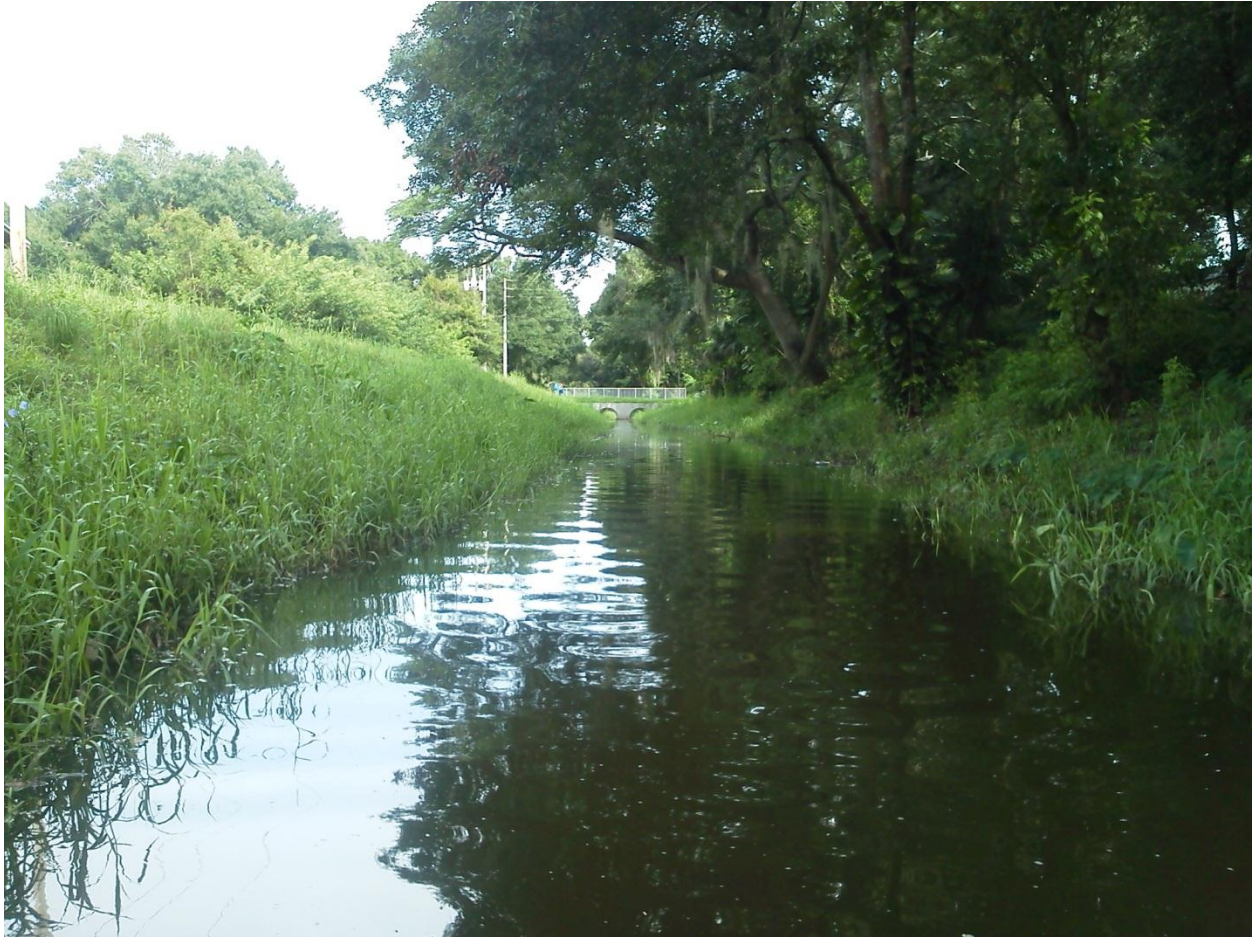
Figure 2 Overview photograph of East Lake Outfall at Danny Bryan Blvd sample site

East Lake Outfall at Danny Bryan Blvd near Veterans Memorial Park received a Habitat Assessment score of 37 due to low substrate diversity, domination by non-native invasive species and the fact that the stream was artificially straightened lacking sinuosity as would be expected in a Coastal Plain flow regime. Artificial channelization was obvious, bankfull was <60% of bank height and there was a significant lack of armoring vegetation along the left bank. Very few productive habitats were observed, only one significant pool was observed and other potentially available habitats were silt/sand smothered. Water velocity was suboptimal at 0.13 m/s at the time of assessment at the 40 meter mark. The riparian buffer zone was almost absent due to residential housing and a maintenance easement along the banks and vegetation removal was obvious. The thickness of the riparian zone was measured at 1 m and 1 m for the left and right banks respectively.

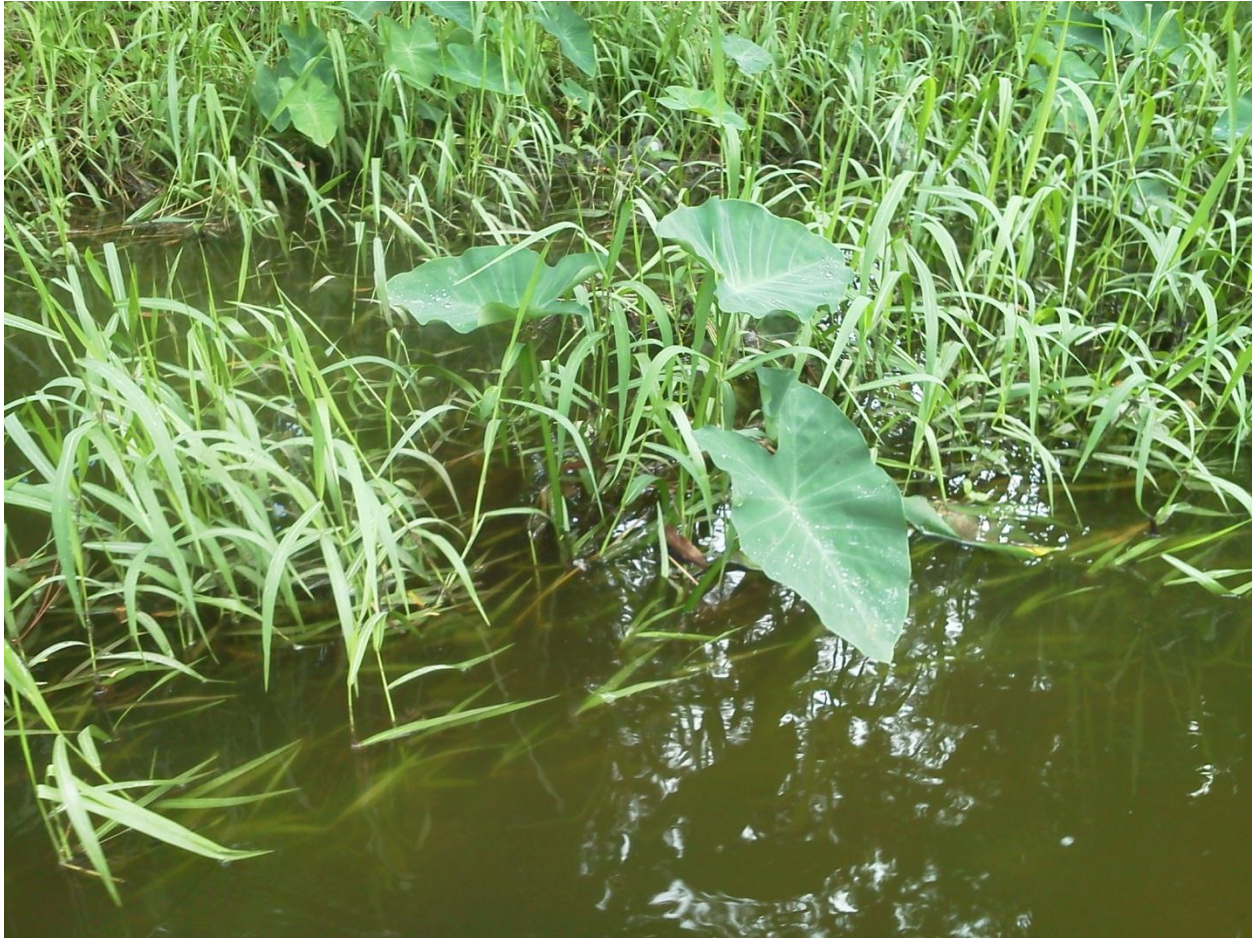
The Linear Vegetation Survey identified 13 species rooted in the water at the time of the assessment. The majority of these species (7) are non-native, invasive species. The remaining 6 species are native to this region. Para Grass (*Urochola mutica*) was the dominant species in all 10 sections of the Linear Vegetation Survey. The vegetation community along this sample location showed evidence of frequent disturbance (mowing) resulting in the dominance by pioneering species. There were a total of 65 species observations in the 100 meter study area. The mean Coefficient of Conservatism (CoC) metric for the study area was 0.73 and the % FLEPPC metric for the study area was 78.46%.

Figure 3. *Colocasia esculenta* and *Urochloa mutica* along the banks of East Lake Outfall at the Danny Bryan Blvd sampling site

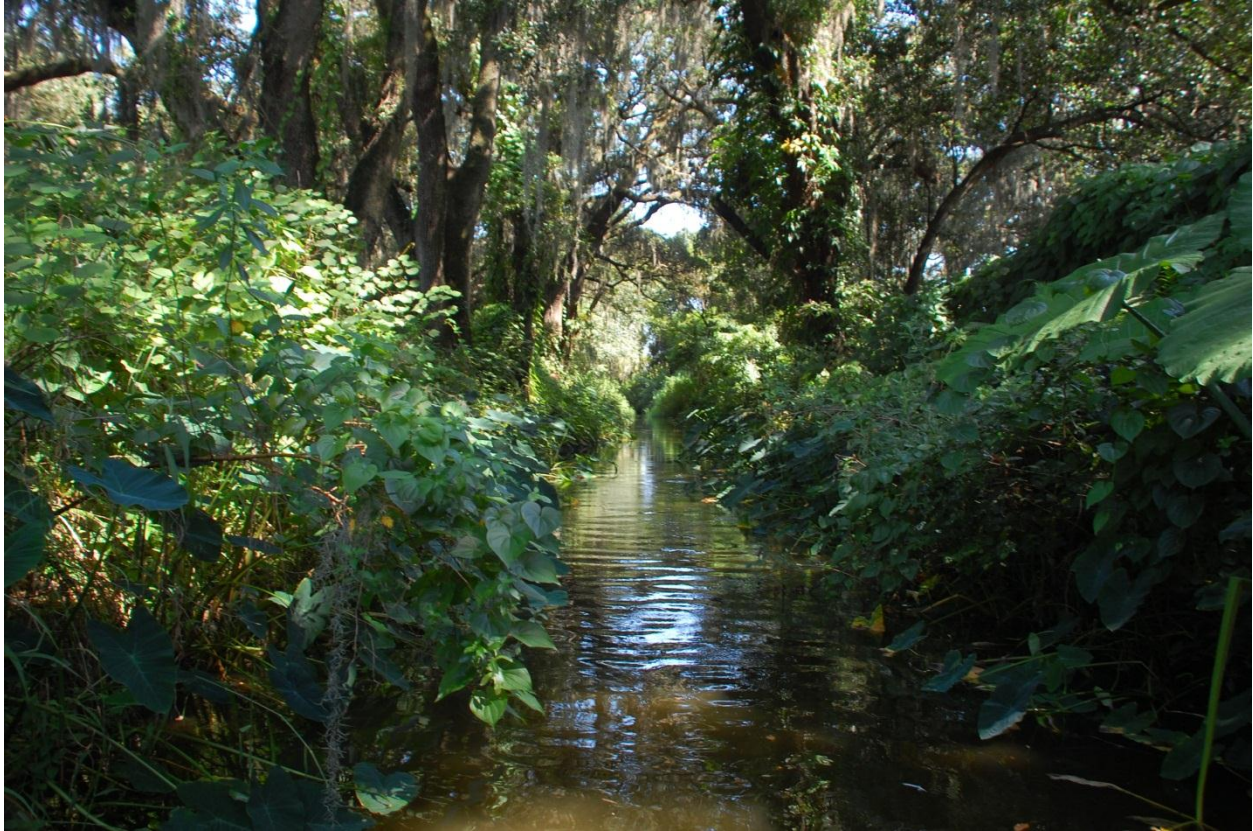
Figure 4. Overview photograph of the East Lake Outfall at Chelsea Avenue Sample Site

East Lake Outfall at Chelsea Avenue received a Habitat Assessment score of 32 due to low substrate diversity and the fact that the stream was artificially straightened lacking sinuosity as would be expected in a typical Coastal Plain flow regime. Artificial channelization was obvious and bank stability was poor given the bankfull was <60% of bank height and numerous erosion zones along the left bank. Very few productive habitats were observed in the field and silt smothering of productive habitats was obvious. Intense human activity significantly reduced the amount of riparian buffer zone available. Water velocity was suboptimal at 0.13 m/s measured at the 30 meter mark. Thickness of riparian zone was measured at 5 m on each bank.

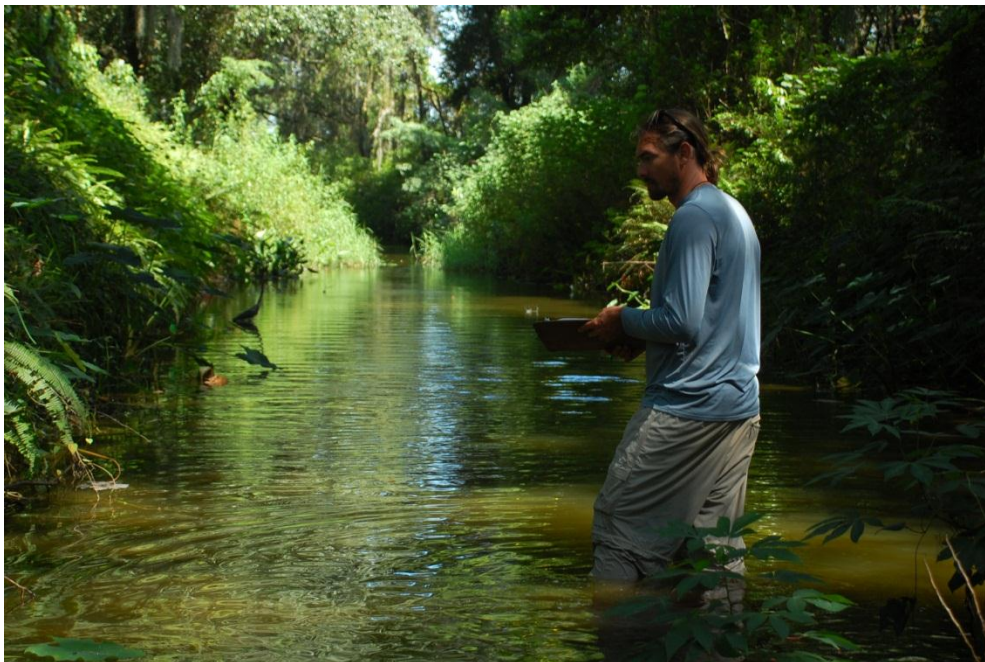
The Linear Vegetation Survey identified 10 species rooted in the water at the time of the assessment. The majority of these species (6) are non-native, invasive species. The remaining 6 species are native to this region. Wild Taro (*Colocasia esculenta*) and Para Grass (*Urochloa mutica*) were the dominant species in the Linear Vegetation Survey. The vegetation community along this sample location showed evidence of frequent disturbance resulting in the dominance by pioneering species. There were

a total of 45 species observations in the 100 meter study area. The mean Coefficient of Conservatism (CoC) metric for the study area was 0.91 and the % FLEPPC metric for the study area was 73.33%. Native vegetation along the creek was sparse.

Figure 5 USF Water Institute staff conducting the Linear Vegetation Survey on East Lake Outfall at Chelsea Avenue
