# LAKE ASSESSMENT REPORT FOR EGYPT LAKE IN HILLSBOROUGH COUNTY, FLORIDA

Date Assessed: **June 26, 2008**

Assessed by: Monetta Wilson, Grant Harley and David Eilers

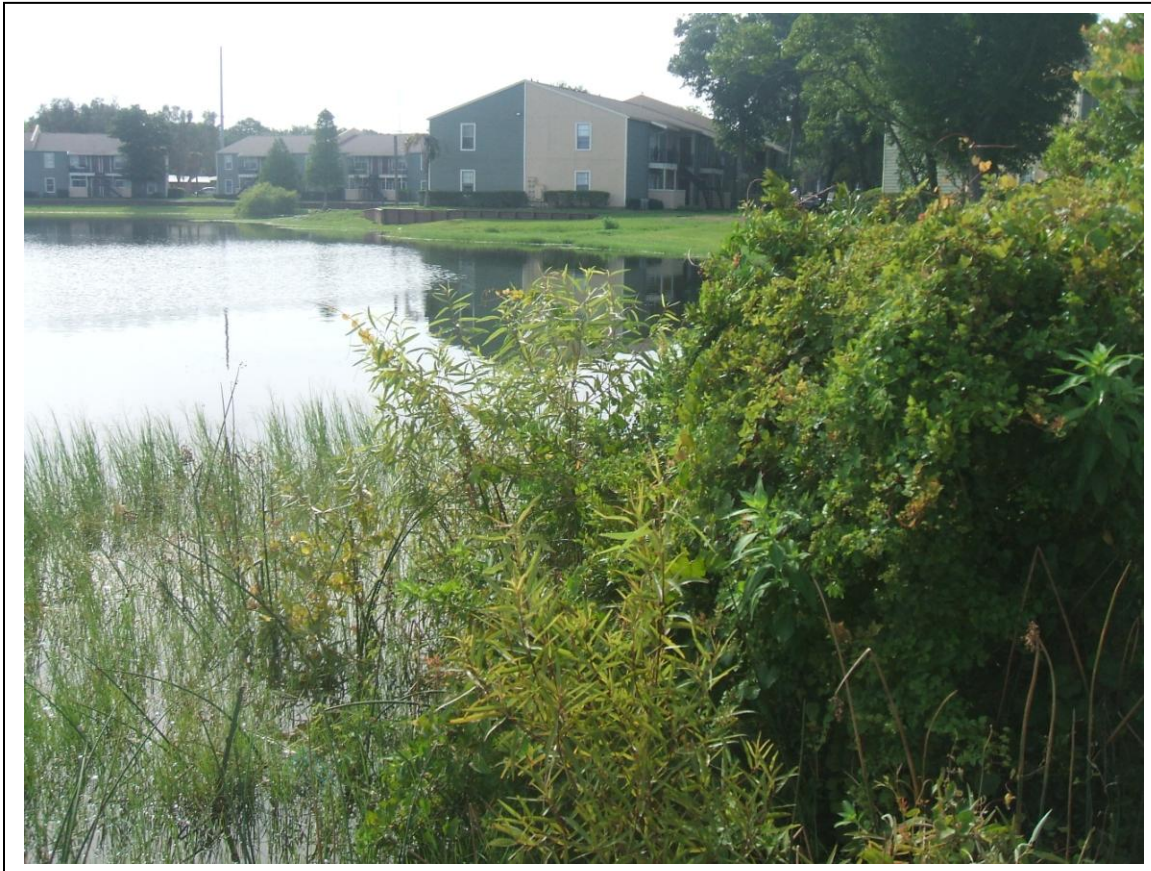
**Figure 1.** Photo of Egypt Lake, taken June 26, 2008

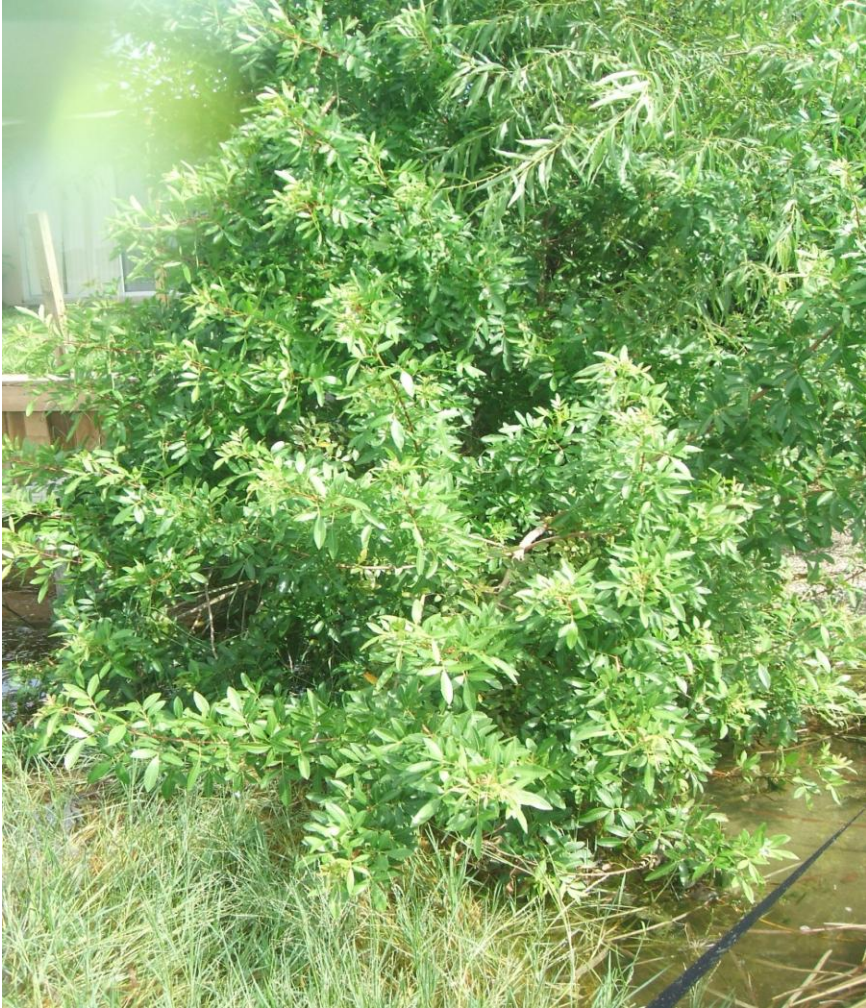
Figure 4 (Left). Photograph of Brazilian Pepper, *Schinus terebinthifolius*, on Egypt Lake. Brazilian Pepper is non-native, invasive plants which commonly out-compete native plant communities in natural and disturbed areas.

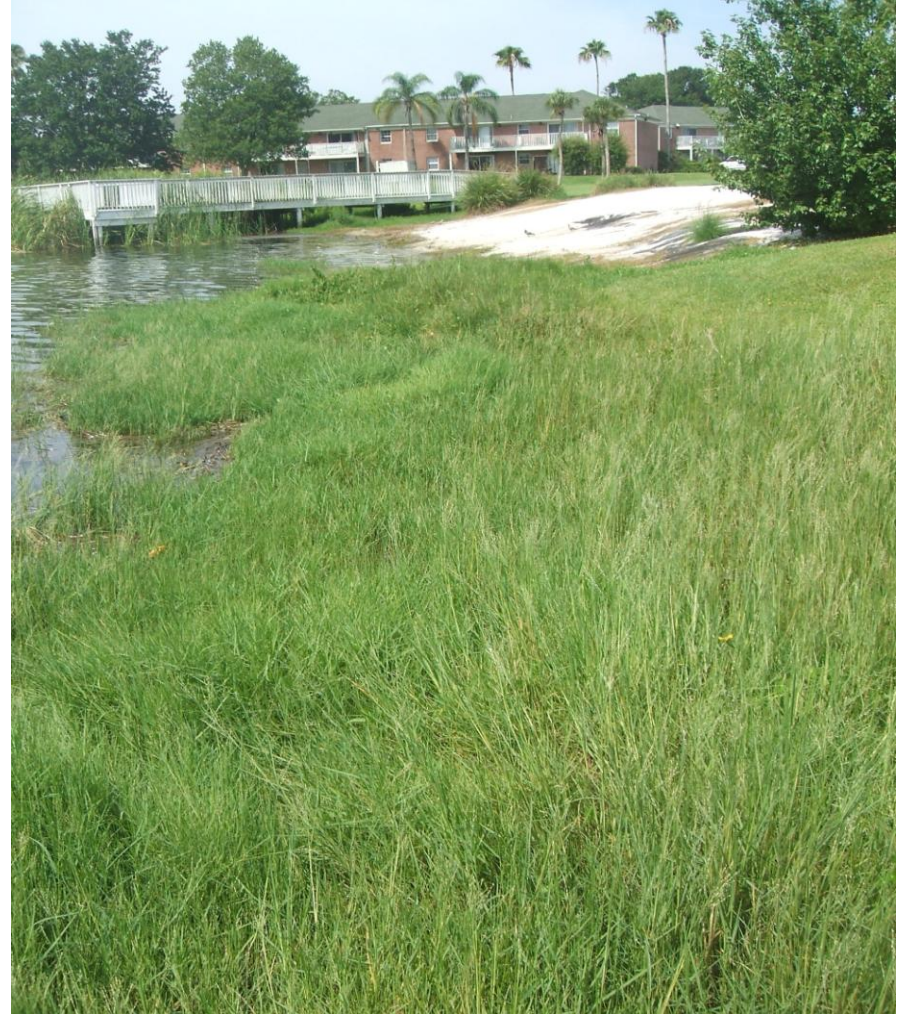
Figure 5 (Right). Torpedo Grass, *Panicum repens*, is a common non-native invasive grass in Florida wetlands. Torpedo grass displaces native species such as Maidencane, *Panicum hemitomon*, and Shore Rush, *Juncus marginatus*.

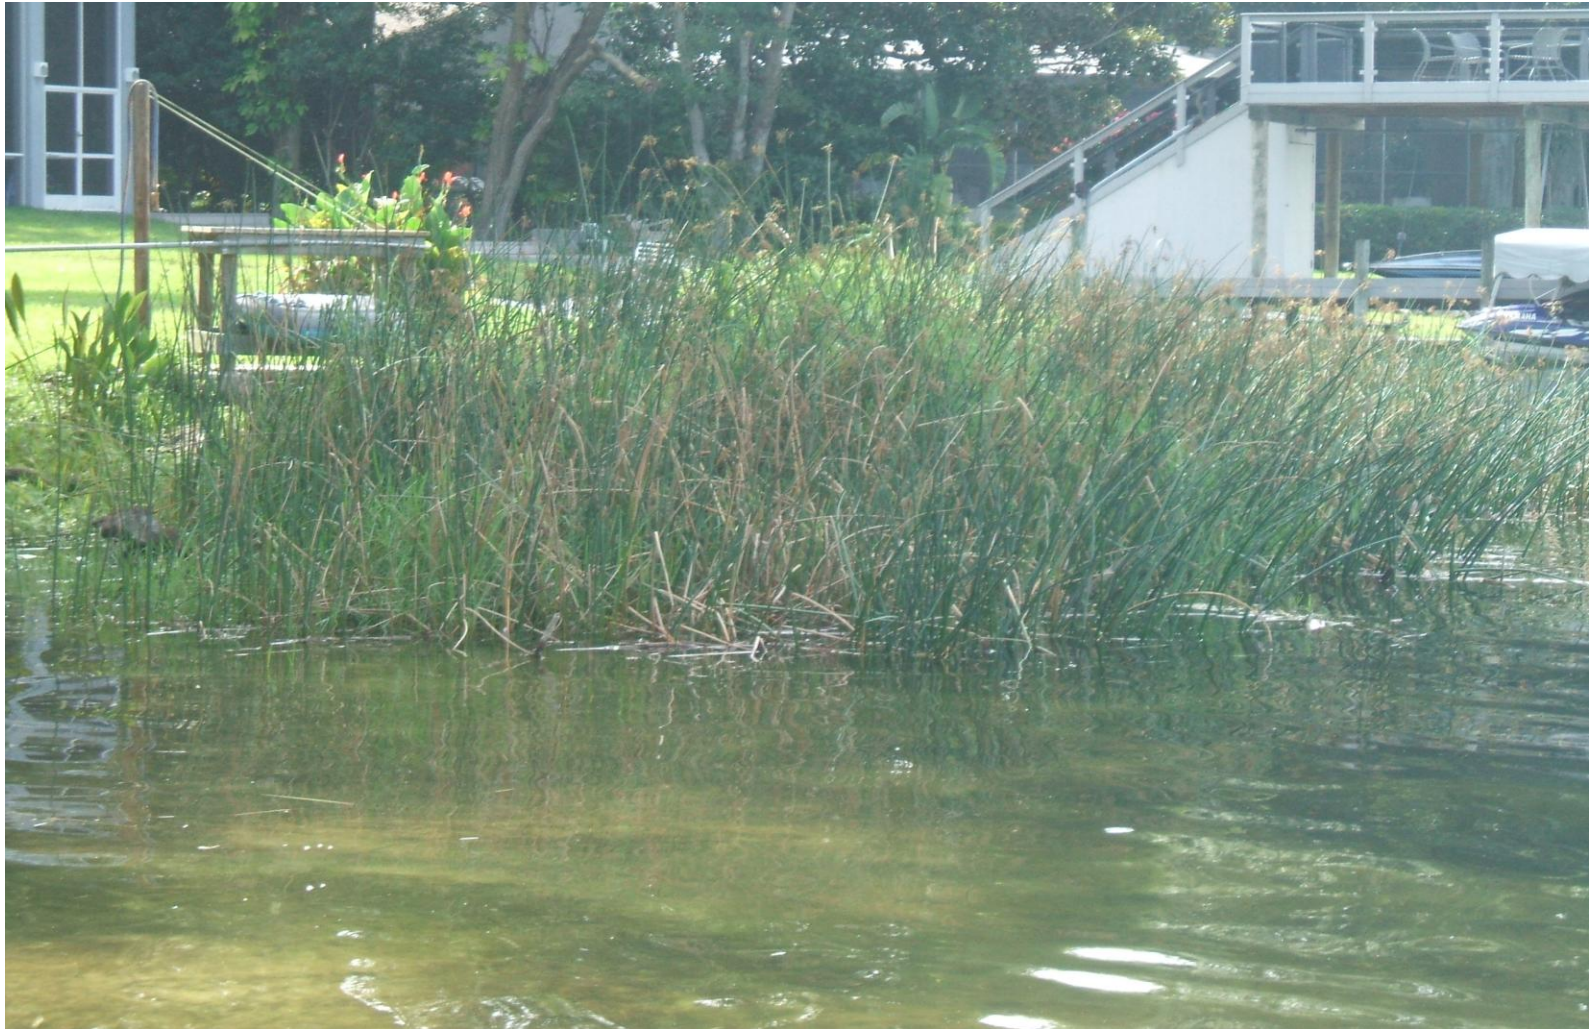
Figure 6. Soft-stem Bullrush, *Scirpus validus*, is a native species commonly occurring in Florida lakes. This species provides shelter for native species of fish and invertebrates.

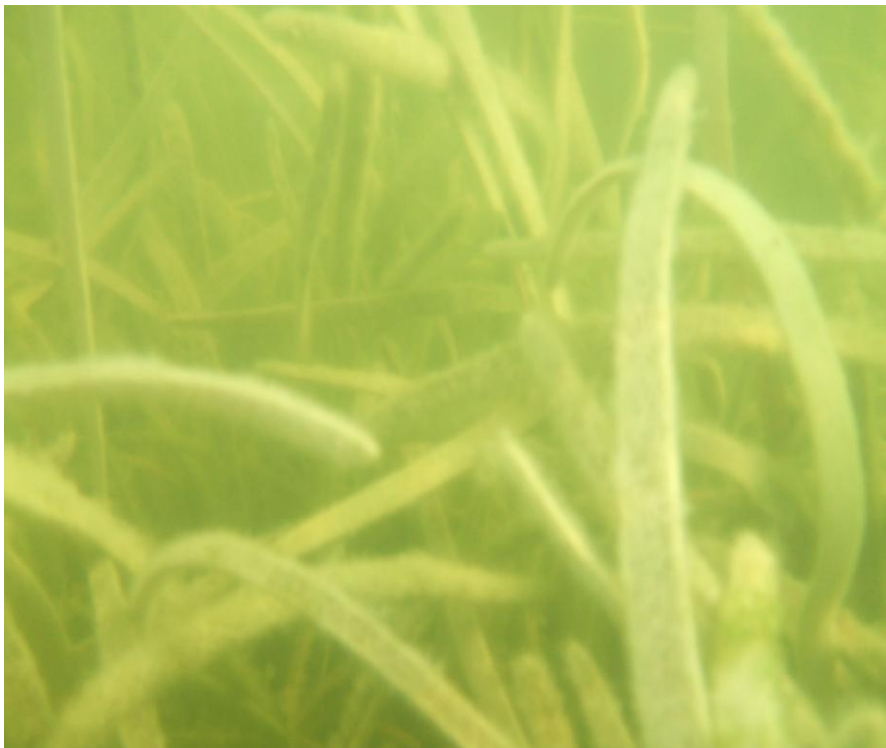
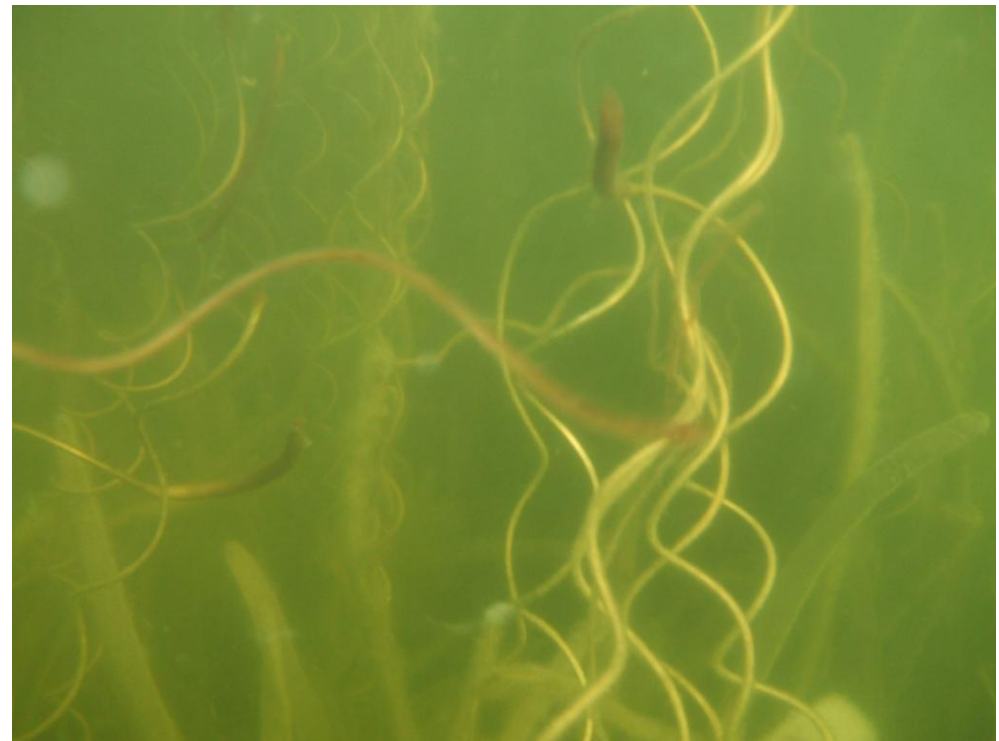
Figure 7. Tapegrass, *Vallisneria Americana*, is a common native submerged vegetation in Florida lakes. Submerged vegetation such as this aids in removing nutrients from the water column, resulting in increased water quality.
