# “Walk the WBID” Summary Presentation #1 (Hogan Creek)

# Bacteria Source Identification Walk the WBID Summary

# Hogan Creek (WBID 2252)

This technical report on Leeds Pond (Waterbody Identification [WBID] Number 2308) is one of a series of technical reports (one each produced for 53 of the impaired tributaries of the Lower St. Johns River) intended to help identify sources of fecal coliform pollution by interpreting the information used to create a series of maps (found in **Appendices A and B**). These maps provide watershed context, summarize water quality sampling locations, and help identify sources of fecal contamination.

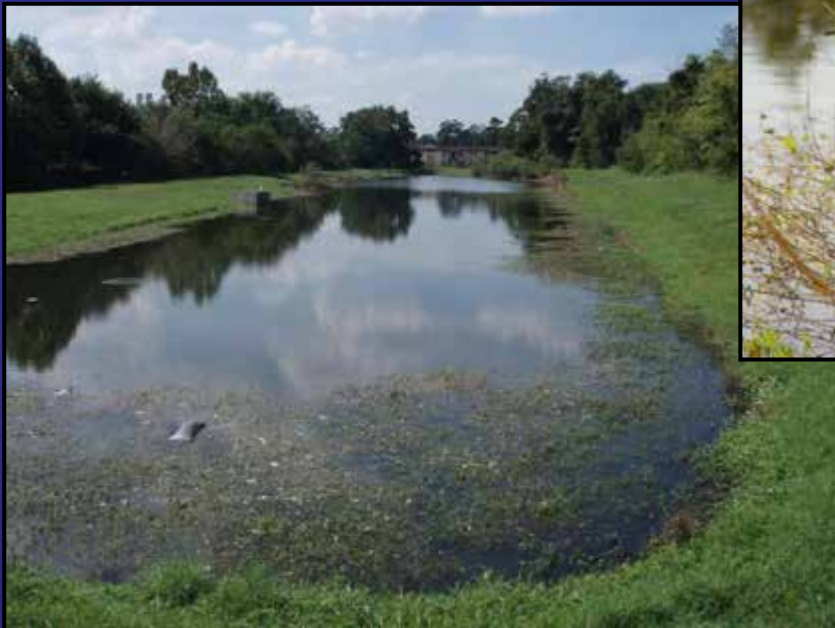
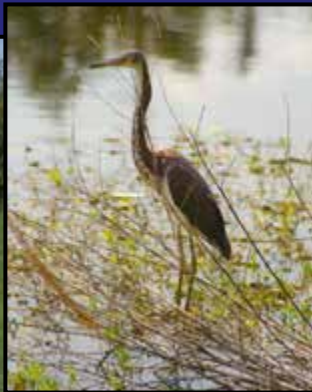
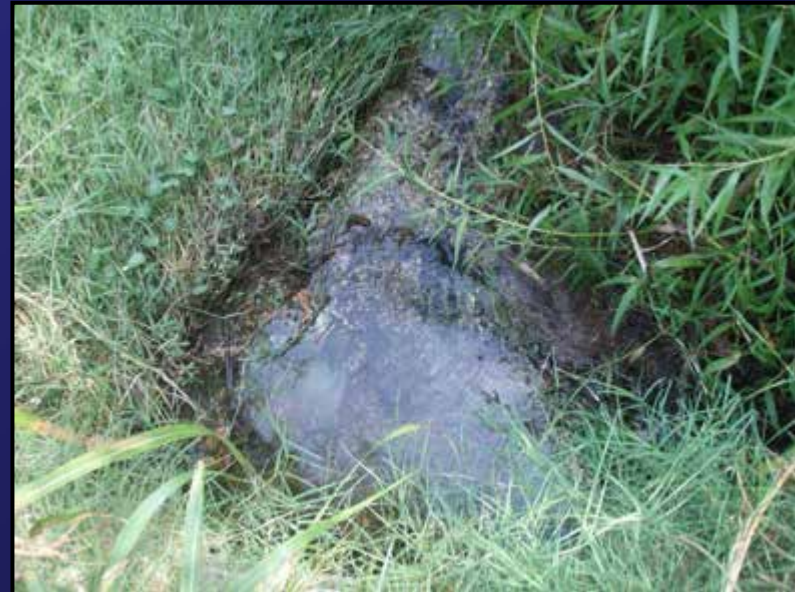
- Northwestern Branch
  - Several drop inlets feed retention pond that connects to creek (THC4)
    - Venus and Mars apartment complex inlet full of trash
    - Few birds in pond

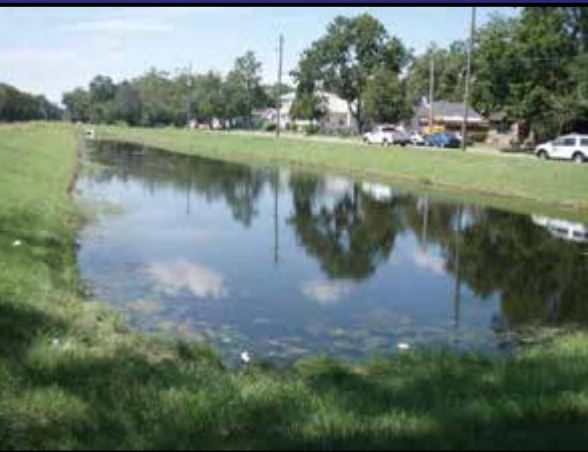
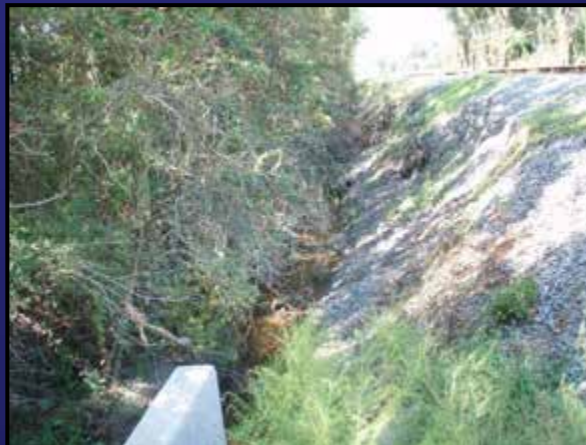
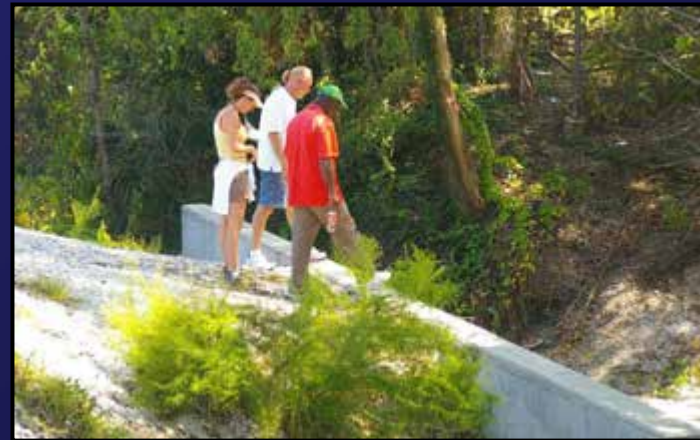
- Main Channel (upstream)
  - New retention pond at Flanders and 16<sup>th</sup> connects into railroad swales and then into creek at new endwall
    - Trash in creek
    - No OSTDS found on west side of creek (JEA Yard)
  - Food out for cats near creek at 13<sup>th</sup> Street (THC5)
  - Creek piped downstream of 10<sup>th</sup> Street (HC3)

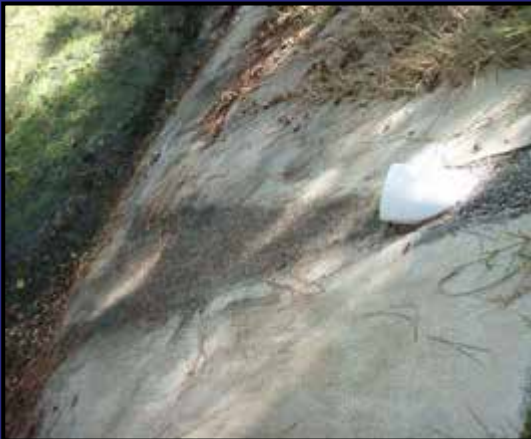
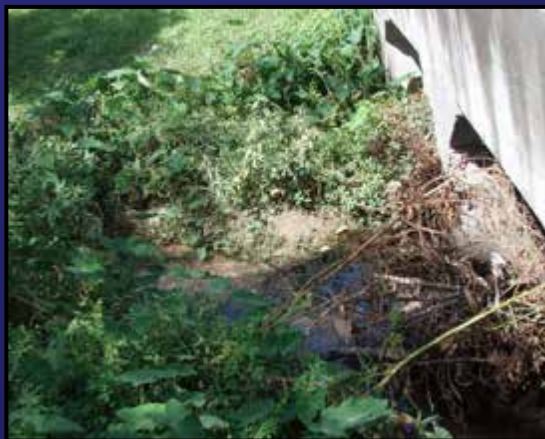
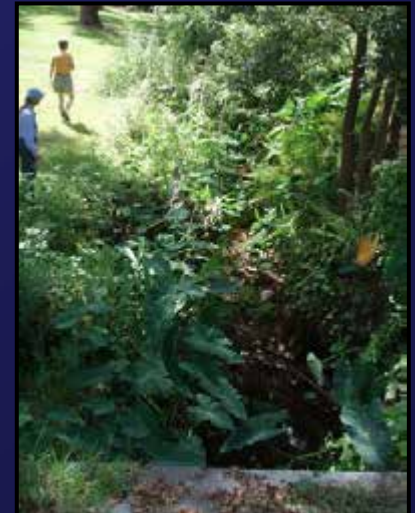
- Western Fork
  - Headwaters at Lakeshore
  - Several PVC pipes entering creek from bank (no flow)
  - Piped downstream of Yerkes St. (TBF6)
    - Smells like dog feces in area
  - Recent OSTDS failure at Park St. – DOH to check status (BF3 downstream)
- Central Fork
  - Piped upstream of Amherst St. (TBF5)
    - PIC (black corrugated pipe) downstream – COJ to investigate

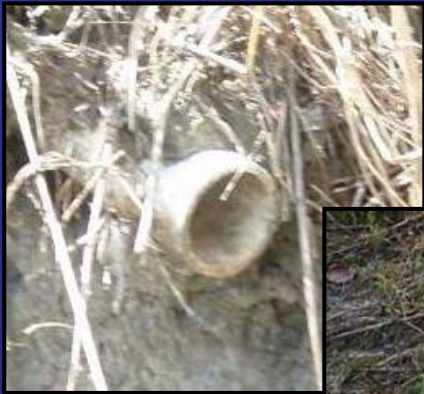
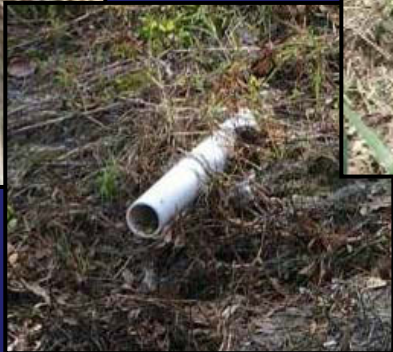
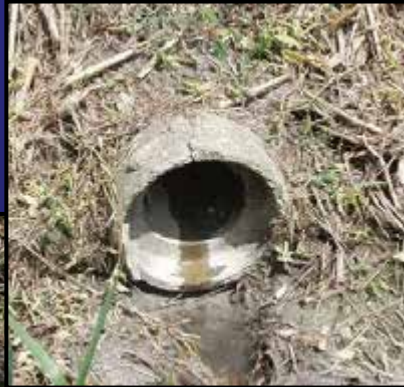
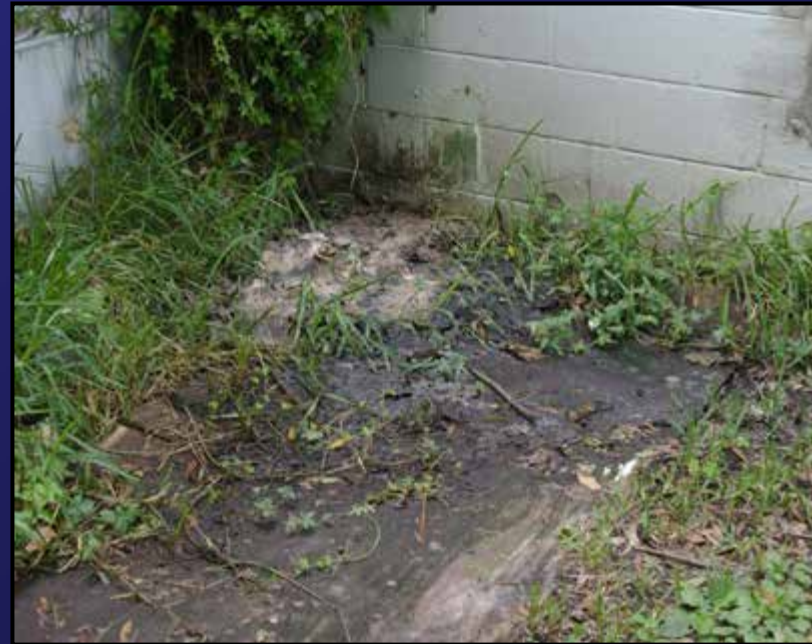
- Eastern Fork
  - Piped upstream of Cassat Ave.
  - 5 PICs between Cassat and Plymouth (most not flowing - **COJ to investigate**) (**TBF4 @ Woodruff Ave**)
    - Fecal material and TP observed outside home
      - DOH: laundry discharge (legal notice sent Oct. 24, 2008); previous plumbing back-up apparently already corrected
  - Hamilton St. (**TBF3**)

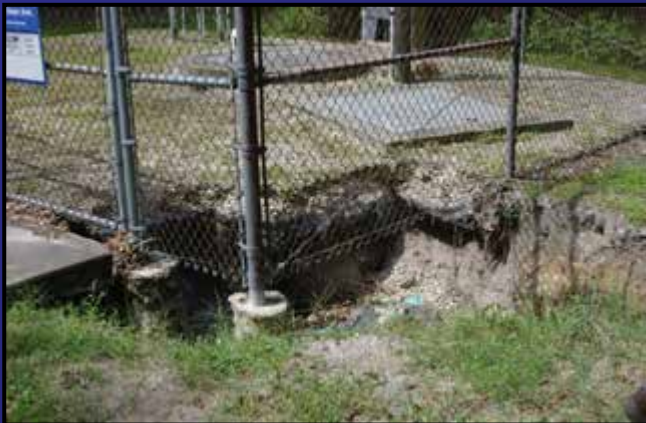
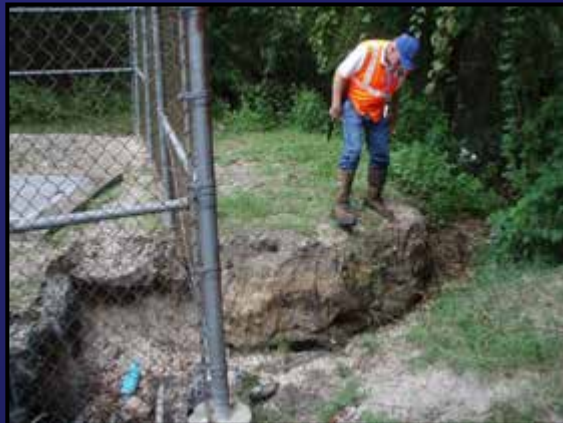
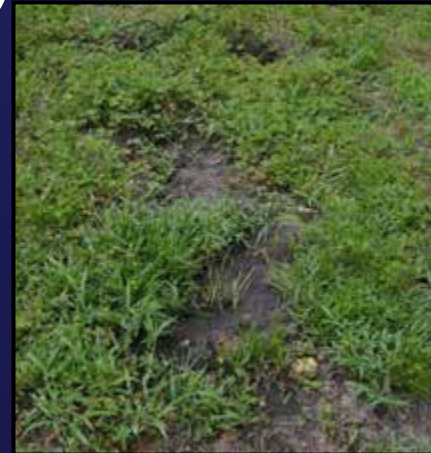
- Main Channel
  - Jersey St. and Glenwood Ave.; between central and eastern forks
    - New JEA LS (not on map) very close to creek
    - Tidal and opens into pond with no canopy (high die-off likely)
  - Merrimac Ave.; downstream of 3 forks
    - JEA LS undermined by runoff (called in by Ron)
    - OSTDS on map, not observed
  - Euclid St. (BF2 @ Herschel St.)
    - OSTDS on map is sewer (grinder pump bad)

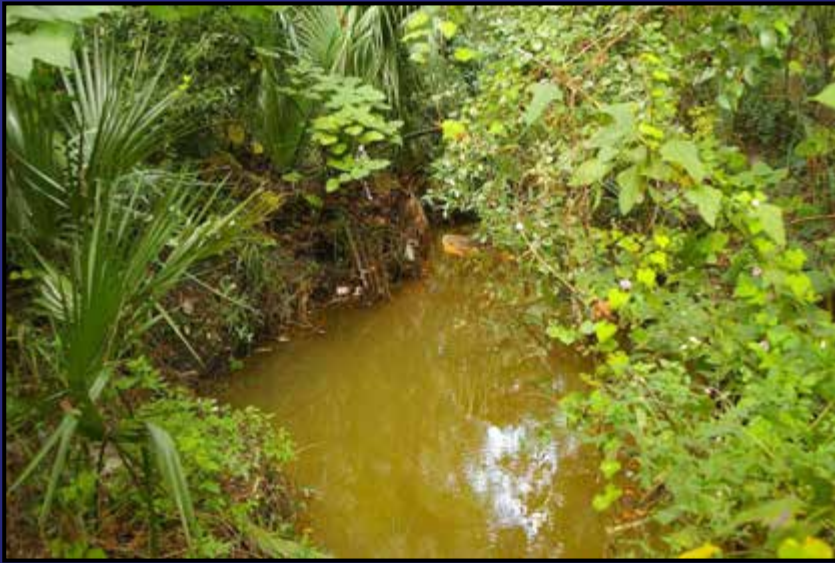
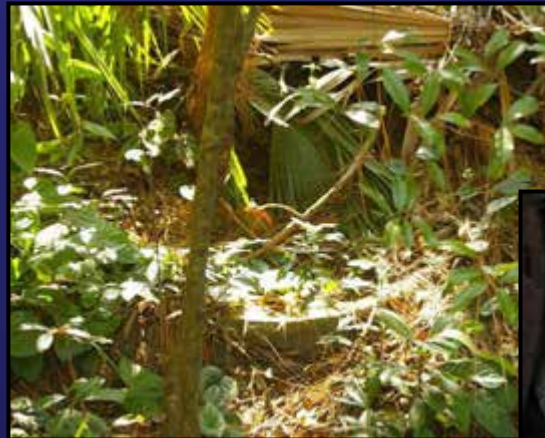
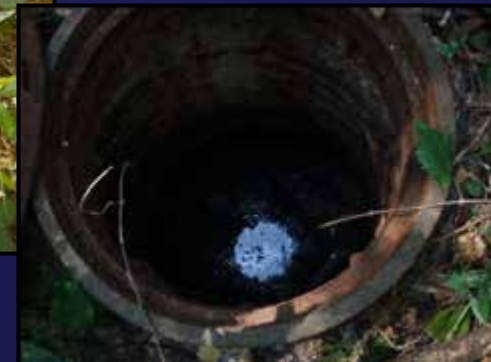
- Southern Fork
  - Piped upstream of Stillman St. (ML3)
    - Stormwater manhole in woods upstream was sampled ~2005 by DEP (FC ~60,000) and by JEA shortly after (FC low)
      - Opened Oct. 1, 2008; sheen, no odor
    - Homeless no longer in area

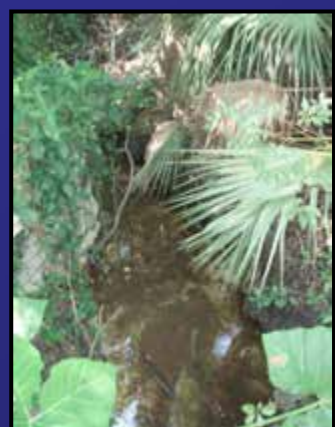
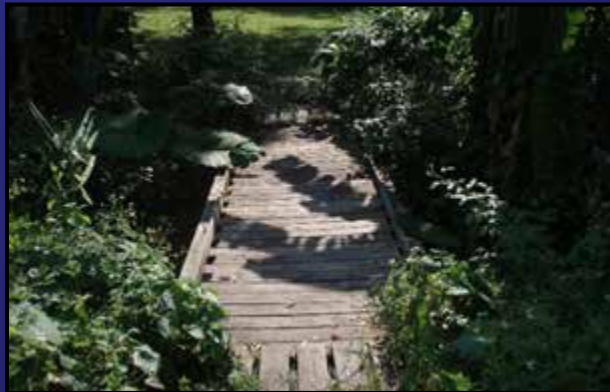
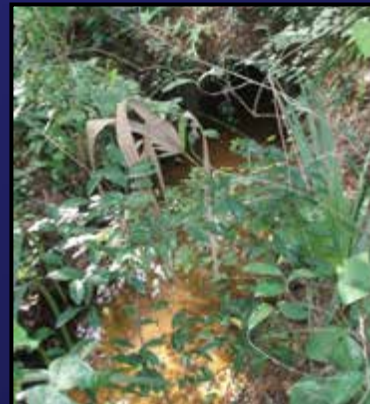
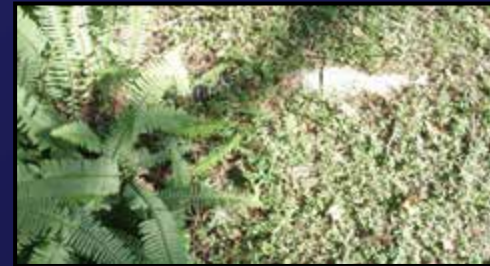
- Northern Fork
  - Walked upstream to footbridge from Camden Ave. (ML2) with resident's permission
    - Piped upstream of footbridge to Spring Park Rd.
    - Upstream OSTDS ~Spring Park Rd. got abandonment permit ~2005/2006
    - Several cats in area (homeowner presumably dumps cat litter into creek)
    - Dog feces in grass next to creek
    - Black corrugated pipe extends from house towards creek (DEP never observed discharge)

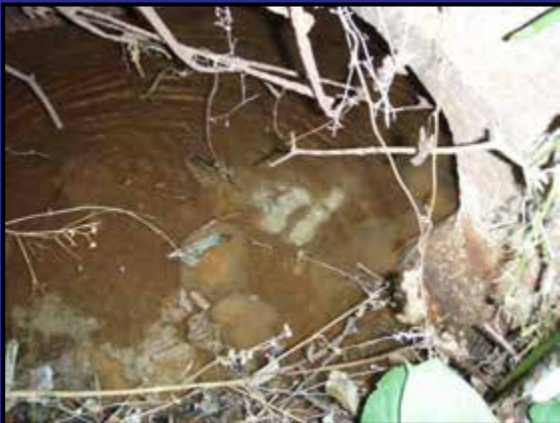
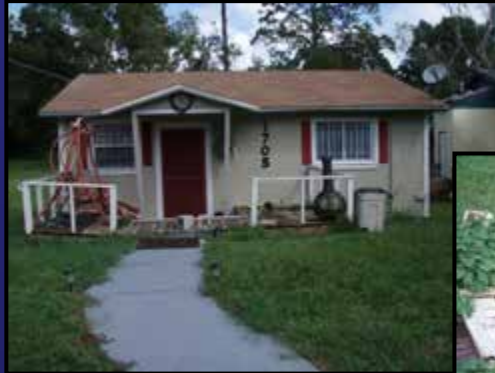
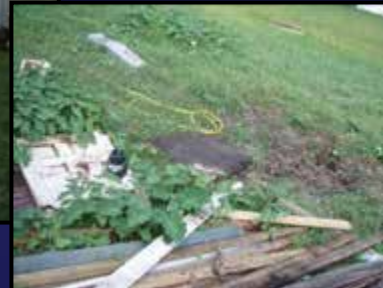
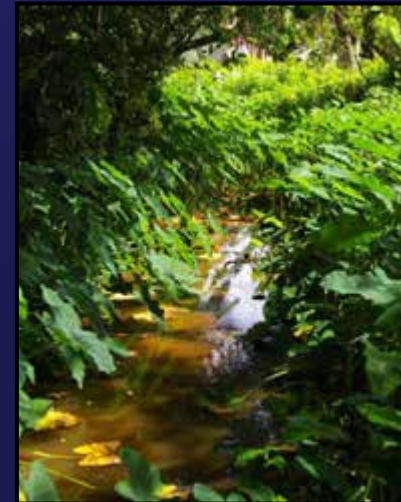
- Main Channel
  - Propose revision of WBID boundary to exclude area east of St. Augustine Rd.
    - Headwaters just west of RPM on Emerson (TMR3)
      - Groundwater seep under culvert (white bubbling sand)
      - 2 small discharge pipes from evaporator behind RPM
  - Western Branch primarily all piped (high flow)
  - Home with sump pump removed, swampy, deck cut into drainfield, no discharge on Brooker Rd. (TMR2) – DOH/DEP to investigate

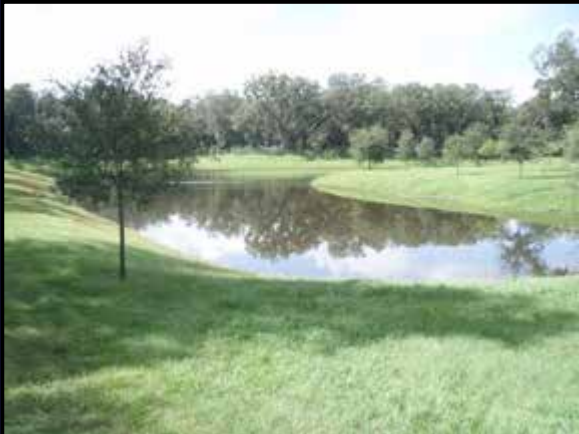
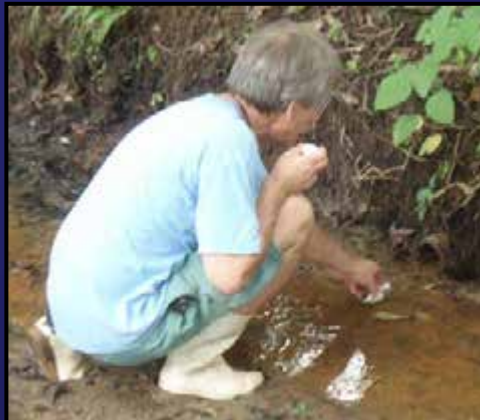
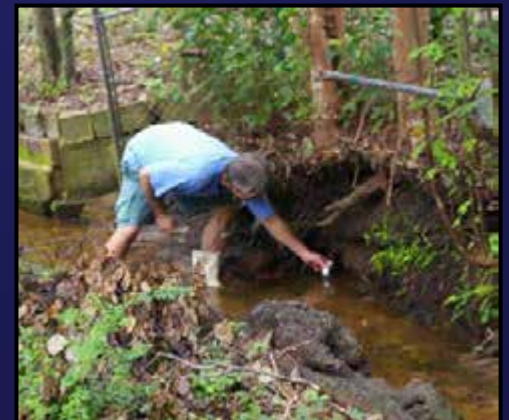
- Main Channel cont.
  - BJP Pond at Callahan St. drains residential neighborhood; outfall to Miramar Creek not identified – **PWD to provide location**
  - COJ sampled PICs in Orlando Cir. Area Sept. 9, 2008 **(MR5)**
    - Rusty pipe (FC = 100)
    - Black corrugated pipe (FC = 5,100) – **DOH to investigate**
    - Vacant house discharge reported to DEP

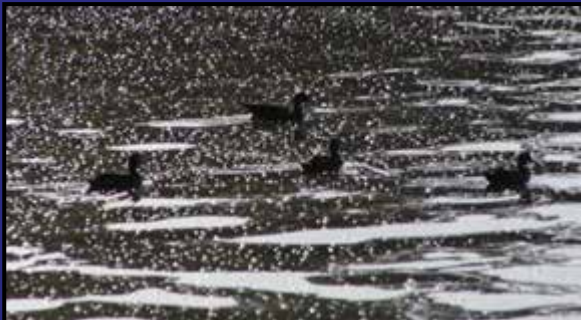
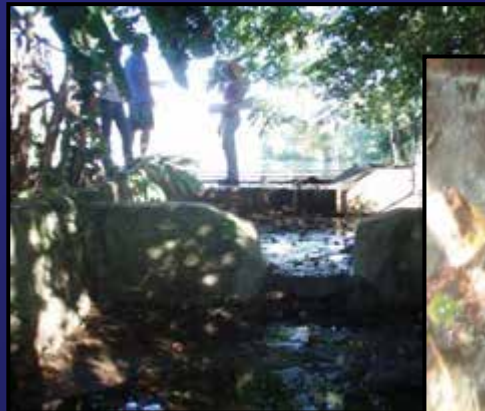
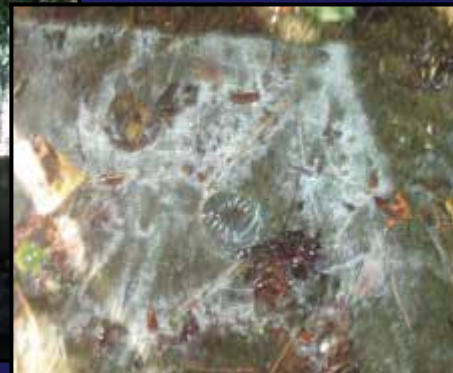
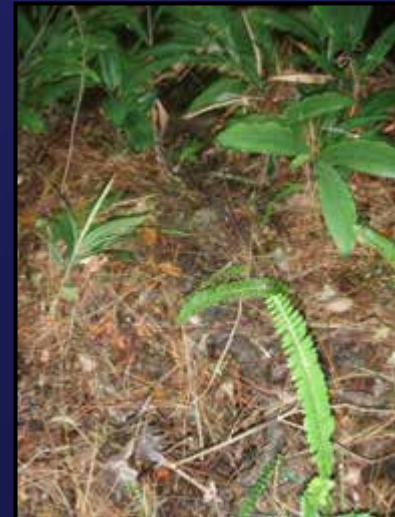
- Northern Branch
  - Colonial Park Pond weir structure overflow
    - *Sphaerotilus* in water?
    - Stormwater outfall and 1-inch PVC pipe just downstream of pond outfall
    - Few ducks in pond
  - JEA Lift Station #S505 (MR4)
    - Operates with dry pit flooded suction (older design allowing for access to work on pumps through dry area)
    - Stormwater outfall to creek from LS probably no longer used
    - Homeless population (caution when sampling)
    - Animal burrow behind LS

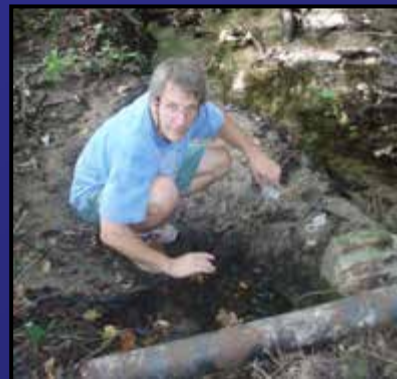
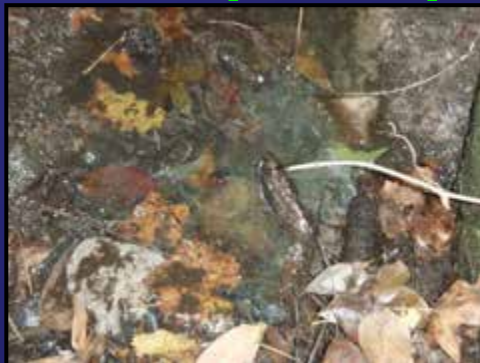
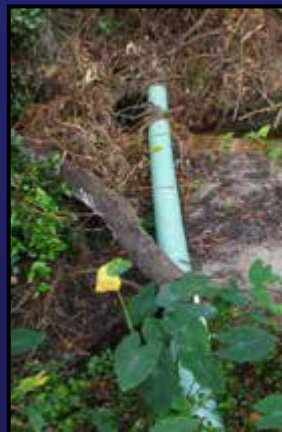
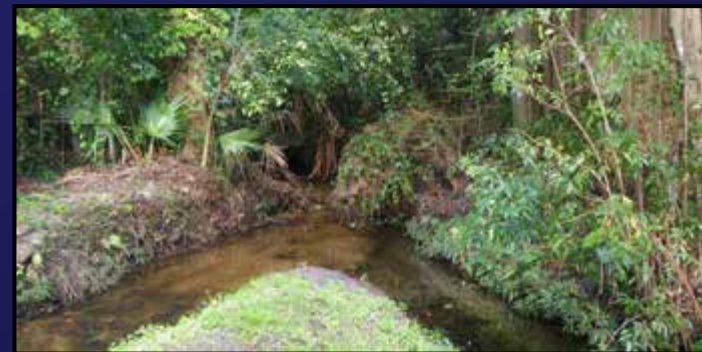
- Northern Branch cont.
  - JEA sewer lines downstream of Greenridge Rd. were upgraded from terra cotta to PVC
  - Seep under sewer line with sewage odor
    - COJ sampled Sept. 9, 2008 (FC = 30,000) – JEA to investigate
  - Green sewer line crossing creek is bowed and needs replacement – JEA to investigate
  - Confluence with main channel upstream of Gadsden Rd. (TMR1)

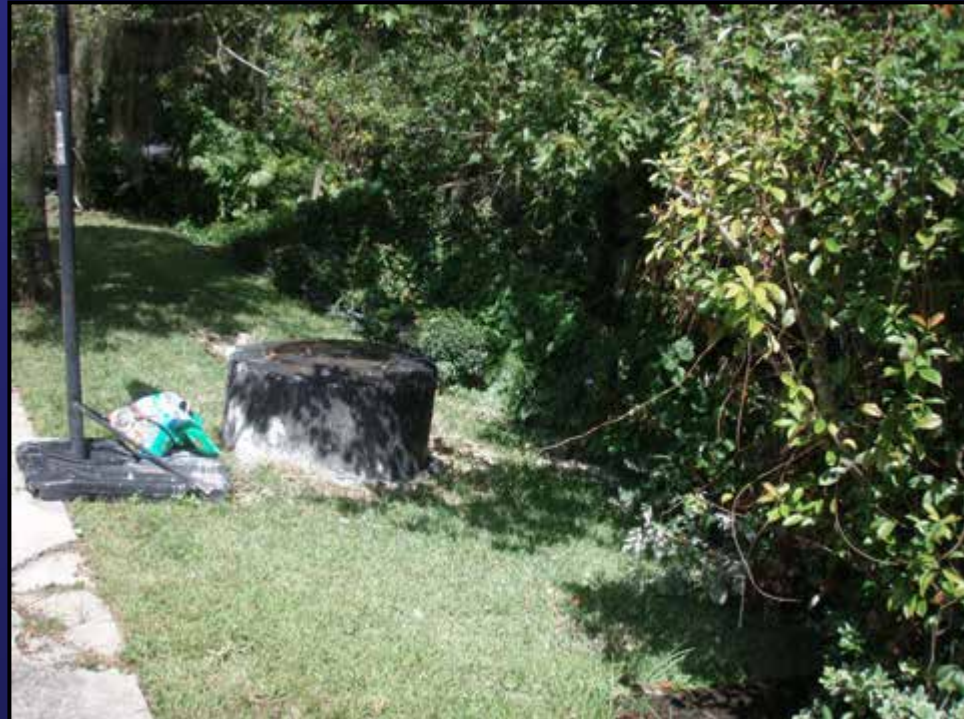
- Main Channel cont.
  - Manhole overflowed into neighboring residence at San Jose Blvd. during Faye (MR1)
  - Last residence on sewer, north of OSTDS failure area

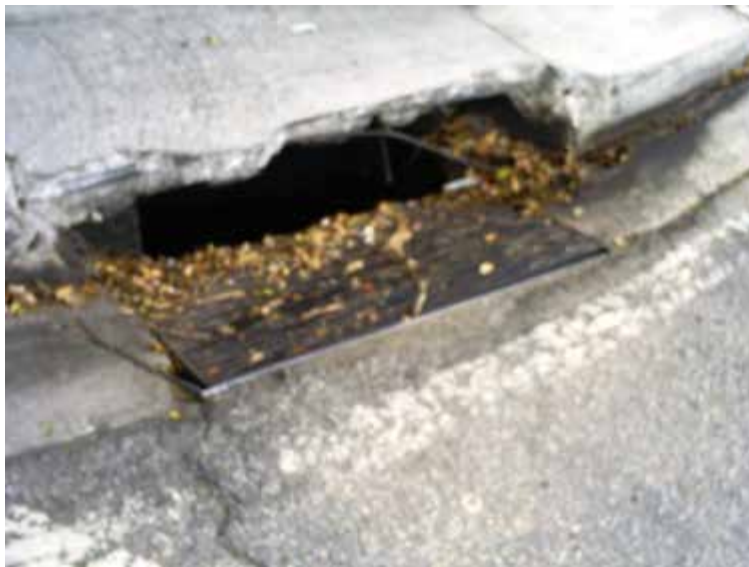
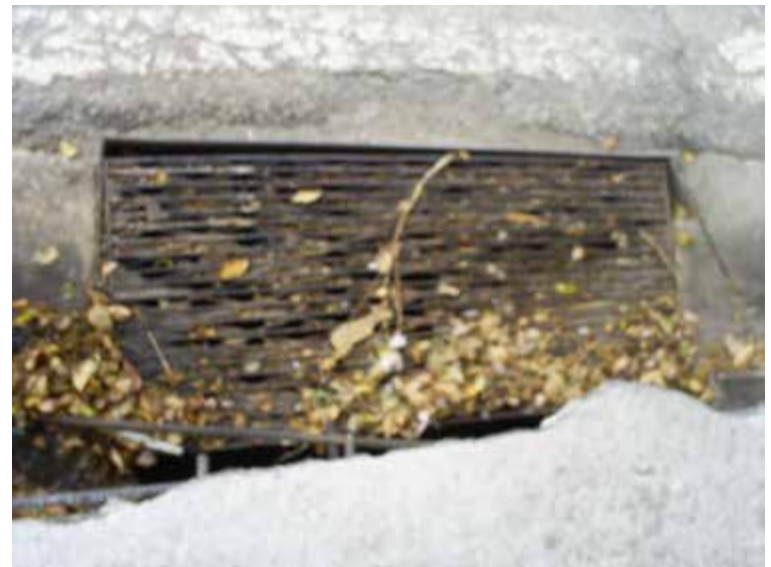
## *Broken Storm Drain Covers @ 20<sup>th</sup> Street*

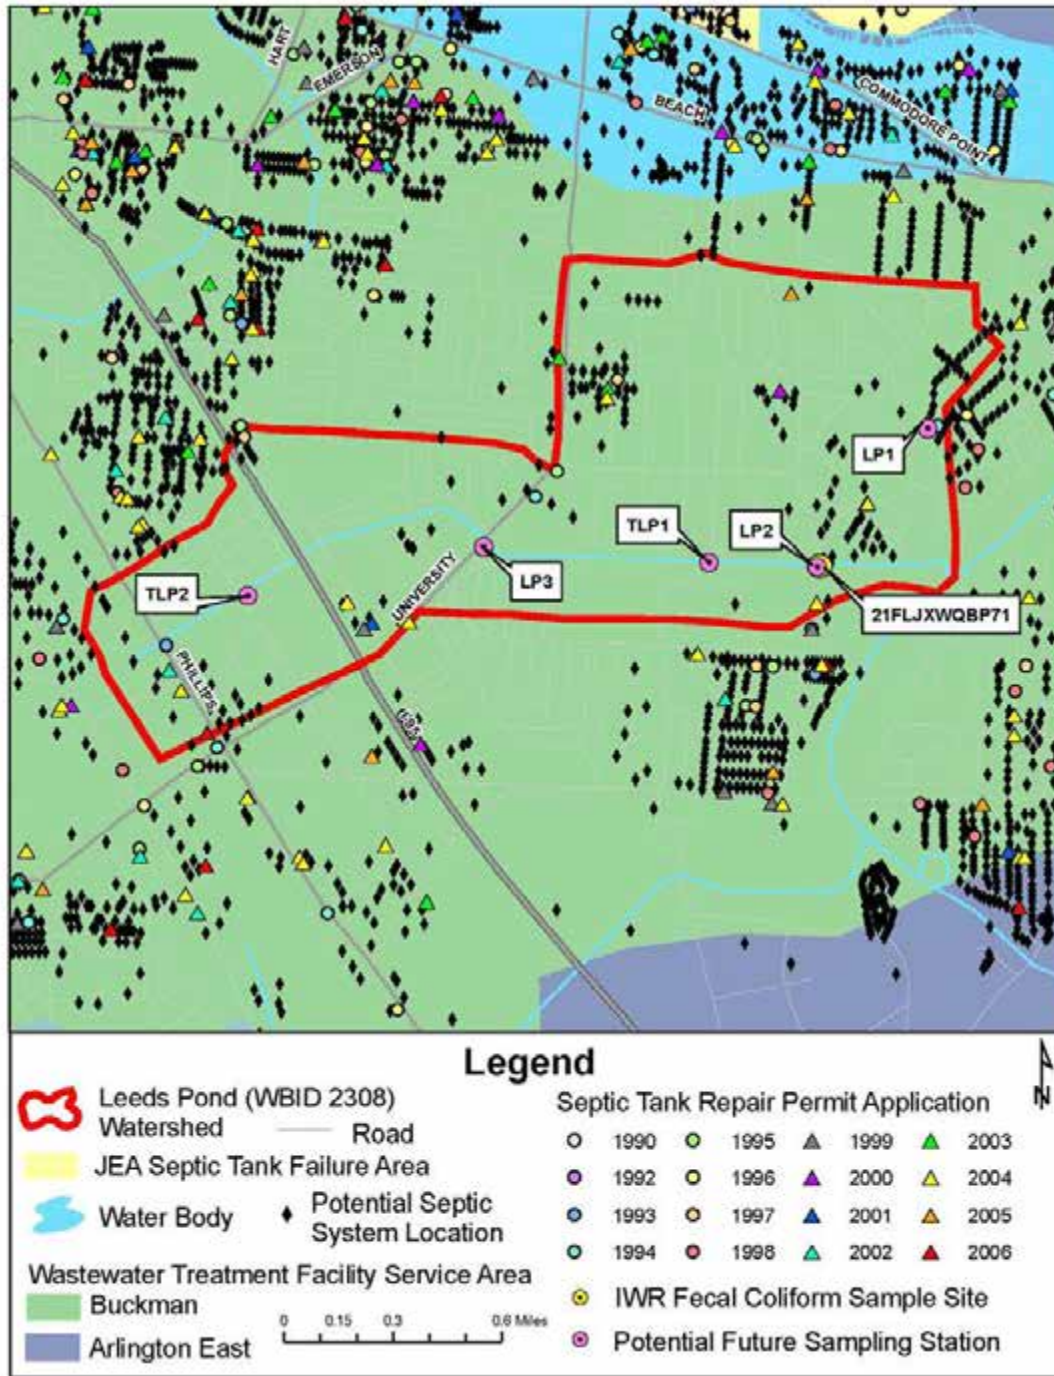
Map 7. OSTDS repair permits and potential locations in the Leeds Pond basin

Considering that an estimated 31% of households utilize OSTDS and that 25 repair permits were filed by property owners throughout the basin, it is possible that OSTDS play a contributing role in fecal loading of Leeds Pond, especially where OSTDS are potentially located and where repair permits occurred in close proximity to surface waters. Many of the potential septic system locations (**Map 7**) and septic system repair permits (**Appendix A, Figure 7**) are located in soils with very slow infiltration rates (**Map 9**), increasing the potential for OSTDS failures in these areas. Of course, it is also possible that failing septic systems that have not been issued repair permits exist in close proximity to the creek and may contribute to bacterial contamination in the receiving waters in other areas of the basin as well. It should be noted that no failing systems were identified within Leeds Pond during the Walk the WBIDs field effort on September 10, 2008.
