# Lake Flynn

## Study Area

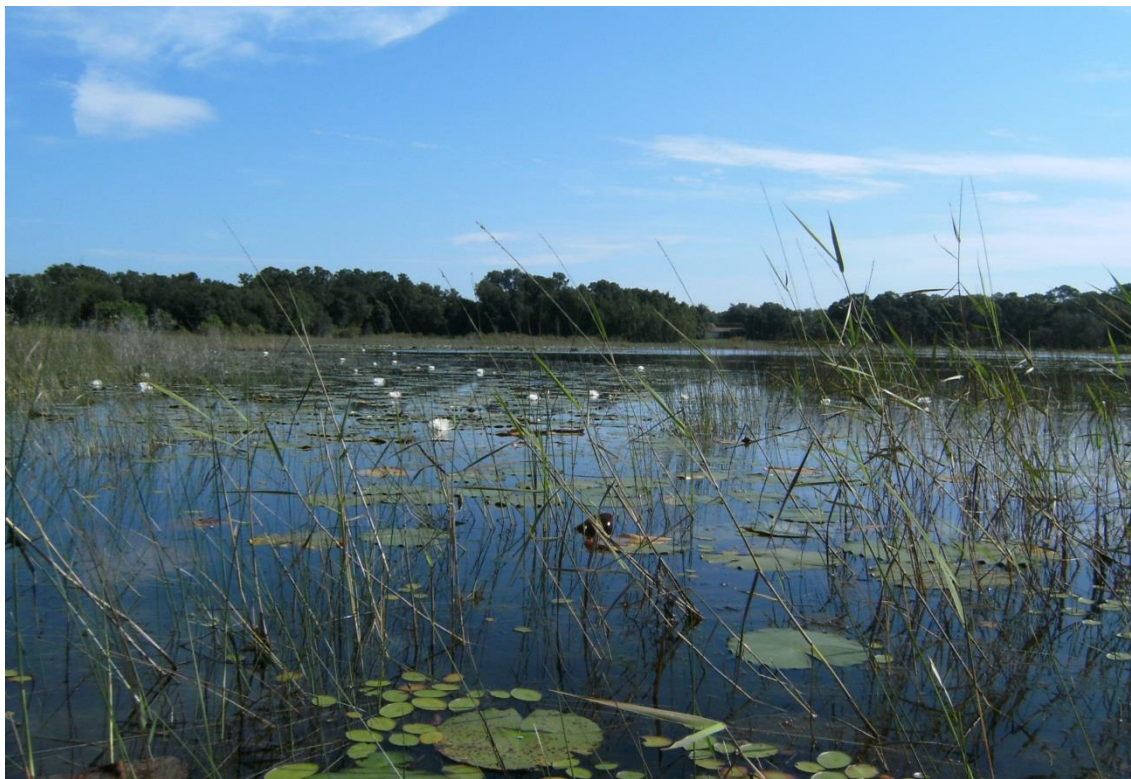
**Figure 3 Overview photograph of Lake Flynn**

The lake assessment for Lake Flynn was conducted on June 23, 2015. Flynn Lake received a lake habitat assessment (FEDP form FD 9000-6) score of 124 due to optimal scores for Vegetation Quality, Stormwater Inputs, Lakeside Adverse Human Alterations, Upland Buffer Zone and Adverse Watershed Land Use. Suboptimal scores were recorded for Secchi and Bottom Substrate Quality. No Marginal or Poor scores were recorded for Flynn Lake.

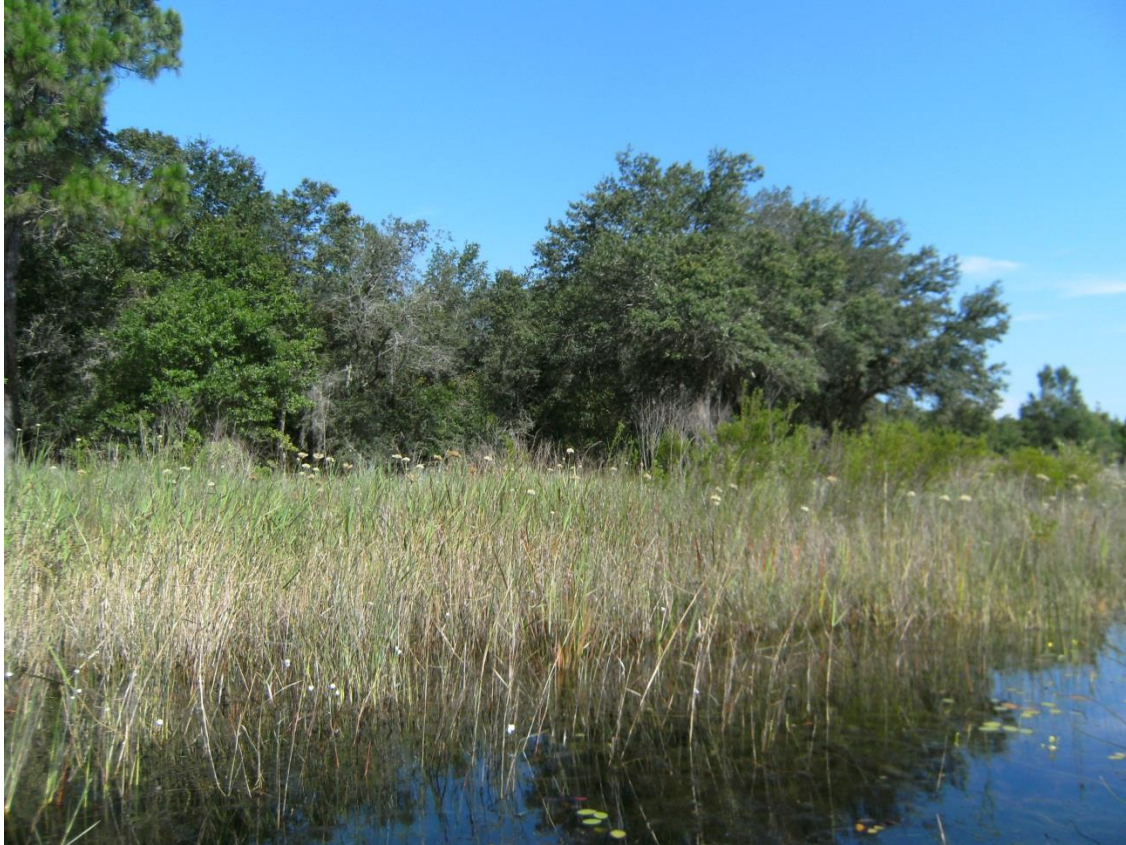
**Figure 4 the emergent vegetation community surrounding Lake Flynn was dominated by native grasses, sedges and rushes.**

The Lake Vegetation Index identified 39 species of wetland vegetation growing in the four selected sections along Lake Flynn. The majority of these species (37) are native species. The remaining 2 species (*Panicum repens* and *Ludwigia peruviana*) are non-native and invasive to this region. The vegetation community along Lake Flynn is dominated by herbaceous emergent species (*Panicum hemitomon*, *Rynchospora tracyi* and *Fuirena scirpoidea*) as shown in Figure 4. The water's surface in Lake Flynn was dominated by *Nymphaea odorata* (Figure 5) with *Nuphar advena* and *Brasenia schreberi* (Figure 6) present as well. The water column of the lake was dominated by *Eleocharis baldwinii* and two species of bladderworts (*Utricularia floridana* and *Utricularia purpurea*). By analyzing the collected sonar chart, submerged aquatic vegetation covered approximately 49% of the surface area of Flynn Lake. This submerged vegetation inhabits an estimated 11.62% of the water volume in Flynn Lake. Figure 7 shows the map of Lake Flynn detailing the LVI regions used for the assessment. Table 2 details the species list results of the Lake Vegetation Index. Table 3 details the scoring result for the Lake Vegetation Index.
