# LAKE ASSESSMENT REPORT FOR LAKE GEORGE IN HILLSBOROUGH COUNTY FLORIDA

Date Assessed: June 15, 2006

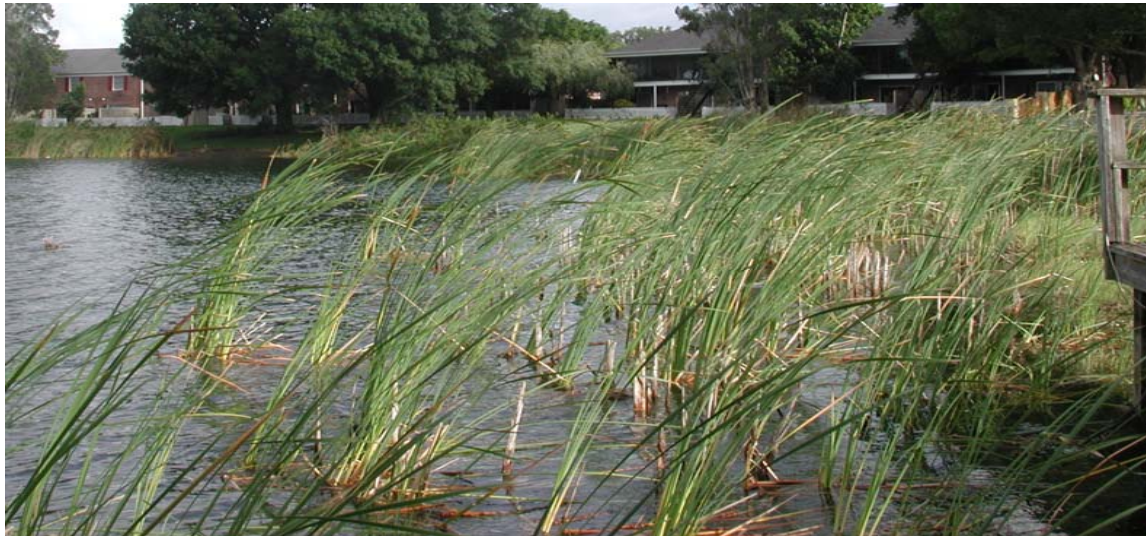
**Figure 4. Cattails (*Typha spp.*) are a common native species on Lake George, however this species can become a dominant species and crowd out other natives.**

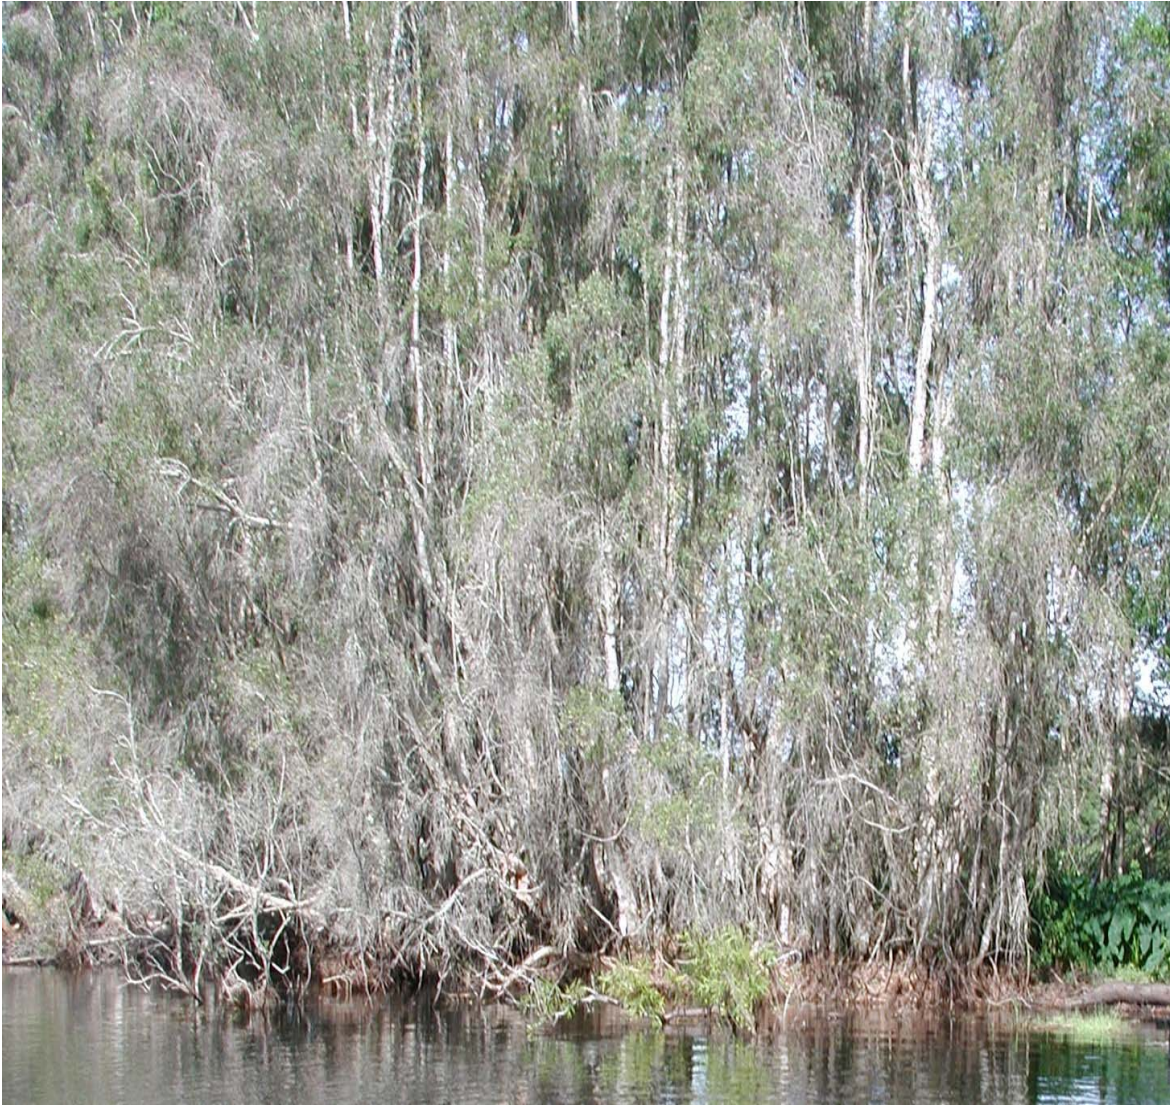
**Figure 5. Melaleuca trees (*Melaleuca quinquenervia*) is a non-native invasive species which can form extensive stands along shorelines as it has in this example from Lake George.**

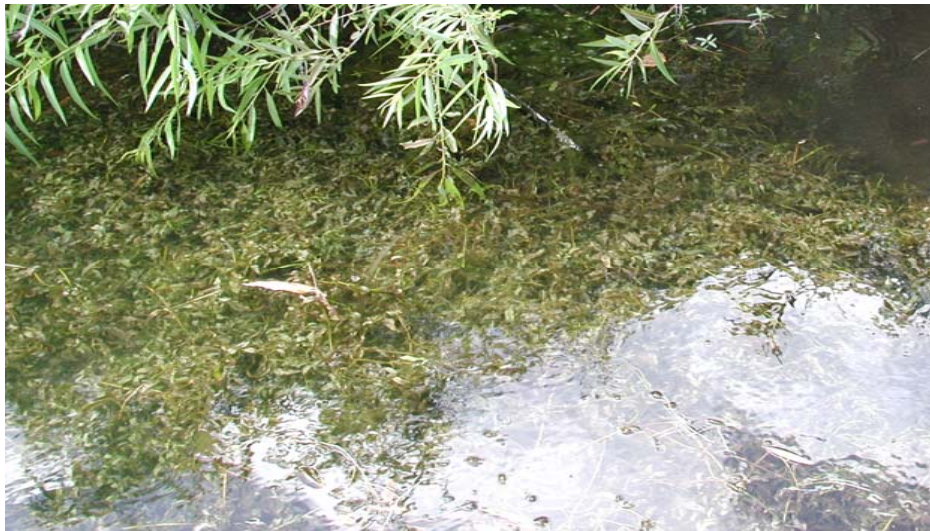
**Figure 6. Pond Weed (*Potamogeton illinoensis*)**

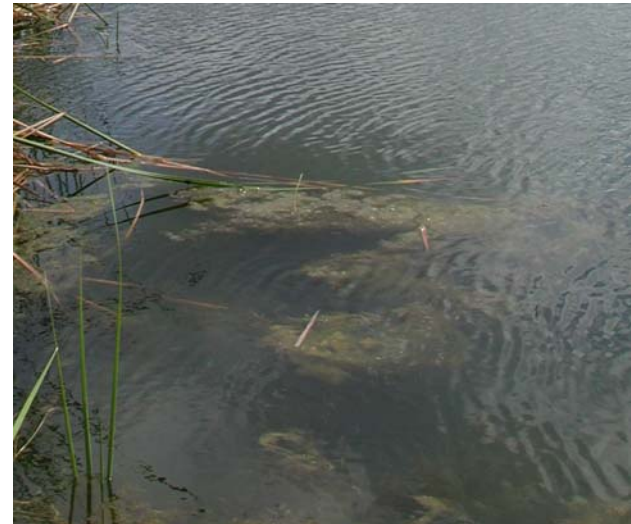
**Figure 7. Floating Algal mats in Lake George.**

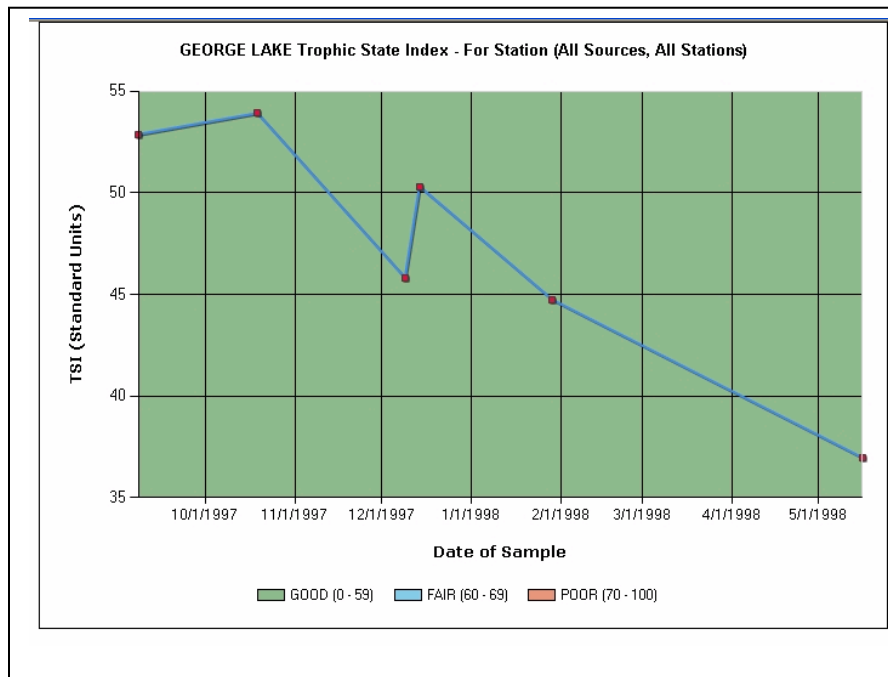
**Note:** The graph above includes benchmarks for using verbal descriptors of "good", "fair" and "poor". The verbal descriptors for these benchmarks are based on an early determination by stakeholders of the generally acceptable and understood terms for describing the state of lakes. The same benchmarks are used for nutrient graphs (Nitrogen and Phosphorus), chlorophyll graphs and trophic state index (TSI) graphs. The TSI is a calculated index of lake condition based on nutrient and chlorophyll (a) concentrations (please see "Learn more about Trophic State Index"). The benchmarks are established based on the TSI range that relates to a specific descriptor. The source for the TSI concentration relationships is the [Florida Water Quality Assessment, 1996, 305\(b\)](#) (Table 2-8). For many lakes there is more than a single source of water quality data. You have the option with the "Select Data Source" drop down to select any available data source and create the graph using that source or you may select "All" to graph all available data. The graph header will also change to reflect the source used.

**Figure 8. Recent Trophic State Index graph from Hillsborough Watershed Atlas.**

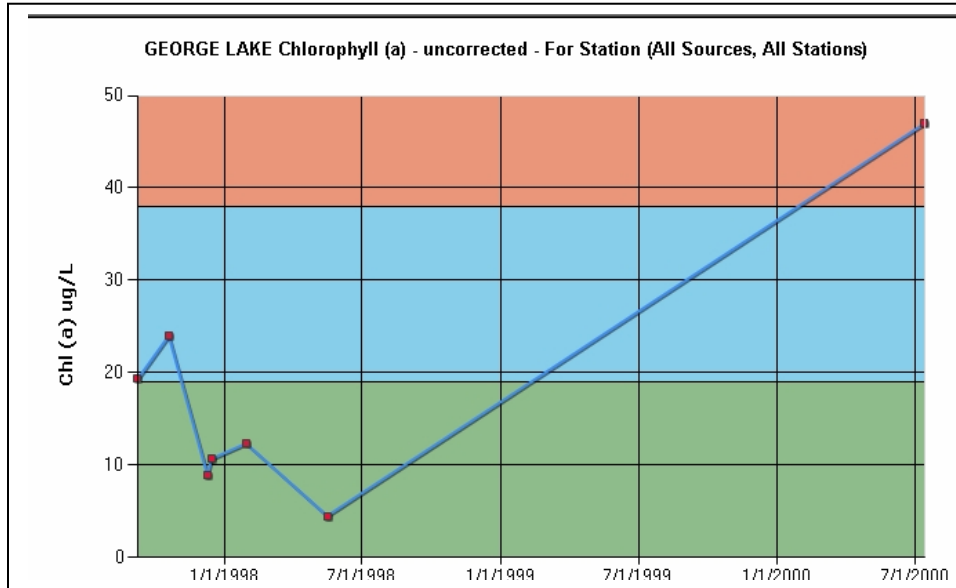
**Figure 9 Lake George Chlorophyll (a) values from LAKEWATCH (uncorrected\_1997-98) and USGS (NWIS) (corrected\_2000)**
