Hendrics East Lake

Study Area

The lake assessment for Hendrics East Lake was conducted on July 27, 2015. Hendrics East Lake received a lake habitat assessment (FEDP form FD 9000-6) score of 35 due to Poor scores for Stormwater Inputs, Vegetation Quality, Adverse Watershed Land Use, Lakeside Adverse Human Alterations, Upland Buffer Zone and Bottom Substrate Quality. Marginal scores were given for the Secchi Depth.

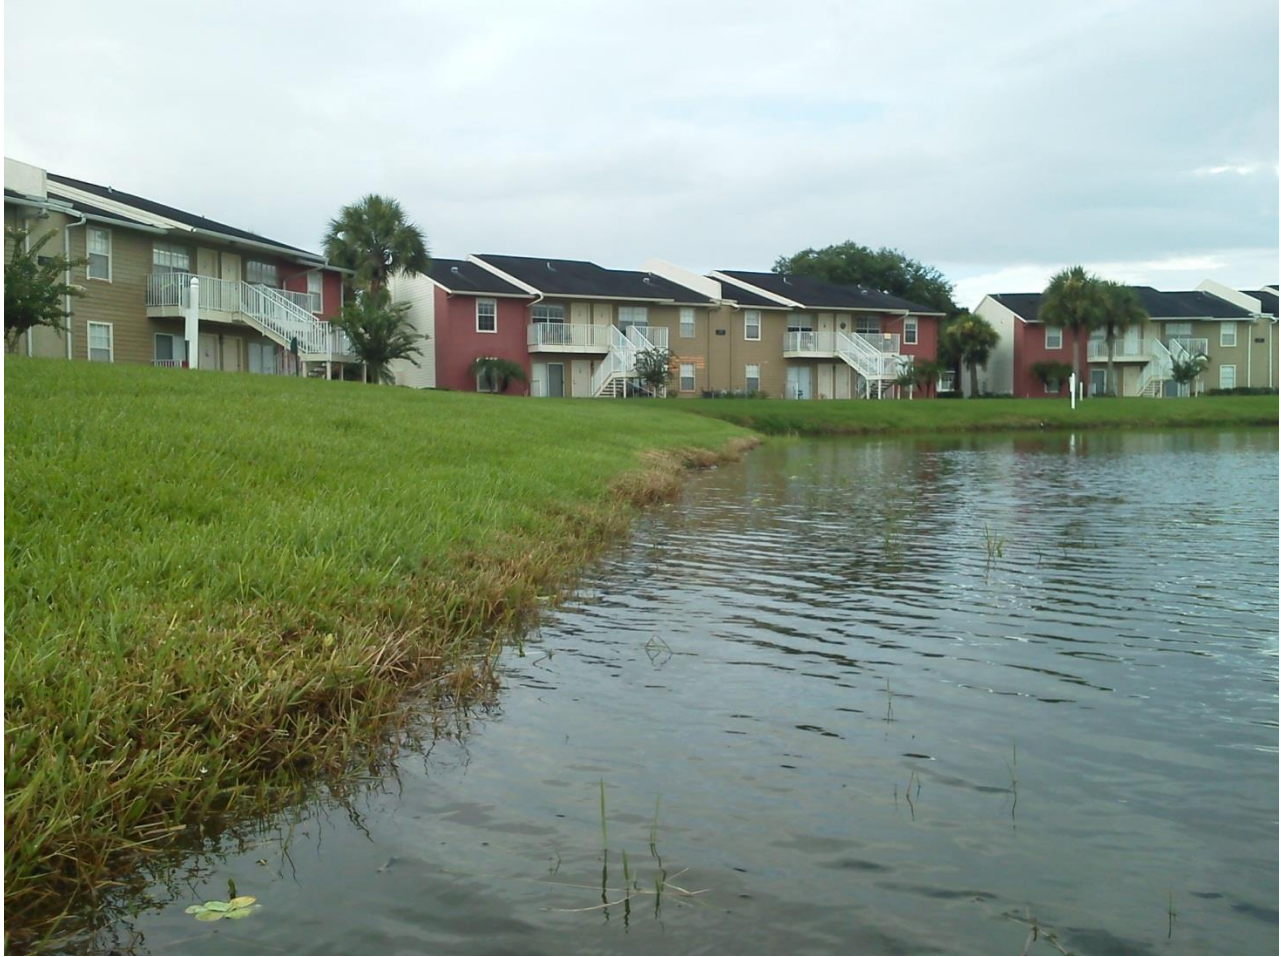
Figure 4 the emergent vegetation community surrounding Hendrics East Lake was heavily disturbed by frequent mowing.

The Lake Vegetation Index identified 25 species of wetland vegetation growing in the four selected sections along George Lake. The majority of these species (18) are native species. The remaining 7 species in bold in Table 2 are non-native and invasive to this region. The emergent vegetation community along Hendrics East Lake is heavily disturbed from frequent mowing leaving very few species of wetland vegetation (Figure 4). The majority of species that are present are small diminutive species. Only region 3 had a dominant species out of the regions used in the analysis. The dominant species in region 3 was *salix caroliniana* shown in Figure 5. The water's surface in Hendrics East Lake was dominated by *pistia stratiotes* (Figure 6). The water column of the lake did not have any observed submerged vegetation species. Hendrics East Lake obtained a LVI score of 5 at the time of the assessment. By analyzing the collected sonar chart, submerged aquatic vegetation covered approximately 9% of the surface area of Hendrics East Lake. This submerged vegetation inhabits an estimated 1.93% of the water volume in Hendrics East Lake. Figure 7 shows the map of Hendrics East Lake detailing the LVI regions used for the assessment. Table 2 details the species list results of the Lake Vegetation Index. Table 3 details the scoring result for the Lake Vegetation Index.
