Itchepackesassa Creek

STREAM HABITAT ASSESSMENT, STREAM CONDITIONS INDEX, LINEAR
VEGETATION SURVEY, RAPID PERIPHYTON SURVEY AND WATER QUALITY

David Eilers, Thomas Van Sant | USF Water Institute | April 1, 2024

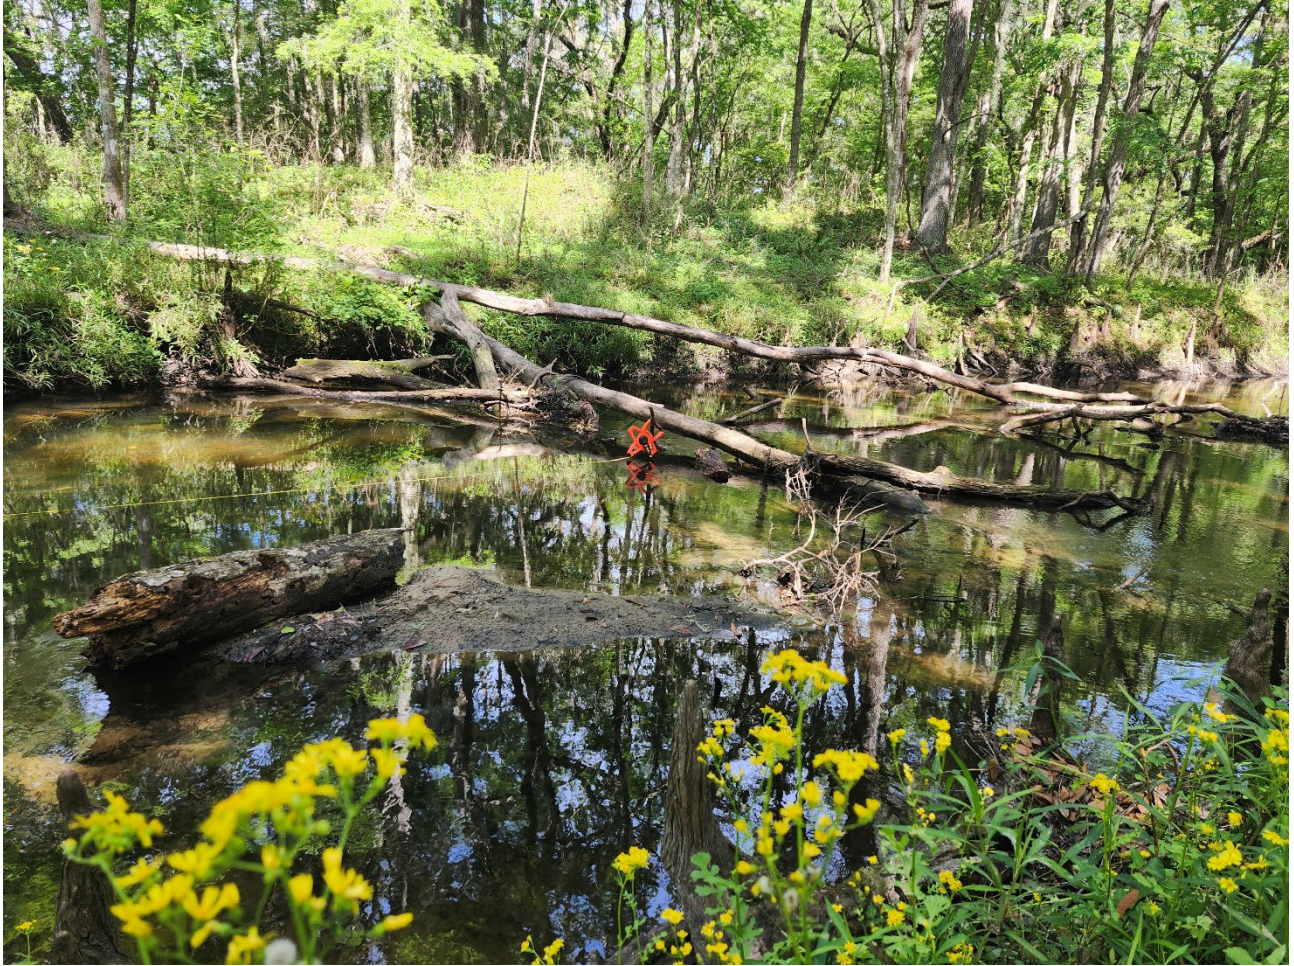
Figure 2 A photograph of the end of the 100 m sample region in Itchepackesassa Creek.

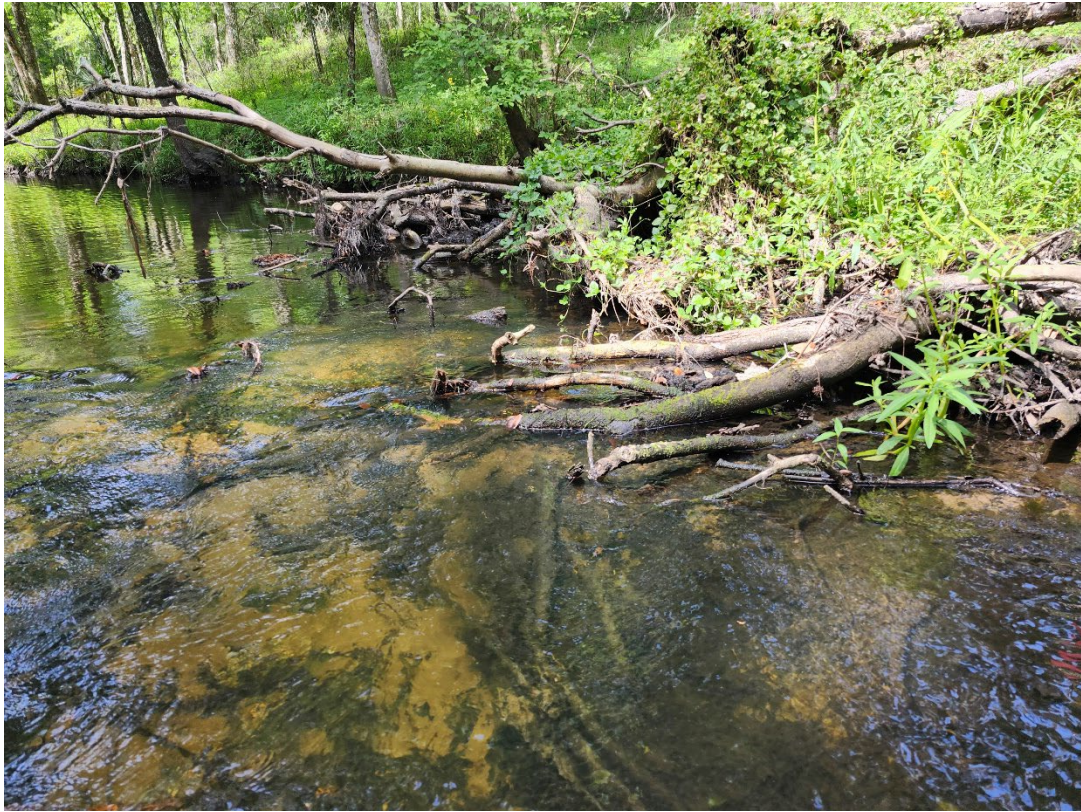
The primary habitat components of the FDEP Habitat Assessment focus on in-water habitat. The primary habitat components score in the suboptimal category for Water Velocity (0.22 m/s), Habitat Smothering (adequate number of stable pools with many productive habitats affected by sand and silt smothering), and Substrate Diversity for having three major productive habitats (rock, snag, and leaf packs) present in the stream. Substrate Availability was scored as marginal for having major productive habitats in 8.9% of the stream. Minor habitats included roots/undercut banks and sand and silt deposits. The total score for the primary habitat components was a 44 out of 80.

Figure 3 A photograph of snag (major productive habitat) with some sedimentation in Itchepackesassa Creek.

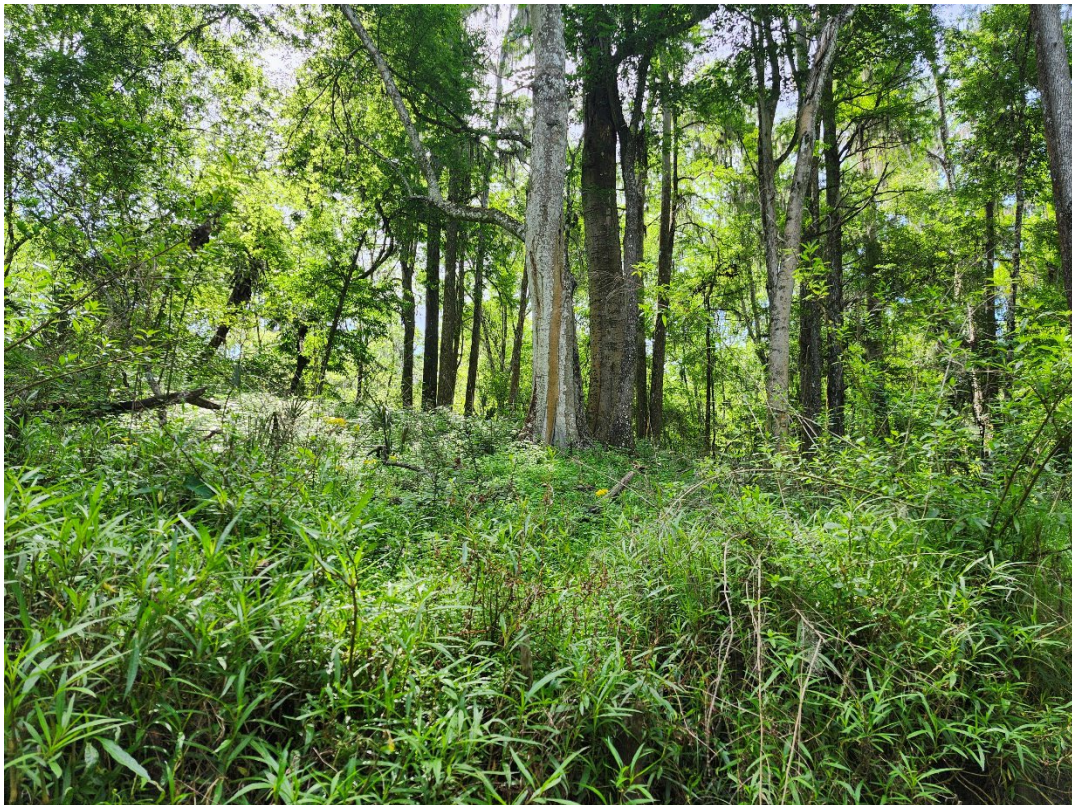
The secondary habitat components of the FDEP Habitat Assessment focus on the surrounding features of the stream. The secondary habitat components scored in the marginal category for Artificial Channelization (straightened with a small degree of sinuosity developed within the channelized area). The secondary habitat components scored in the suboptimal category for Bank Stability (the percent bank full requirement was not met for either bank) and Riparian Zone Vegetation Quality (>50% to 80% of the riparian zone was undisturbed with some disruption observed). Riparian Buffer Zone Width for the left and right banks were scored as optimal (>18 meters). The secondary habitat components received a score of 53 out of 80. The resulting FDEP Habitat Assessment score was a 97.

Figure 4 Photograph of the Itchepackesassa Creek Sample Site showing the extent of the Riparian Buffer Zone Width (>18m).
