Lake Grace

Figure 1 2015 Lake Grace Assessment Study Area Map

Figure 2 2015 1-Foot Bathymetric Contour Map for Lake Grace

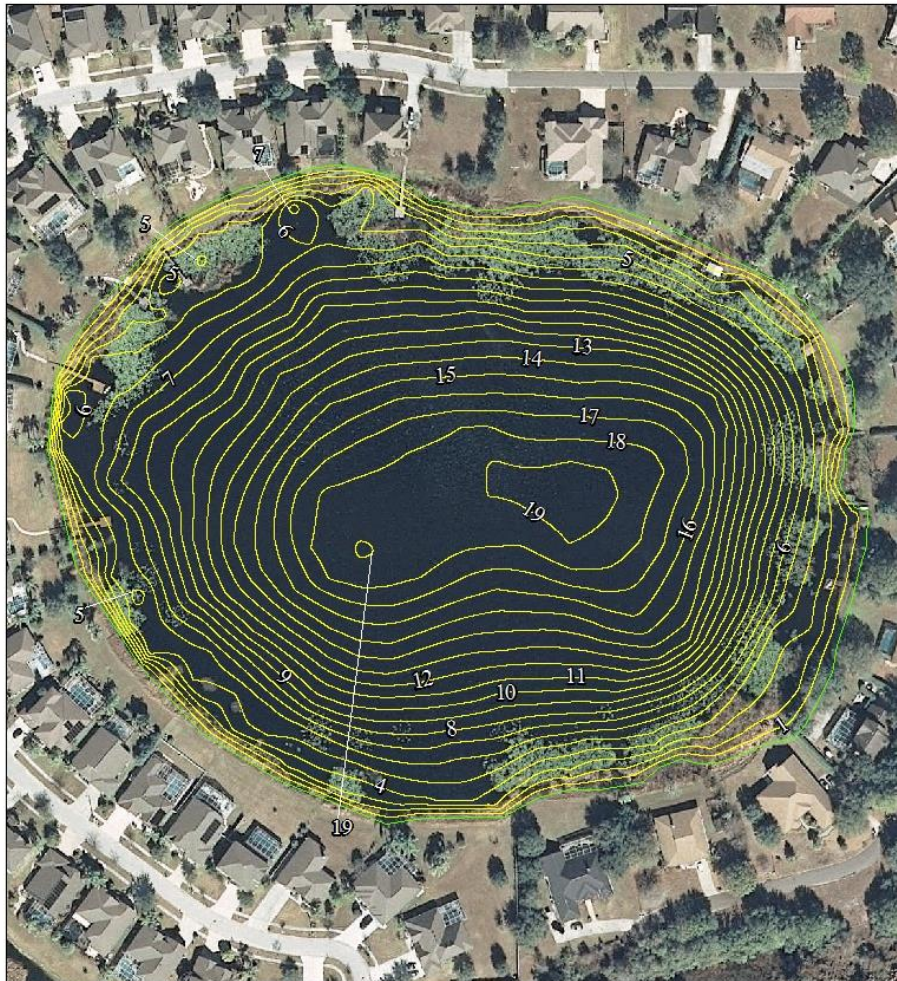
Lake Grace is an isolated lake that is relatively deep system for its size. At the time of the assessment, Lake Grace was experiencing moderately high water levels resulting in a 16.28 acre water body. Lake Grace at the time of the assessment had a mean water depth of 9.84 feet and a maximum observed depth of 19.74 feet. The volume at this time was approximately 52,189,828 gallons. Figure 2 shows the resulting bathymetric contour map for Lake Grace from data collected on August 13, 2015. The collected data has been overlain the 2011 Hillsborough County aerials.

Perimeter 3,124 ft;
Area 16.28 Acres;
Mean Depth 9.84 ft;
Volume 160.16 Acre-ft; (52,189,828 gallons);
Deepest point 19.74 ft

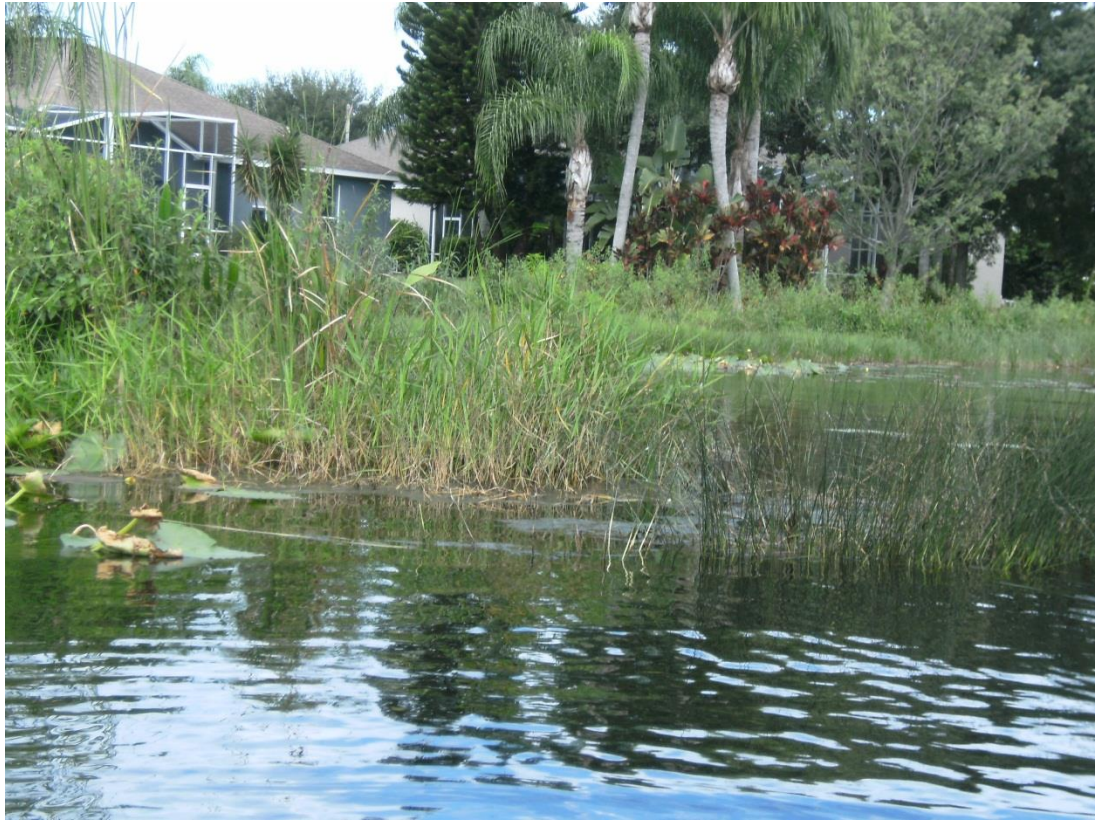
Figure 3 Overview photograph of Lake Grace

The lake assessment for Lake Grace was conducted on August 13, 2015. Lake Grace received a lake habitat assessment (FEDP form FD 9000-6) score of 54 due to suboptimal scores for Vegetation Quality. Marginal scores were achieved for Secchi, Stormwater Inputs, Bottom Substrate Quality and Adverse Watershed Land Use. Lakeside Adverse Human Alterations and Upland Buffer Zone received poor scores.

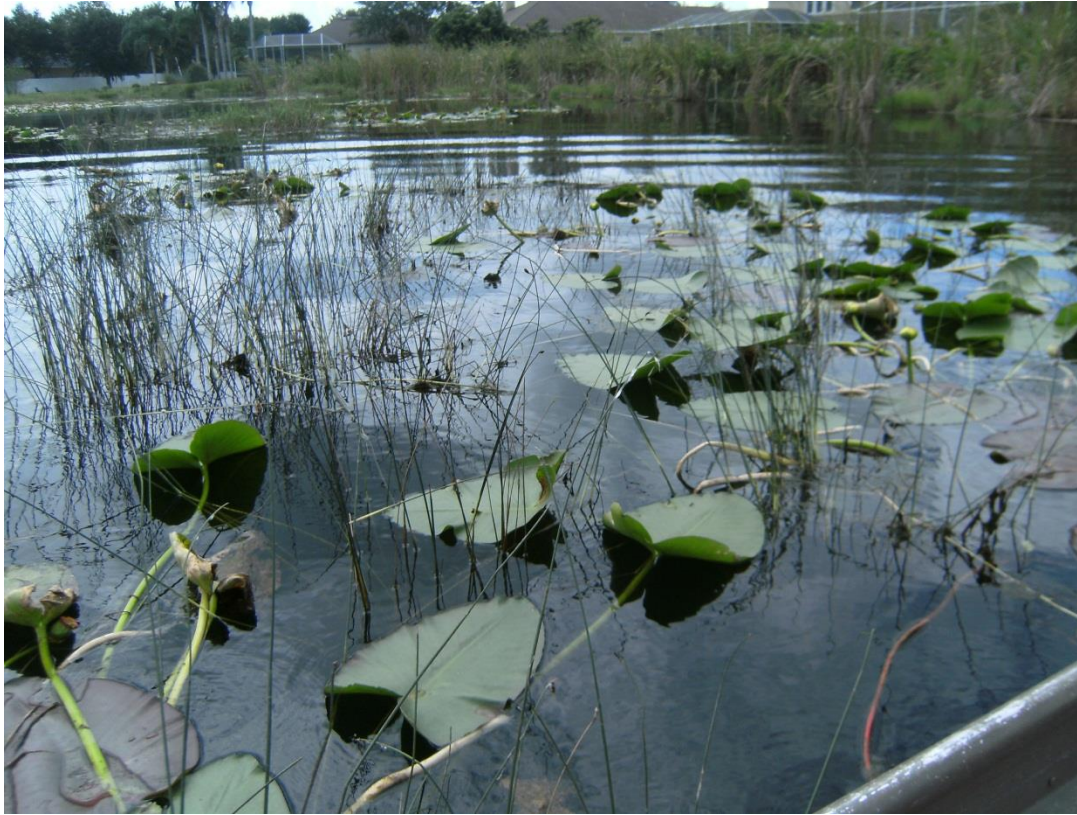
Figure 4 Portions of Lake Grace had a buffering zone of emergent and floating leaved vegetation surrounding the lake containing a mixture of native and invasive species.

The Lake Vegetation Index identified 28 species of wetland vegetation growing in the four selected sections along Lake Grace. The majority of these species (22) are native species. The remaining 6 species (*Panicum repens*, *Alternanthera philoxeroides*, *Oxycaryum cubense*, *Salvinia minima*, *Eichhornia crassipes* and *Ludwigia peruviana*) are non-native and invasive to this region. The vegetation community along Lake Grace is dominated by a variety of emergent species including *Typha*, *Fuirena scirpoidea* and *Panicum hemitomom* (Figure 5). The water's surface in Lake Grace was dominated by *Nuphar* (Figure 6) and *Nymphaea odorata*. The calculated LVI score for Lake Grace was 39, above the impairment threshold of 37. Figure 7 shows the map of Lake Grace detailing the LVI regions used for the assessment. Table 2 details the species list results of the Lake Vegetation Index. Table 3 details the scoring result for the Lake Vegetation Index. The submerged vegetation of Lake Grace was dominated by *Eleocharis baldwinii*. Some *Chara* and *Najas guadalupensis*, two species of submerged vegetation were also observed during the assessment. By analyzing the collected sonar chart, submerged aquatic vegetation covered approximately 40% of the surface area of Lake Grace. This submerged vegetation inhabits an estimated 7.97% of the water volume in Lake Grace.

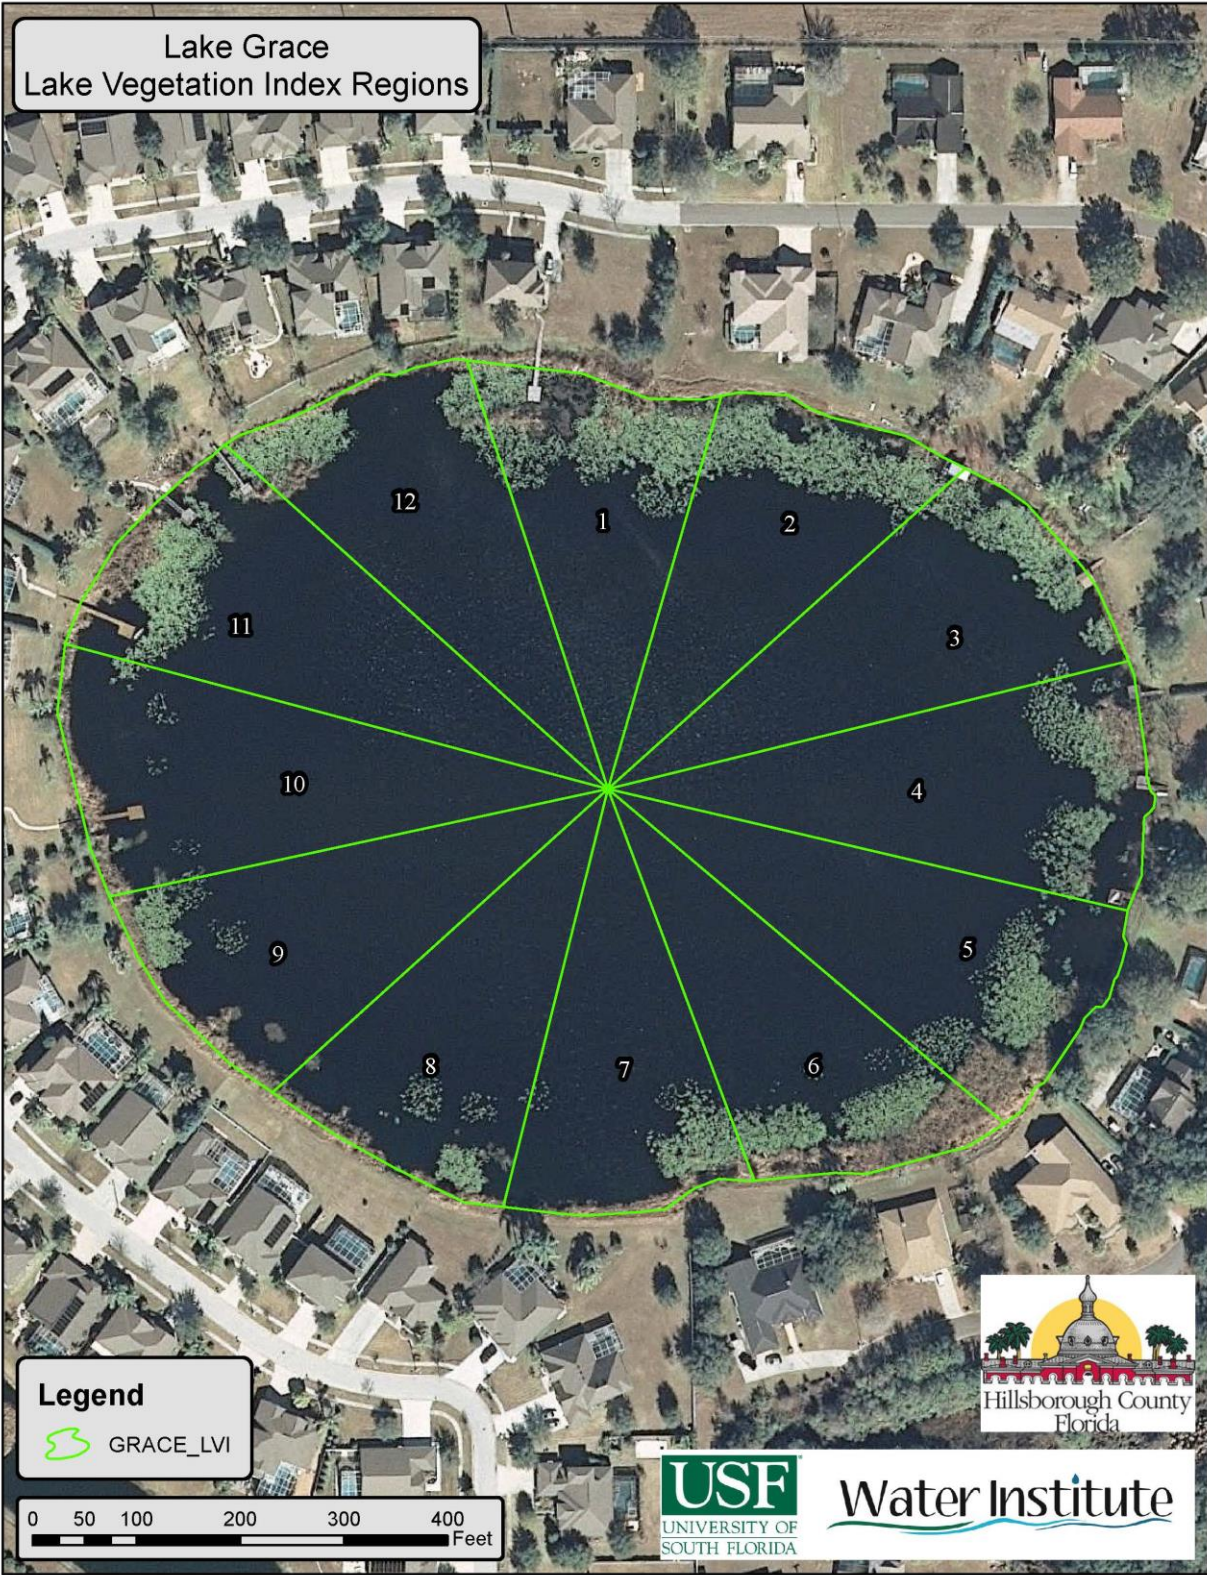
Figure 7 Lake Vegetation Index region map for Lake Grace

LVI Score Summary	Region			
	3	6	9	12
Total # of taxa in sampling unit	18	15	19	20
% Native taxa in sampling unit	72.22222	73.33333	78.94737	80
% FLEPPC CAT 1 taxa in sampling unit	16.66667	20	15.78947	10
% Sensitive taxa in sample unit	5.555556	0	10.52632	10
Dominant CoC in sample unit	2.82	2.82	2.82	2.82
Native Score $((x-62.5)/37.5)$ or $((x-66.67)/25.89)=$	0.214454	0.257371	0.474213	0.514871
Invasive FLEPPC 1 Score $(1 - (x/30))=$	0.444444	0.333333	0.473684	0.666667
Sensitive Score $(x/(27.78 \text{ or } 20)) =$	0.277778	0	0.526316	0.5
Dominant CoC Score $(x/(7.91 \text{ or } 7)) =$	0.402857	0.402857	0.402857	0.402857
Raw Score Total = N+I+S+D =	1.339534	0.993561	1.87707	2.084394
Division Factor = (3 D=0 or 4) =	4	4	4	4
Average LVI dividend = Raw /DF	0.334883	0.24839	0.469267	0.521099
South				
LVI Score for sampling unit =	33.48834	24.83904	46.92675	52.10986
Total LVI SCORE =	39
