Lake Brant

LAKE HABITAT ASSESSMENT, LAKE VEGETATION INDEX, SUBMERGED
VEGETATION SURVEY AND WATER QUALITY

David Eilers, Karina Gonthier | USF Water Institute | June 26, 2023

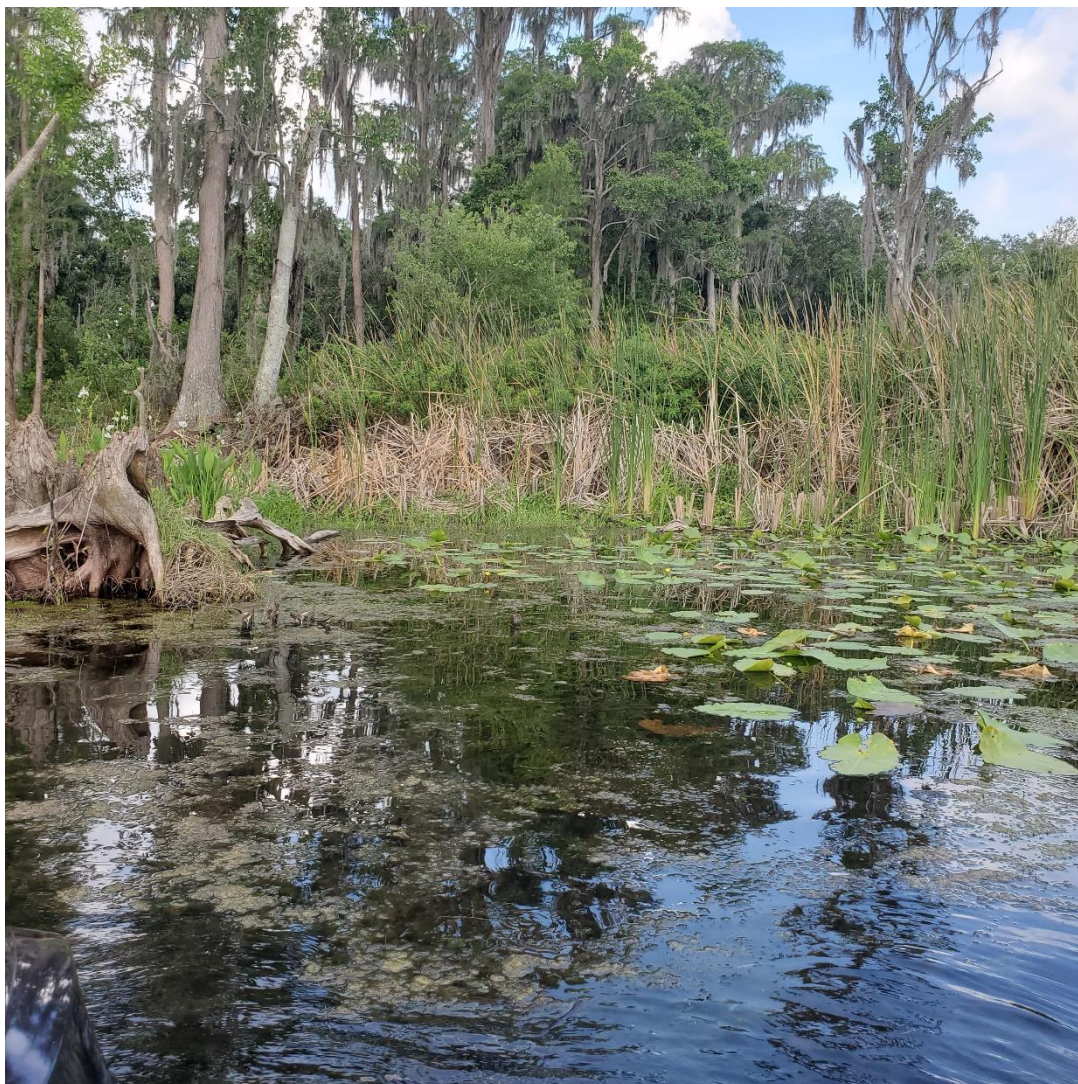
Figure 3 Overview photograph of Lake Brant showing the undeveloped portion of shoreline along region 6 of the Lake Vegetation Index.

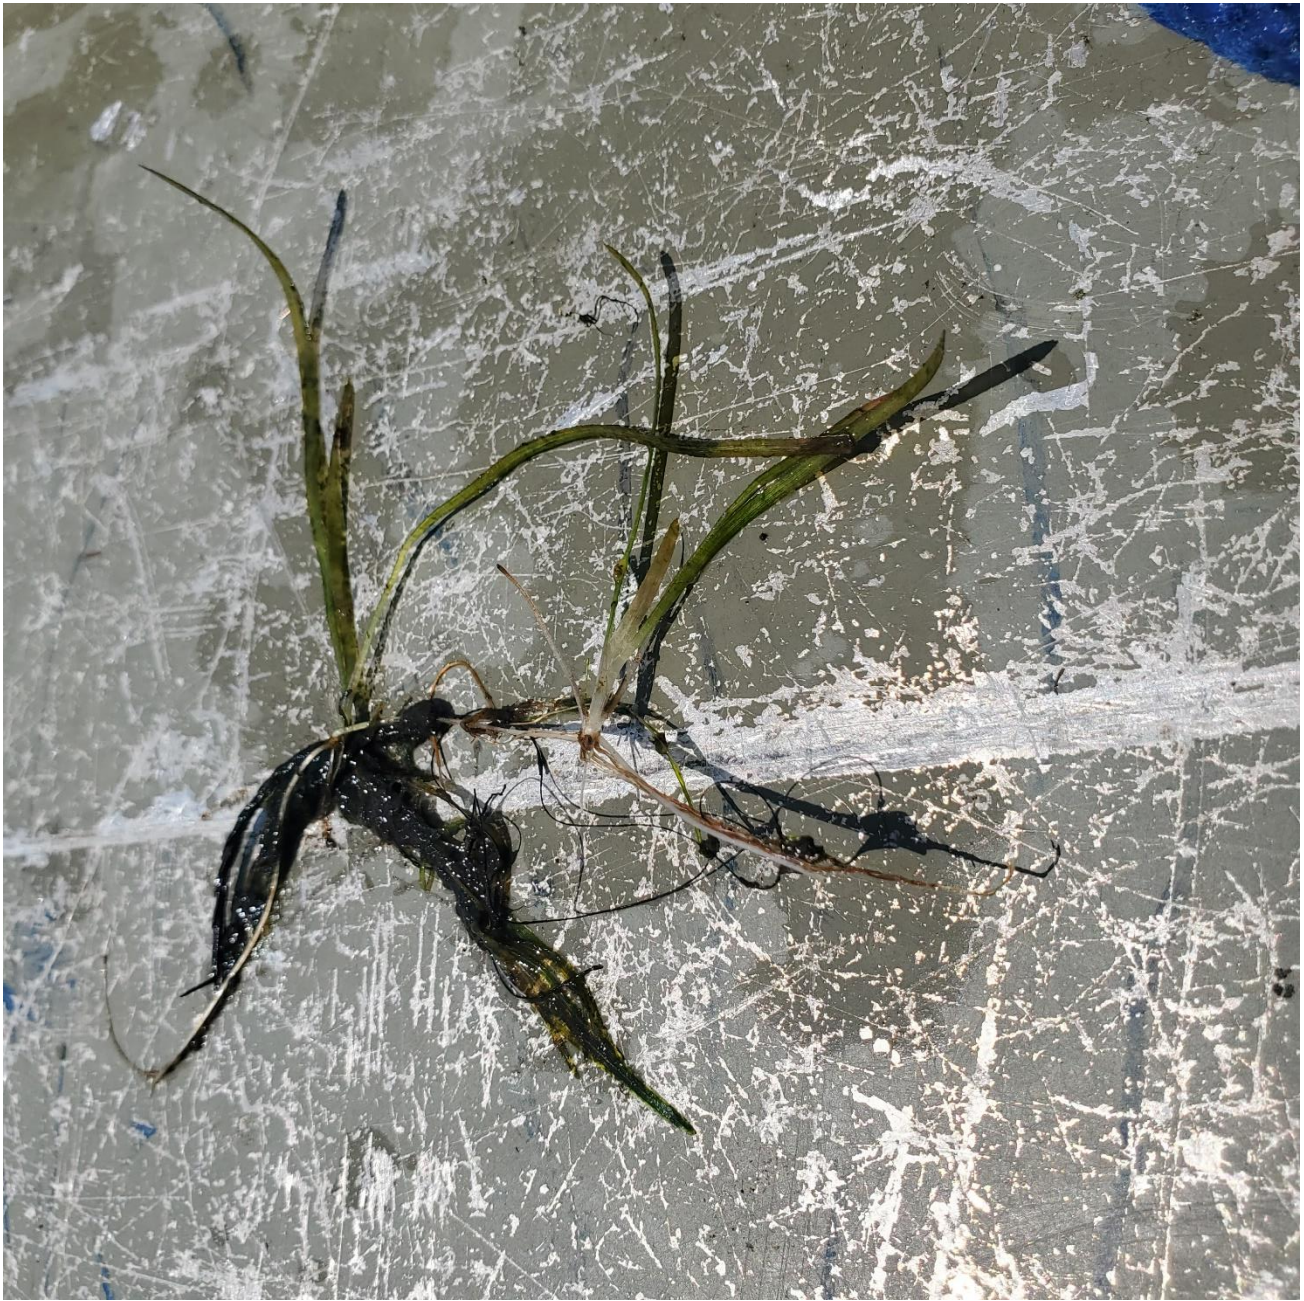
Figure 4 Vallisneria americana, Tapegrass, was co-dominant in regions 3 and 12 of the Lake Vegetation Index on Lake Brant

The Lake Vegetation Index identified 46 species of wetland vegetation growing in the four selected sections along Lake Brant. The majority of these species (30) are native species. The remaining 16 species (*shown in **bold** in Table 2*) are non- native or invasive to this region. The vegetation community along the shorelines of Lake Brant has been altered by lawn maintenance activities leaving a *Taxodium* canopy with a sparse shrub and ground cover community. The edges of the lake are dominated by species able to rapidly colonize following the frequent disturbance of mowing, such as *Panicum repens* and *Cyperus blepharoleptos*. At the time of the assessment the water transparency was 2.74 m (9.0 ft). High annual average secchi disk depths allow for an extensive littoral zone with establishment of floating leaved and submerged aquatic vegetation. Seven species of submersed aquatic vegetation were observed during the lake vegetation index. *Vallisneria americana* and *Najas guadalupensis* were both co-dominant species in LVI regions. The floating leaved vegetation community had 5 species observed with both *Nuphar* and *Nymphaea odorata* being co-dominant in LVI regions.
