Lake Carlton

Study Area

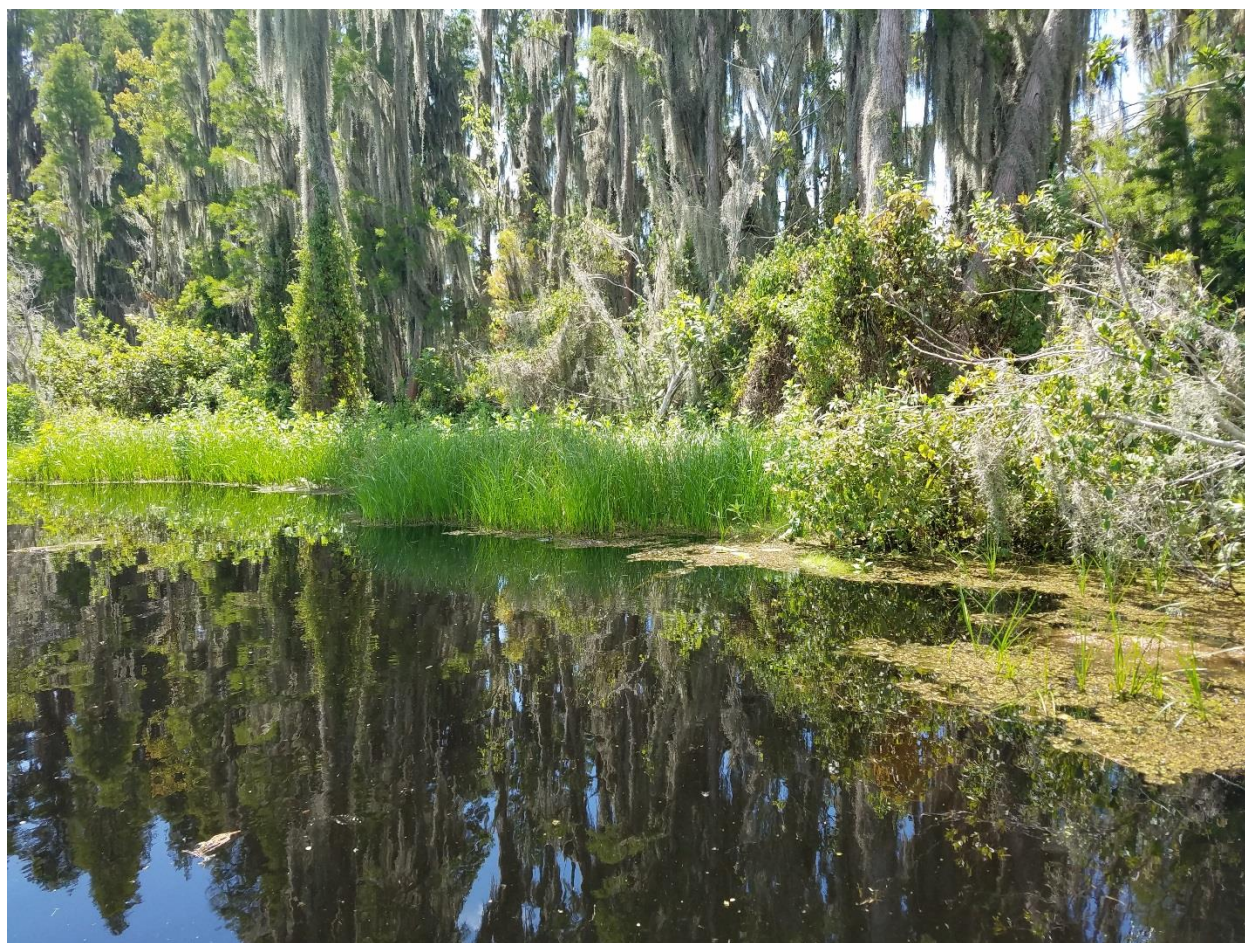
Figure 3 Overview photograph of Lake Carlton.

The lake assessment for Lake Carlton was conducted on July 17, 2016. Lake Carlton received a lake habitat assessment (FEDP form FD 9000-6) score of 103 due to optimal scores for Stormwater Inputs, Lakeside Adverse Human Alterations, Upland Buffer Zone and Adverse Watershed Land Use. Suboptimal scores were recorded for Vegetation Quality. Marginal scores were achieved for Secchi and Bottom Substrate Quality.

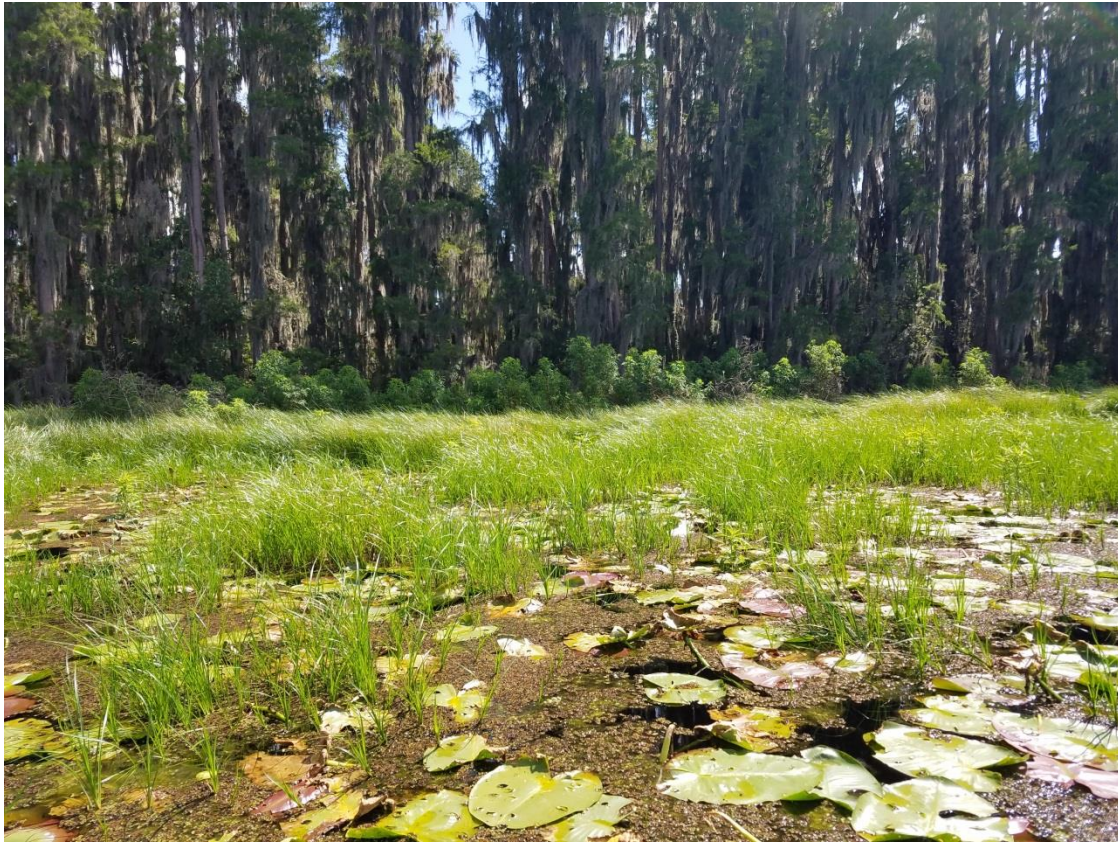
Figure 4 Lake Carlton had a buffering zone of emergent vegetation surrounding the lake containing a mixture of native and invasive species.

The Lake Vegetation Index identified 44 species of wetland vegetation growing in the four selected sections along Lake Carlton. The majority of these species (37) are native species. The remaining 7 species (in bold on Table 2) are non-native and invasive to this region. The vegetation community along Lake Carlton is dominated by a variety of emergent species including *Taxodium* and *Oxycaryum cubense* (Figure 4). The water's surface in Lake Carlton was dominated by *Nuphar* and *Salvinia minima* (Figure 5 and 6). The calculated LVI score for Lake Carlton was 56, above the impairment threshold of 37. Figure 7 shows the map of Lake Carlton detailing the LVI regions used for the assessment. Table 2 details the species list results of the Lake Vegetation Index. Table 3 details the scoring result for the Lake Vegetation Index. Submerged vegetation (*Mayaca fluviatilis*) was observed during the assessment. By analyzing the collected sonar chart, submerged aquatic vegetation covered approximately 14% of the surface area of Lake Carlton. This submerged vegetation inhabits an estimated 3.1% of the water volume in Lake Carlton. Submerged vegetation is limited in Lake Carlton at the current water levels due to shading by the emergent rim of *taxodium* and *nuphar*.

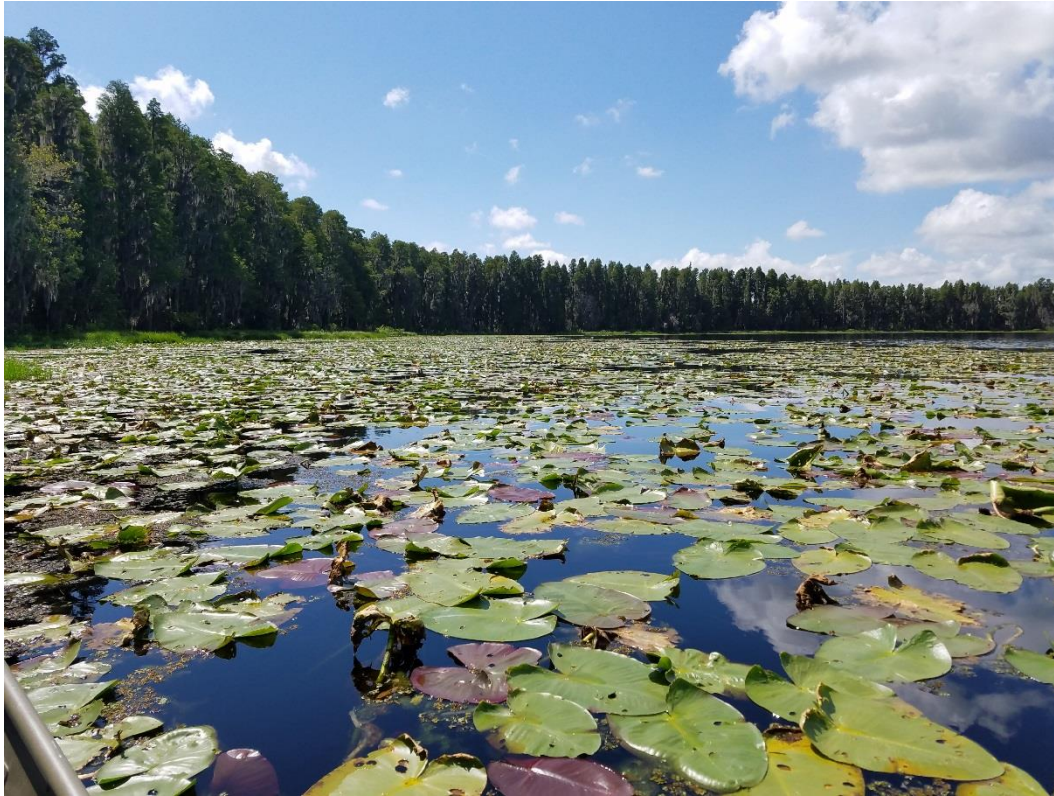
Figure 5 *Nuphar* on Lake Carlton.

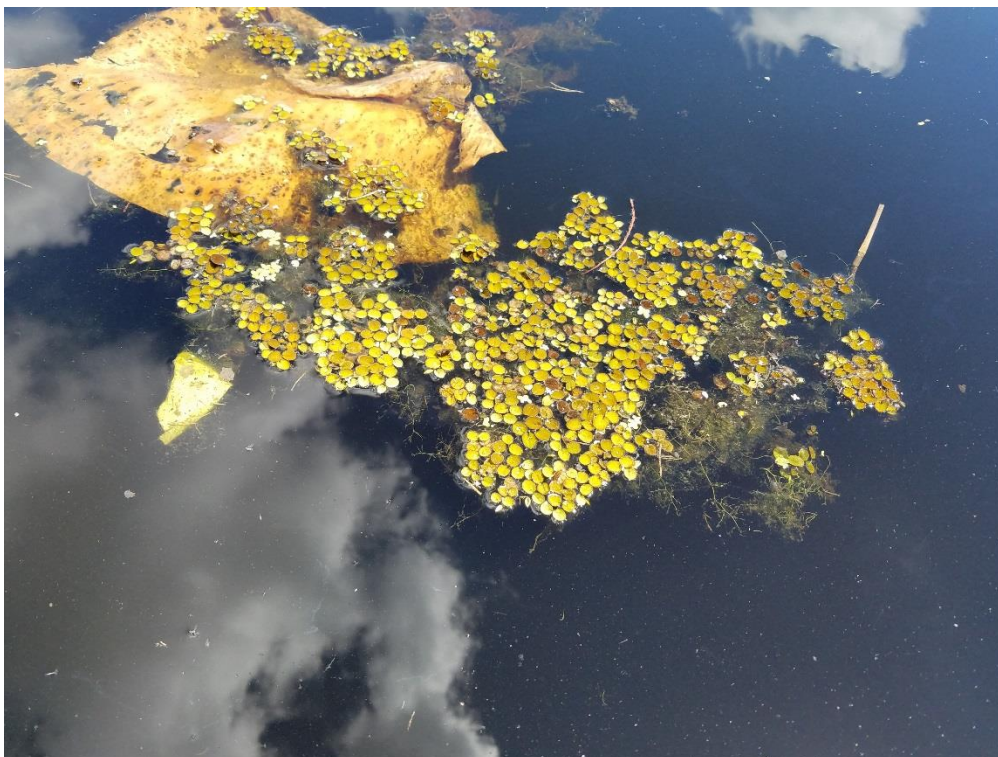
Figure 6 *Salvinia minima* on Lake Carlton.
