Lake Carroll

Methods

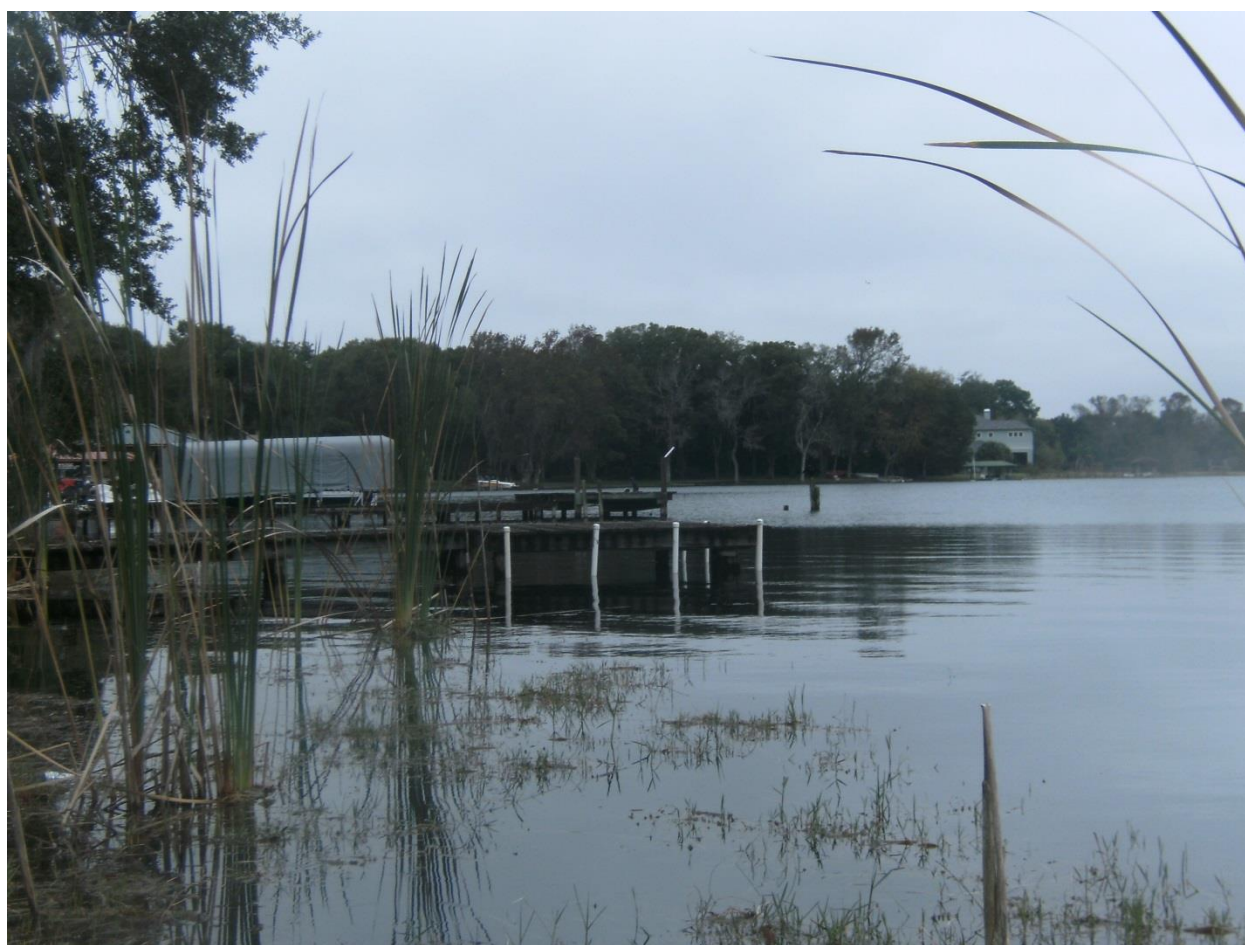
Figure 3 Overview photograph of Lake Carroll

The lake assessment for Lake Carroll was conducted on June 23, 2016. Lake Carroll received a lake habitat assessment (FEDP form FD 9000-6) score of 68 due to optimal scores for Bottom Substrate Quality and suboptimal scores for Secchi and Vegetation Quality. Marginal scores were achieved for Stormwater Inputs and Adverse Watershed Land Use. Lakeside Adverse Human Alterations and Upland Buffer Zone received poor scores.

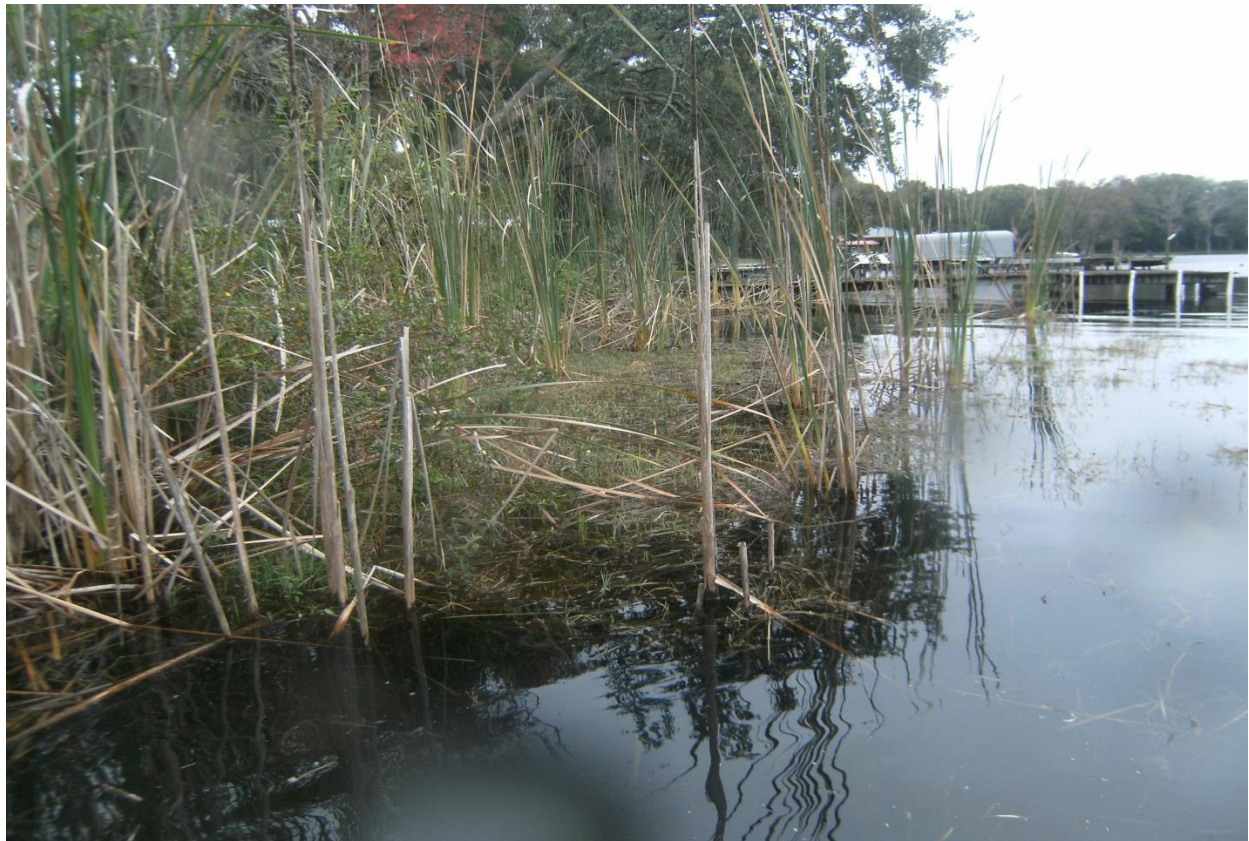
Figure 4 Lake Carroll had a limited buffering zone of emergent vegetation surrounding the lake containing a mixture of native and invasive species.

The Lake Vegetation Index identified 49 species of wetland vegetation growing in the four selected sections along Lake Carroll. The majority of these species (39) are native species. The remaining 10 species (In bold on Table 2) are non-native and invasive to this region. The vegetation community along Lake Carroll is heavily altered by residential yards. What emergent vegetation is present is dominated by a variety of emergent species including *Typha*, *Taxodium* and *Panicum repens* (Figure 5). The water's surface in Lake Carroll was dominated by *Nymphaea odorata* (Figure 6). The calculated LVI score for Lake Carroll was 57, above the impairment threshold of 37. Figure 7 shows the map of Lake Dan detailing the LVI regions used for the assessment. Table 2 details the species list results of the Lake Vegetation Index. Table 3 details the scoring result for the Lake Vegetation Index. Submerged vegetation was observed during the assessment both visually and by using the produs sampler indicating dominance by *Bacopa caroliniana* and *Vallisneria americana*. By analyzing the collected sonar chart, submerged aquatic vegetation was present in most areas to a depth of 15.2 feet. The submerged vegetation covered approximately 71% of the surface area of Lake Carroll. This submerged vegetation inhabits an estimated 19.2% of the water volume in Lake Carroll.

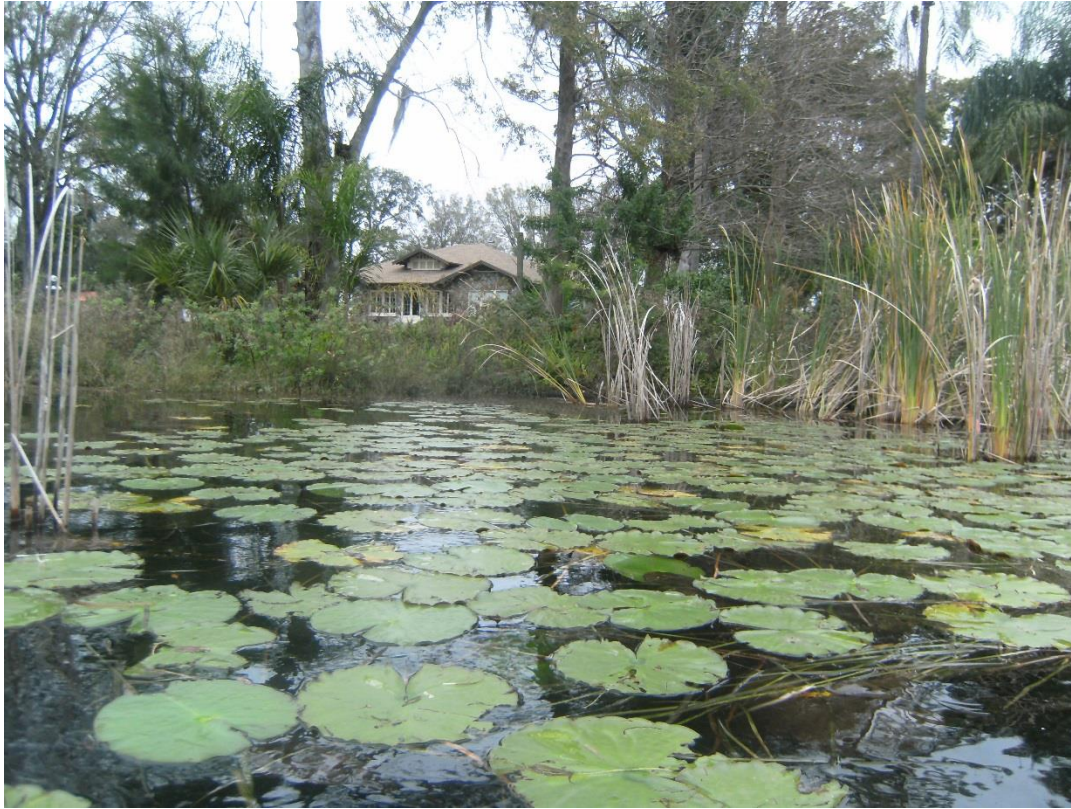
Figure 5 emergent vegetation zone on Lake Carroll
