# Lake Dan

Figure 1 2016 Lake Dan Assessment Study Area Map

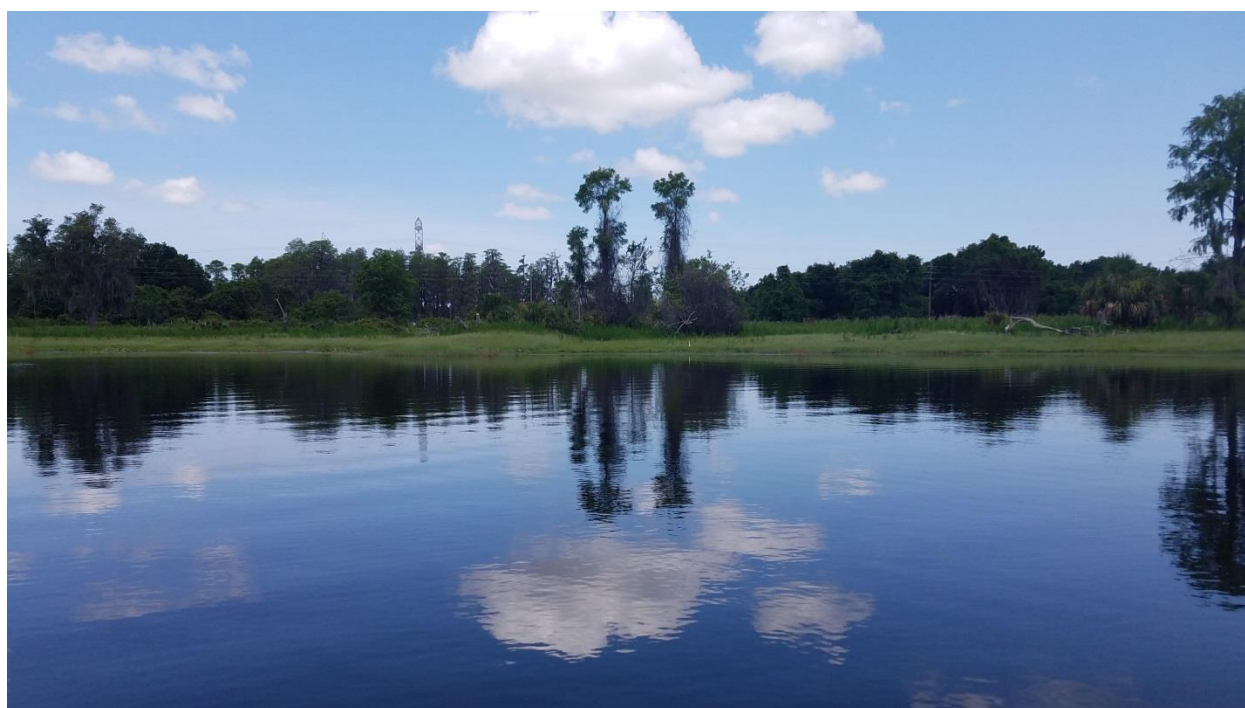
**Figure 3 Overview photograph of Lake Dan.**

The lake assessment for Lake Dan was conducted on June 28, 2016. Lake Dan received a lake habitat assessment (FEDP form FD 9000-6) score of 116 due to optimal scores for Stormwater Inputs, Adverse Watershed Land Use, Lakeside Adverse Human Alterations and Upland Buffer Zone. Suboptimal scores for Secchi, Vegetation Quality and Bottom Substrate Quality.

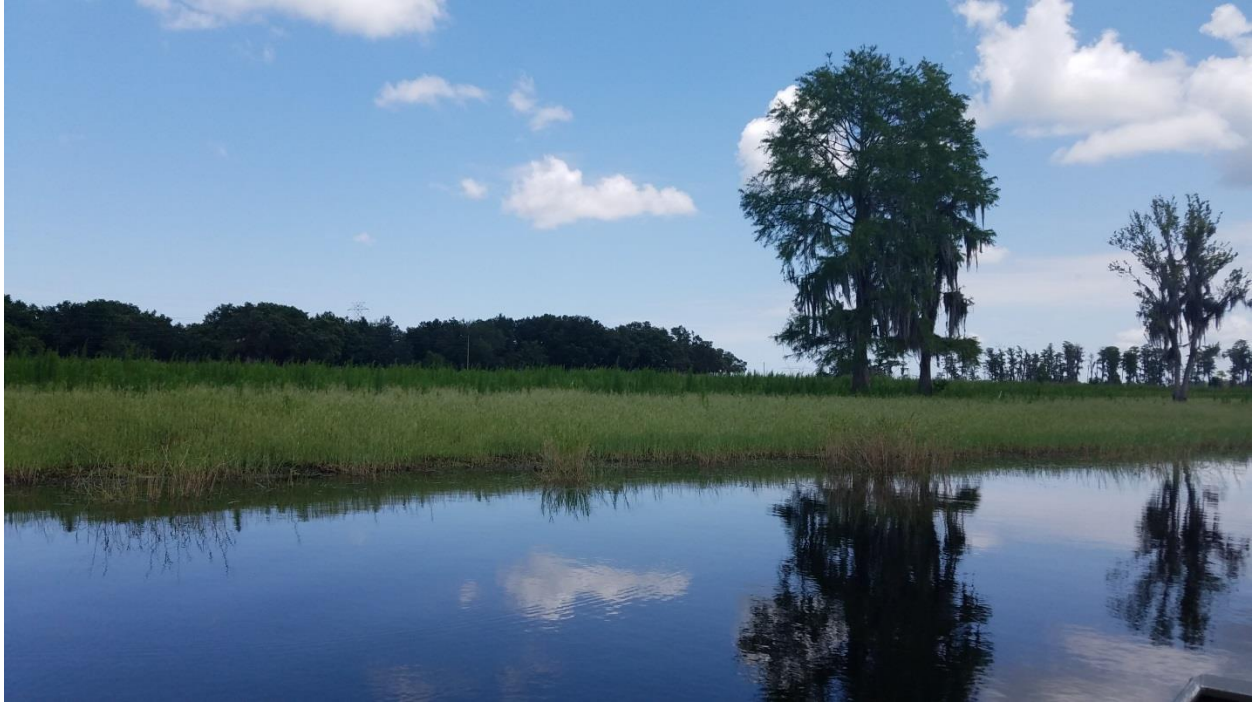
**Figure 4 Lake Dan had a buffering zone of emergent vegetation surrounding the lake containing a mixture of native and invasive species.**

The Lake Vegetation Index identified 38 species of wetland vegetation growing in the four selected sections along Lake Dan. The majority of these species (34) are native species. The remaining 4 species (*Panicum repens*, *Alternanthera philoxeroides*, *Schinus terebinthifolius* and *Salvinia minima*, shown in bold on Table 2) are non-native and invasive to this region. The vegetation community along Lake Dan is dominated by a variety of emergent species including *Panicum hemitomon*, *Taxodium* and *Panicum repens* (Figure 5). The water's surface in Lake Dan was dominated by *Nuphar*. (Figure 6). The calculated LVI score for Lake Dan was 56, above the impairment threshold of 37. Figure 7 shows the map of Lake Dan detailing the LVI regions used for the assessment. Table 2 details the species list results of the Lake Vegetation Index. Table 3 details the scoring result for the Lake Vegetation Index. Four species of submerged vegetation were observed during the assessment. By analyzing the collected sonar chart, submerged aquatic vegetation covered approximately 8% of the surface area of Lake Dan. This submerged vegetation inhabits an estimated 1.04% of the water volume in Lake Dan. The deepest observed submerged vegetation was at 5.8 feet.

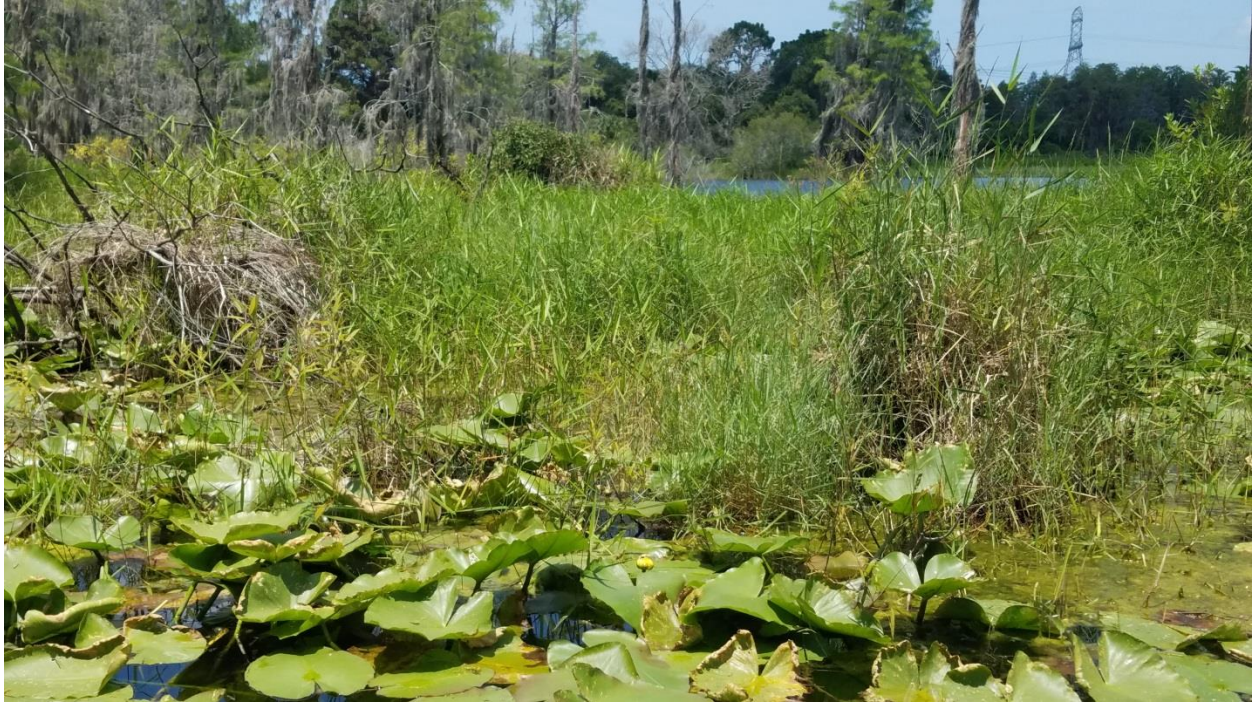
Figure 5 Emergent vegetation zone on Lake Dan

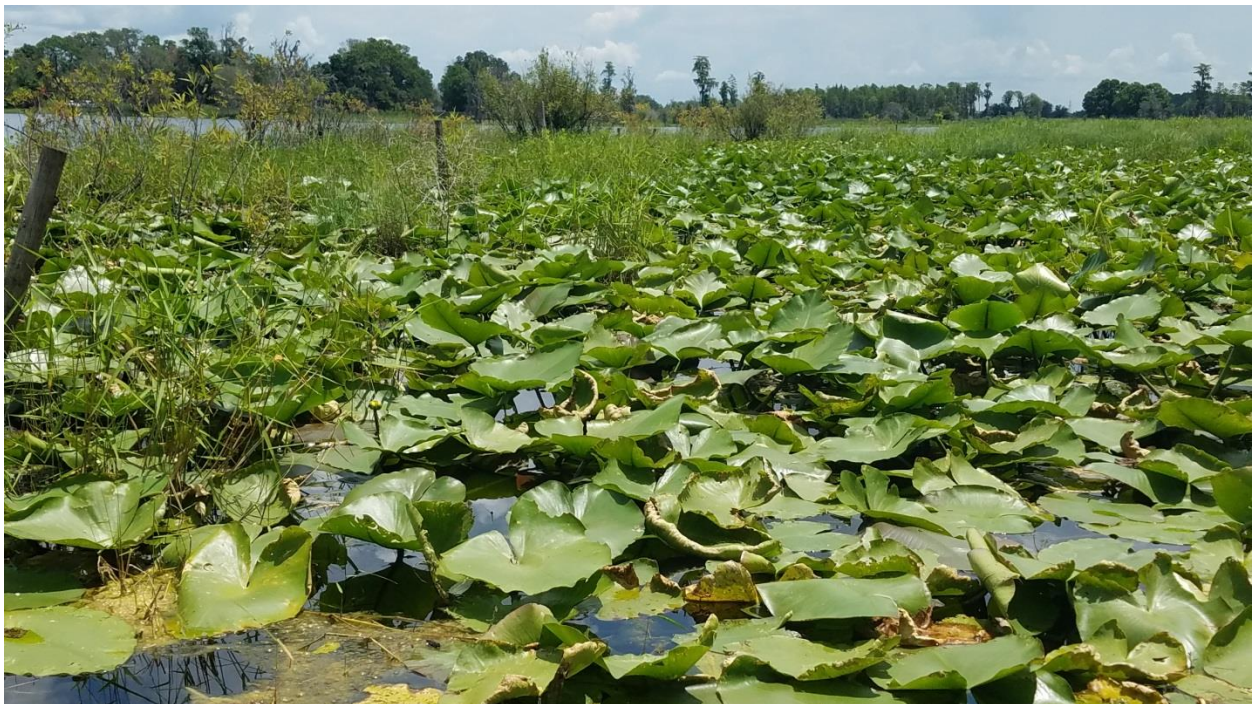
Figure 6 Nuphar on Lake Dan
