East Lake

Study Area Analysis

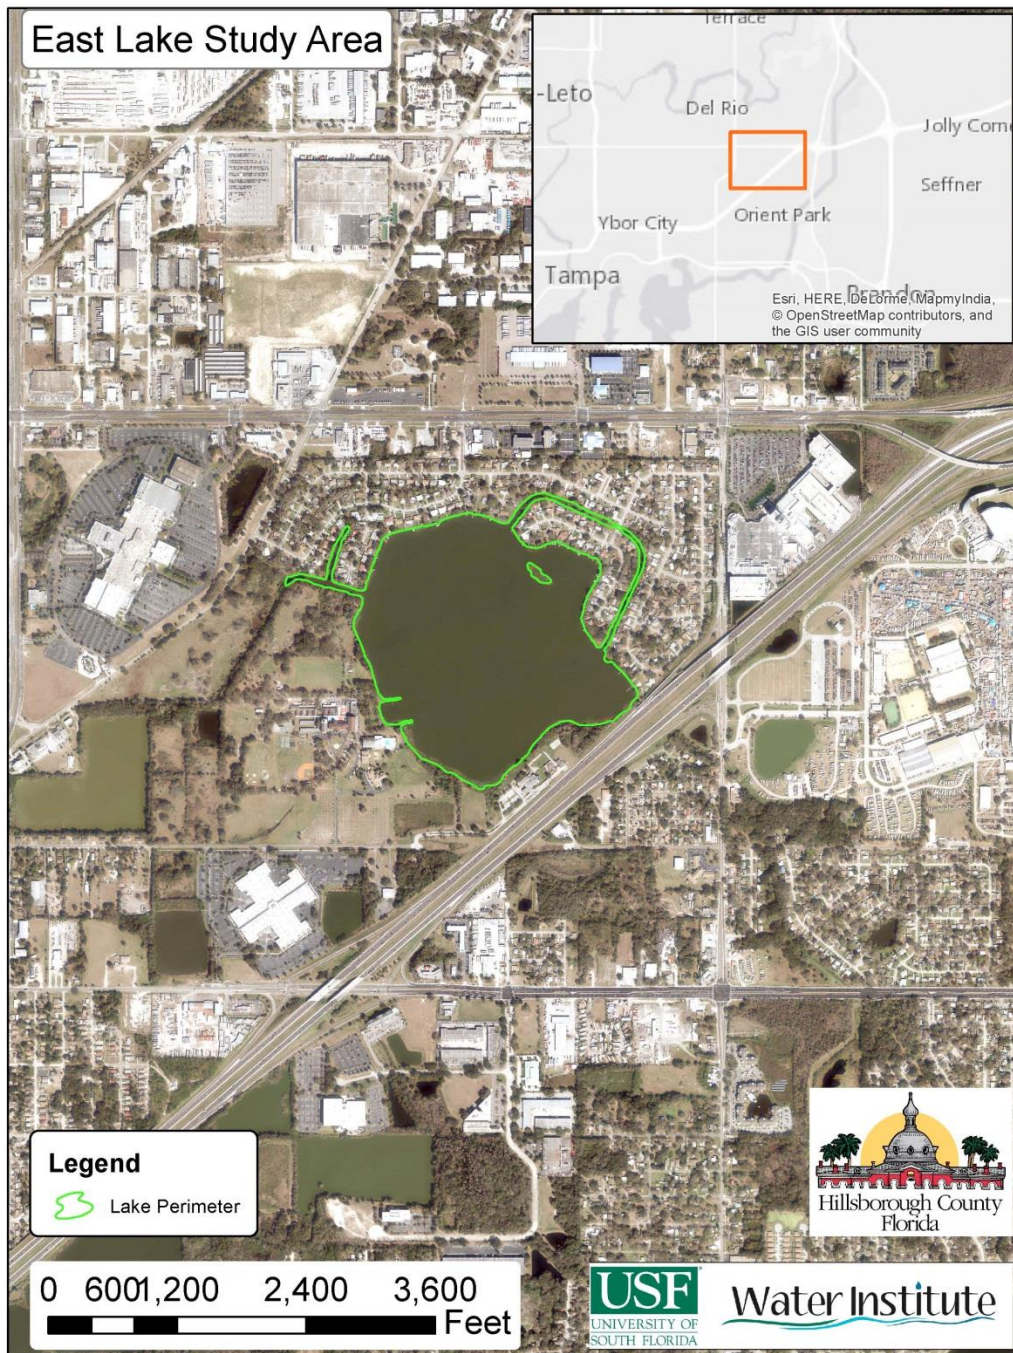
Figure 1 2016 East Lake Assessment Study Area Map

East Lake is located between East Hillsborough Avenue and I-4 in East Lake-Orient Park, Florida. The Landscape Development Intensity Index of the 100 meter buffer around East Lake is dominated by Residential (57.55%) and Institutional (17.91%) land uses. The resulting LDI value for the 100 meter buffer around East Lake is 7.73.

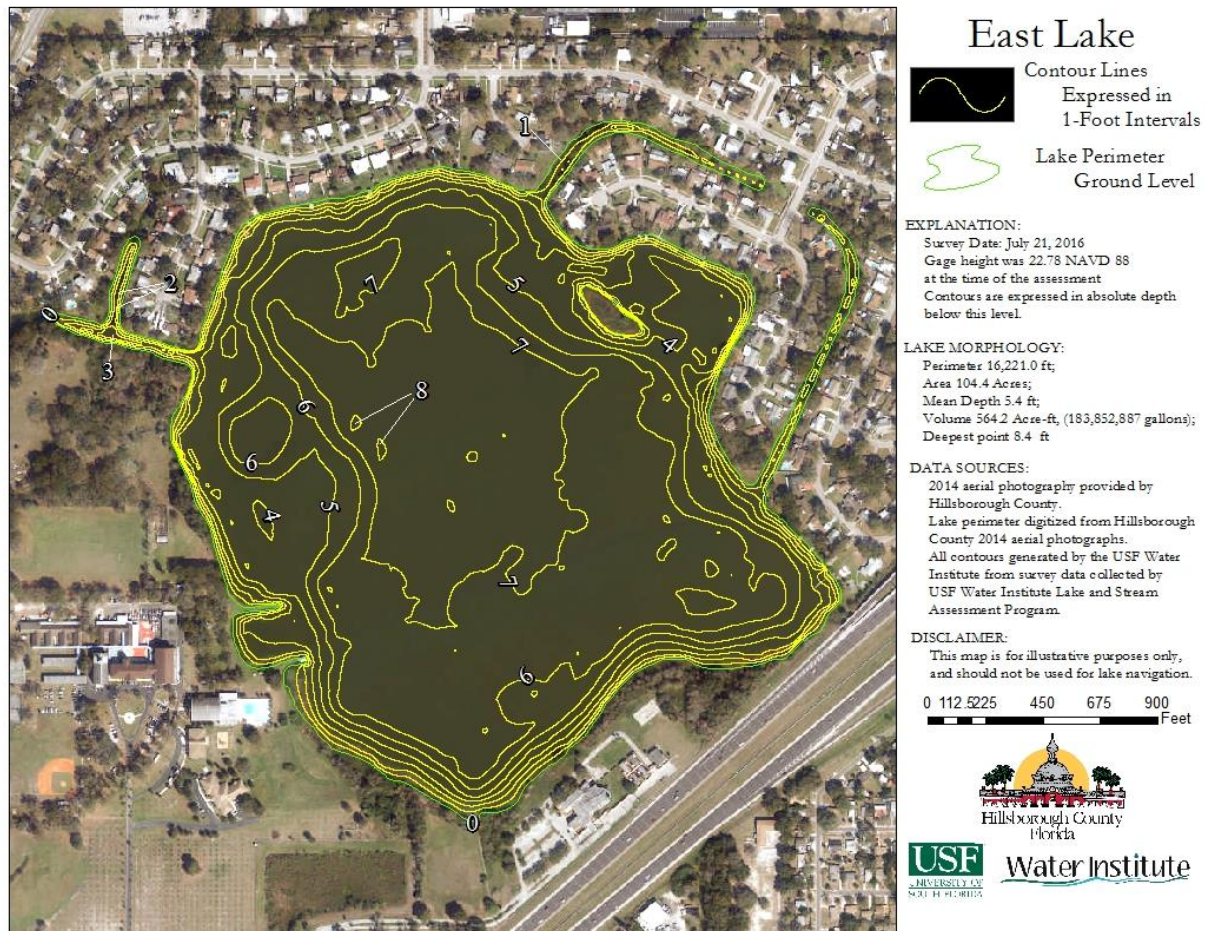
Figure 2 2016 1-Foot Bathymetric Contour Map for East Lake

East Lake is a shallow eutrophic lake with a surface area of 104.44 acres. East Lake at the time of the assessment had a mean water depth of 5.4 feet and a maximum observed depth of 8.4 feet. The volume at this time was approximately 183,852,887 gallons. Figure 2 shows the resulting bathymetric contour map for East Lake from data collected on July 21, 2016. The collected data has been overlain the 2014 Hillsborough County aerials.

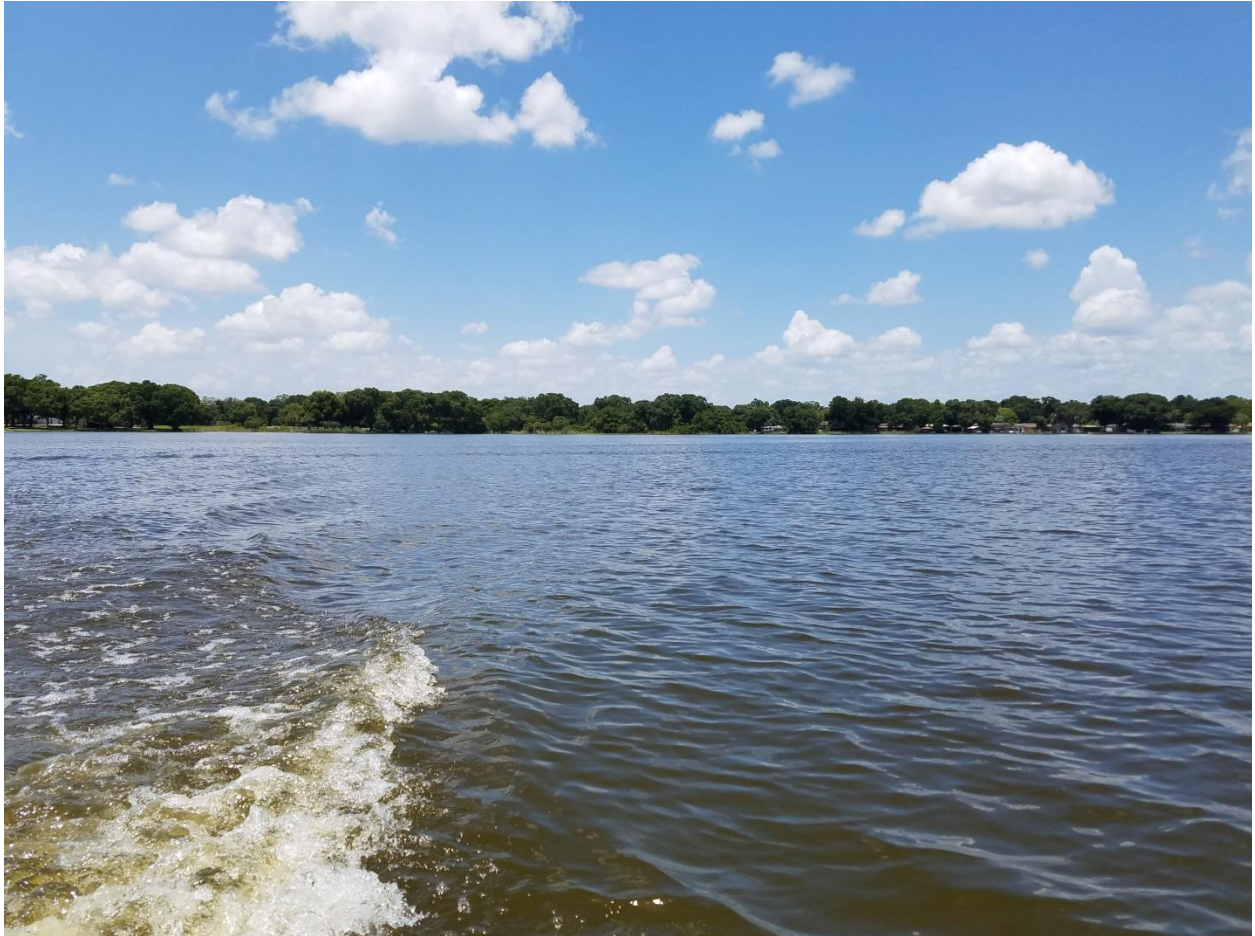
Figure 3 Overview photograph of East Lake

The lake assessment for East Lake was conducted on July, 2016. East Lake received a lake habitat assessment (FEDP form FD 9000-6) score of 60 due to suboptimal scores for Lakeside Adverse Human Alterations and marginal scores for Vegetation Quality, Stormwater Inputs, Bottom Substrate Quality, Upland Buffer Zone and Adverse Watershed Land Use. Poor scores were recorded for Secchi Depth.

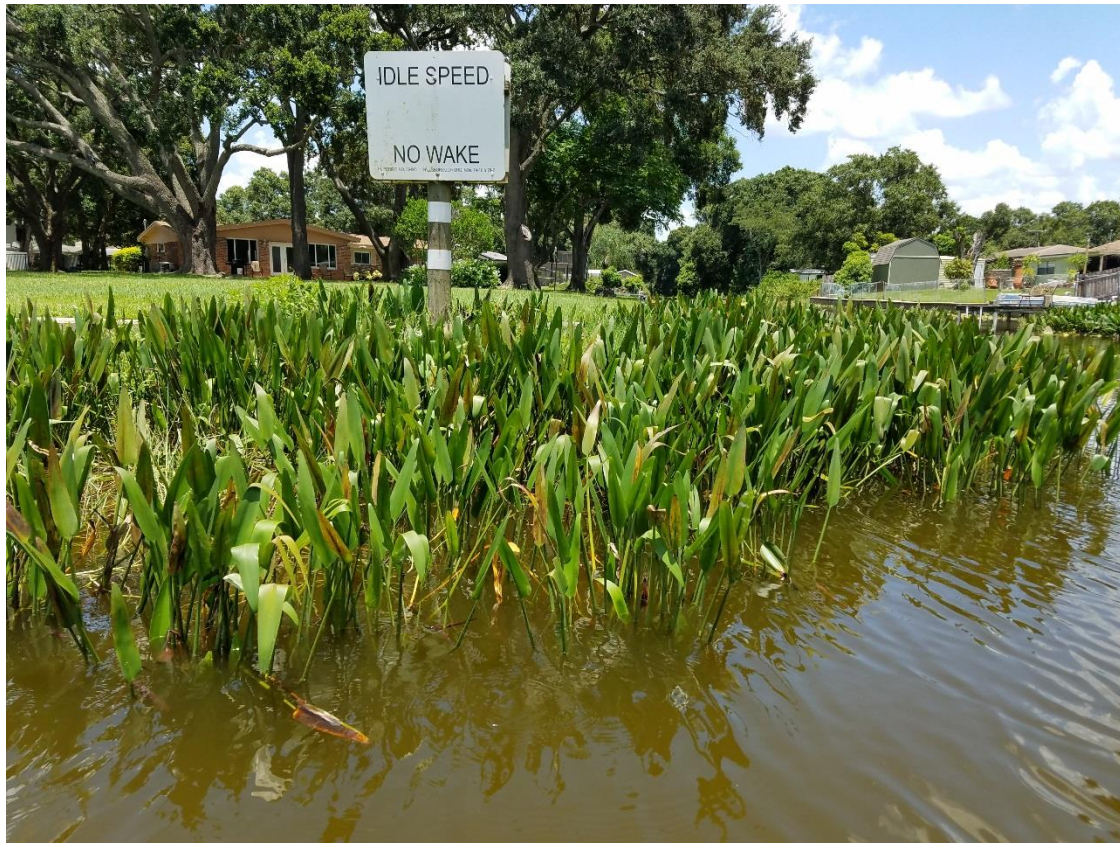
Figure 4 East Lake had a buffering zone of emergent vegetation surrounding about half of the shoreline, the remainder was mostly seawall with some areas of native vegetation shown above.

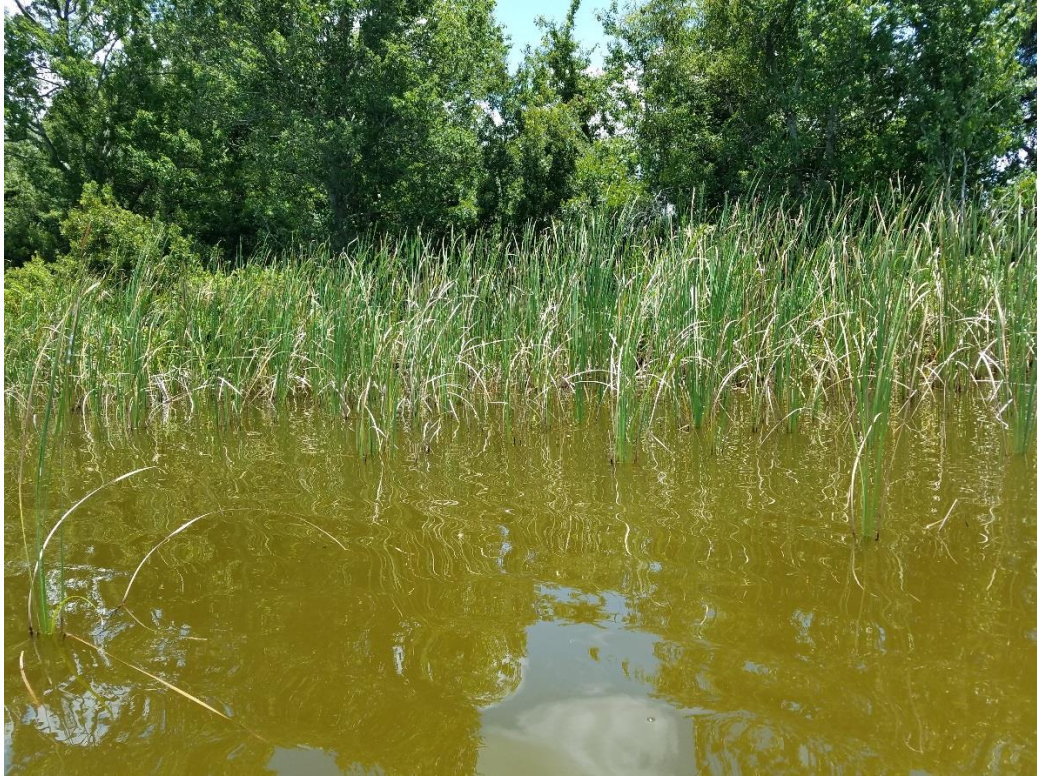
Figure 5 *Typha* was a dominant species in 3 of the 4 LVI regions on East Lake

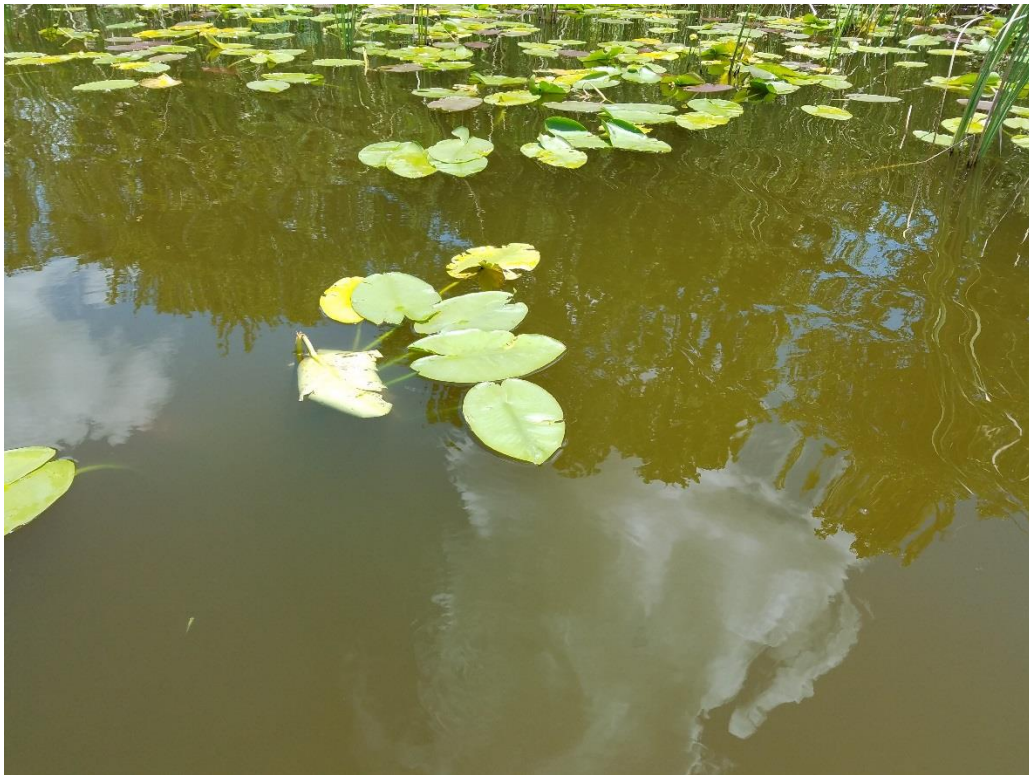
Figure 6 *Nuphar* was the dominant species of floating leaved vegetation on East Lake
