Lake Eckles

Study Area

Lake Bathymetry and Morphological Characterization

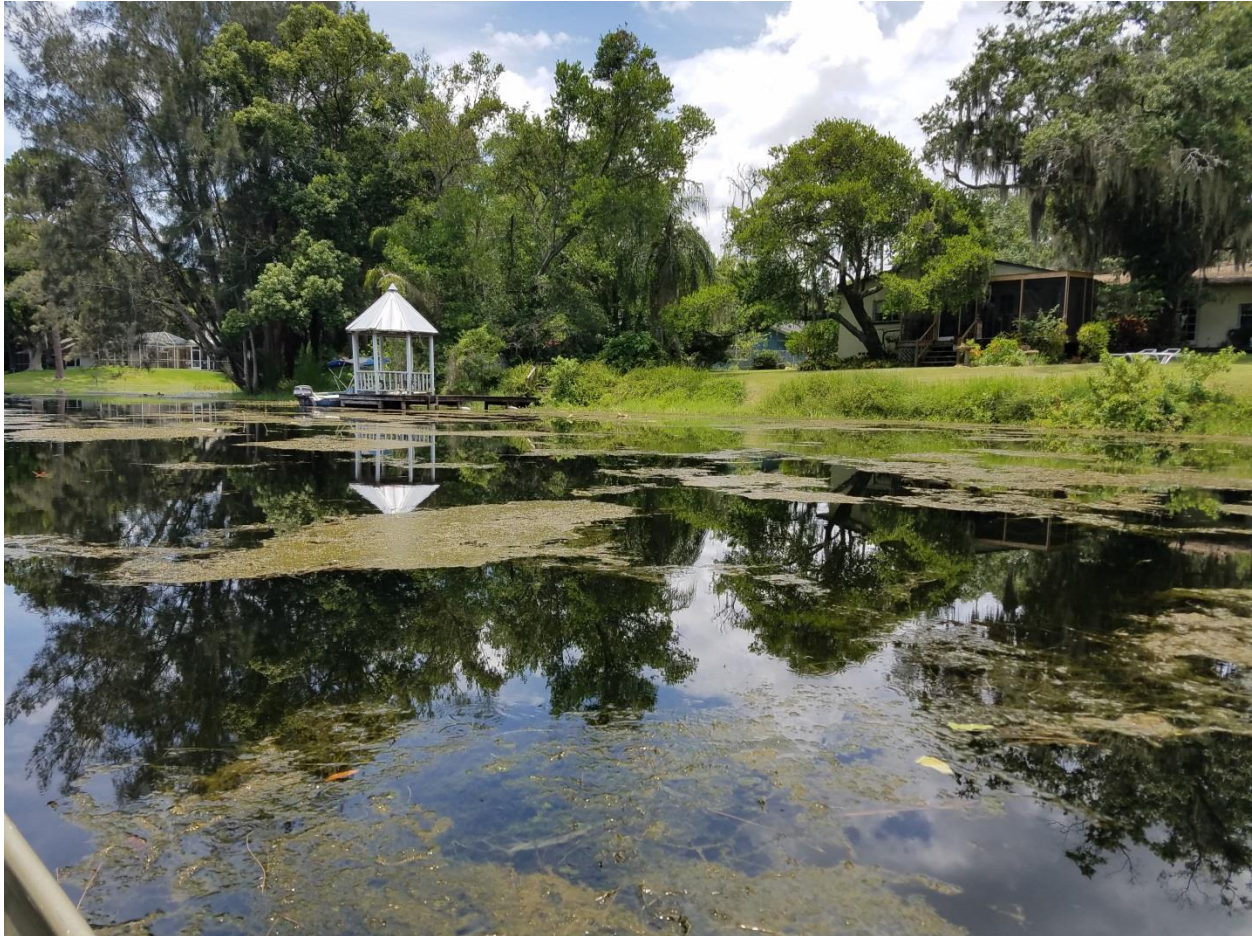
Figure 3 Overview photograph of Lake Eckles.

The lake assessment for Lake Eckles was conducted on July 17, 2016. At the time of the assessment, Lake Eckles was in the process of conducting a whole lake treatment for the invasive submerged aquatic vegetation *Hydrilla verticillata*. This treatment has broader ranging effects on aquatic vegetation than just the targeted species. As such, the results of the Lake Vegetation Index and Submerged Aquatic Vegetation Analysis should be utilized as a snapshot of the intermediate stages of the treatment process, and not to be used as a measure of lake health per FDEP guidelines. In this report we will discuss the results in terms of the FDEP processes. Lake Eckles received a lake habitat assessment (FDEP form FD 9000-6) score of 66 with optimal scores for Secchi and marginal scores for Vegetation Quality, Stormwater inputs, Bottom Substrate Quality and Adverse Watershed Land Use. Poor scores were recorded for Upland Buffer Zone and Lakeside Adverse Human Alterations.

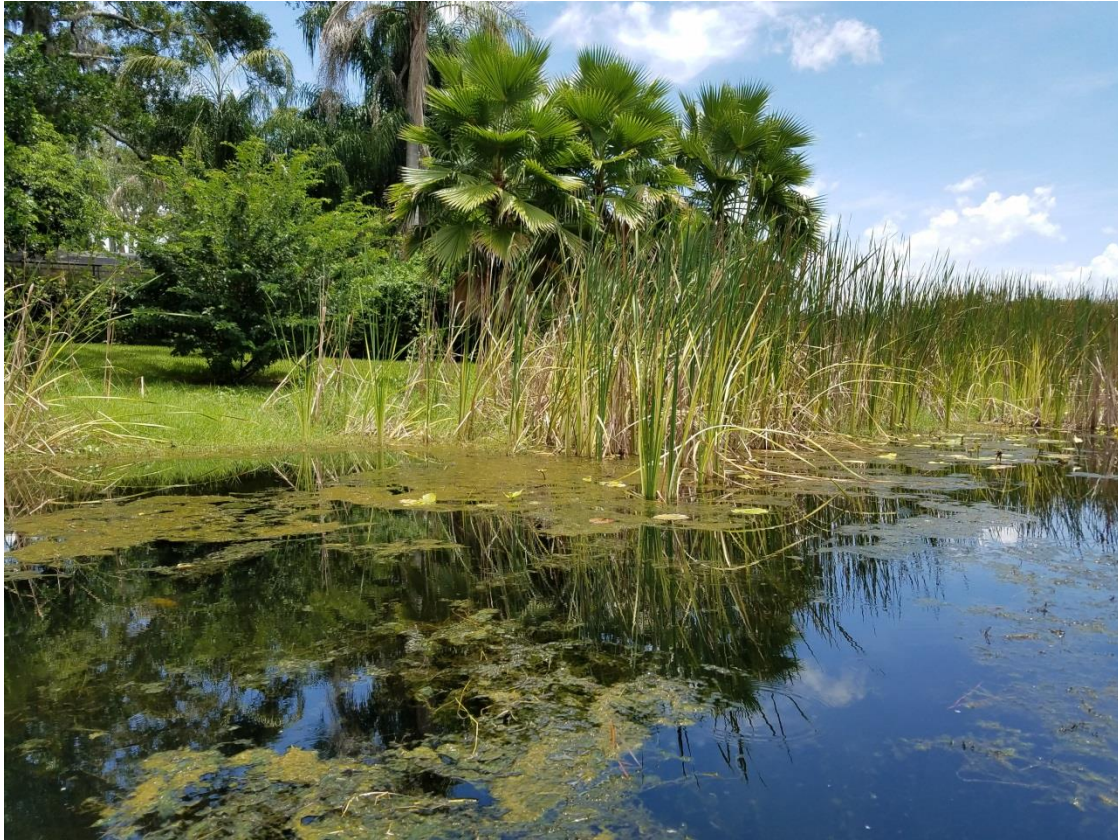
Figure 4 Lake Eckles had a buffering zone of emergent vegetation surrounding the lake containing a mixture of native and invasive species.

The Lake Vegetation Index identified 48 species of wetland vegetation growing in the four selected sections along Lake Eckles. The majority of these species (37) are native species. The remaining 11 species (*Hydrilla verticillata*, *Ludwigia peruviana*, *Melaleuca quinquenervia*, *Oxycaryum cubense*, *Panicum repens*, *Shinus terebinthifolius*, *Sphagneticola trilobata*, *Casuarina equisetifolia*, *Colocasia esculenta*, *Cyperus alternifolius*) are non-native and invasive to this region. The vegetation community of Lake Eckles is Co-dominated by submerged and emergent vegetation species including *Hydrilla verticillata* and *Melaleuca quinquenervia* (Figure 5). The emergent vegetation zone was dominated by *Melaleuca quinquenervia* and *Panicum repens*. The water's surface in Lake Eckles was dominated by *Nuphar* (Figure 6). The calculated LVI score for Lake Eckles was 33, below the impairment threshold of 37. Figure 7 shows the map of Lake Eckles detailing the LVI regions used for the assessment. Table 2 details the species list results of the Lake Vegetation Index. In Table 2, plant species in bold indicate non-native, invasive species. The CofC column is a measure of each individual plant Coefficient of Conservatism, a measure of each species fidelity to a natural undisturbed Florida habitat. For CofC, a higher value indicates sensitive native species and a higher fidelity to undisturbed Florida systems. In each Region, a "1" indicates the species was present and a "D" or a "C" indicates that the species was Dominant or Co-dominant in the region. Table 3 details the scoring result for the Lake Vegetation Index. Submerged vegetation was commonly observed during the assessment, dominated by *Hydrilla verticillata* with *Vallisneria americana* locally abundant. By analyzing the collected sonar chart,

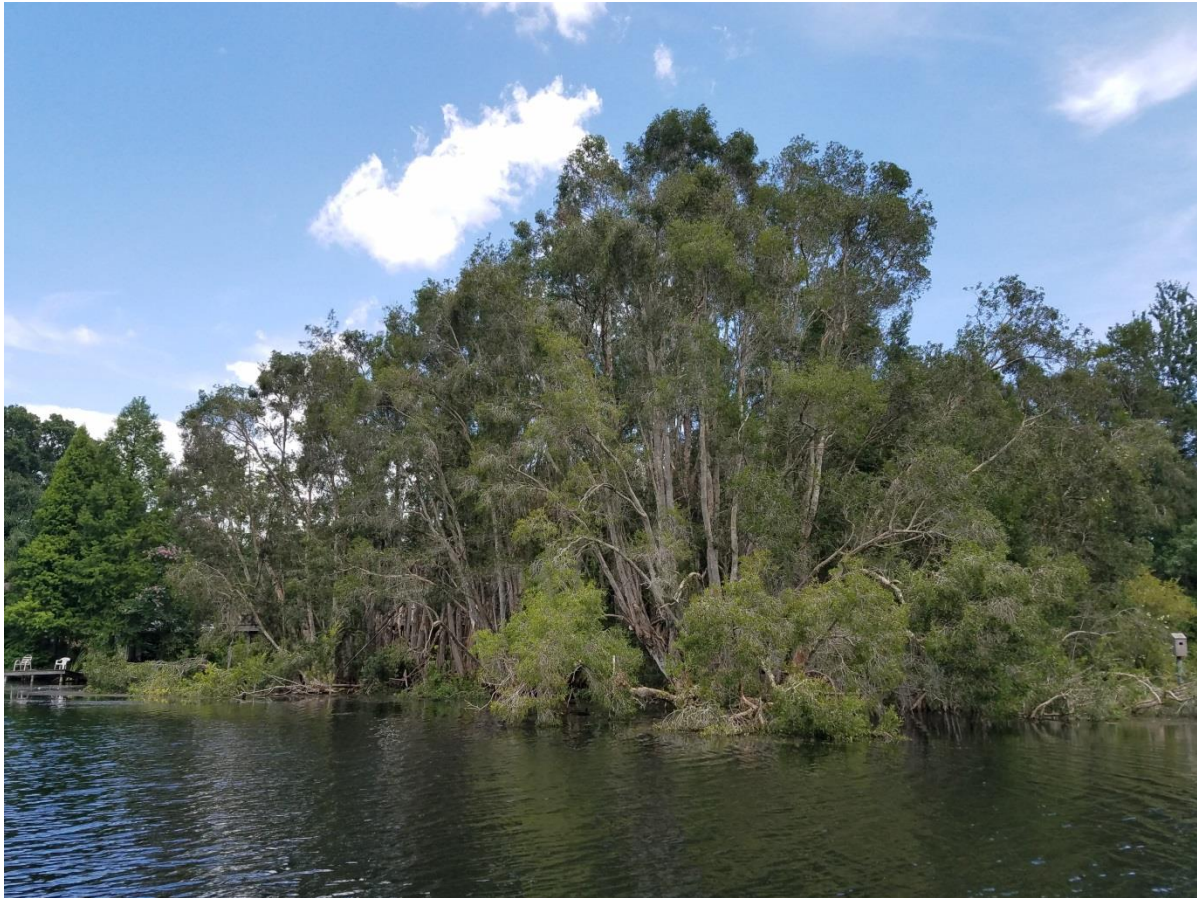
Figure 5 *Melaleuca quinquenervia* on Lake Eckles.

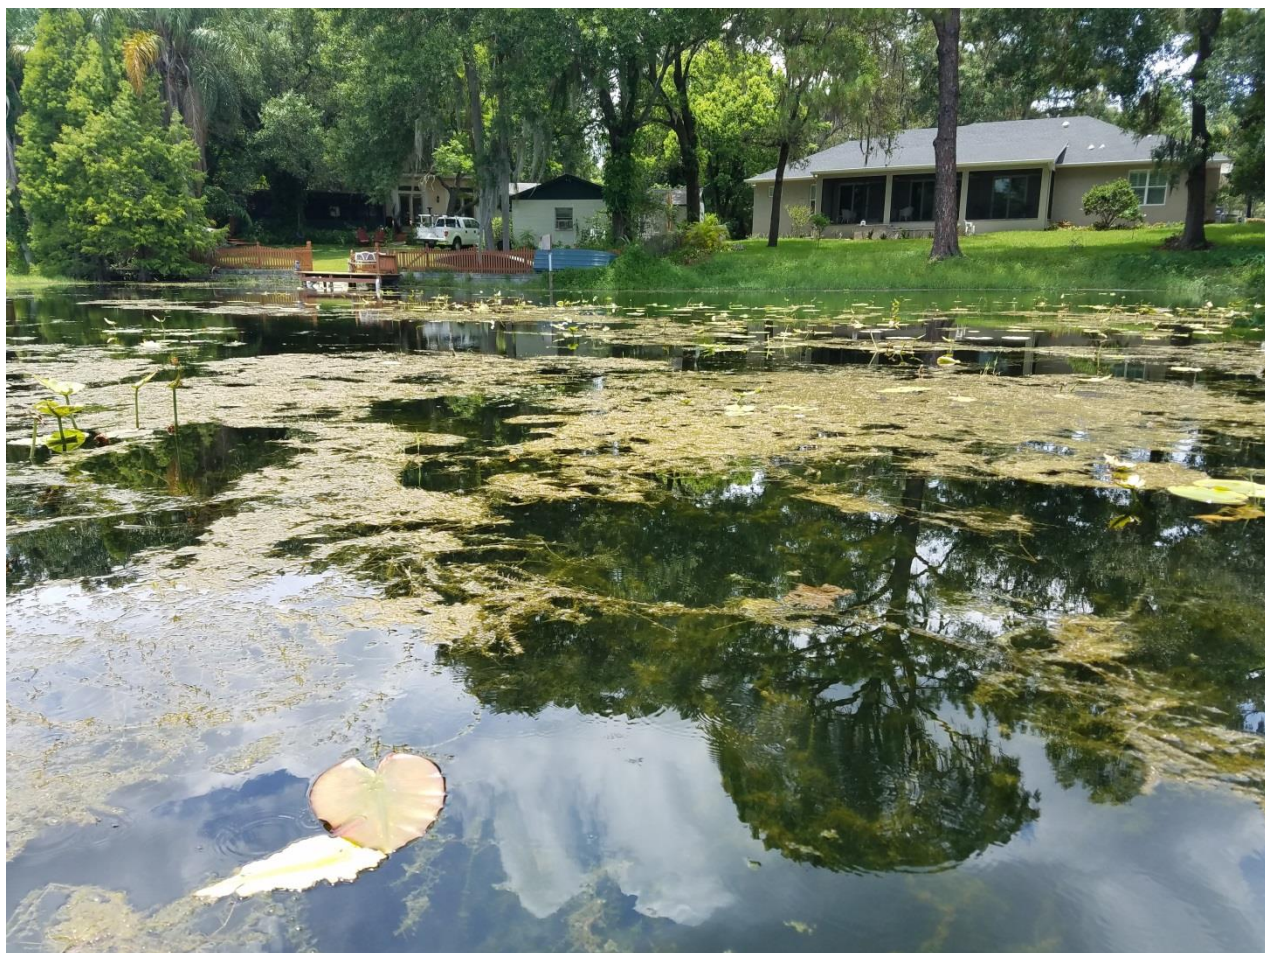
Figure 6 *Nuphar* was observed among the *hydrilla* on Lake Eckles.
