# Lake Eckles

LAKE HABITAT ASSESSMENT, LAKE VEGETATION INDEX, SUBMERGED  
VEGETATION SURVEY AND WATER QUALITY

David Eilers, Karina Gonthier | USF Water Institute | August 21, 2023

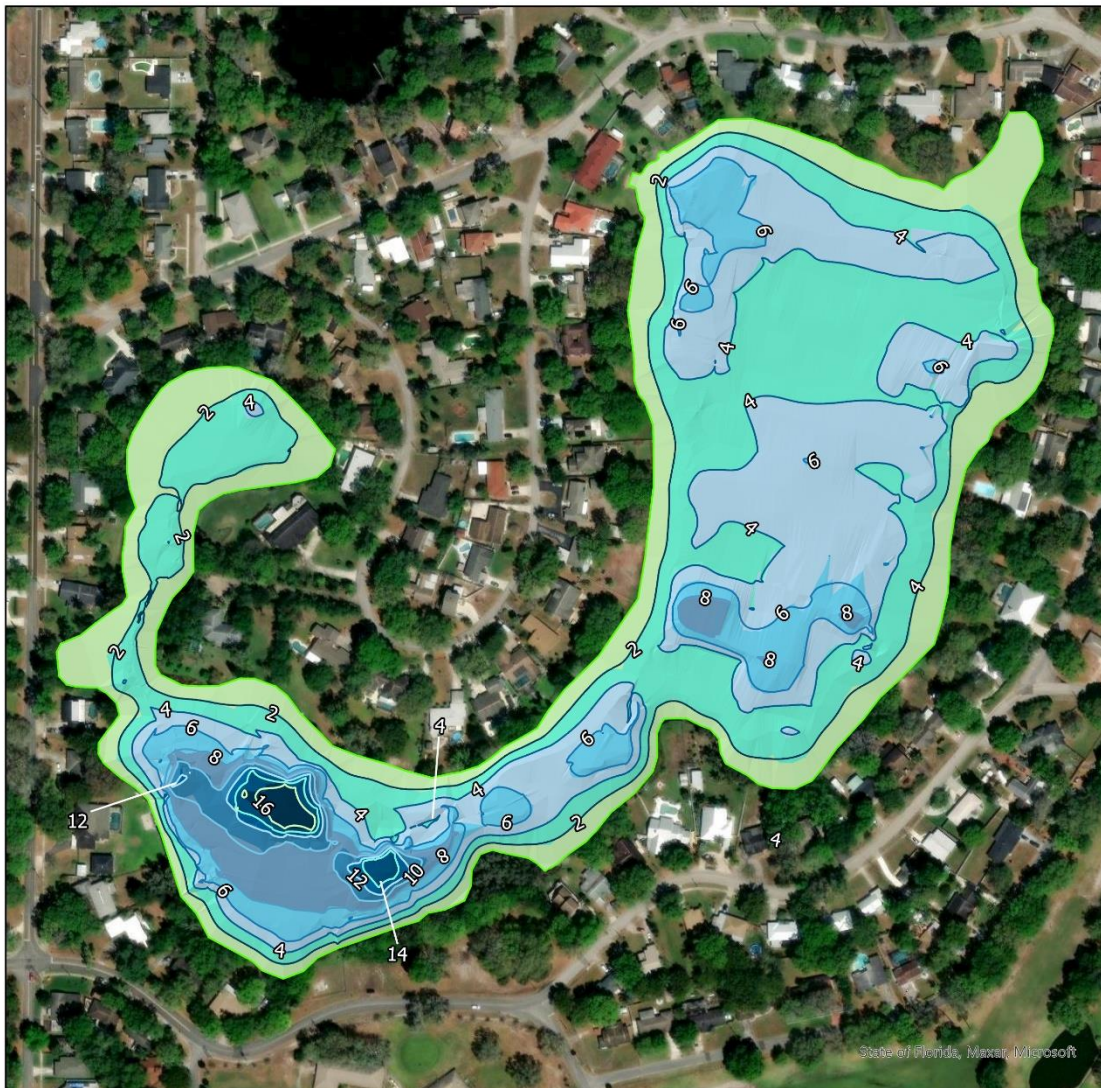
Figure 2: 2023 2-Foot Bathymetric Contour Map for Lake Eckles

At the time of the assessment, Lake Eckles was experiencing normal water levels (28.87 feet NAVD88 on staff gauge) resulting in a 28.0 acre water body. Lake Eckles at the time of the assessment had a mean water depth of 4.1 feet and a maximum observed depth of 17.98 feet. The volume at this time was approximately 37,045,398 gallons. Figure 2 shows the resulting bathymetric contour map for Lake Eckles from data collected on August 21, 2023. The collected data has been overlain the 2022 ESRI Basemap aerials.

EXPLANATION:  
 Survey Date: August 21, 2023  
 Water level was 28.87 NAVD88  
 at the time of the assessment.  
 Contours are expressed in absolute  
 depth below this level.

LAKE MORPHOLOGY:  
 Perimeter 8,272 ft;  
 Area 28.0 Acres;  
 (1,218,816 Sqft)  
 Mean Depth 4.1 ft;  
 Volume 113.7 Acre-ft,  
 (37,045,398 gallons);  
 Deepest point 17.98 ft

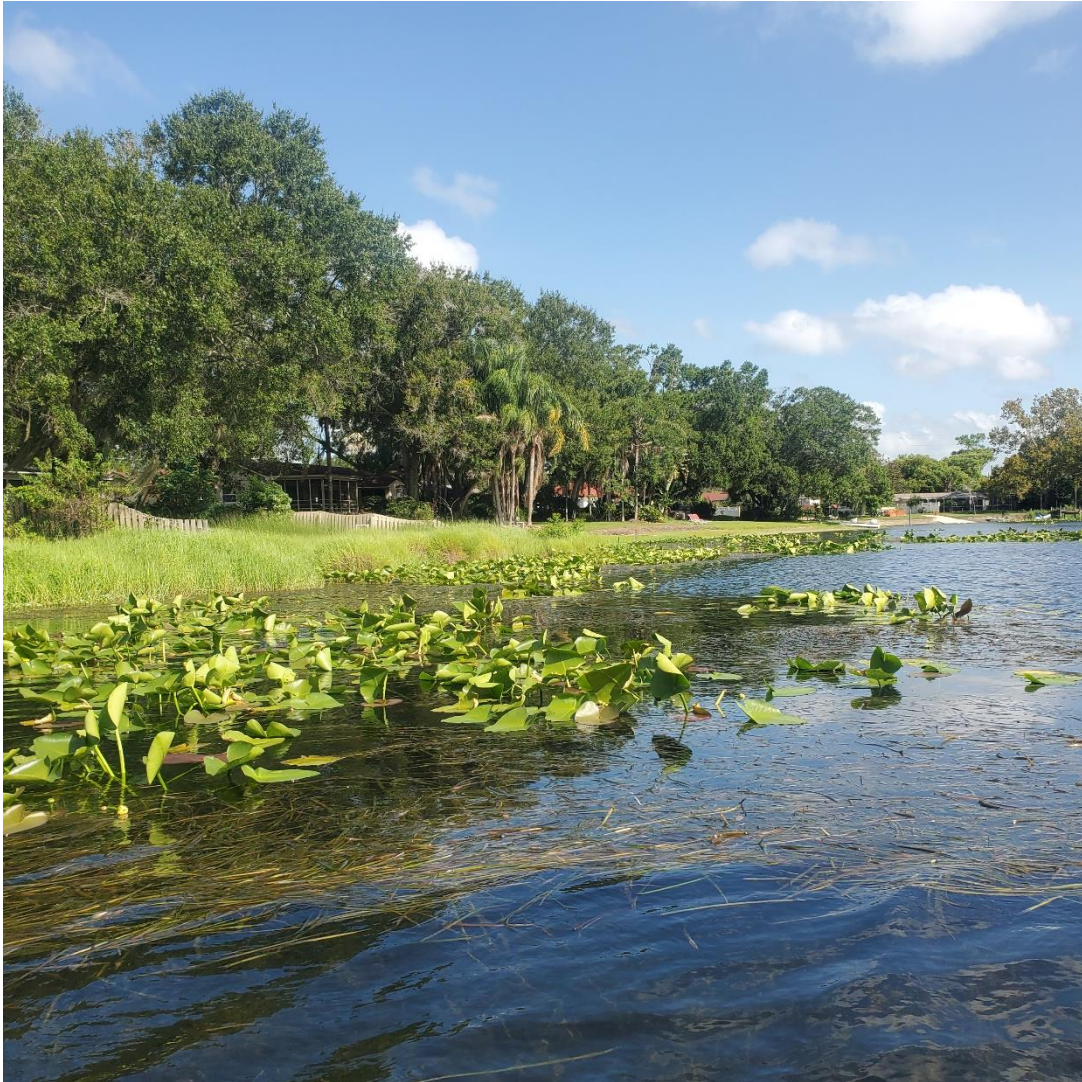
Figure 3 Overview photograph of Lake Eckles showing the typical residentially developed shoreline along region 2 of the Lake Vegetation Index.

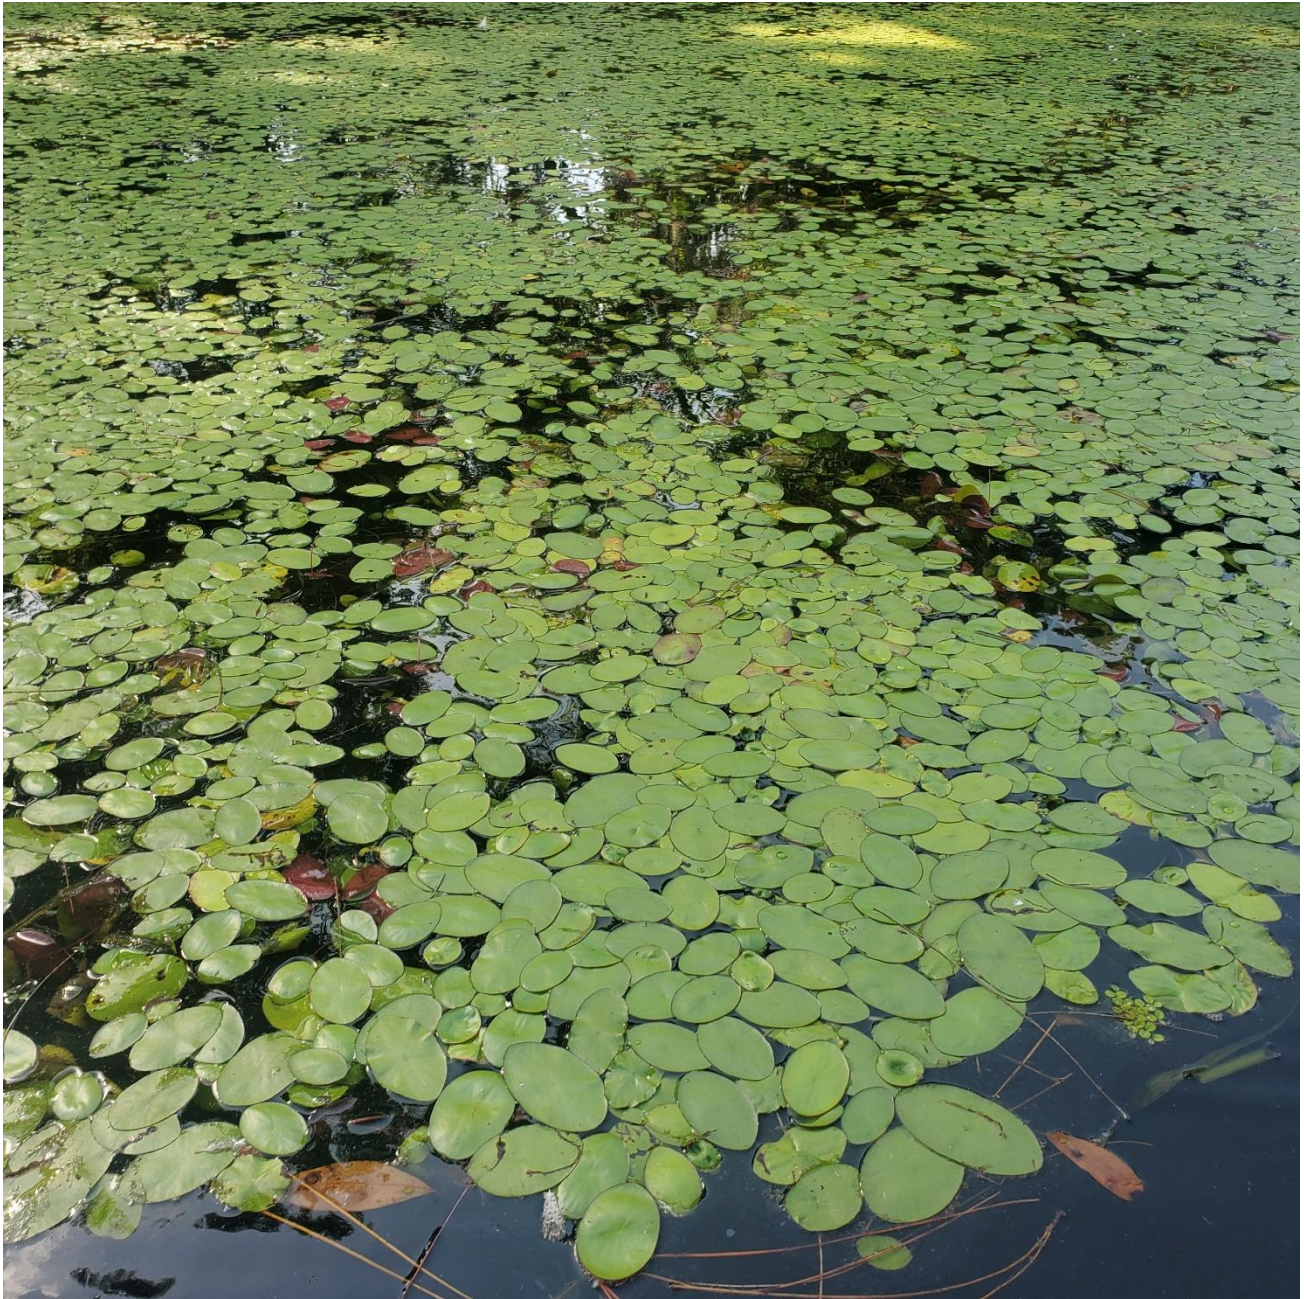
*Figure 4 Brasenia schreberi, Water Shield was co-dominant in region 11 of the Lake Vegetation Index on Lake Eckles*

The Lake Vegetation Index identified 37 species of wetland vegetation growing in the four selected sections along Lake Eckles. The majority of these species (26) are native species. The remaining 11 species (*shown in **bold** in Table 2*) are non- native or invasive to this region. The edges of the lake are dominated by species able to rapidly colonize following the frequent disturbance of mowing, such as *Panicum repens* and *Ludwigia peruviana*. At the time of the assessment the water transparency was 1.89 m (6.2 ft). High annual average secchi disk depths allow for an extensive littoral zone with establishment of floating leaved and submerged aquatic vegetation. Four species of submersed aquatic vegetation were observed during the lake vegetation index. *Vallisneria americana* was dominant or co-dominant species in LVI regions 2, 5 and 8. The floating leaved vegetation community had 6 species observed with *Nuphar* being co-dominant in LVI regions 5, 8 and 11.

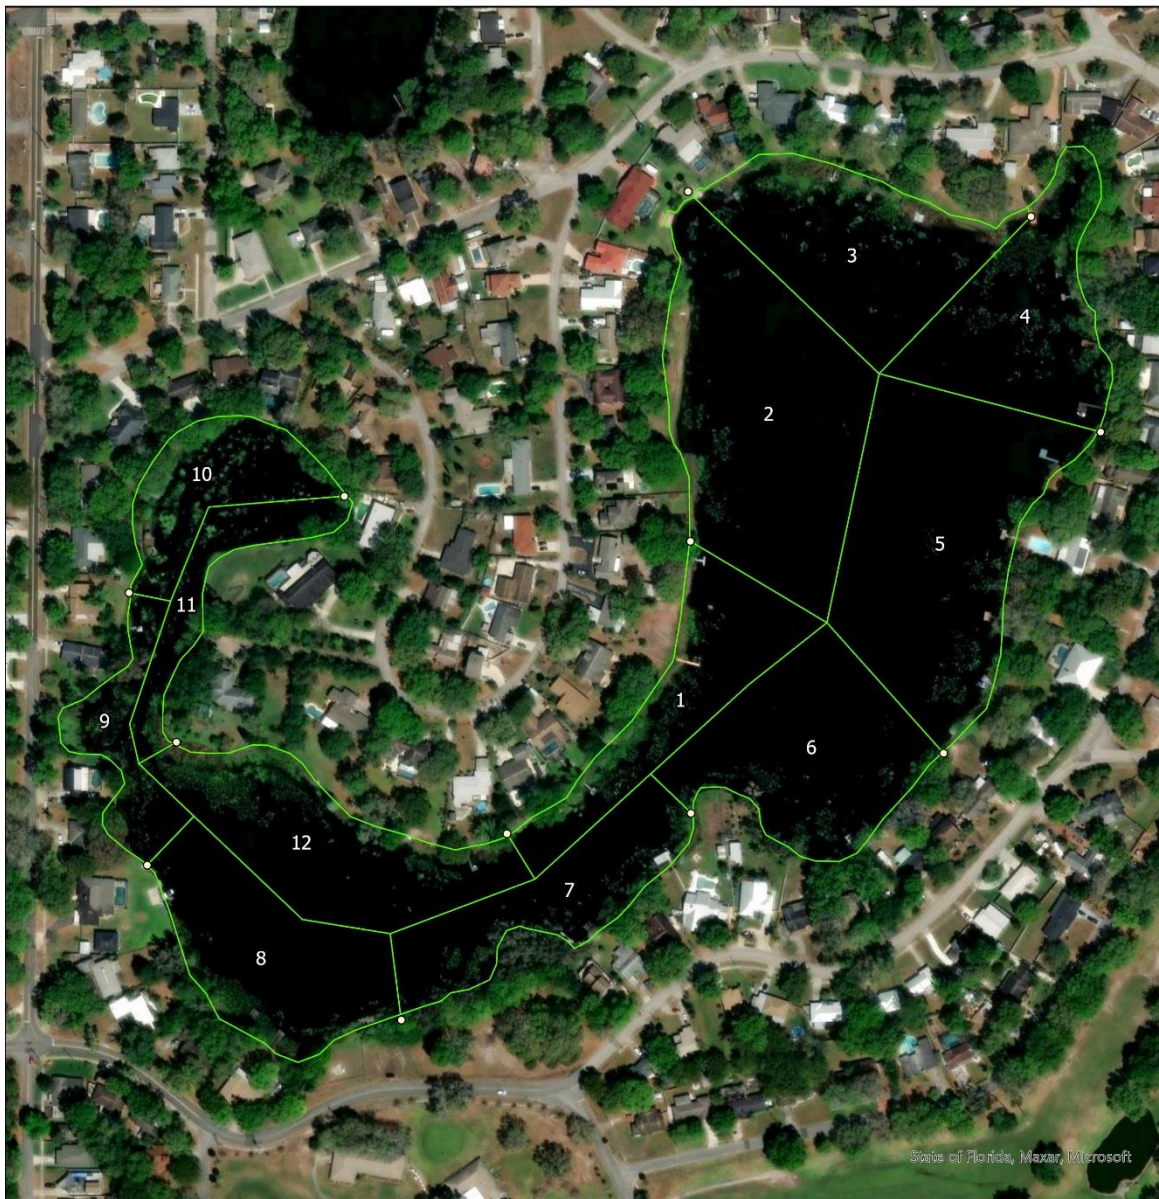
Figure 6: Lake Vegetation Index region map for Lake Eckles

The calculated LVI score for Lake Eckles was 48, above the impairment threshold of 43 indicating the vegetation community is showing evidence of being “Healthy”. Figure 6 shows the map of Lake Eckles detailing the LVI regions used for the assessment (Regions 2, 5, 8, 11). Table 2 details the species list results of the Lake Vegetation Index. Table 3 details the scoring result for the Lake Vegetation Index.

Sample Date - August 21, 2023  
Regions Assessed - 2, 5, 8, 11  
Dominant Species per Region -  
2 - *Vallisneria americana*  
5 - *Nymphaea odorata*,  
*Vallisneria americana*  
8 - *Nymphaea odorata*,  
*Vallisneria americana*  
11 - *Nymphaea odorata*,  
*Brasenia schreberi*

Lake Description  
Water Clarity - 1.9m (6.2ft)  
Color - Slightly Turbid, Clear  
Sediment Types - Sandy/Silt, Vegetated  
Lake Vegetation Index - 48
