# Lake Grady

LAKE HABITAT ASSESSMENT, LAKE VEGETATION INDEX, SUBMERGED  
VEGETATION SURVEY AND WATER QUALITY

David Eilers, Karina Gonthier | USF Water Institute | August 7, 2023

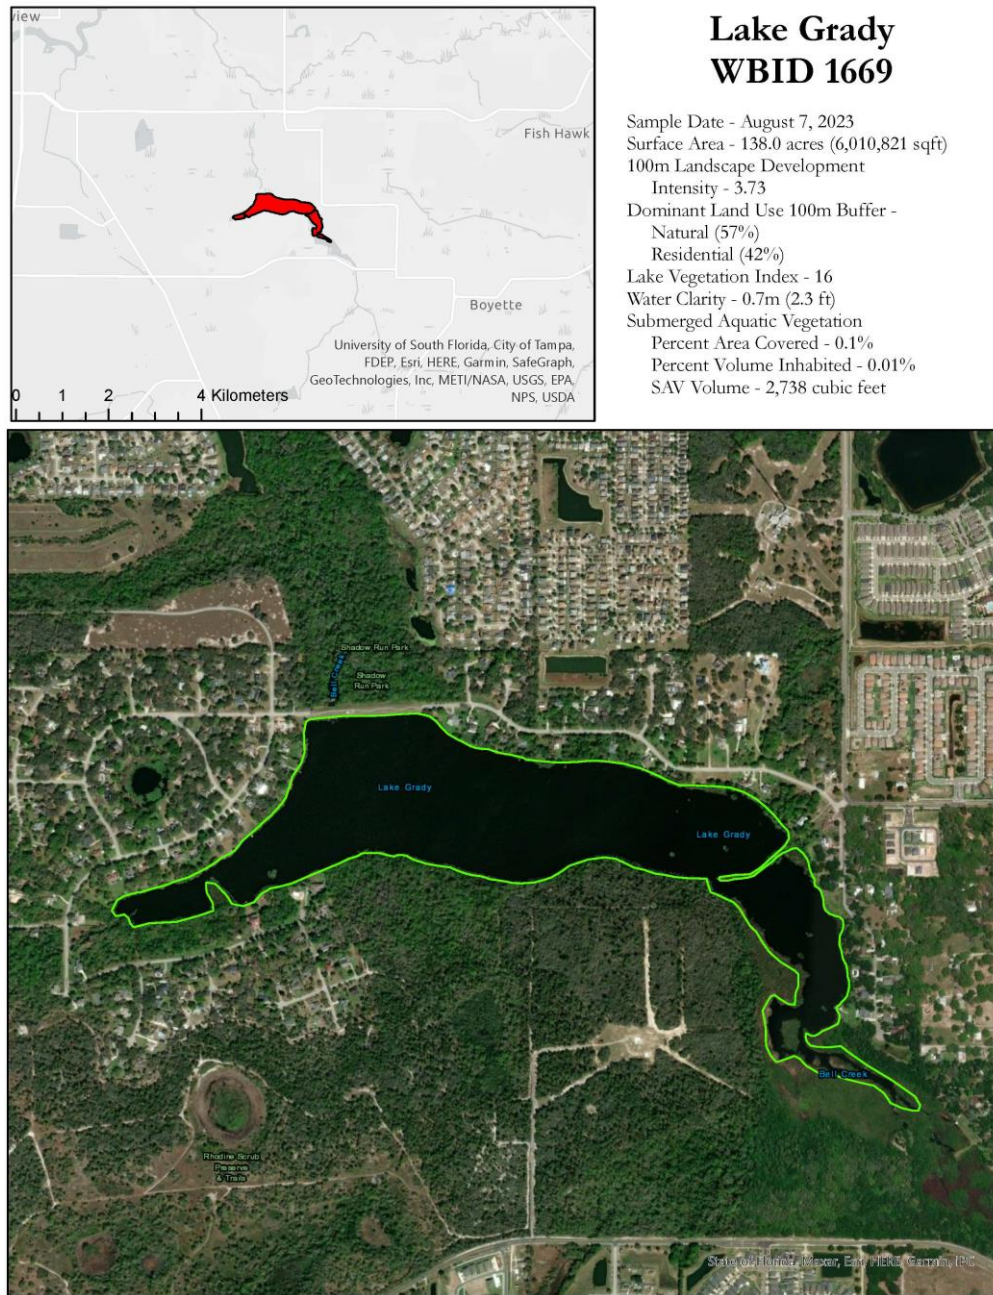
FIGURE 1: 2023 LAKE GRADY ASSESSMENT STUDY AREA MAP

Lake Grady is located in the Hillsborough Bay Watershed in central Hillsborough County, Florida. The Landscape Development Intensity Index of the 100 meter buffer around Lake Grady is dominated by natural (57%) and residential (42%) land uses. The resulting LDI value for the 100 meter buffer around Lake Grady is 3.73.

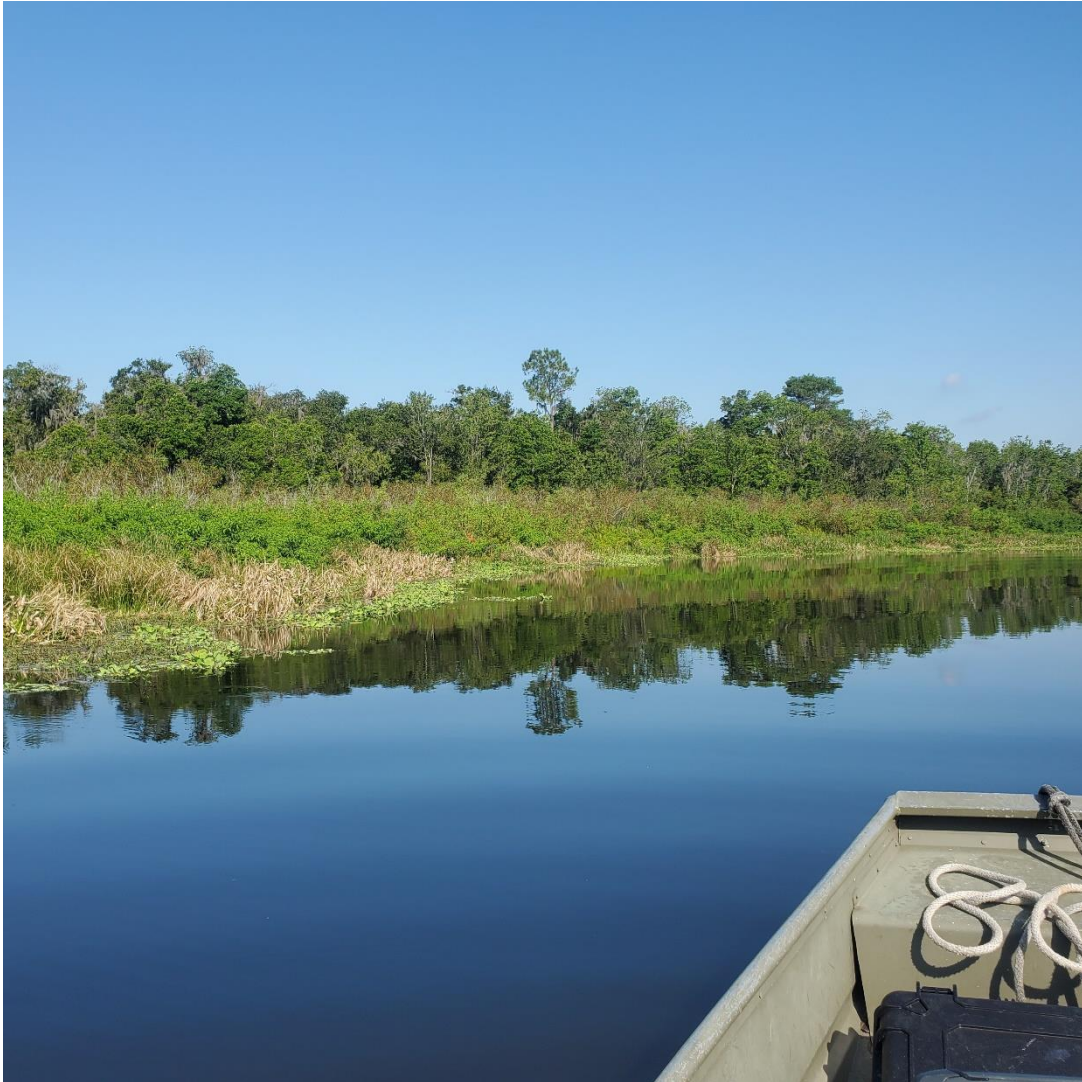
Figure 3 Overview photograph of Lake Grady showing the undeveloped portion of shoreline along region 7 of the Lake Vegetation Index.

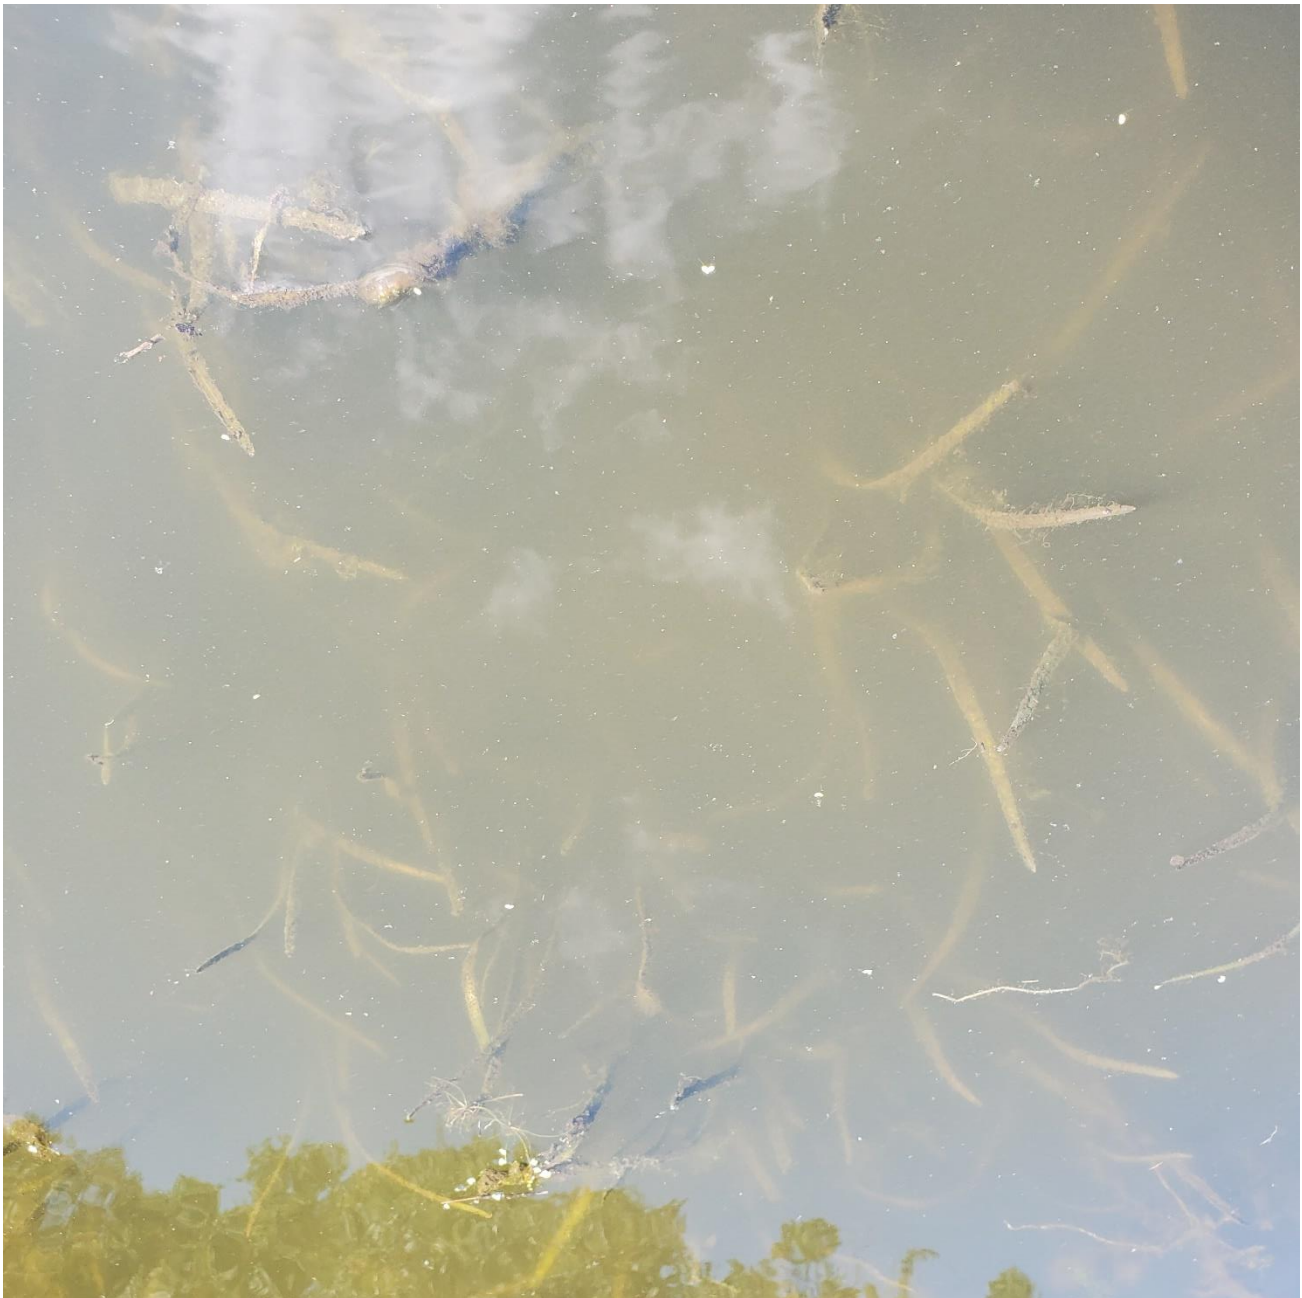
*Figure 4 Vallisneria americana, Tapegrass, was the only rooted submersed vegetation observed during the LVI. This shallow bed was observed in region 10.*

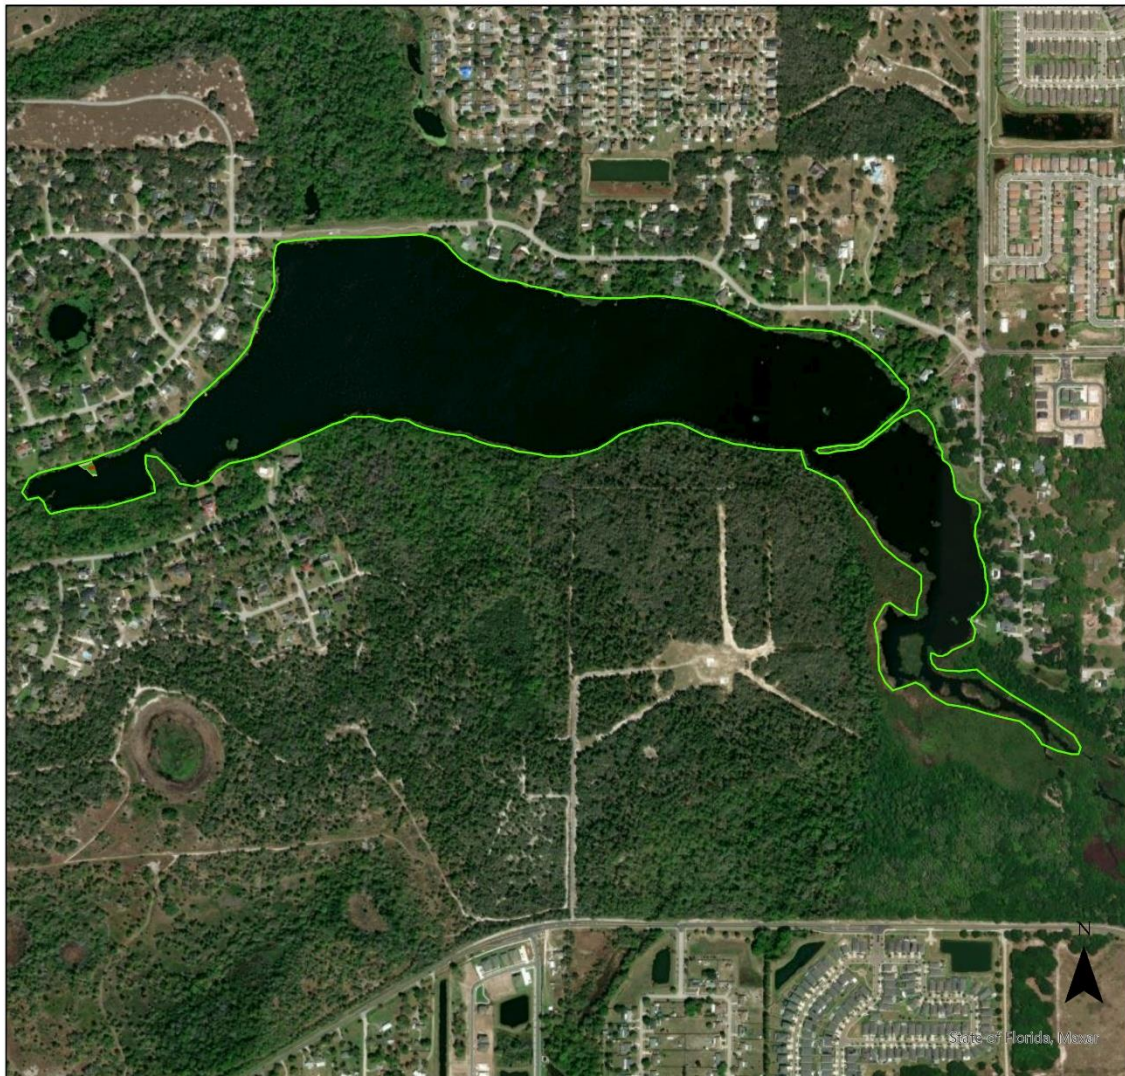
Figure 5 Lake Grady Submerged Aquatic Vegetation Assessment Results

By analyzing the collected sonar chart, submerged aquatic vegetation potentially covered approximately 0.1% of the surface area of Lake Grady. This submerged vegetation inhabits an estimated 0.01% of the water volume in Lake Grady. Figure 5 shows the results of the SAV analysis indicating the location and height of SAV estimated from collected sonar readings.

Survey Date: August 7, 2023  
 Water level was 35.26 ft NAVD88 at the time of the assessment.  
 Submerged Aquatic Vegetation was analyzed from collected sonar data.  
 The height of the SAV where present is shown in 0.5 foot increments.

Area 6,226 square ft; 0.1 Acres;  
 (0.1% of Lake Surface Area)  
 Mean SAV Height 0.4 ft;  
 Volume 2,738 Cubic ft, (20,482 gallons);  
 (0.01% of Lakes Volume)

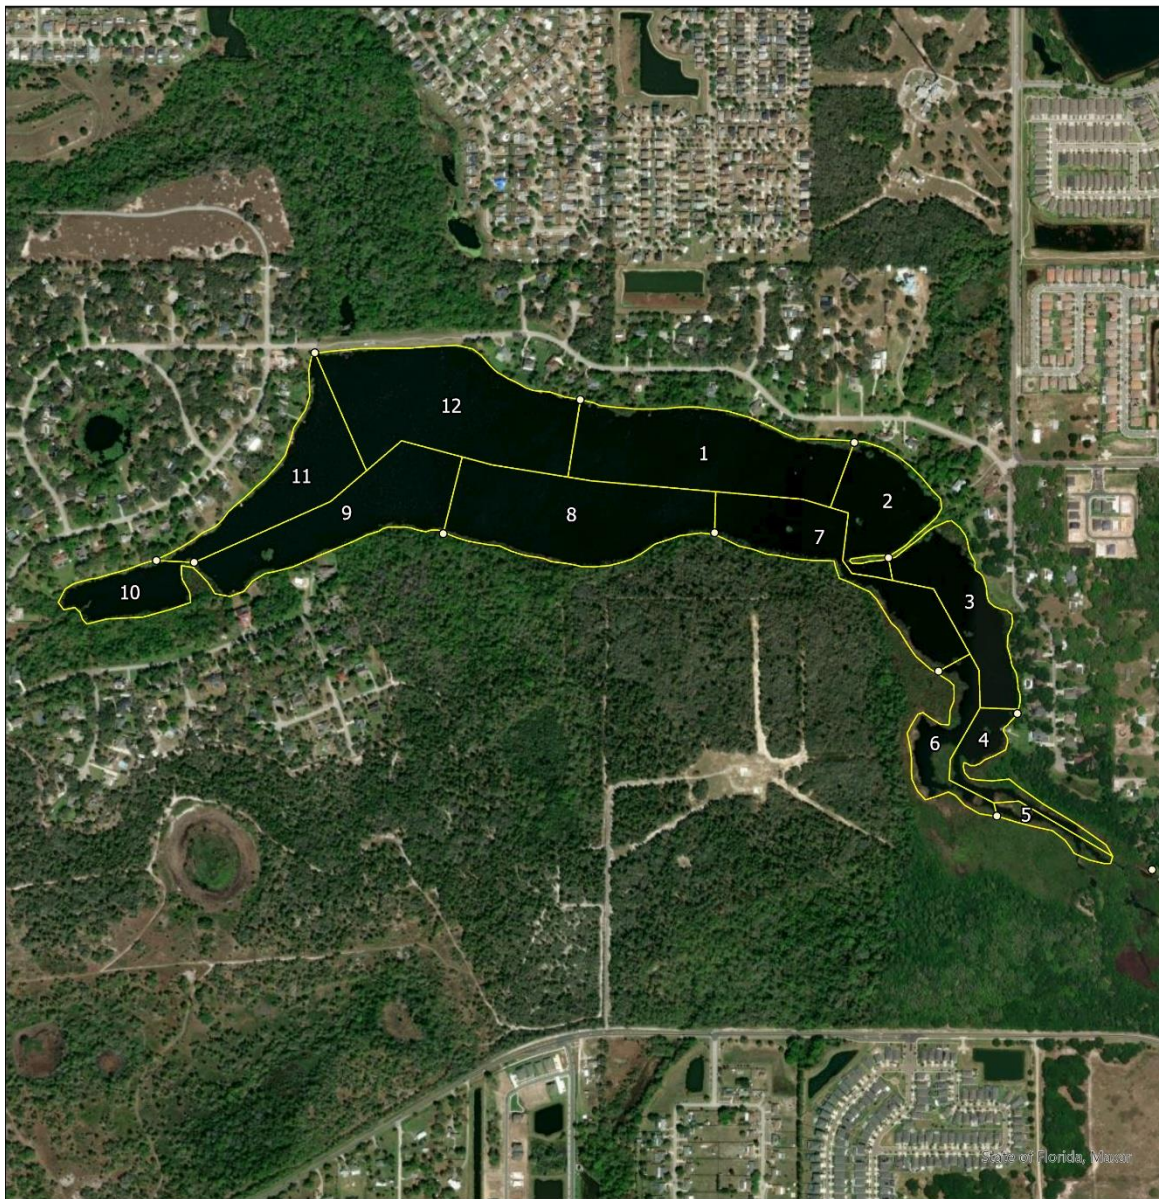
Figure 6: Lake Vegetation Index region map for Lake Grady

The calculated LVI score for Lake Grady was 16, below the impairment threshold of 43 indicating the vegetation community is showing evidence of being “Impaired”. Figure 6 shows the map of Lake Grady detailing the LVI regions used for the assessment (Regions 1, 4, 7, 10). Table 2 details the species list results of the Lake Vegetation Index. Table 3 details the scoring result for the Lake Vegetation Index.

Sample Date - August 7, 2023  
Regions Assessed - 1, 4, 7, 10  
Dominant Species per Region -  
1 - *Ludwigia peruviana*,  
*Pistia stratiotes*  
4 - *Ludwigia peruviana*,  
*Pistia stratiotes*  
7 - *Urochloa mutica*,  
*Pistia stratiotes*  
10 - *Alternanthera philoxeroides*,  
*Pistia stratiotes*

Lake Description  
Water Clarity - 0.7m (2.3ft)  
Color - Slightly Turbid, Tannic  
Sediment Types - Sandy/Silt, CPOM,  
Lake Vegetation Index - 16
